# Northern Divide Energy Storage, LLC

## Northern Divide Energy Storage Project, Burke County

### Case No. PU-24-371

#### Construction Inspection Report

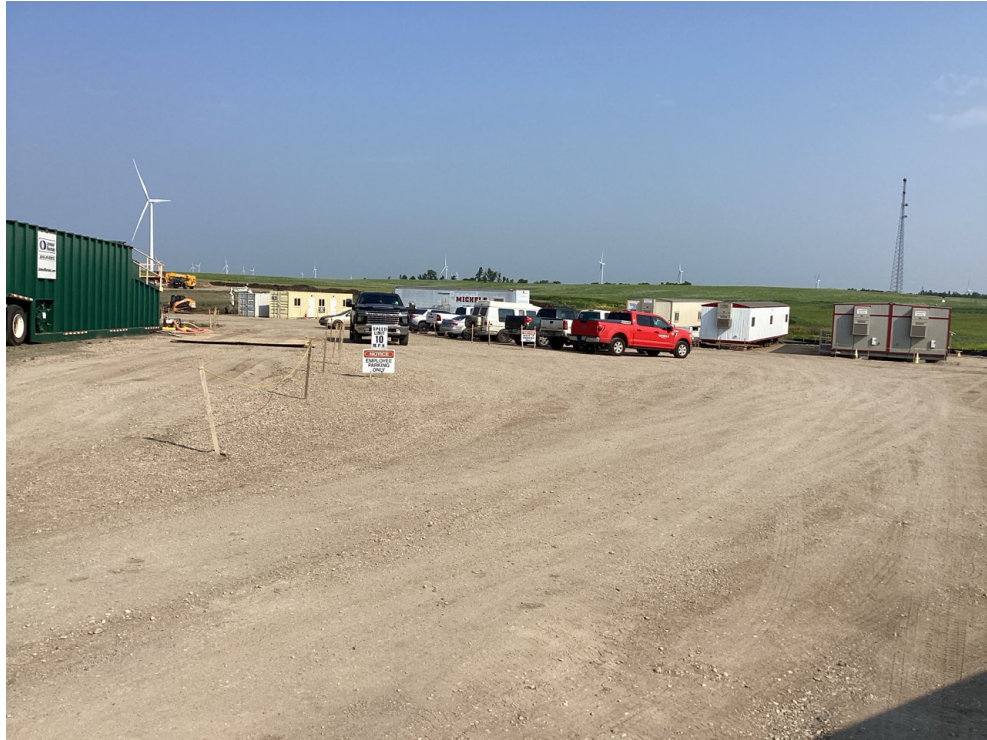
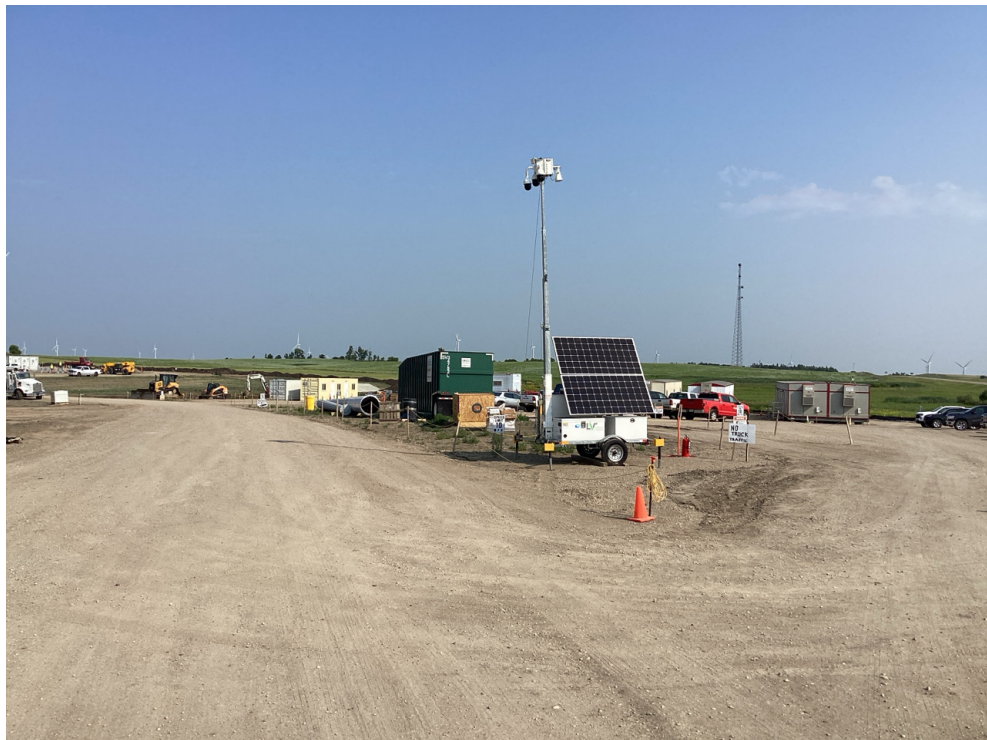
**Photo Number:** 1-2

**Location:** Parking lot general -

**Notes:** Gravel and maintained

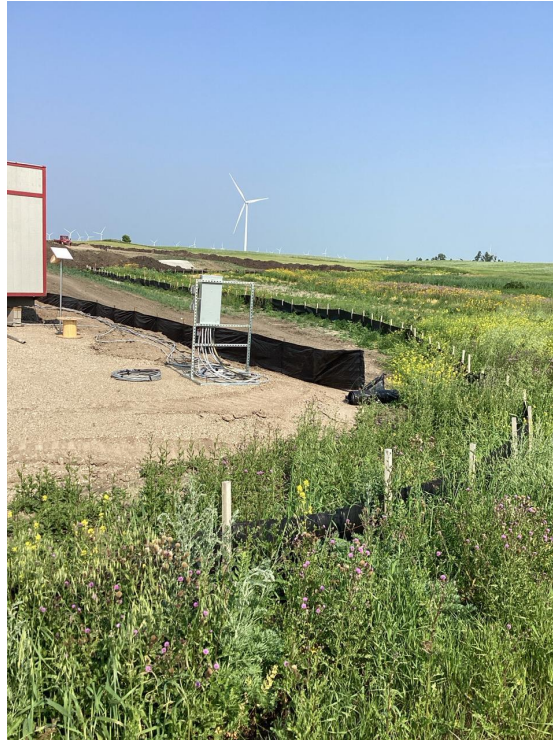
**Photo Number:** 3

**Location:** Parking lot NE corner

**Notes:** Erosion control in place for gravel parking lot to mitigate any soil runoff

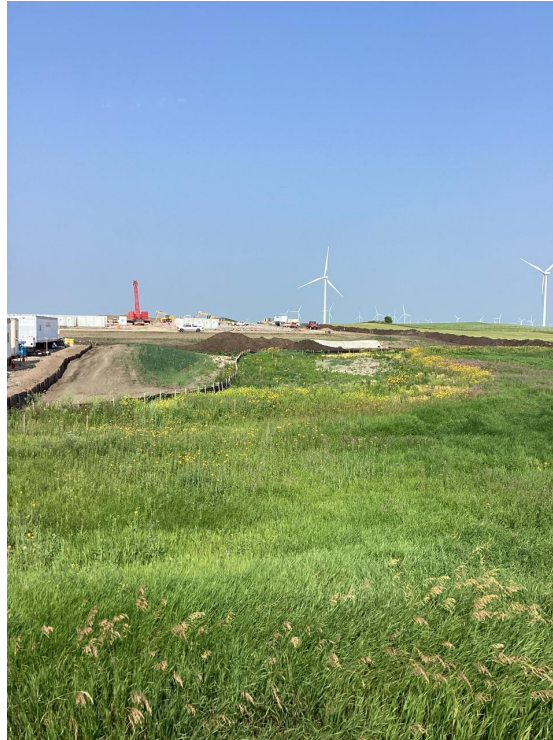
**Photo Number:** 4

**Location:** Shoulder of ND 40

**Notes:** Silt fence protection and topsoil segregation

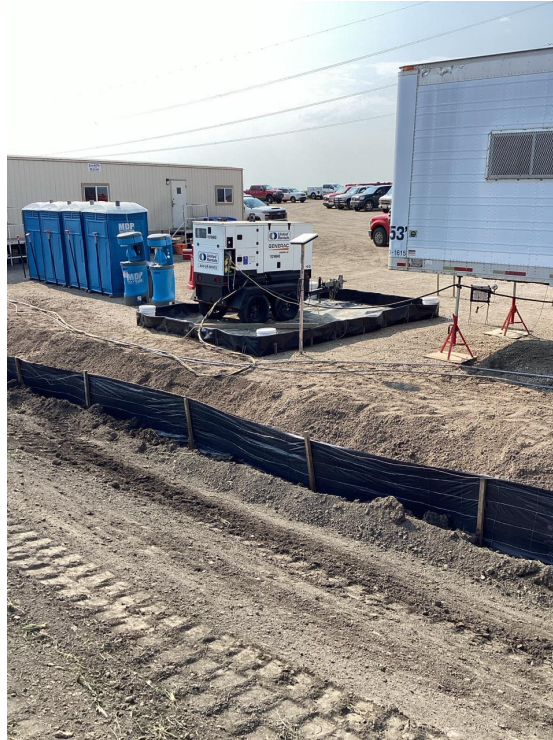
**Photo Number:** 5

**Location:** N side of staging area

**Notes:** Fuel containment example

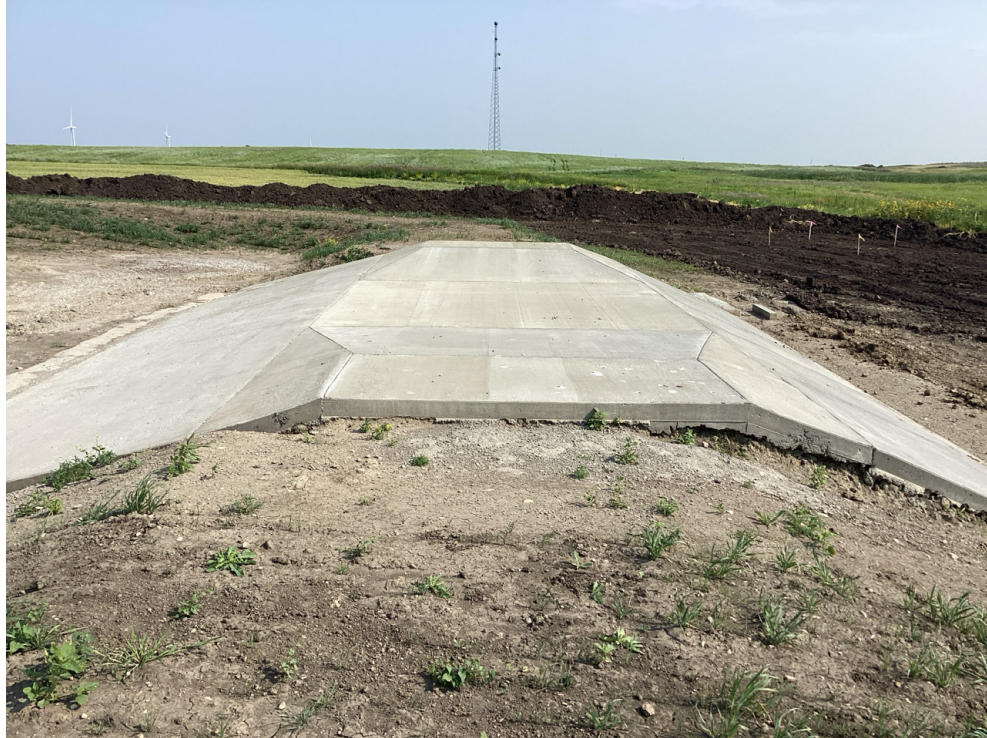
**Photo Number:** 6

**Location:** Storm water pond outlet

**Notes:** Installed and ready for outlet protection at ditch bottom

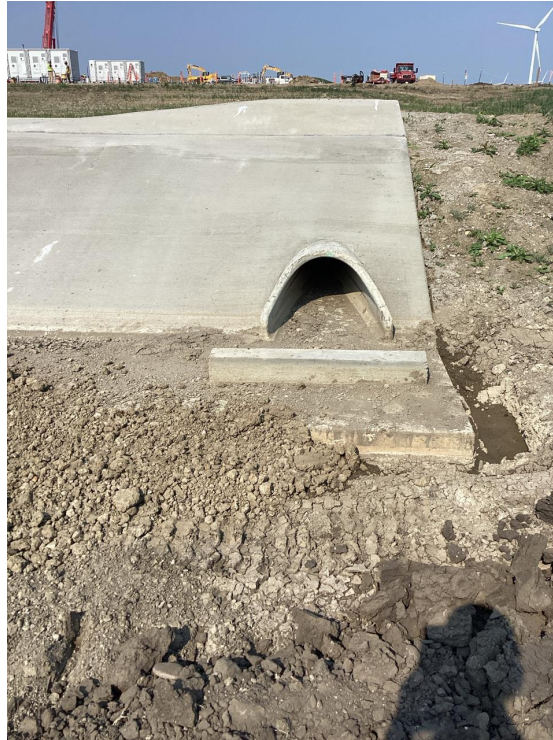
**Photo Number:** 7

**Location:** Storm water pond outlet

**Notes:** Low flow pond outlet

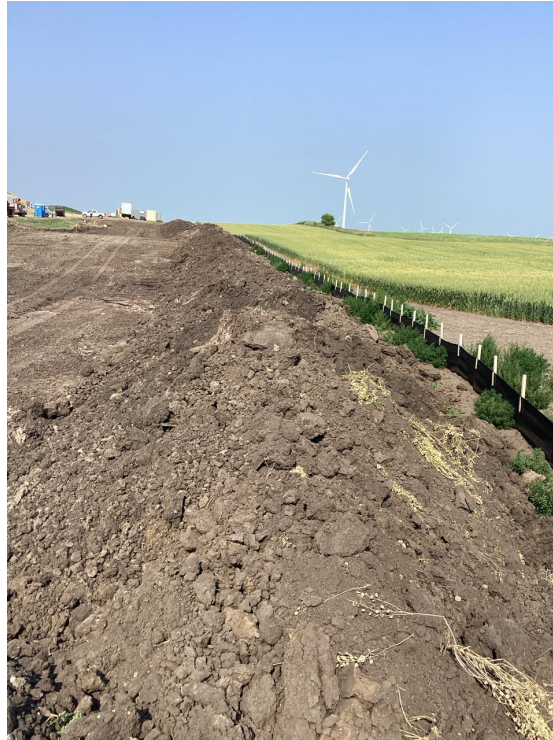
**Photo Number:** 8

**Location:** North side of site

**Notes:** Topsoil segregated with erosion control in-place

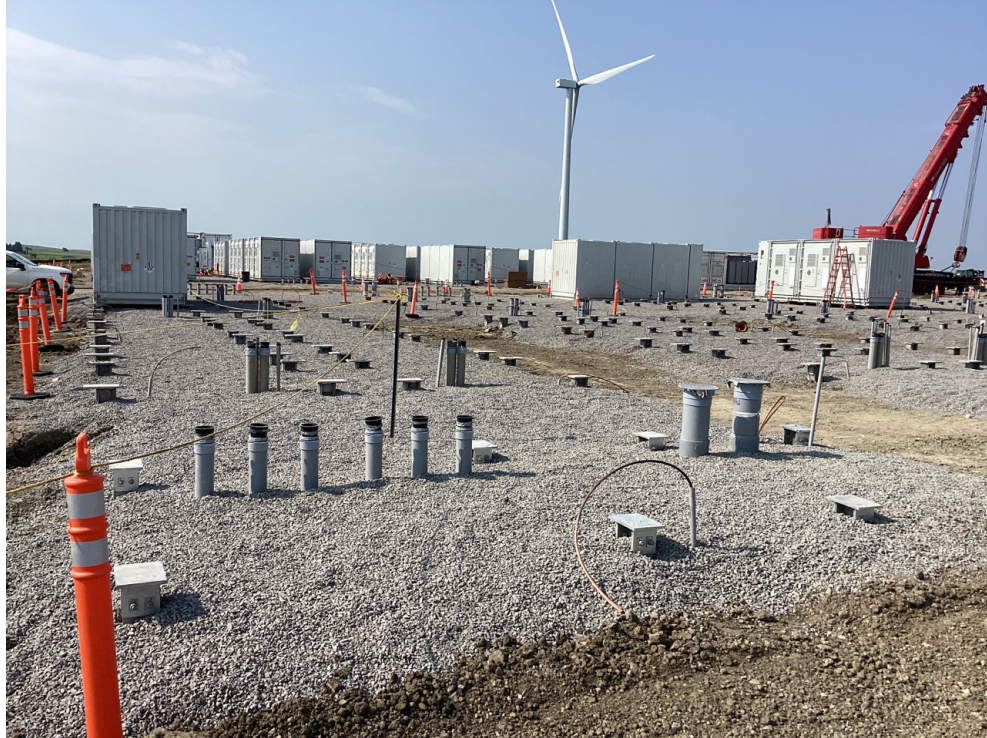
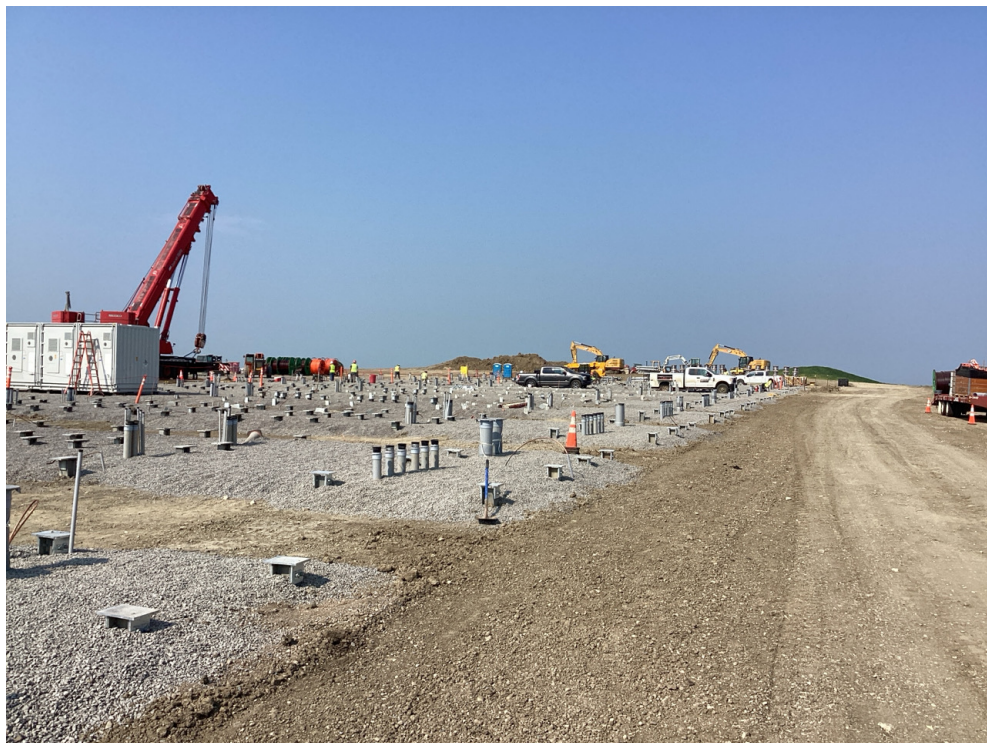
**Photo Number:** 9-10

**Location:** NE of battery pack site

**Notes:** Battery pack site

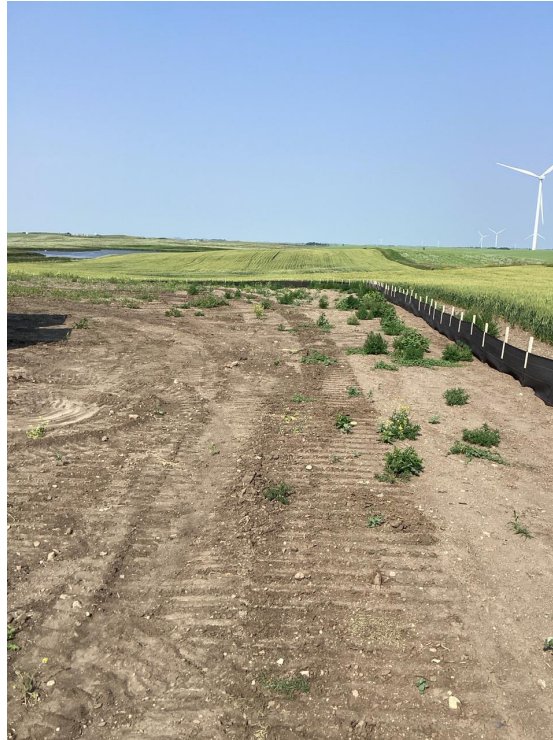
**Photo Number:** 11

**Location:** NW corner of site

**Notes:** Erosion control continuous

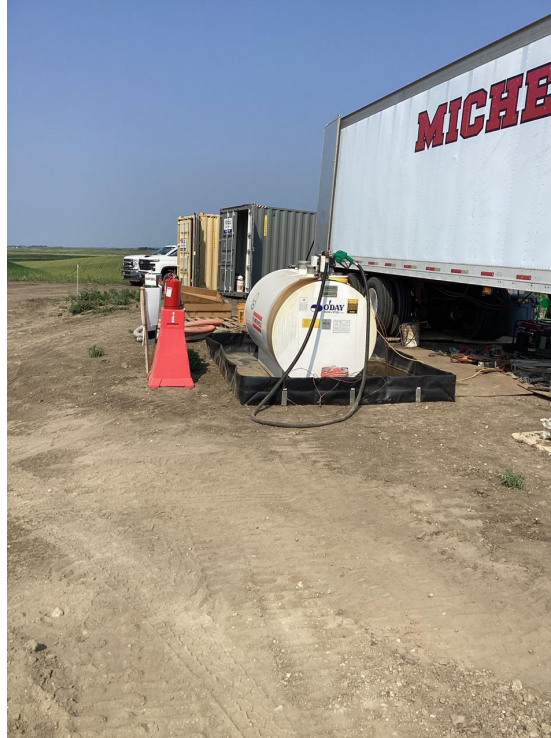
**Photo Number:** 12

**Location:** NW corner of site

**Notes:** Example fuel storage containment

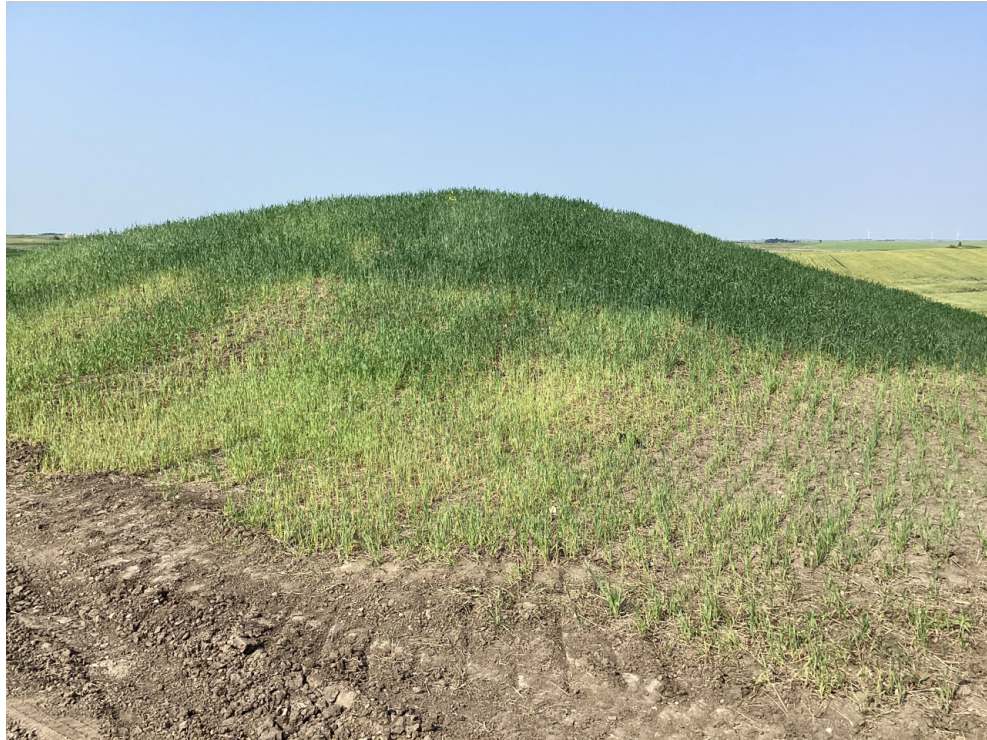
**Photo Number:** 13

**Location:** NW corner of site - topsoil

**Notes:** Topsoil was seeded for erosion control measure

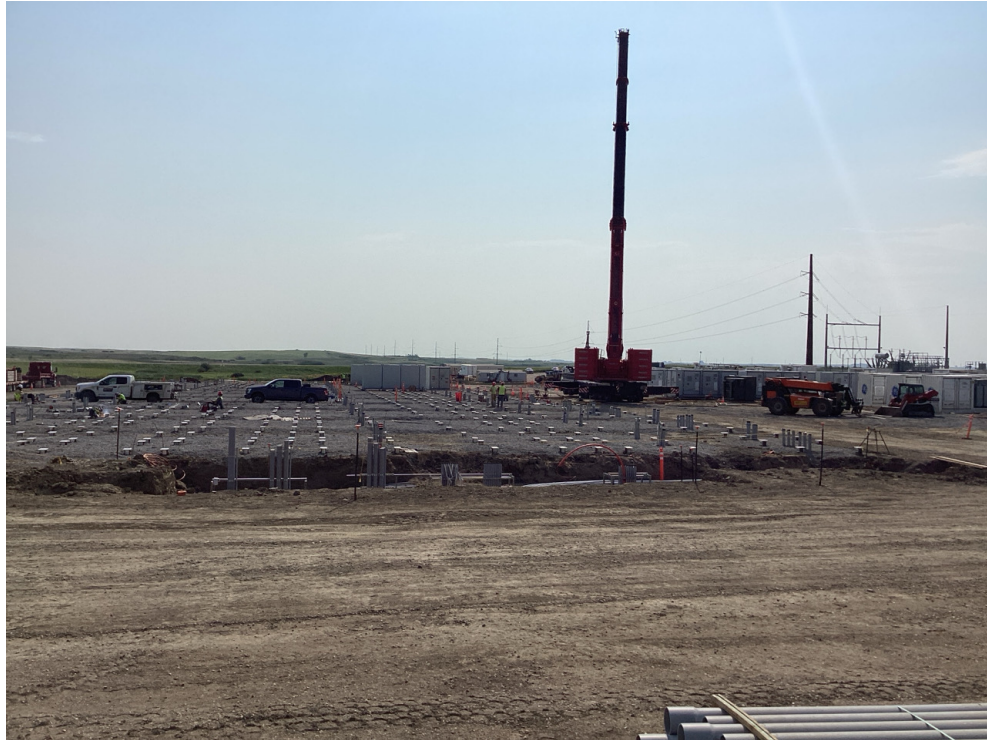
**Photo Number:** 14

**Location:** West side of site - Battery Pack Area

**Notes:** Site work area

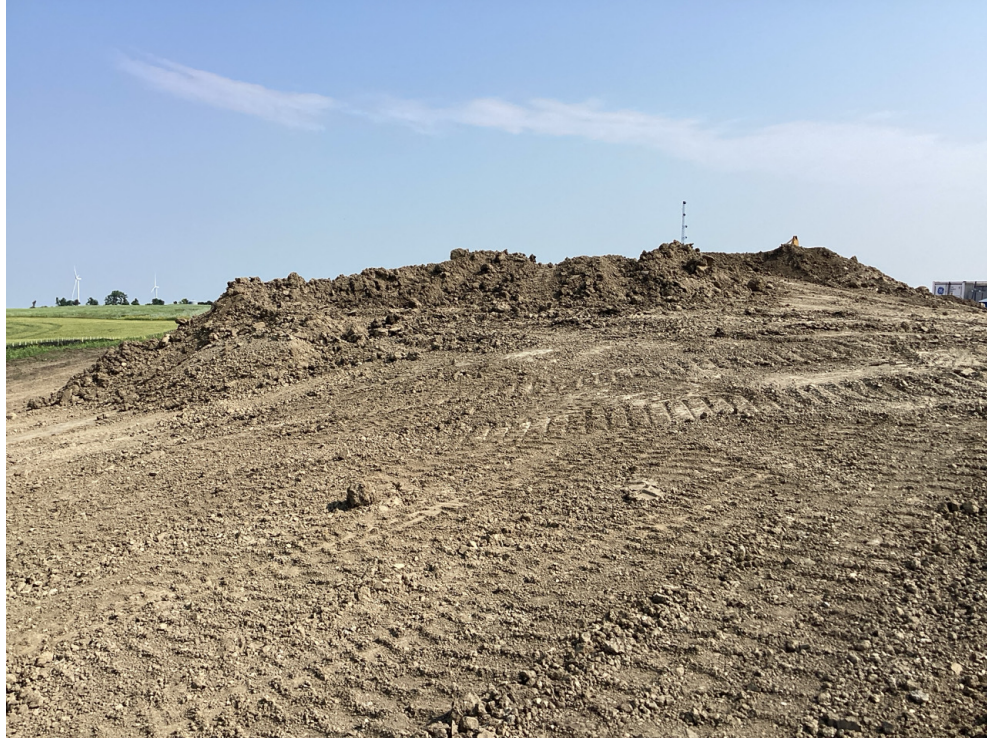
**Photo Number:** 15

**Location:** West side of site

**Notes:** Subsoil storage area on west side of site

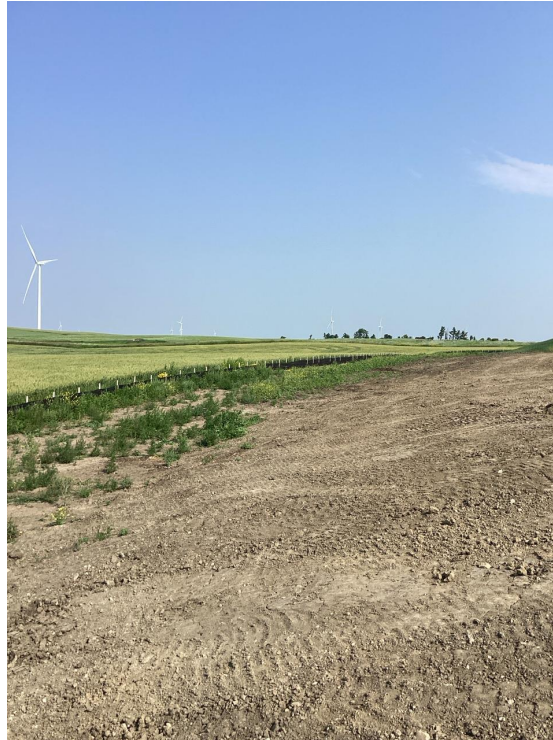
**Photo Number:** 16

**Location:** West side of site - erosion control

**Notes:** Continuous erosion control silt fence in place

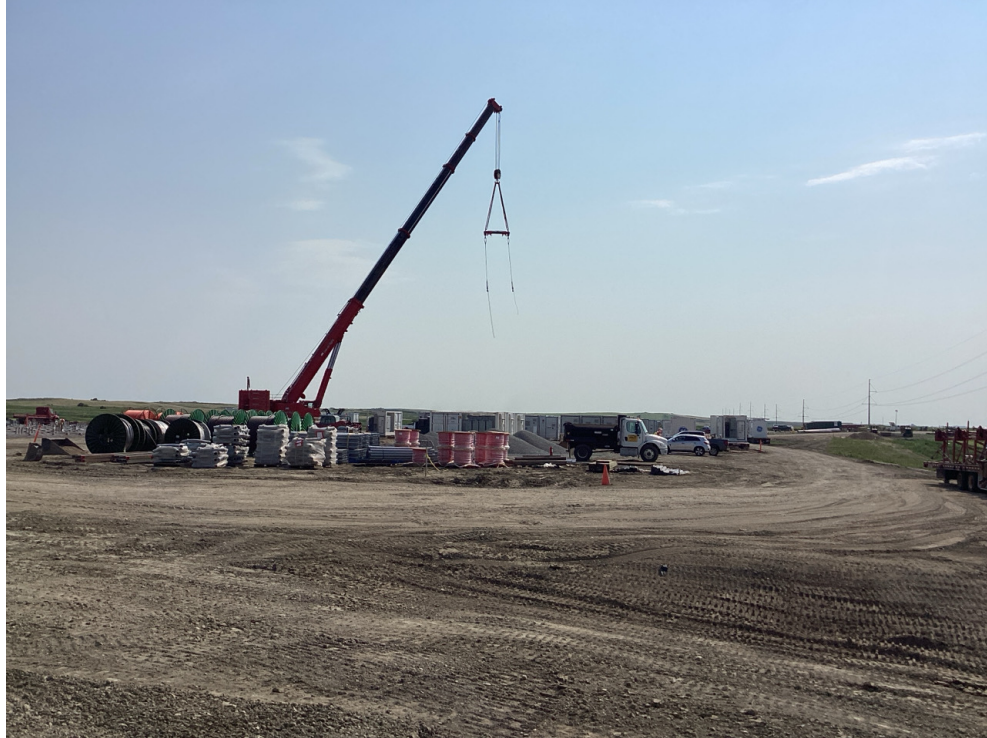
**Photo Number:** 17

**Location:** South side of site

**Notes:** Battery pack area

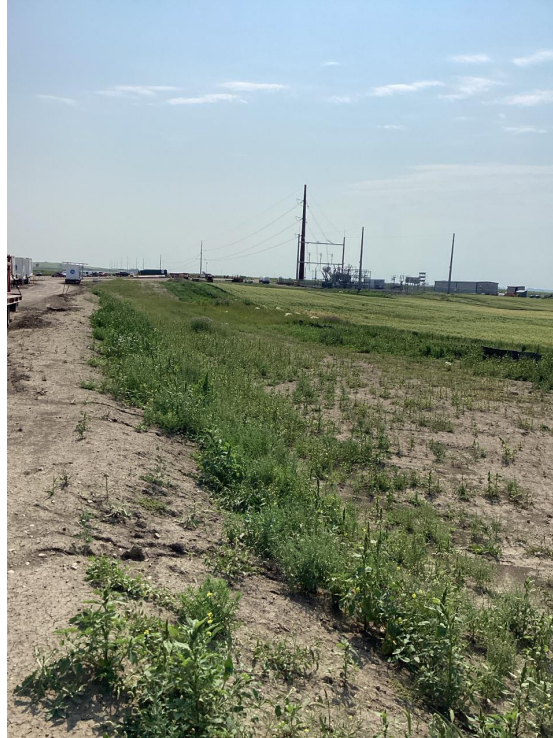
**Photo Number:** 18

**Location:** South side of site

**Notes:** Erosion control in-place and ditch grading to capture storm runoff

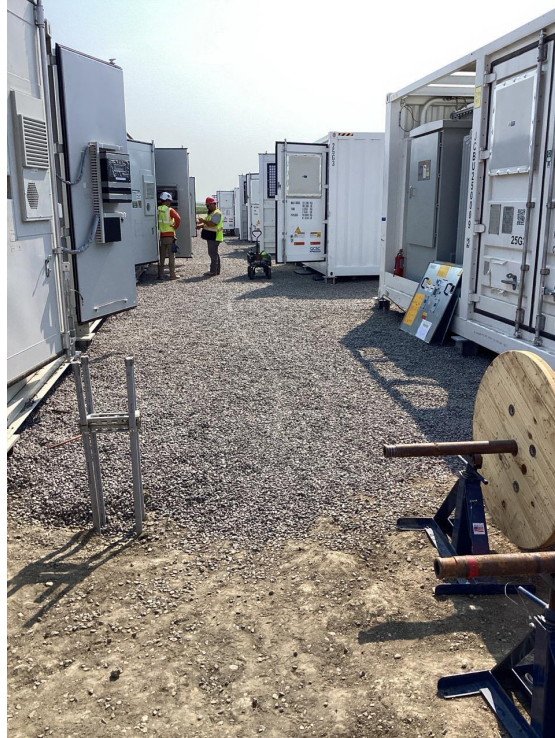
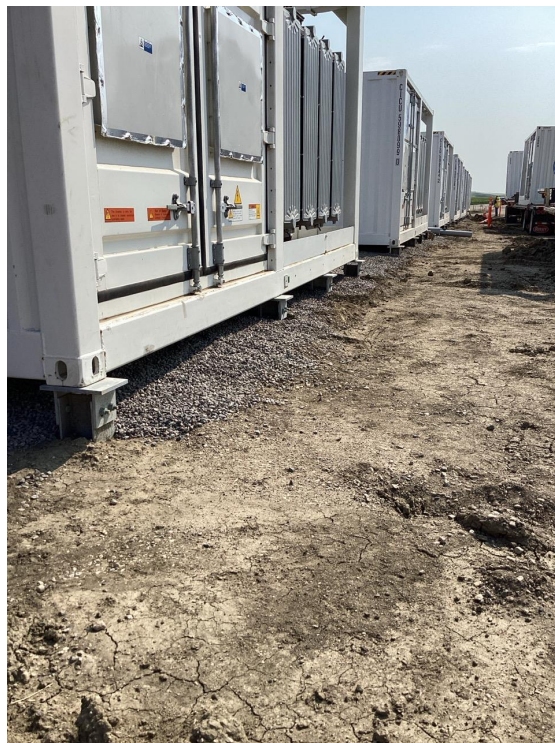
**Photo Number:** 19-20

**Location:** South side Battery Pack

**Notes:** Installed battery packs

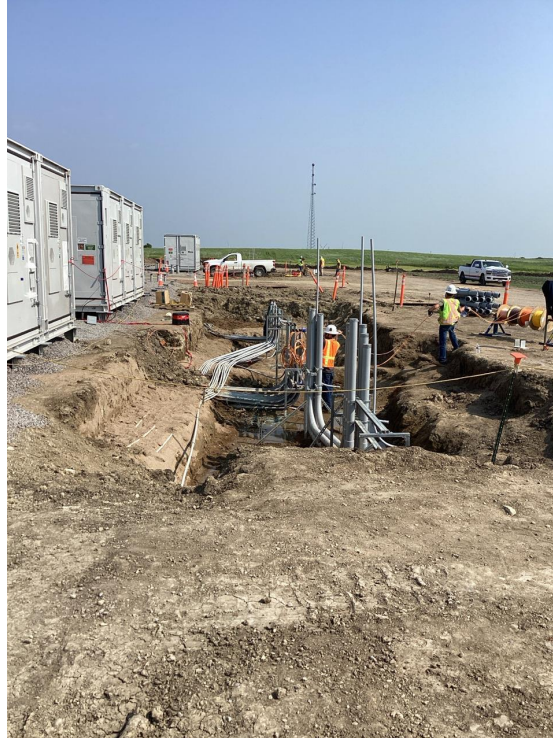
**Photo Number:** 21

**Location:** East side Battery Pack

**Notes:** Underground conduit hub

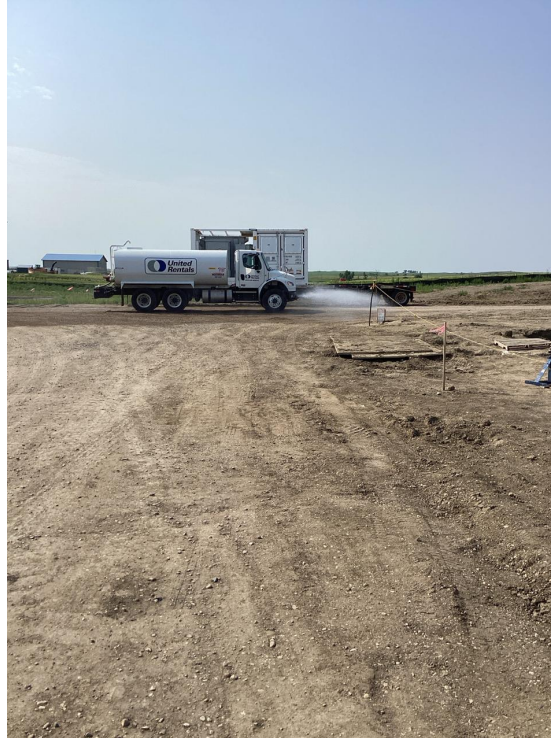
**Photo Number:** 22

**Location:** South side access road

**Notes:** Watering of access roads

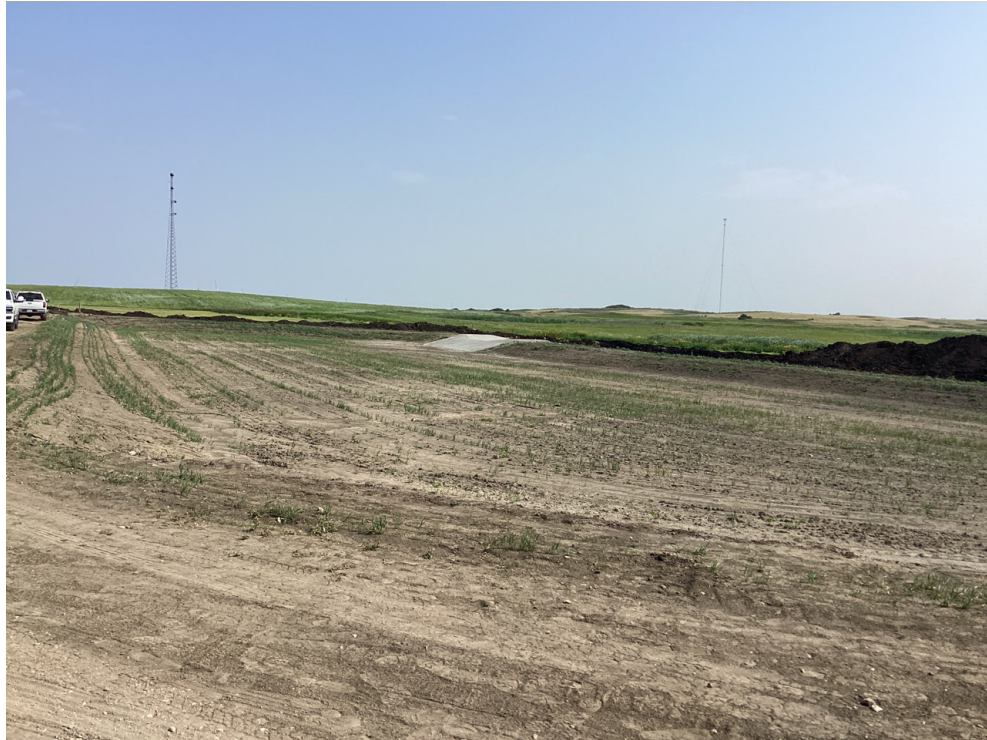
**Photo Number:** 23

**Location:** Storm water Pond

**Notes:** Graded storm water pond
