Minnesota Power and Great River Energy  
HVDC Modernization Project, Oliver County  
Case No. PU-24-381  
Topsoil Removal Inspection Report

RE: Case No. PU-24-381  
Minnesota Power and Great River Energy  
HVDC Modernization Project  
Topsoil Removal Inspection Report

Date:	Inspection - 08/18/2025, Report - 08/27/2025
-------	--

Project: PU-25-912, HVDC Modernization
--

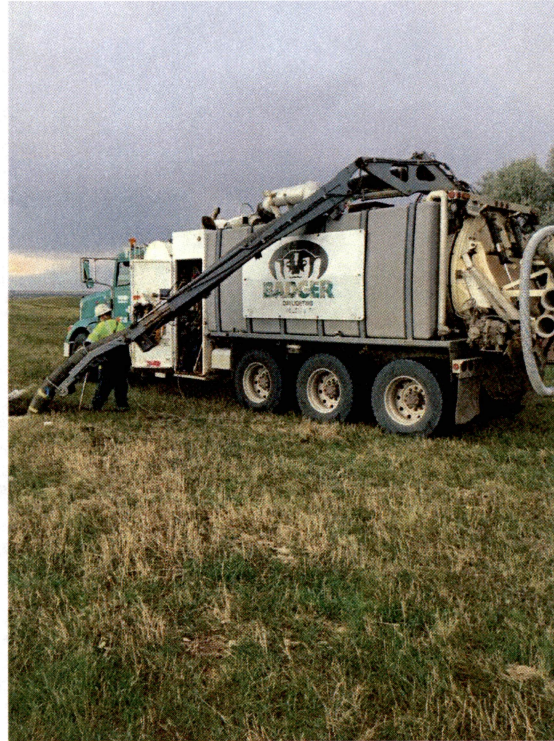
**Photo Number:** 1

**Notes:** Crew pot holing to find water line, equipment, water jetting truck.

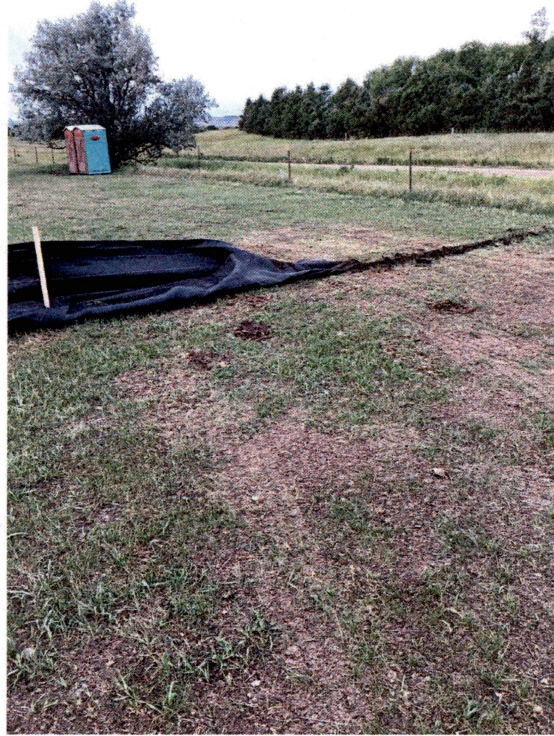
**Photo Number:** 5

**Notes:** Downed silt fence, temporarily removed to allow access for jet truck. Will make note if free does not reinstall it by EOD.

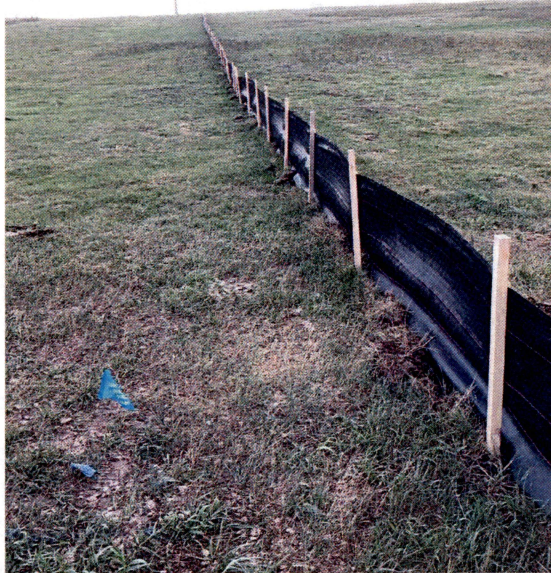
**Photo Number:** 7

**Notes:** Existing conditions and silt fence that was installed yesterday.

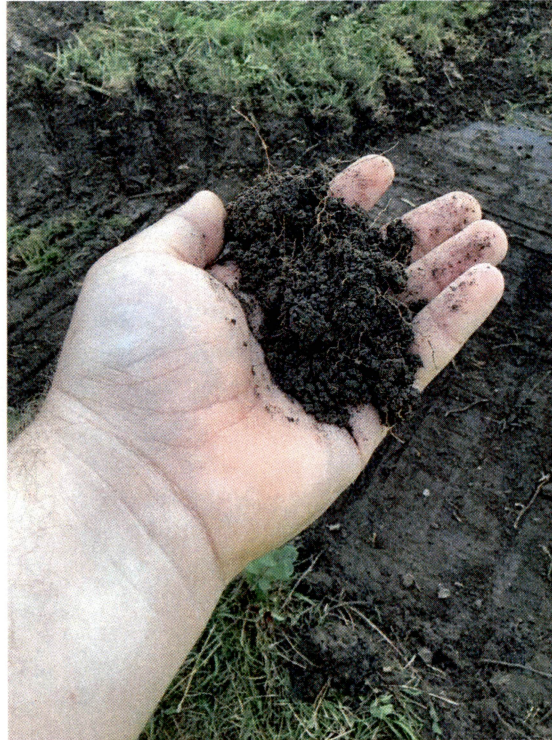
**Photo Number:** 8

**Notes:** Topsoil layer, very lumpy and dry.

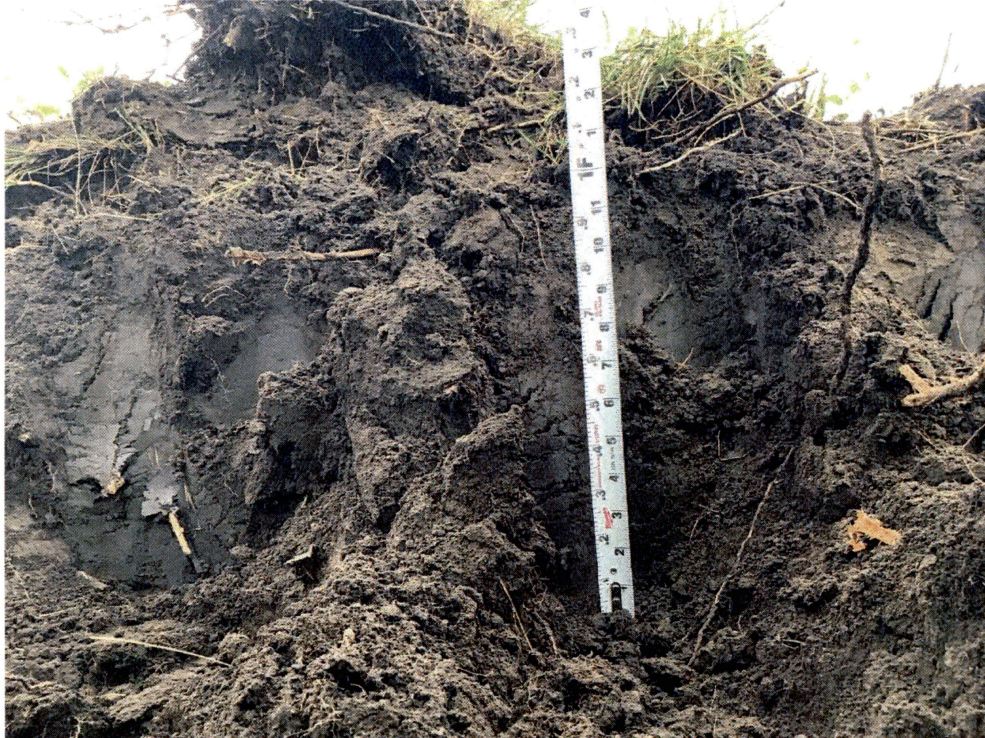
**Photo Number:** 10

**Notes:** Topsoil depth stripped to 12"

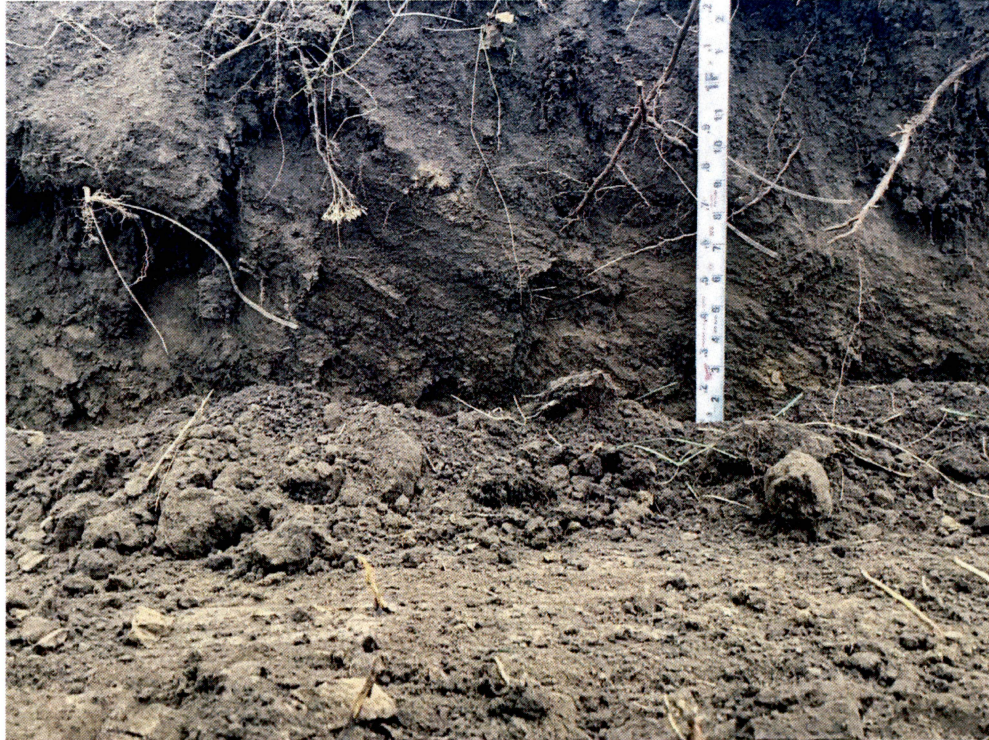
**Photo Number:** 11

It should be noted that during the first path the dozer made, they over excavated into the subsoil layer (see P11). Inspector spoke with the operators again to remind them of what the NDPSC specs ask for in regards to stripping and segregation of topsoils. The issue was remedied and did not show up again for remainder of site inspection.

**Comments:** At 9:30 I spoke with one of the dozer operators and let him know he was overexcavating and reiterated that topsoil should be stripped to 12" or to a layer change.

**Notes:** Crew is overexcavating here. I reiterated the 12" or layer change rule and will be keeping a close eye moving forward. Actual topsoil depth here is 12"

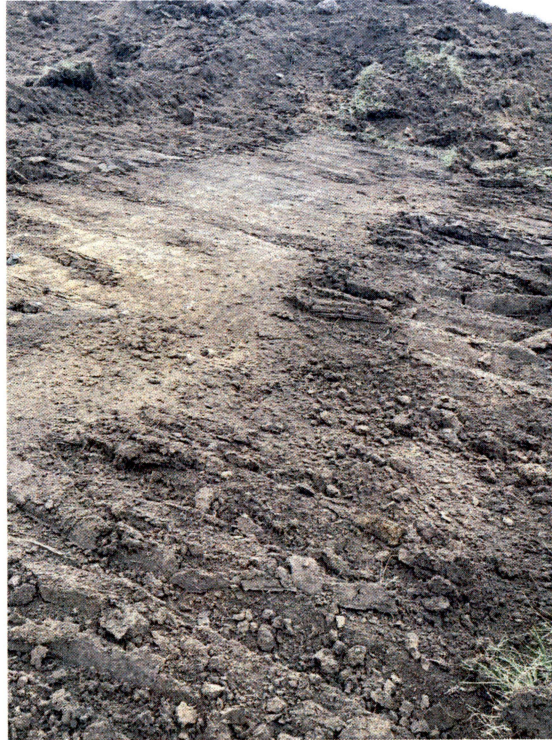
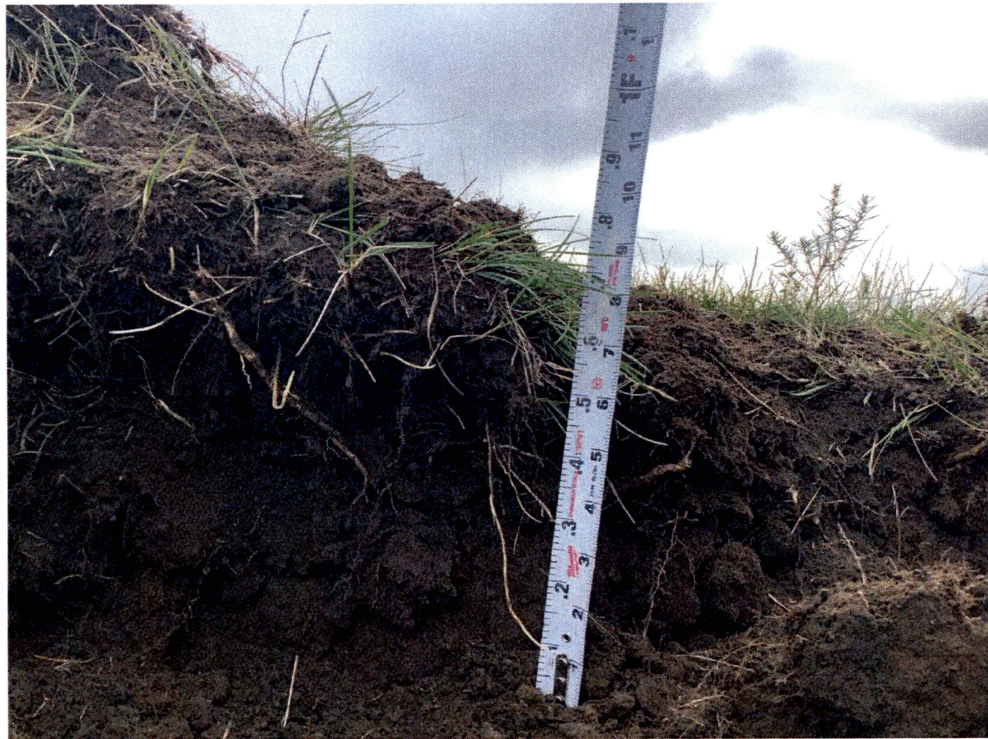
**Photo Number:** 12-13

**Notes:** Topsoil depth in this location 7", subsoil seems to be a light brown to gray clayey loam.

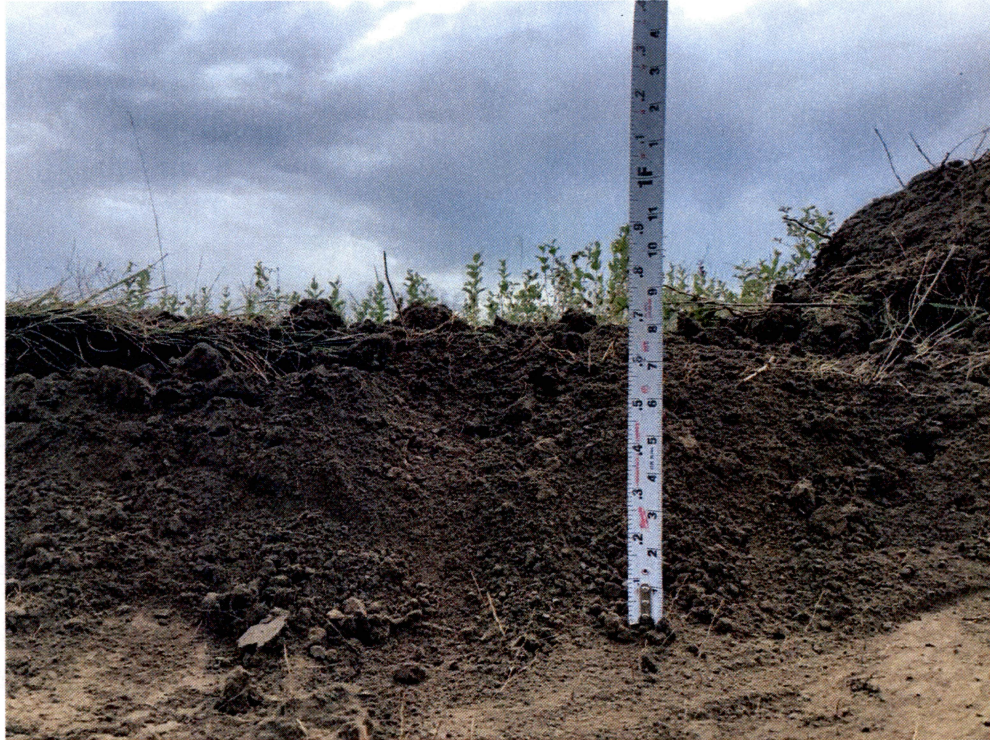
**Photo Number:** 16

**Notes:** Topsoil depth check of 8in.

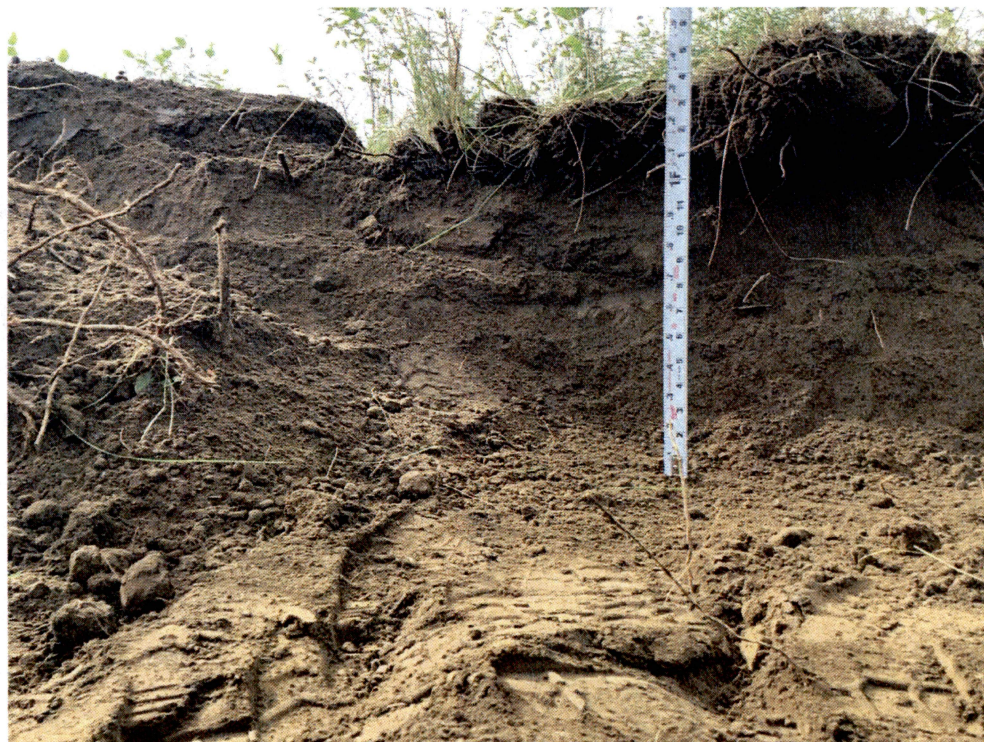
**Photo Number:** 17

**Notes:** Topsoil depth in this area up to 18"+

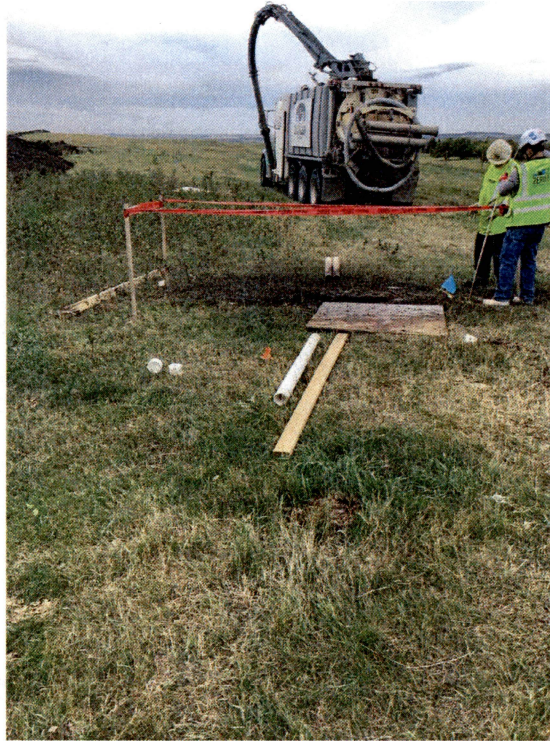
**Photo Number:** 19

**Notes:** Safety procedures: subcontractor cordoned off area where jetting had occurred to keep people away from hazardous fall risks.

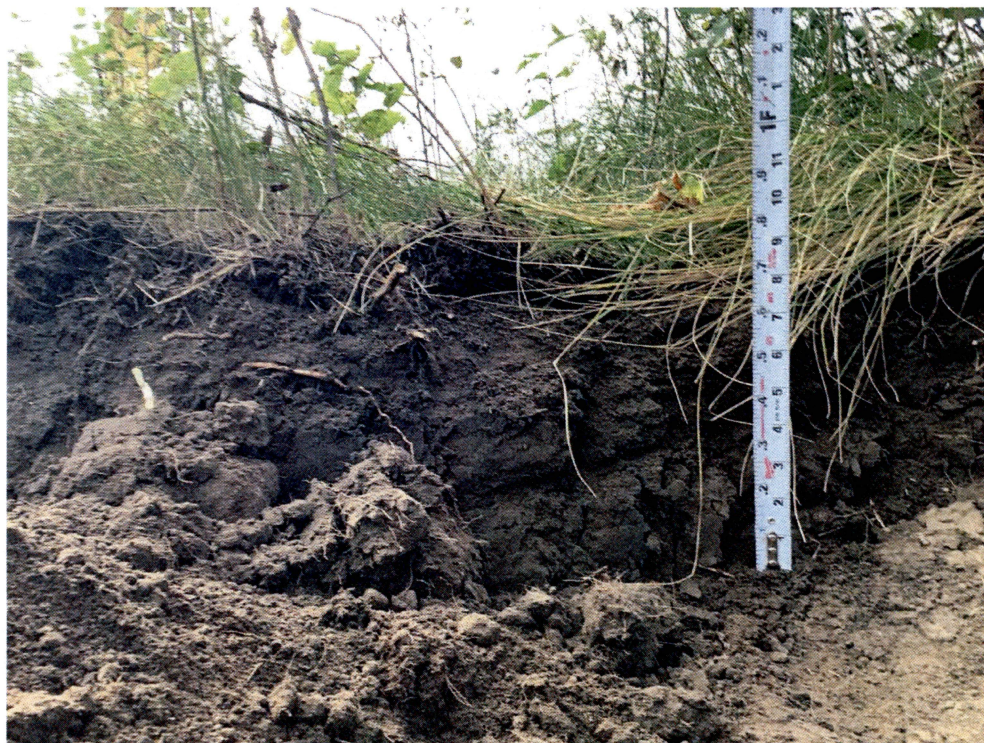
**Photo Number:** 20

**Notes:** Topsoil depth check: 10"

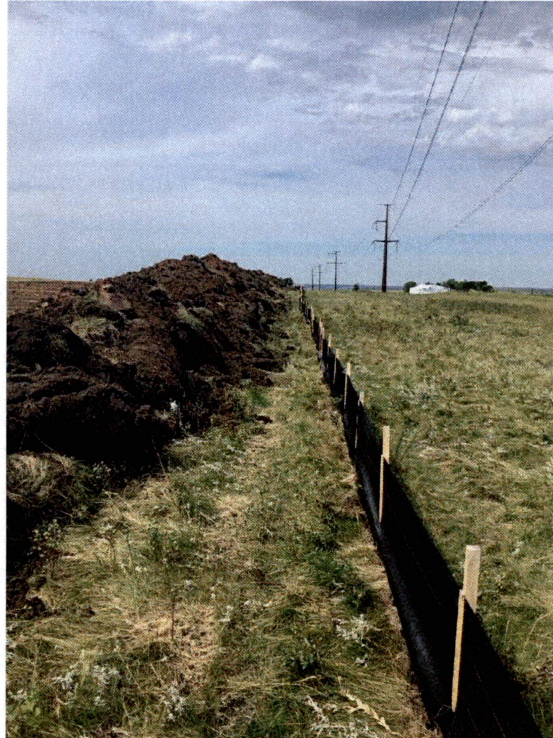
**Photo Number:** 22

**Notes:** Topsoil piles are staying within ROW

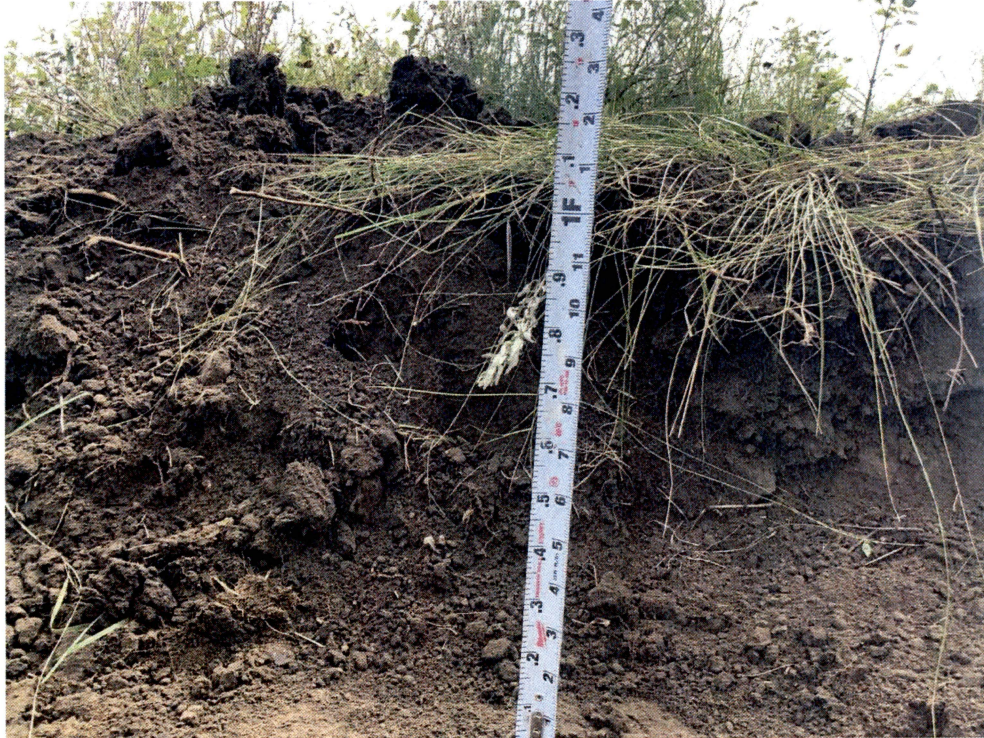
**Photo Number:** 23

**Notes:** Topsoil depth check, 13"

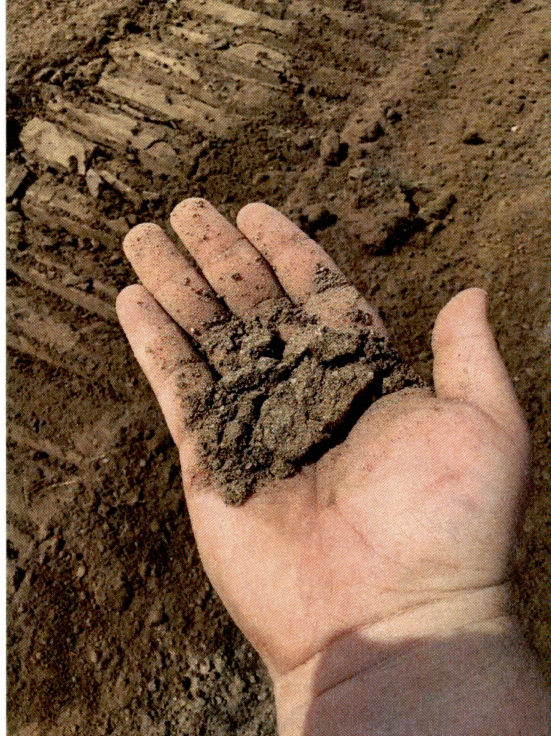
**Photo Number:** 25

**Notes:** One of several subsoils on site. This one appears to be a pale clayey sand loam

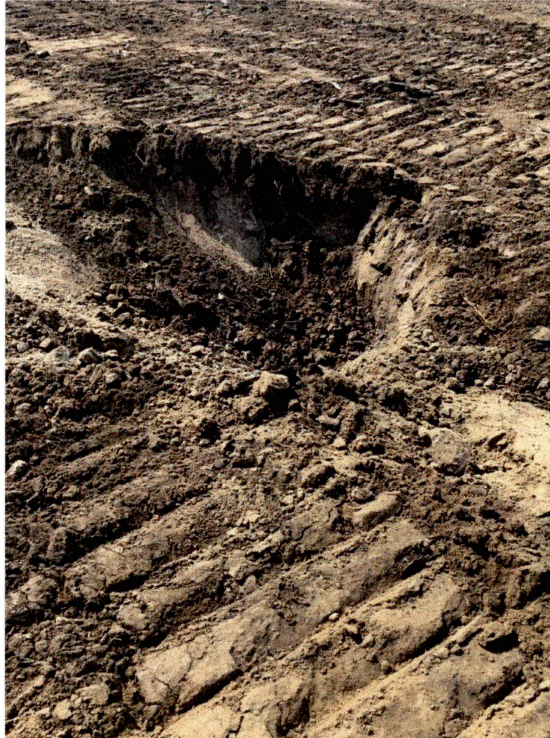
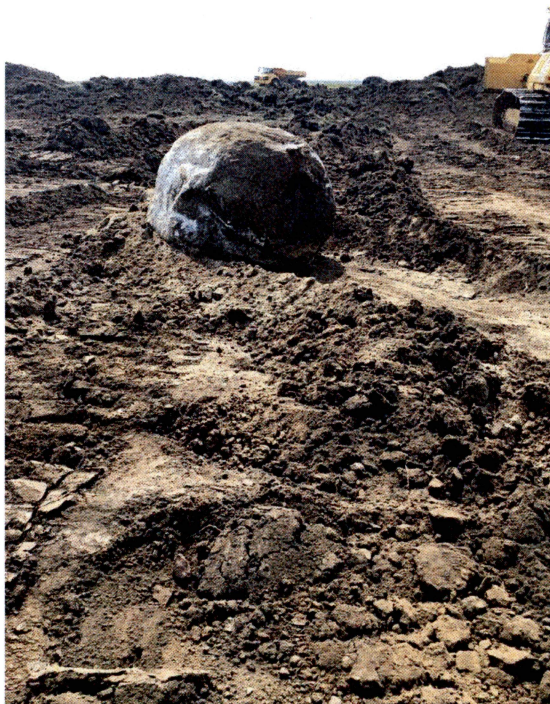
**Photo Number:** 27-28

**Notes:** Misc: crew unearthed a large boulder while stripping topsoil.

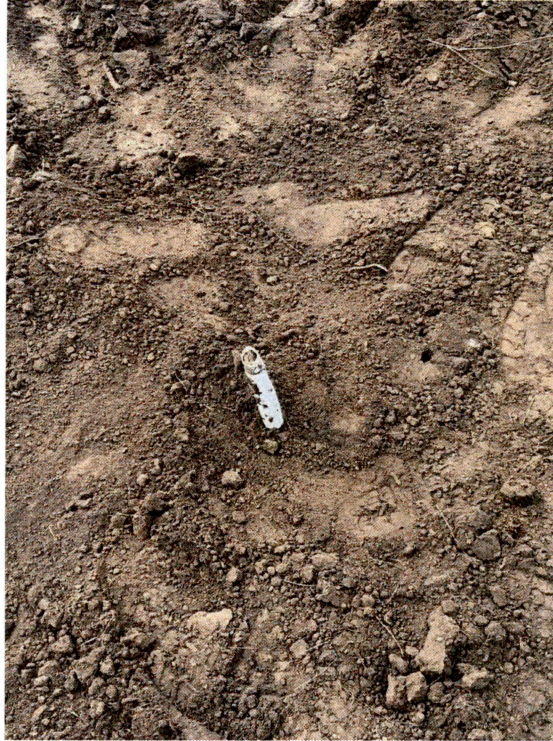
**Photo Number:** 29

**Comments:** Met with Kyle Larson to discuss findings for day. I found out that the pipe was part of an old irrigation system that's no longer in service. Minnesota power installed a new one south of location some time ago. I reminded them of what PSC considers adequate stripping depth and to keep an eye on that. I left site at 3:50pm

**Notes:** Crew appears to have hit a small vertical tube which is set into the ground. Unsure if abandoned or in use.

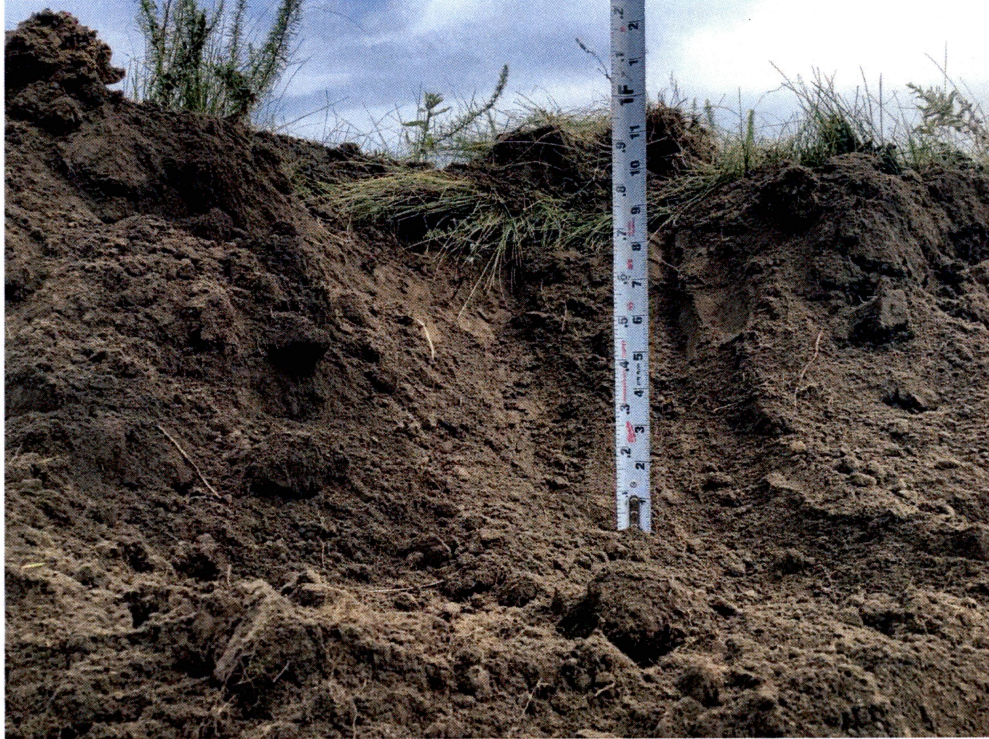
**Photo Number:** 31

**Notes:** Topsoil depth check: 12"
