**PU-25-83**  
**Hiland Crude, LLC**  
**Hiland Gullickson Reroute Pipeline**  
**Topsoil Inspection Report**

File No. 193807545

November 2025

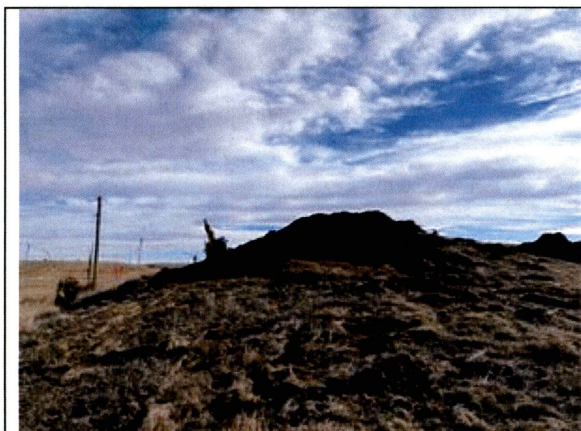
**Observation Point: 1**

Photo Description: Topsoil stripping along steep slope, properly segregated and stockpiled along south side of ROW.

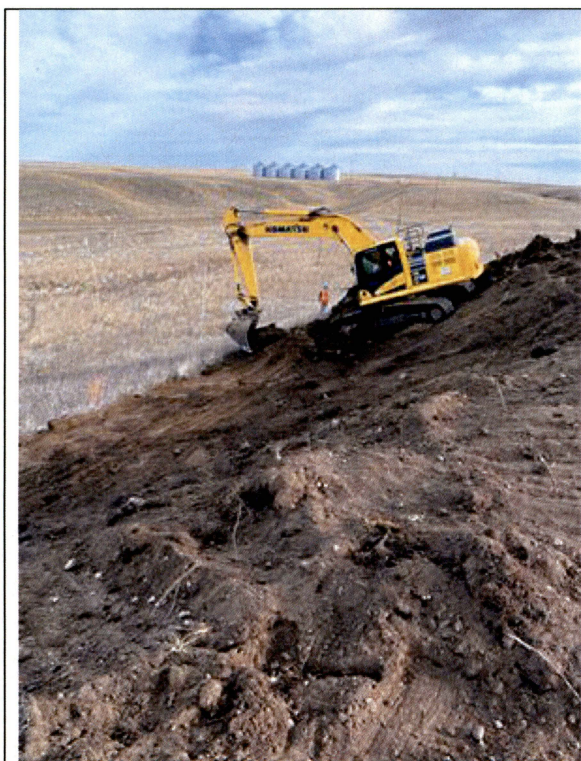
**Observation Point: 2**

Photo Description: Topsoil stripping along steep slope at beginning of project. Stripped depth of approx. 4", very minimal existing topsoil in this area.

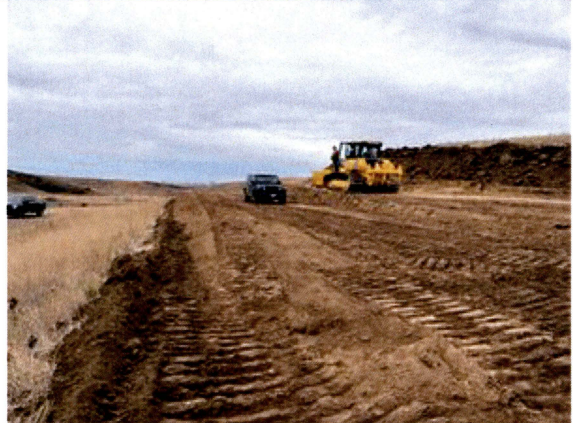
<p><b>Observation Point: 3</b> Date Taken: November 10, 2025 10:44 AM Direction Photo is Taken: West</p> <p>Photo Description: Overlooking stripped and segregated soils along the ROW</p> <p>Latitude: 47.93477950243774 Longitude: -103.88165759130021</p>
---	--

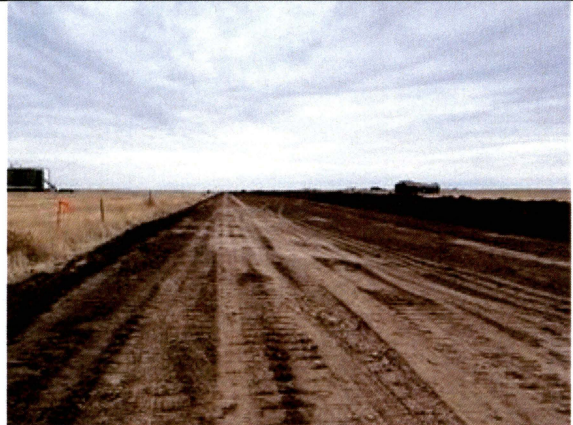
<p><b>Observation Point: 4</b> Date Taken: November 10, 2025 10:50 AM Direction Photo is Taken: North</p> <p>Photo Description: Right-of-way fully stripped of topsoil and segregated in this area. Depth of topsoil is approx. 8".</p> <p>Latitude: 47.93591517145697 Longitude: -103.88320273767935</p>
--	---

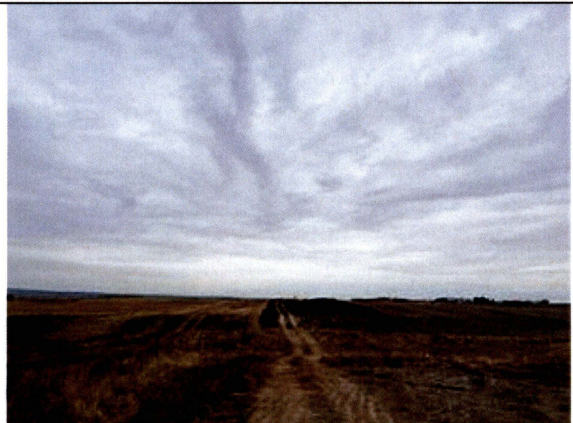
<p><b>Observation Point: 5</b> Date Taken: November 10, 2025 10:55 AM Direction Photo is Taken: North</p> <p>Photo Description: Contractor demonstrating use of rig mats across wetland. Topsoil not stripped in this area, designated for boring under wetland as required.</p> <p>Latitude: 47.93832366919854 Longitude: -103.88320122719254</p>
---	--

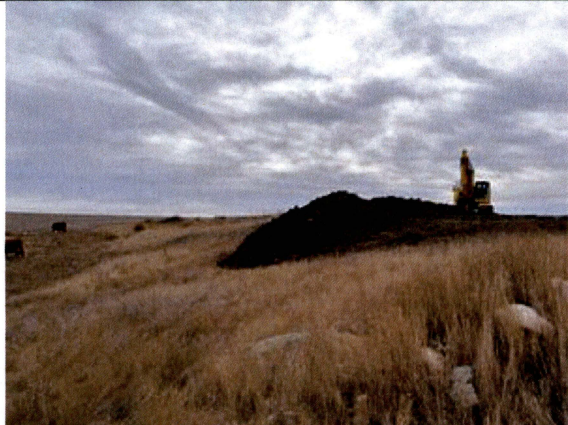
The pipeline route for this project navigates a challenging terrain consisting of several bluffs, steep hills and multiple wetland crossings. Extra attention to soil erosion management is critical to a project with this type of terrain. During Mr. Twete's two site visits, there were no erosion control BMP's in place at any locations. One location was observed where topsoil was stockpiled on a relatively steep slope abutting a wetland avoidance area. Mr. Twete recommended to the Kinder Morgan inspectors that a silt fence or bio-roll be placed at the downslope end of this stockpile to contain soils and prevent erosion into the underlying wetland, which appeared to be a drainage route for the surrounding agricultural land. Mr. Twete mentioned to the inspectors that erosion control BMP's should be installed at any other locations similar to the previously described scenario. The Kinder Morgan inspectors stated that they would direct Shanco to install BMPs at the requested location and noted that they would be installed at other locations as well.

<p><b>Observation Point: 6</b> Date Taken: November 10, 2025 10:59 AM Direction Photo is Taken: Southeast</p> <p>Photo Description: Topsoil stockpile terminated at the top of a valley where erosion into the underlying drainage route could be an issue. It is recommended that an erosion BMP is placed here</p> <p>Latitude: 47.94124050587614 Longitude: -103.8830968516288</p>
---	---

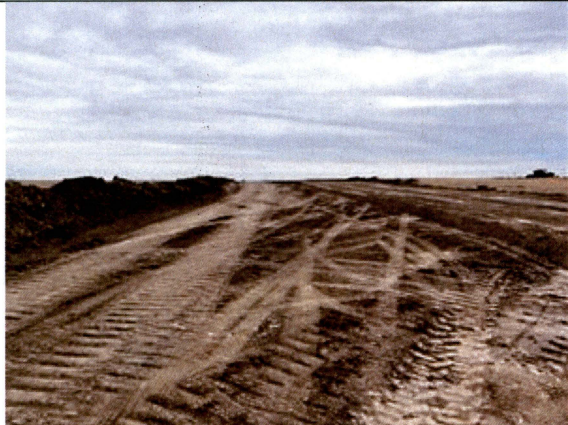
<p><b>Observation Point: 7</b> Date Taken: November 10, 2025 11:23 AM Direction Photo is Taken: East</p> <p>Photo Description: Topsoil stripped within right of way. Minor amounts of topsoil present within stripped area but negligible, subsoil is apparent across the right of way.</p> <p>Latitude: 47.9364792753403 Longitude: -103.90448086317927</p>
--	--

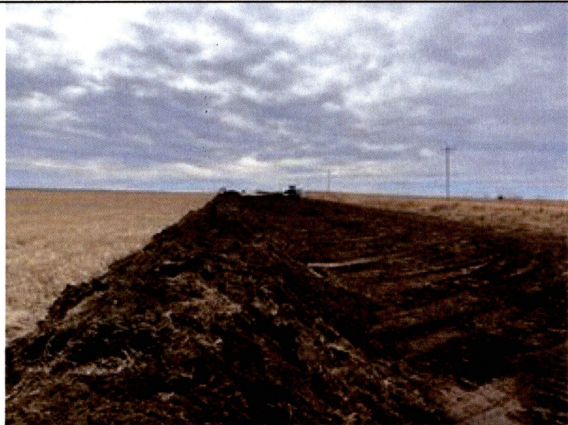
<p><b>Observation Point: 8</b> Date Taken: November 10, 2025 11:30 AM Direction Photo is Taken: South</p> <p>Photo Description: Topsoil stripped along right-of-way, stockpiled within construction easement.</p> <p>Latitude: 47.9445348024772 Longitude: -103.9044852695478</p>
---	---

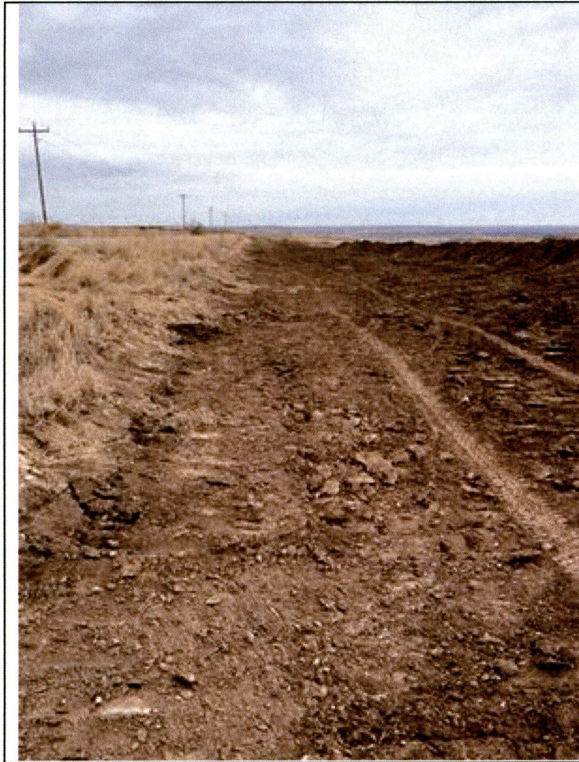
**Observation Point: 9**  
Date Taken: November 10, 2025 11:42 AM  
Direction Photo is Taken: North

Photo Description: Edge of stripping limits shown to depict approximate depth of topsoil stripped across right of way

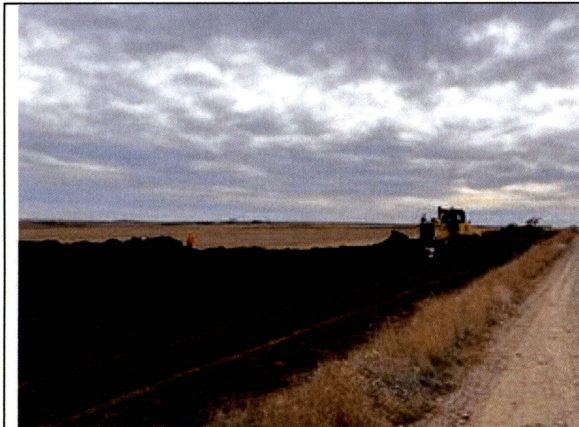
**Observation Point: 10**  
Date Taken: November 10, 2025 11:46 AM  
Direction Photo is Taken: South

Photo Description: Contractors stripping operations consisting of one dozer and one laborer.
