PU-25-83
Hiland Crude, LLC
Hiland Gullickson Reroute Pipeline
Construction Inspection Report

File No. 193807545

January 2026

North Dakota Public Service Commission
600 E. Boulevard Avenue
Bismarck, ND 58505-0480

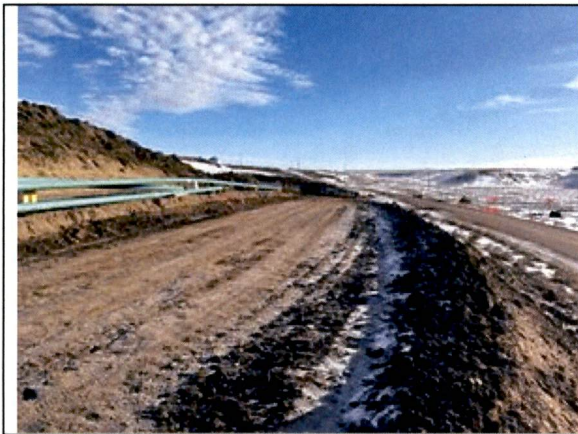
Observation Point: 1

Photo Description: Topsoil stripped and segregated in this area at the very beginning of the project. Appears to be holding up well with minimal erosion.

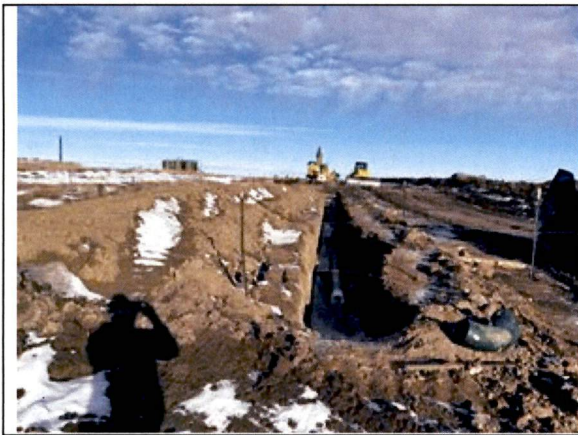
Observation Point: 2

Overall, Stantec observed adequate soil handling techniques with regard for PSC Order #11 (**Observation Points 1, 2, 4, 8, 9, 12, 14, 15, 18, and 19**). Topsoil stockpiles were found to be relatively clear of subsoil mixing. **Observation Point 2** adequately depicted the in-situ soil profile due to the exposed trench being cut relatively vertical. Closer inspection at this observation point showed only small amounts of organic rich topsoil along the top ~2-inches of the trench, which indicates that the topsoil within the right-of-way was adequately stripped to the subsoil with minimal mixing of soils during segregation. Topsoil and subsoil stockpiles, where observed, appeared to be placed separately and parallel to each other with adequate separation distances to minimize the risk of mixing.

Photo Description: Exposed pipeline soon to be tied in. Trench area appears to all be subsoil with trace hints of organics in the top 2"-4" which can be considered negligible.

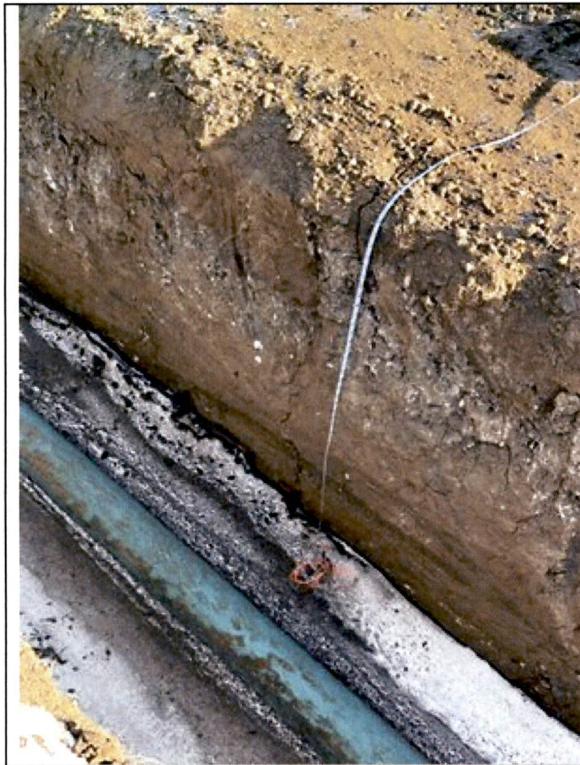
Observation Point: 3

The depth of the pipeline was ≥ 48 inches deep or ≥ 48 below assumed final grades in all inspected areas. There were no exposed pipeline segments under undeveloped section lines at the time of observation, so no verifications were made that the depths of these crossings are ≥ 72 inches. **Observation Points 3 and 10** show pipe depth measurements. Pipe depths were measured at multiple other locations, although not photographed. Stantec did not note any concerns with the depth of trenching and pipe placement accounting for assumed backfill depth at some locations.

Photo Description: Top of pipeline approx. 4.5' from top of subsoil.

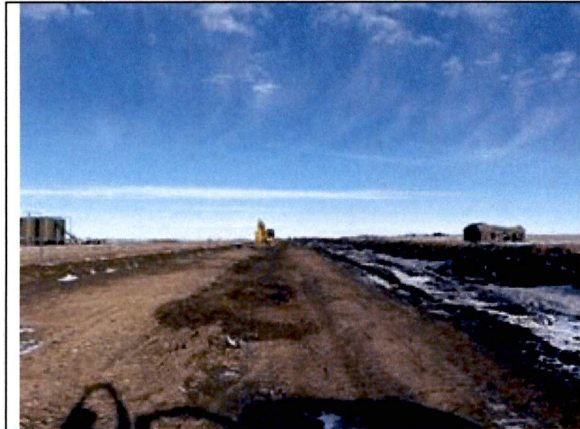
Observation Point: 4

Photo Description: Pipeline installation complete in this area. Topsoil still appears to be fully segregated and ready to be re spread.

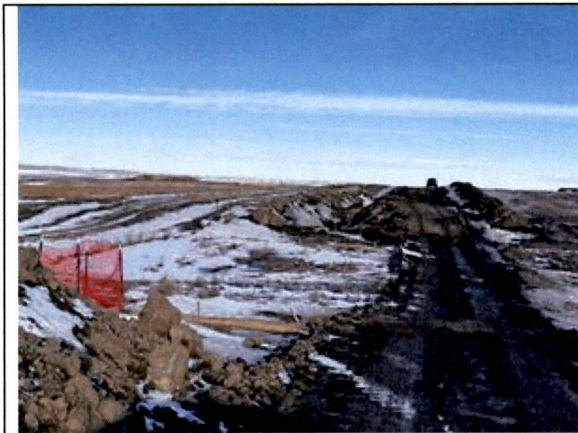
Observation Point: 5

The Project alignment crosses wetlands and/or streams which were inspected to ensure compliance with the PSC order provisions. Impacts to wetlands can be mitigated through use of BMP's such as HDD, silt fences, bio rolls, or timber mats. Wetland/stream crossings (**Observation Points 5 and 11**) were observed to employ both silt fence and bio rolls. At the time of inspection, pipe installation was complete in this area and was in the process of being reclaimed, so pipe depths were not able to be documented. No eroding soils or soil deposits were observed along the stream banks or in wetlands.

Photo Description: Pipeline bored through this avoidance area (wetland). Proper use of BMPs, no apparent soil erosion into wetland.

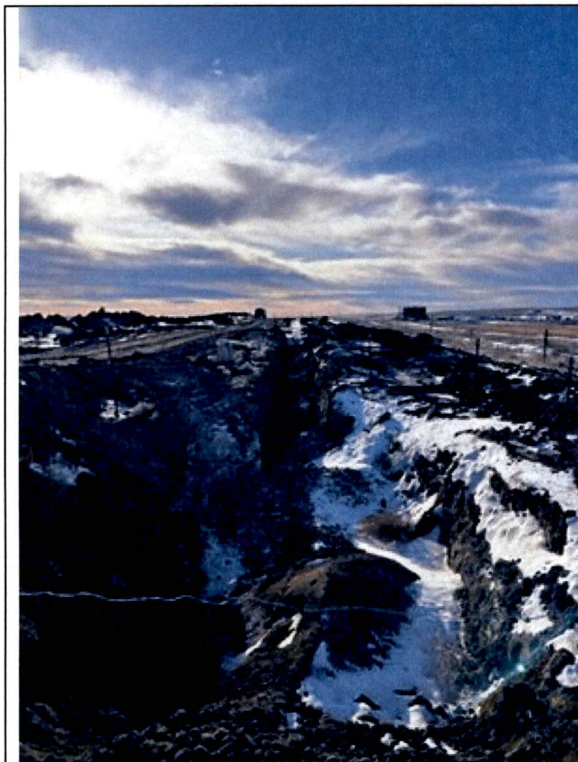
Observation Point: 6

Photo Description: Trench area partially backfilled, backfill material appears to not have any topsoil mixed in.

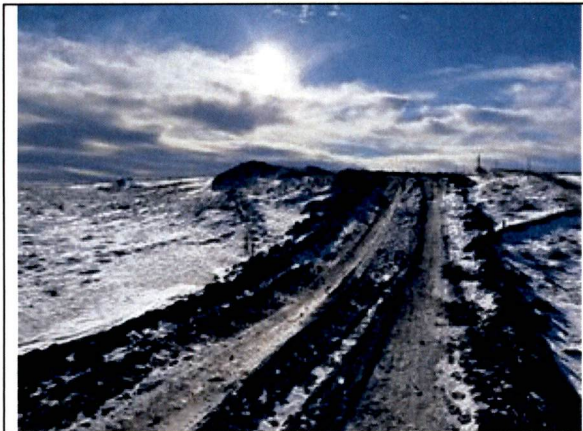
<p>Observation Point: 7 Date Taken: January 5, 2026 11:45 AM Direction Photo is Taken: South</p> <p>Photo Description: Bio logs placed adjacent to avoidance area per recommendation from previous site visit (topsoil inspection).</p> <p>Latitude: 47.94146294286103 Longitude: -103.8831928445595</p>
---	---

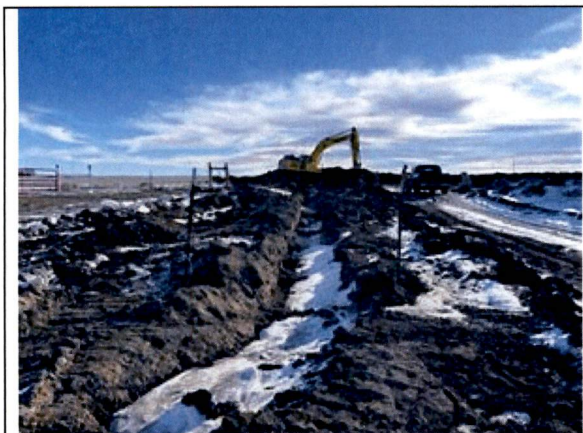
<p>Observation Point: 8 Date Taken: January 5, 2026 11:54 AM Direction Photo is Taken: East</p> <p>Photo Description: Trench backfill in progress. No apparent concerns.</p> <p>Latitude: 47.94430814359458 Longitude: -103.88361596087665</p>
--	---

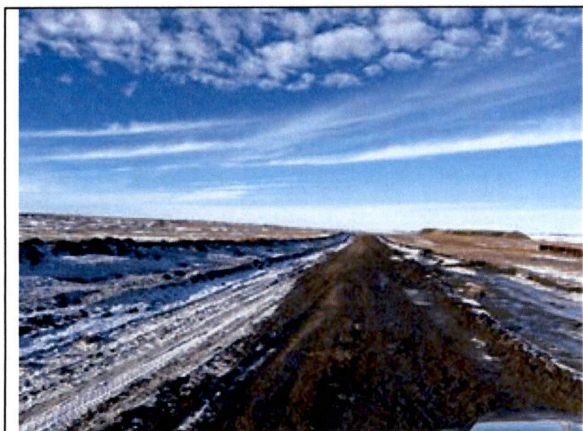
<p>Observation Point: 9 Date Taken: January 5, 2026 11:56 AM Direction Photo is Taken: Northwest</p> <p>Photo Description: Pipeline installed and backfilled in this area. Topsoil still properly segregated.</p> <p>Latitude: 47.94433964861591 Longitude: -103.88388593980191</p>
---	--

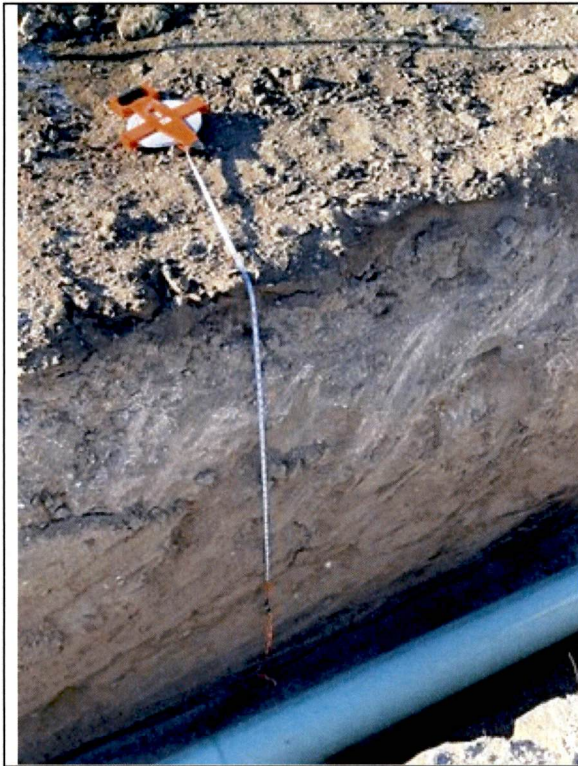
Observation Point: 10

Photo Description: Exposed pipeline at a depth of approx. 5 ft

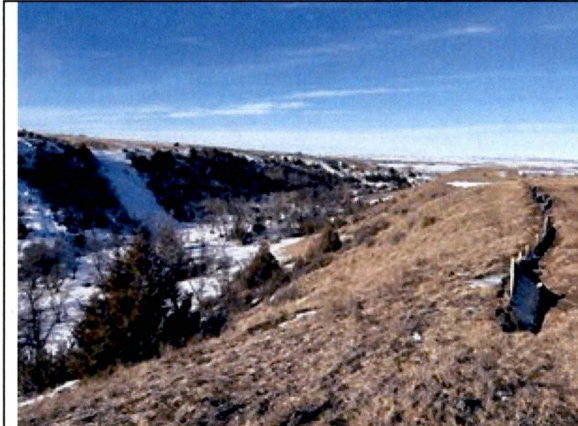
Observation Point: 11

The Findings of Fact document completed for the Project did not indicate any geologically unstable areas. However, the pipeline crosses a large ravine, which has potential for soil movement and erosion due to the steep slopes and significant elevation change. The pipeline crossed this area via HDD, which had been completed at the time of Stantec's visit. Soil handling and BMP practices at these locations (**Observation Point 11**) appeared to be adequate, with no soil erosion present outside of the construction area. The Project corridor contains many other locations with steep terrain. Stripping efforts on steep slopes were observed at various locations, depicted in **Observation Points 1, 7 and 17**. These areas commonly resulted in large stockpiles on the downslope side of the ROW in order to create a flat workspace. These areas were observed to have adequate soil handling practices.

Photo Description: Overview of large ravine which pipeline was bored underneath. No above ground disturbance observed in this area.

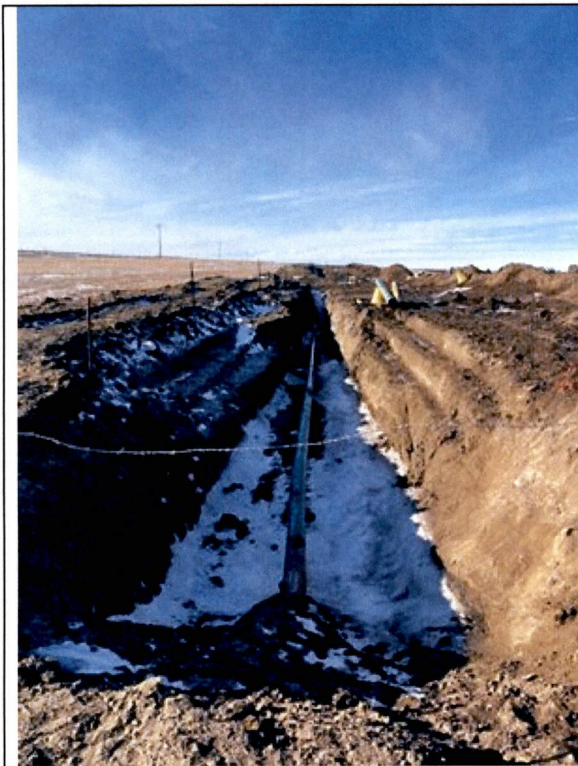
Observation Point: 12

Photo Description: Exposed pipeline installed and partially backfilled. Confirmed depth greater than required 48".

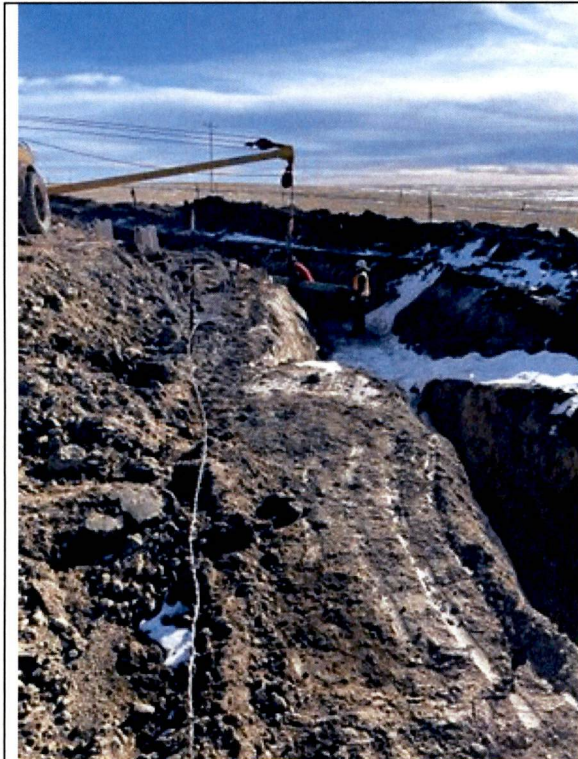
Observation Point: 13

Photo Description: Contractor installing pipeline, confirmed beyond 48" depth

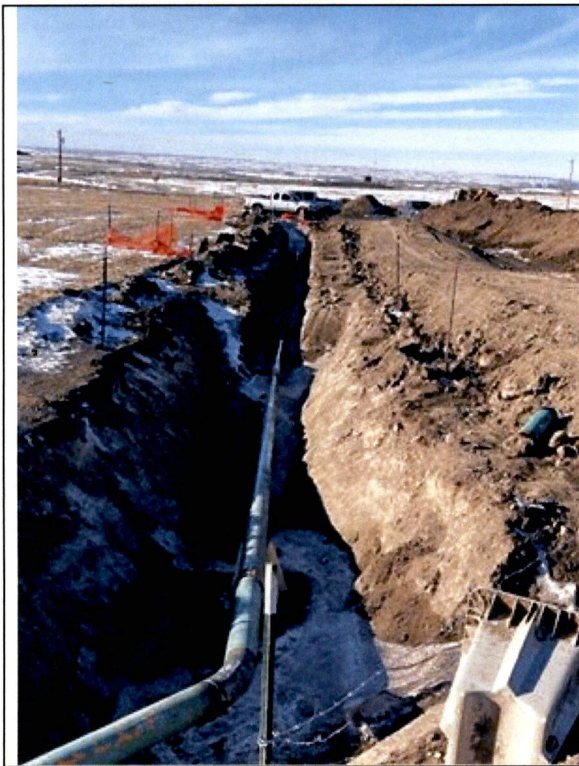
Observation Point: 14

Photo Description: Pipeline installed and yet to be backfilled. Confirmed >48" depth.

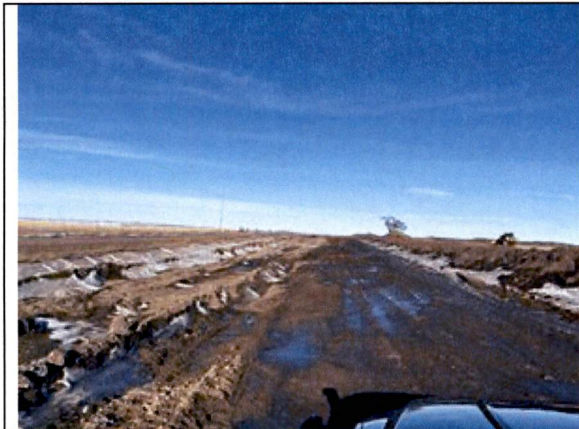
Observation Point: 15

Photo Description: Pipeline installed and backfilled in this area. Topsoil still properly segregated, ready for reclamation.

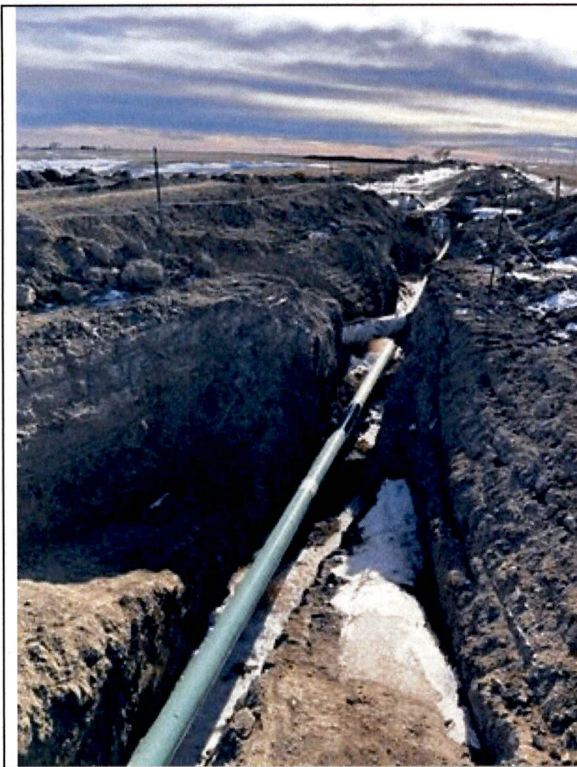
Observation Point: 16

Photo Description: Pipeline installed underneath existing pipeline (per engineering drawings).

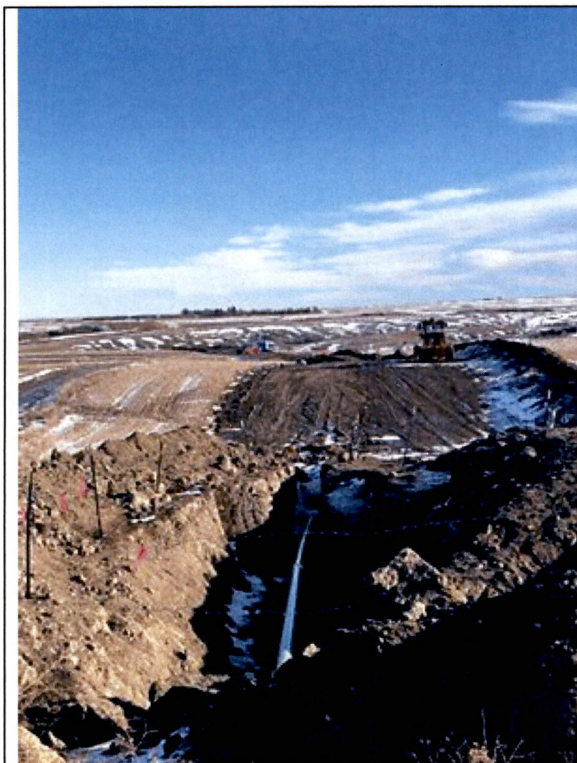
Observation Point: 17

Photo Description: Exposed pipeline to be backfilled, area behind properly backfilled, visible pipe buried beyond req. 48"

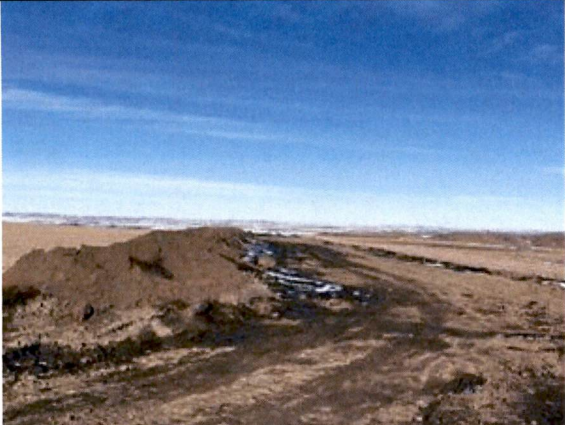
<p>Observation Point: 18 Date Taken: January 5, 2026 1:10 PM Direction Photo is Taken: North</p> <p>Photo Description: Pipeline installed and backfilled in this area, topsoil still adequately stockpiled and segregated following pipeline trenching activities.</p> <p>Latitude: 47.94588794790498 Longitude: -103.899810972457</p>
---	---

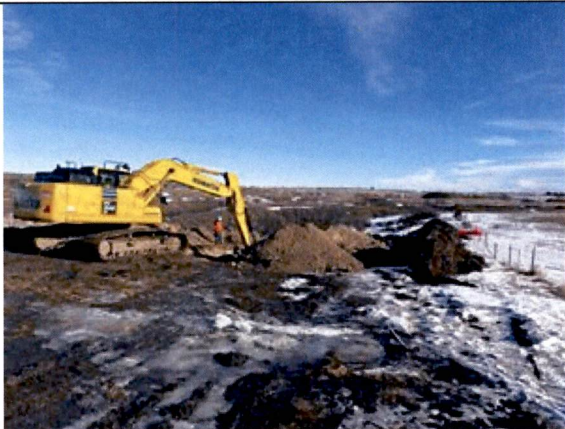
<p>Observation Point: 19 Date Taken: January 5, 2026 1:17 PM Direction Photo is Taken: Northeast</p> <p>Photo Description: Contractor demonstrating proper soil segregation while trenching.</p> <p>Latitude: 47.94953447141392 Longitude: -103.89871437299627</p>
--	---
