**PU-25-83  
Hiland Crude, LLC  
Hiland Gullickson Reroute Pipeline  
As-Built Inspection Report**

July 2026

**North Dakota Public Service Commission**  
600 E. Boulevard Avenue  
Bismarck, ND 58505-0480

**Stantec Consulting Services Inc.**  
100 Collins Avenue, Suite 101  
Mandan, ND 58554

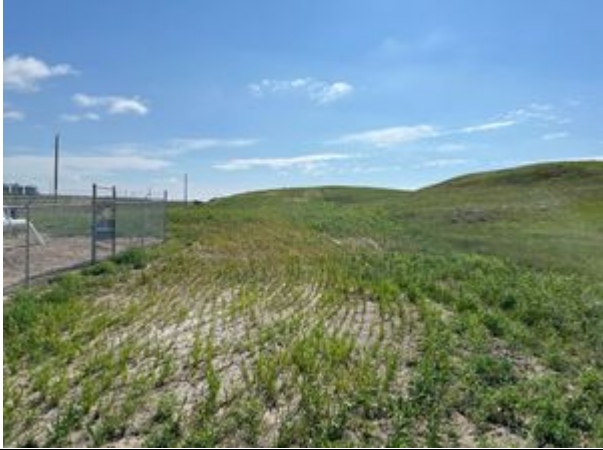
| | <p><b>Observation Point: 1</b><br/>Date Taken: July 16, 2026 11:00 AM<br/>Direction Photo is Taken: East</p> <p>Photo Description: Good contouring, vegetation beginning to establish</p> <p>Latitude: 47.93382442667809<br/>Longitude: -103.88316767411105</p> |

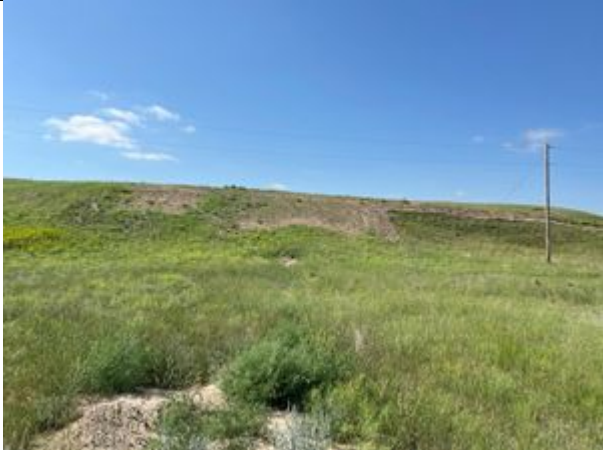
| | <p><b>Observation Point: 2</b><br/>Date Taken: July 16, 2026 11:04 AM<br/>Direction Photo is Taken: South</p> <p>Photo Description: Proper grading and vegetation, erosion control BMPs in place</p> <p>Latitude: 47.93425093148693<br/>Longitude: -103.88157530042794</p> |

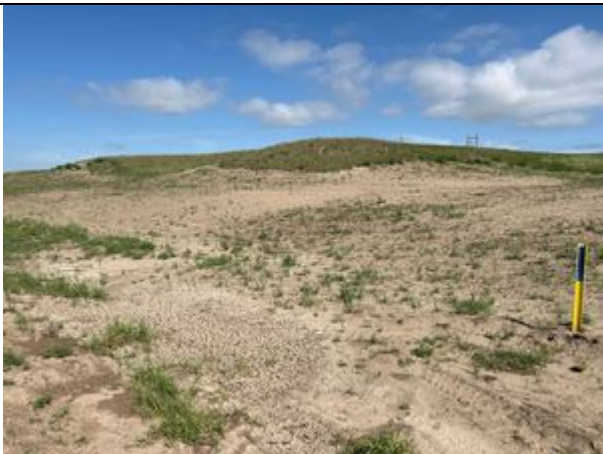
| | <p><b>Observation Point: 3</b><br/>Date Taken: July 16, 2026 11:06 AM<br/>Direction Photo is Taken: West</p> <p>Photo Description: Good contouring, sandy soils preventing adequate vegetation. May need to be re-seeded in the fall.</p> <p>Latitude: 47.93469715038621<br/>Longitude: -103.88099709648404</p> |

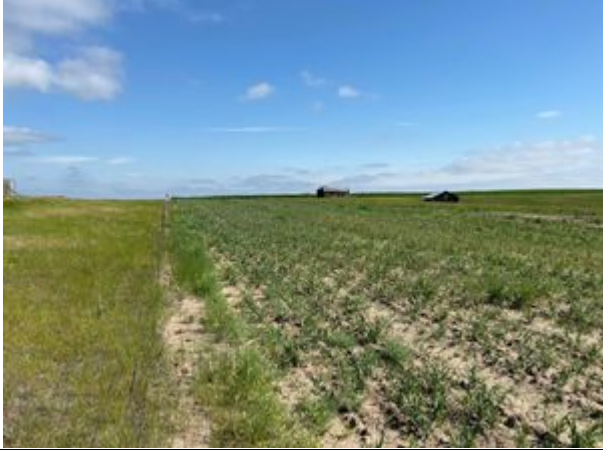
| | <p><b>Observation Point: 4</b><br/>Date Taken: July 16, 2026 11:10 AM<br/>Direction Photo is Taken: North</p> <p>Photo Description: Good contouring and tie-ins to ROW, vegetation establishing well</p> <p>Latitude: 47.935525469502<br/>Longitude: -103.88323734374939</p> |

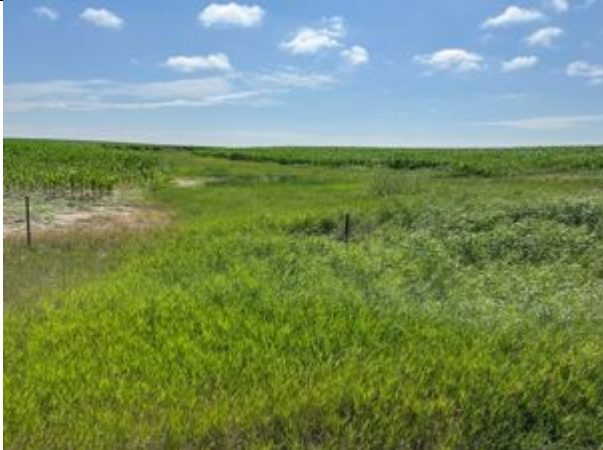
| | <p><b>Observation Point: 5</b><br/>Date Taken: July 16, 2026 11:12 AM<br/>Direction Photo is Taken: East</p> <p>Photo Description: Good contouring, no erosion or sedimentation noticeable along drainage swale</p> <p>Latitude: 47.93874910816623<br/>Longitude: -103.88334707206957</p> |

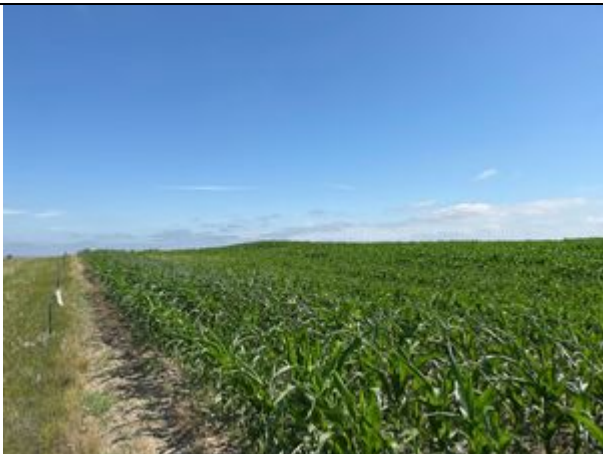
| | <p><b>Observation Point: 6</b><br/>Date Taken: July 16, 2026 11:14 AM<br/>Direction Photo is Taken: North</p> <p>Photo Description: Good contouring, crops well established through ROW</p> <p>Latitude: 47.9391528401158<br/>Longitude: -103.88326900000764</p> |

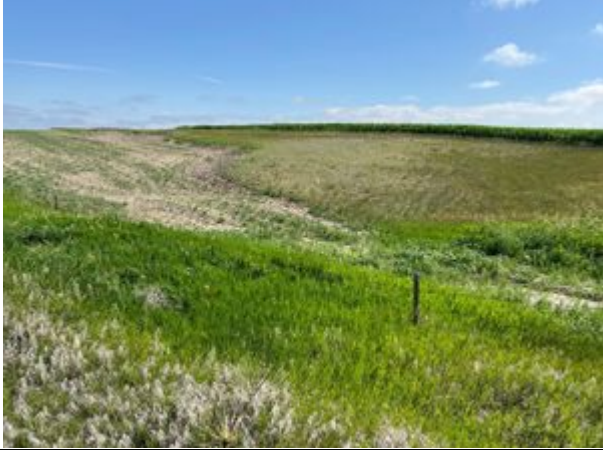
| | <p><b>Observation Point: 7</b><br/>Date Taken: July 16, 2026 11:17 AM<br/>Direction Photo is Taken: North</p> <p>Photo Description: Good contouring, vegetation beginning to establish</p> <p>Latitude: 47.941367699885<br/>Longitude: -103.88334308854073</p> |

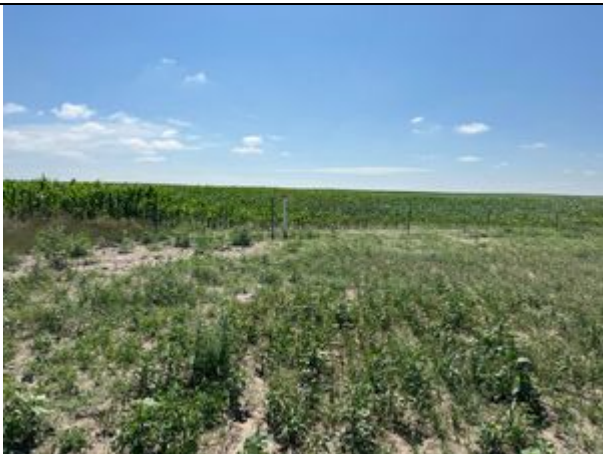
Hiland committed to repairing and replacing all fences and gates (PSC Order Provision #22). Generally, existing fences and/or gates that were impacted by pipeline construction appeared to be replaced or repaired as needed (**Appendix A, Observation Point 9, 13**).

| | <p><b>Observation Point: 9</b><br/>Date Taken: July 16, 2026 11:26 AM<br/>Direction Photo is Taken: East</p> <p>Photo Description: Fencing re-installed properly.</p> <p>Latitude: 47.94423771358739<br/>Longitude: -103.88345433293182</p> |

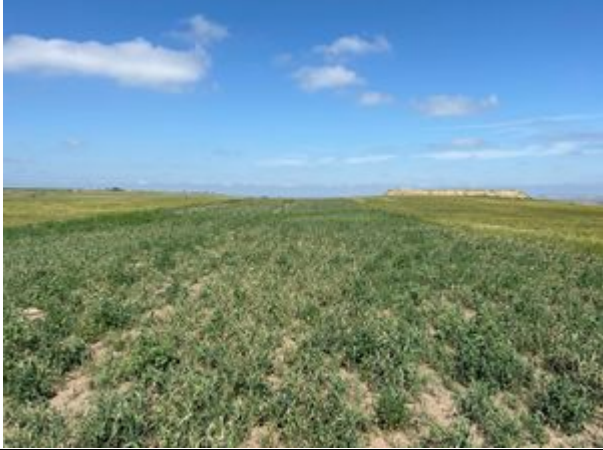
| | <p><b>Observation Point: 10</b><br/>Date Taken: July 16, 2026 11:29 AM<br/>Direction Photo is Taken: West</p> <p>Photo Description: Good contouring, vegetation beginning to establish</p> <p>Latitude: 47.94479950066636<br/>Longitude: -103.88497845543225</p> |

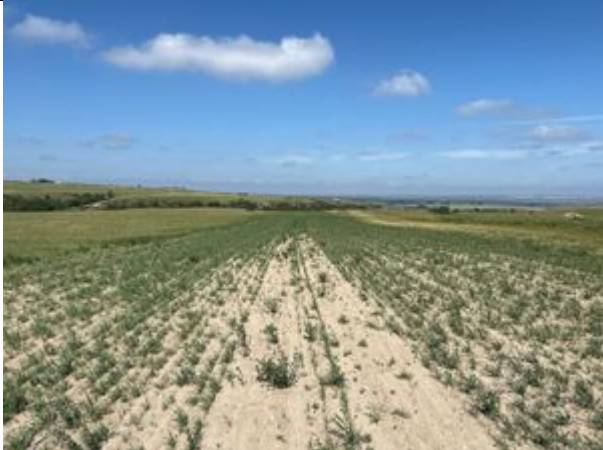
| | <p><b>Observation Point: 11</b><br/>Date Taken: July 16, 2026 11:33 AM<br/>Direction Photo is Taken: West</p> <p>Photo Description: Good contouring, vegetation beginning to establish</p> <p>Latitude: 47.94632365088256<br/>Longitude: -103.88913318107186</p> |

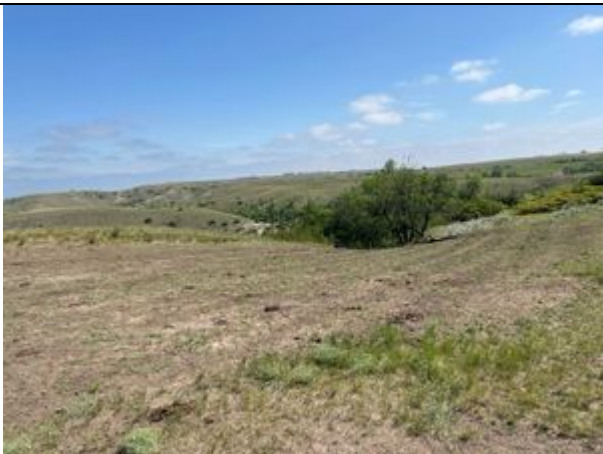
| | <p><b>Observation Point: 12</b><br/>Date Taken: July 16, 2026 11:54 AM<br/>Direction Photo is Taken: Northeast</p> <p>Photo Description: Good contouring, silt fence adequately installed for erosion prevention</p> <p>Latitude: 47.94951796239115<br/>Longitude: -103.89844556006766</p> |

- Request company to remove any remaining silt fence once vegetation is fully established **(Appendix A, Observation Point 12)**.
- Request company to address poor quality topsoil and re-seed area noted in Section 3.4.2 **(Appendix A, Observation Point 3)**.
- Request company to implement straw waddles or comparable BMP's as noted in Section 3.4.2 **(Appendix A, Observation Point 8)**.

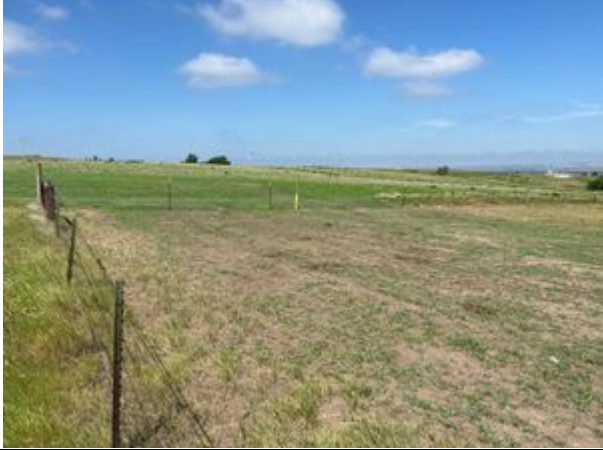
| | <p><b>Observation Point: 13</b><br/>Date Taken: July 16, 2026 11:56 AM<br/>Direction Photo is Taken: West</p> <p>Photo Description: Fencing properly reinstalled.</p> <p>Latitude: 47.94951325946823<br/>Longitude: -103.89928364785648</p> |

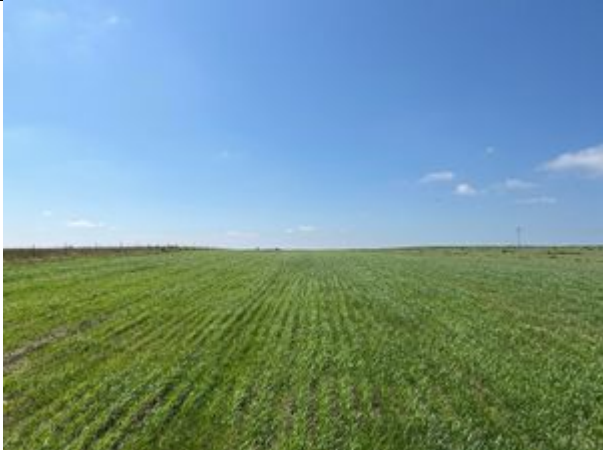
| | <p><b>Observation Point: 14</b><br/>Date Taken: July 16, 2026 11:58 AM<br/>Direction Photo is Taken: South</p> <p>Photo Description: Good contouring, crops well established through ROW</p> <p>Latitude: 47.94935516053175<br/>Longitude: -103.89979352875942</p> |

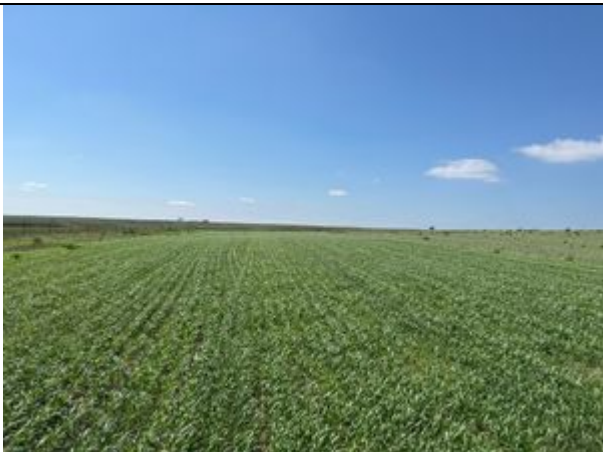
| | <p><b>Observation Point: 15</b><br/>Date Taken: July 16, 2026 12:02 PM<br/>Direction Photo is Taken: South</p> <p>Photo Description: Good contouring, crops well established through ROW</p> <p>Latitude: 47.94699114477678<br/>Longitude: -103.89970233926118</p> |

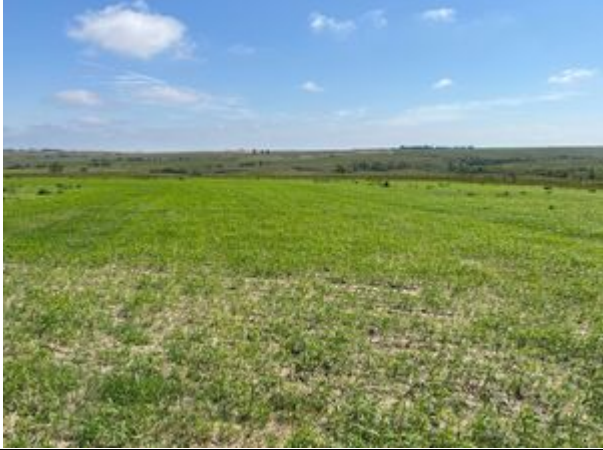
| | <p><b>Observation Point: 16</b><br/>Date Taken: July 16, 2026 12:06 PM<br/>Direction Photo is Taken: East</p> <p>Photo Description: Good contouring, vegetation well-established</p> <p>Latitude: 47.94567449298865<br/>Longitude: -103.90047610633187</p> |

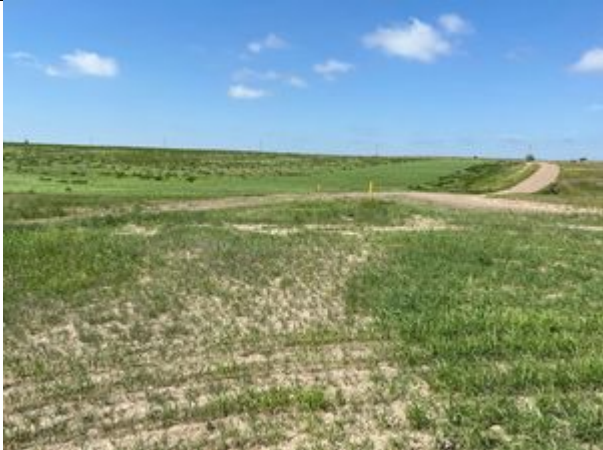
| | <p><b>Observation Point: 17</b><br/>Date Taken: July 16, 2026 12:07 PM<br/>Direction Photo is Taken: Southwest</p> <p>Photo Description: Good contouring, vegetation beginning to establish</p> <p>Latitude: 47.94549143404544<br/>Longitude: -103.90088280626597</p> |

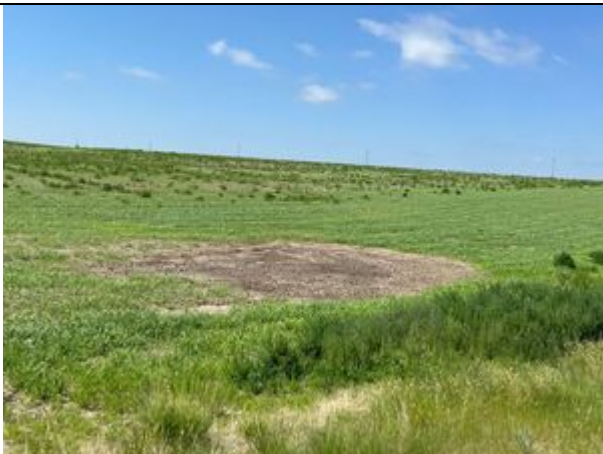
| | <p><b>Observation Point: 18</b><br/>Date Taken: July 16, 2026 12:09 PM<br/>Direction Photo is Taken: Southwest</p> <p>Photo Description: Low spot appears to be natural closed depression and is holding water, thus hindering vegetation.</p> <p>Latitude: 47.94544870709858<br/>Longitude: -103.90141476113999</p> |

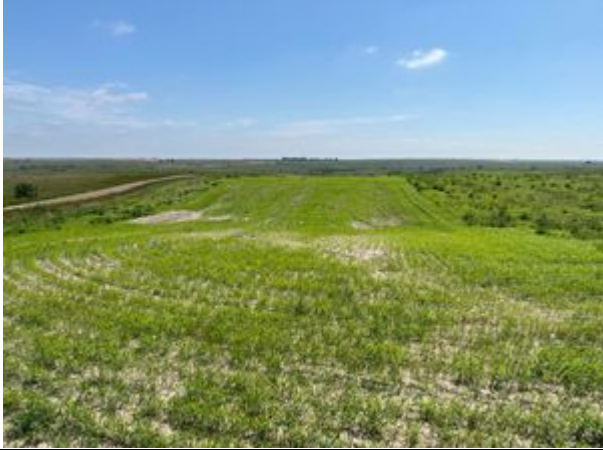
| | <p><b>Observation Point: 19</b><br/>Date Taken: July 16, 2026 12:12 PM<br/>Direction Photo is Taken: East</p> <p>Photo Description: Good contouring, vegetation well-established</p> <p>Latitude: 47.94533016940067<br/>Longitude: -103.90458112036256</p> |

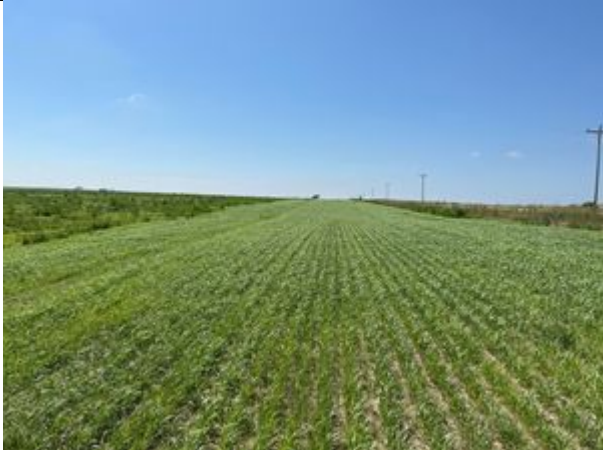
| | <p><b>Observation Point: 20</b><br/>Date Taken: July 16, 2026 12:13 PM<br/>Direction Photo is Taken: South</p> <p>Photo Description: Good contouring, crops well established through ROW</p> <p>Latitude: 47.94517971741458<br/>Longitude: -103.9045568393992</p> |

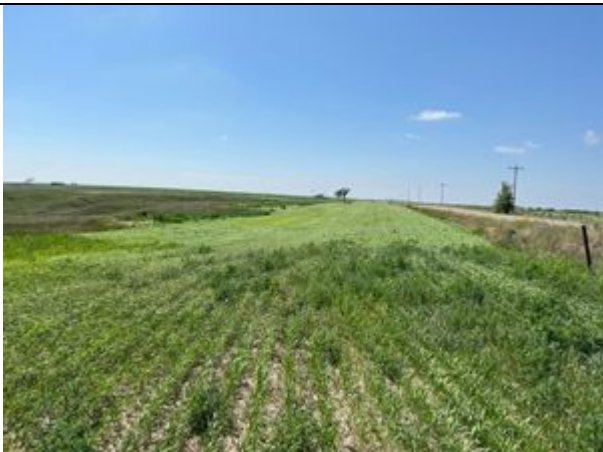
| | <p><b>Observation Point: 21</b><br/>Date Taken: July 16, 2026 12:15 PM<br/>Direction Photo is Taken: South</p> <p>Photo Description: Good contouring, crops well established through ROW</p> <p>Latitude: 47.94236261272018<br/>Longitude: -103.9045965249594</p> |

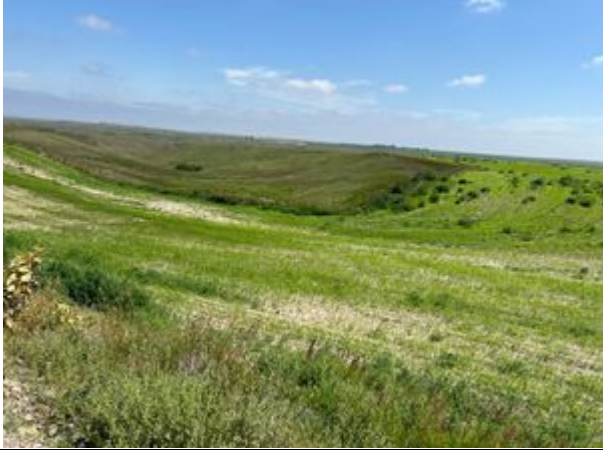
| | <p><b>Observation Point: 22</b><br/>Date Taken: July 16, 2026 12:17 PM<br/>Direction Photo is Taken: East</p> <p>Photo Description: Sparse vegetation in drainage, no immediate concern but will need to revisit this area to confirm vegetation is adequate during final inspection.</p> <p>Latitude: 47.94000068399241<br/>Longitude: -103.90480546638456</p> |

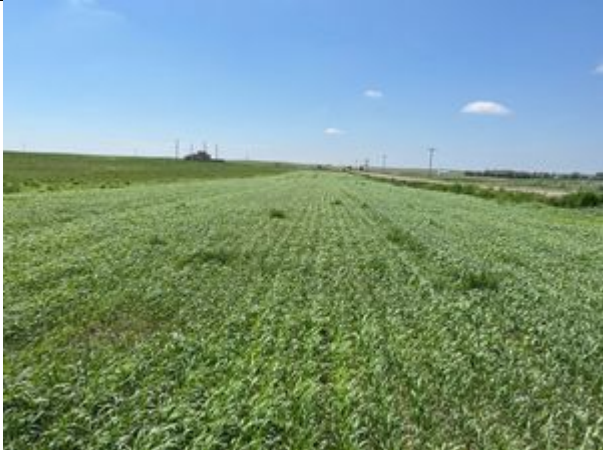
| | <p><b>Observation Point: 23</b><br/>Date Taken: July 16, 2026 12:20 PM<br/>Direction Photo is Taken: South</p> <p>Photo Description: Good contouring, crops well established through ROW</p> <p>Latitude: 47.93859906612114<br/>Longitude: -103.90456978072785</p> |

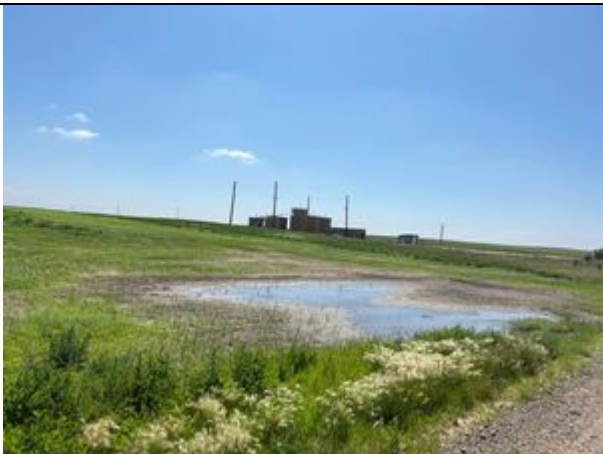
| | <p><b>Observation Point: 24</b><br/>Date Taken: July 16, 2026 12:23 PM<br/>Direction Photo is Taken: Southeast</p> <p>Photo Description: Low spot holding water adjacent to oil pad entrance and hindering vegetation. No apparent natural outlet was observed, this was likely an issue prior to construction.</p> <p>Latitude: 47.93662235435136<br/>Longitude: -103.9047698710772</p> |

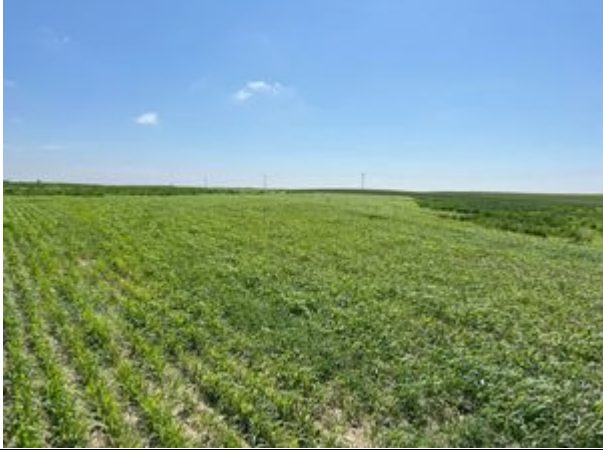
| | <p><b>Observation Point: 25</b><br/>Date Taken: July 16, 2026 12:24 PM<br/>Direction Photo is Taken: Southeast</p> <p>Photo Description: Good contouring, crops well established through ROW</p> <p>Latitude: 47.93630810324143<br/>Longitude: -103.90319809053854</p> |

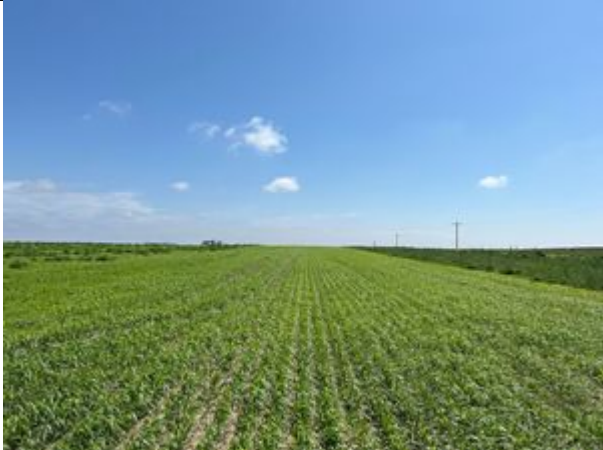
| | <p><b>Observation Point: 26</b><br/>Date Taken: July 16, 2026 12:26 PM<br/>Direction Photo is Taken: East</p> <p>Photo Description: Good contouring, crops well established through ROW</p> <p>Latitude: 47.93551300120505<br/>Longitude: -103.9018666750364</p> |

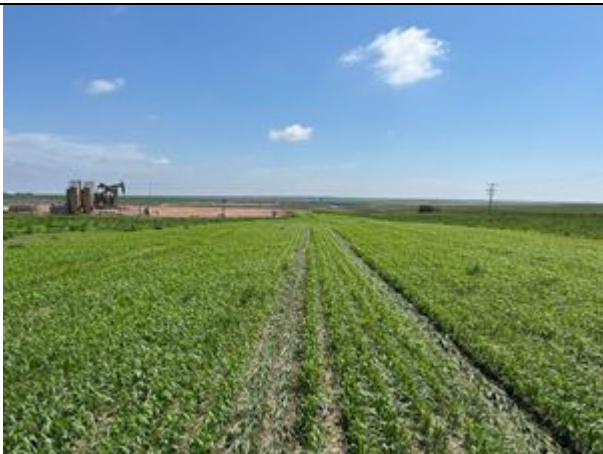
| | <p><b>Observation Point: 27</b><br/>Date Taken: July 16, 2026 12:29 PM<br/>Direction Photo is Taken: East</p> <p>Photo Description: Good contouring, crops well established through ROW</p> <p>Latitude: 47.93554038997728<br/>Longitude: -103.89940573165366</p> |

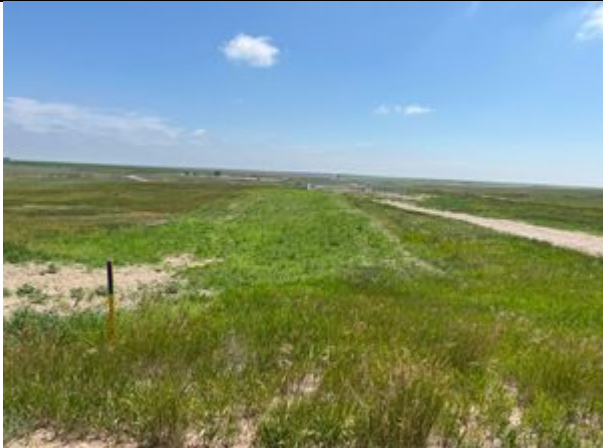
| | <p><b>Observation Point: 28</b><br/>Date Taken: July 16, 2026 12:31 PM<br/>Direction Photo is Taken: East</p> <p>Photo Description: Good contouring,<br/>vegetation well established</p> <p>Latitude: 47.93548359671067<br/>Longitude: -103.89642068842069</p> |
