**PU-25-84**  
**Hiland Crude, LLC**  
**Hiland Express Spine Pipeline**  
**As-Built Inspection Report**

File No. 193807520

July 2026

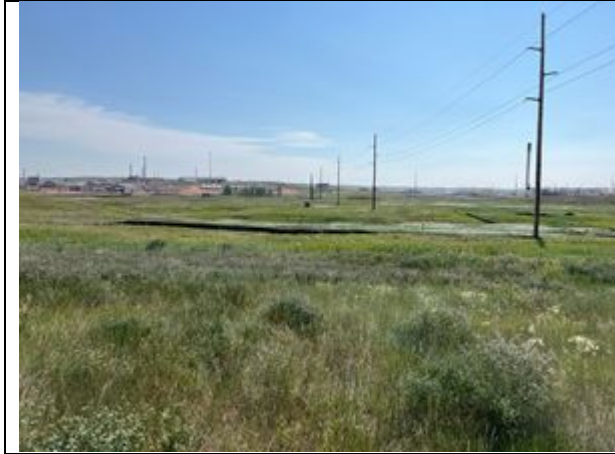
**Observation Point: 1**

Stantec did not observe any geologically unstable areas during the as-built inspection. Per FoF #20, there are geologically unstable areas within the project corridor, but there are no locations where the pipeline crosses these areas. The Project corridor contains many other locations with steep terrain. As noted in the Construction Inspection, stripping efforts on steep slopes commonly resulted in large stockpiles on the downslope side of the ROW in order to create a flat workspace, where subsoil mixing was of relatively high likelihood. Generally, soil replacement and BMP practices at locations with steep side slopes (**Appendix A, Observation Point 1**) appeared to be adequate.

- Request company to remove any remaining silt fence once vegetation is fully established (**Appendix A, Observation Points 1, 20**).
- Request company to re-seed areas with inadequate vegetation cover, such as noted in Section 3.4.2 (**Appendix A, Observation Points 14, 33, 47, 54** [55 excluded as this is cropland]).
- Request company to seed roadway ditches, such as noted in Section 3.4.2 (**Appendix A, Observation Points 49, 51**).
- Request company to file Tree and Shrub Mitigation Plan and georeferenced as-built alignment file for the project.
- Request company to submit an as-built pipeline alignment as noted in Section 3.2.

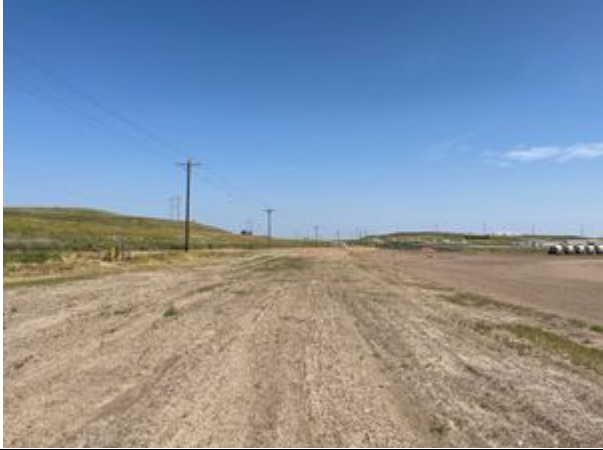
| | <p><b>Observation Point: 4</b><br/>Date Taken: July 20, 2026 11:38 AM<br/>Direction Photo is Taken: North</p> <p>Photo Description: Aggregate re-installed over pipeline ROW, no concerns with final restoration</p> <p>Latitude: 47.69591717401604<br/>Longitude: -103.28185690443445</p> |

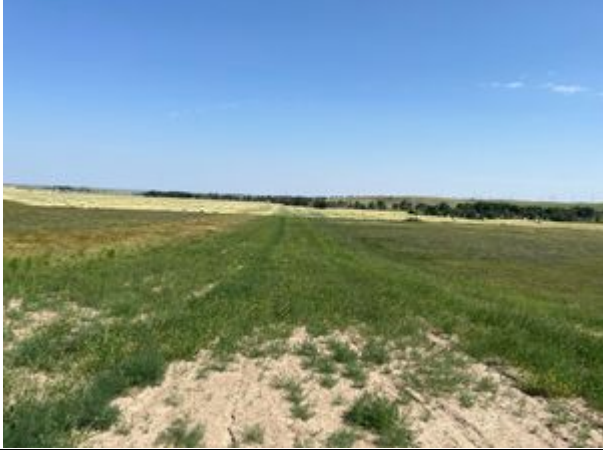
| | <p><b>Observation Point: 10</b><br/>Date Taken: July 20, 2026 12:01 PM<br/>Direction Photo is Taken: North</p> <p>Photo Description: Minor bare spot on downslope, will need to verify vegetation is established well during final inspection.</p> <p>Latitude: 47.71980225237781<br/>Longitude: -103.29279711092796</p> |

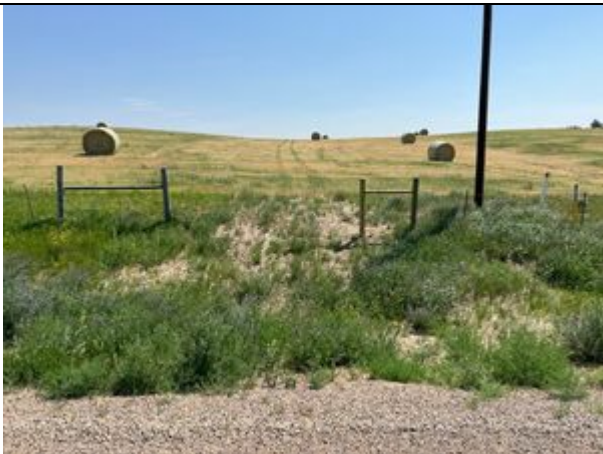
Hiland committed to repairing and replacing all fences and gates (PSC Order Provision #22). Generally, existing fences and/or gates that were impacted by pipeline construction appeared to be replaced or repaired as needed (**Appendix A, Observation Points 12, 32, 49, 51, 52, 54**).

| | <p><b>Observation Point: 12</b><br/>Date Taken: July 20, 2026 12:18 PM<br/>Direction Photo is Taken: East</p> <p>Photo Description: Timber mats removed and fence replaced, good vegetation establishment.</p> <p>Latitude: 47.72642687171786<br/>Longitude: -103.30464861259539</p> |

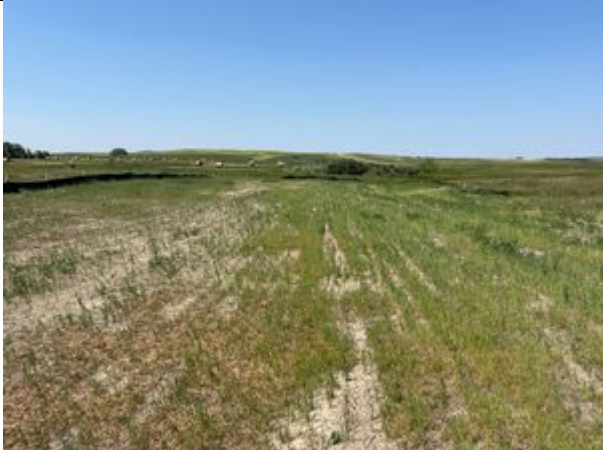
Construction waste removal along the route was generally acceptable. Construction mats and timbers were completely removed at the time of inspection. As noted above in Section 3.4.3, some silt fence remained in place and should be removed once vegetation is fully established.

| | <p><b>Observation Point: 20</b><br/>Date Taken: July 20, 2026 12:42 PM<br/>Direction Photo is Taken: West</p> <p>Photo Description: Silt fence still in place, can be removed since vegetation is partially established.</p> <p>Latitude: 47.74659166049554<br/>Longitude: -103.326718255976</p> |

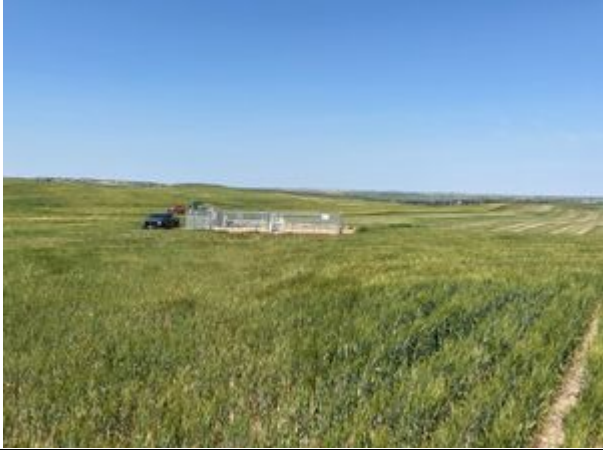
| | <p><b>Observation Point: 28</b><br/>Date Taken: July 20, 2026 1:24 PM<br/>Direction Photo is Taken: North</p> <p>Photo Description: Above ground pig launcher facility constructed w/ aggregate pad and fencing.</p> <p>Latitude: 47.77526032807171<br/>Longitude: -103.36789425179136</p> |

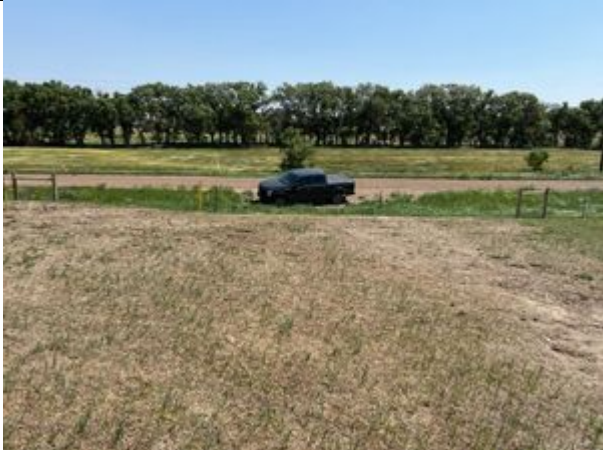
| | <p><b>Observation Point: 32</b><br/>Date Taken: July 20, 2026 1:43 PM<br/>Direction Photo is Taken: East</p> <p>Photo Description: Fencing properly replaced.</p> <p>Latitude: 47.79603257595121<br/>Longitude: -103.3695419322435</p> |

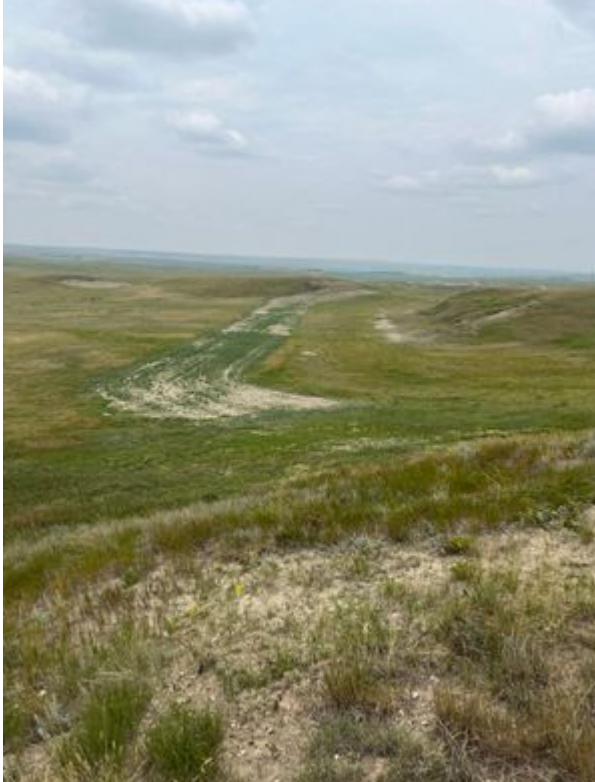
| | <p><b>Observation Point: 45</b><br/>Date Taken: July 21, 2026 11:46 AM<br/>Direction Photo is Taken: West</p> <p>Photo Description: Good contouring overall, vegetation beginning to establish. Topsoil appears to resemble adjacent topsoil coloring and depth.</p> <p>Latitude: 47.85963085471307<br/>Longitude: -103.47667585825653</p> |

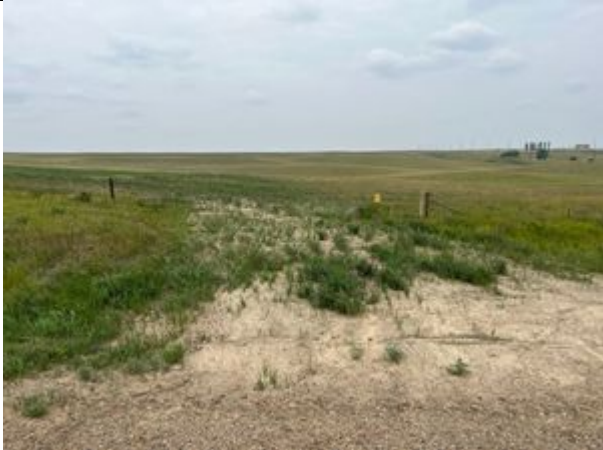
| | <p><b>Observation Point: 51</b><br/>Date Taken: July 21, 2026 12:24 PM<br/>Direction Photo is Taken: West</p> <p>Photo Description: Fencing properly replaced. Ditch may need additional seeding and BMPs installed to allow for proper vegetation establishment.</p> <p>Latitude: 47.90426176475969<br/>Longitude: -103.5195630183902</p> |

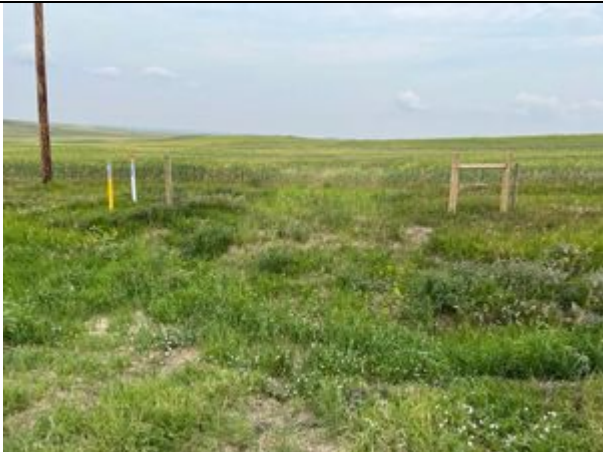
| | <p><b>Observation Point: 52</b><br/>Date Taken: July 21, 2026 12:27 PM<br/>Direction Photo is Taken: North</p> <p>Photo Description: Fencing properly replaced.</p> <p>Latitude: 47.90623221374499<br/>Longitude: -103.5217530794369</p> |
