PU-25-086
Basin Electric Power Cooperative
Bison Generation Station
Topsoil Inspection Report

File No. 227708322

August 2025

Stantec Consulting Services Inc.
3303 Fiechtner Drive, Suite 100
Fargo, ND 58103

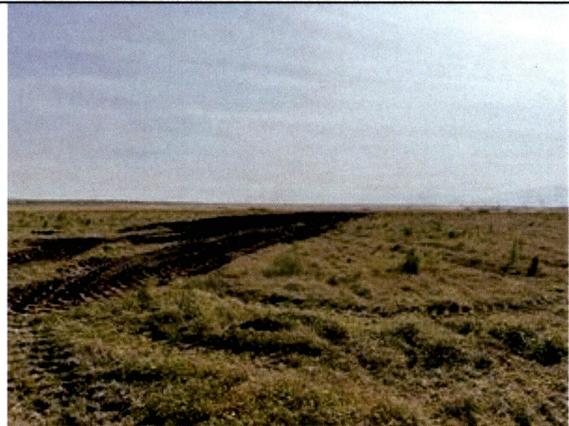
<p>Observation Point: 1 Date Taken: August 18, 2025 11:06 AM Direction Photo is Taken: East</p> <p>Photo Description: Beginning of topsoil stockpile, NW corner of site.</p> <p>Latitude: 48.326924 Longitude: -103.31903419</p>
---	---

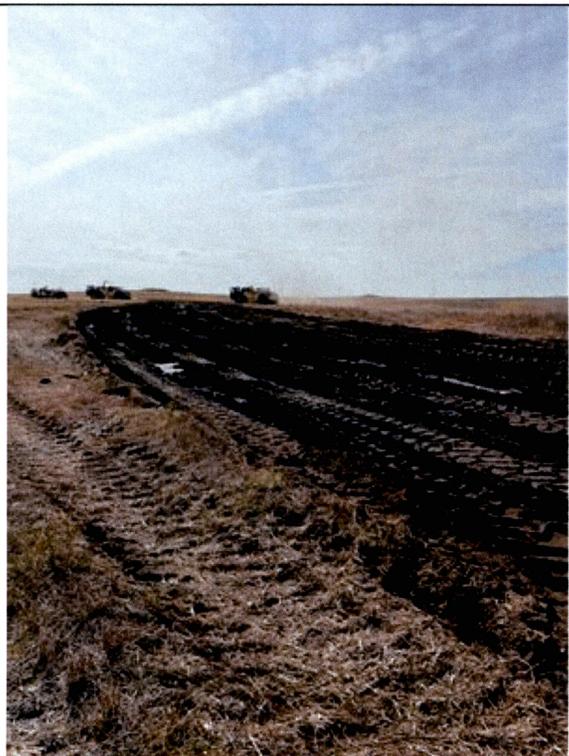
<p>Observation Point: 2 Date Taken: August 18, 2025 11:15 AM Direction Photo is Taken: East</p> <p>Photo Description: Topsoil stripping, approx. 8" deep, subsoil not yet reached by construction equipment.</p> <p>Latitude: 48.32697011 Longitude: -103.31446636</p>
--	---

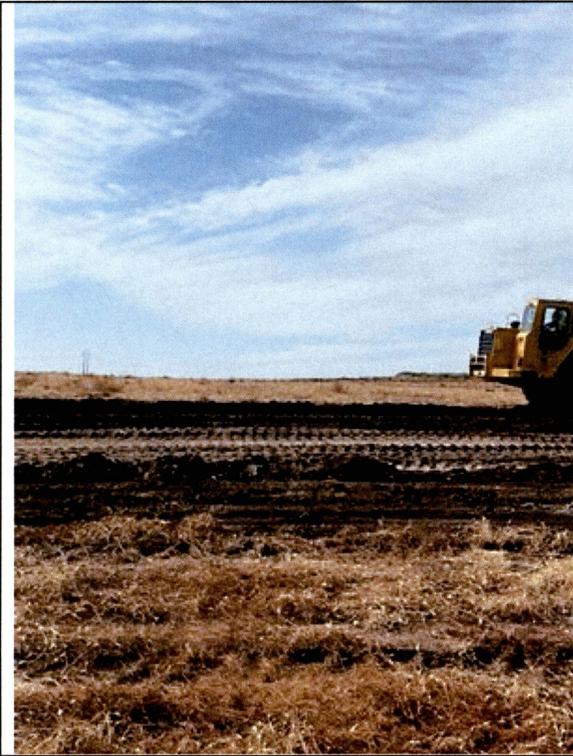
Observation Point: 3
Date Taken: August 18, 2025 11:24 AM
Direction Photo is Taken: South

Photo Description: Subsoil reached at approximately 8" depth (light brown in contrast with topsoil).

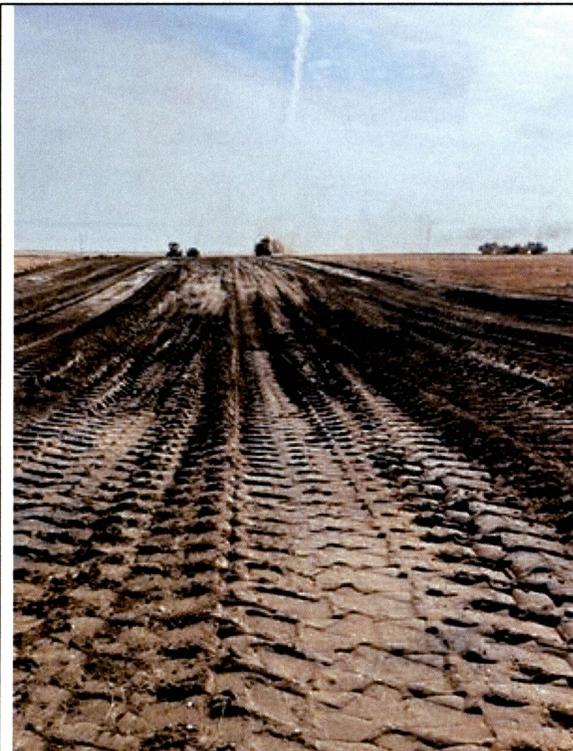
Observation Point: 4
Date Taken: August 18, 2025 11:26 AM
Direction Photo is Taken: East

Photo Description: Subsoil reached at approx 8" depth
