**PU-25-086**  
**Basin Electric Power Cooperative**  
**Bison Generation Station**  
**Construction Inspection Report**

File No. 227708322

September 2026

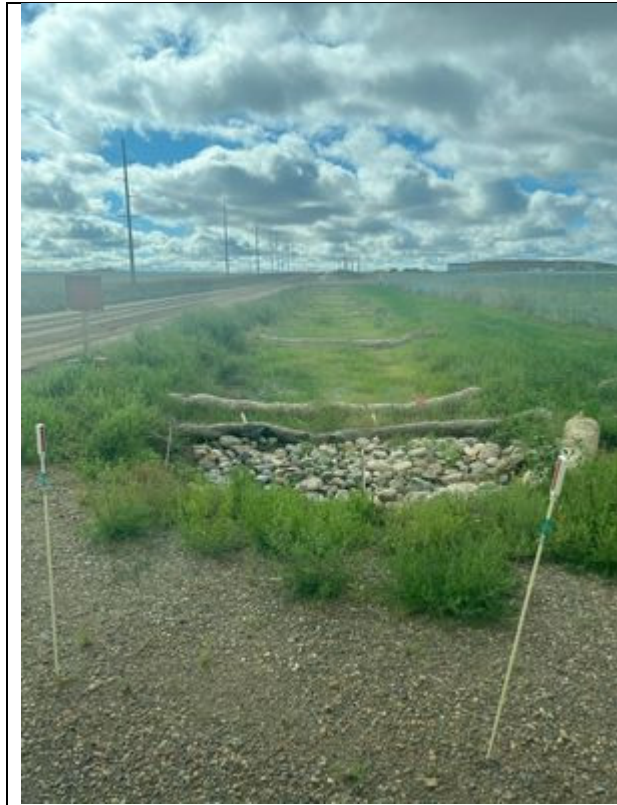
**Observation Point: 1**

Various Best Management Practices (BMP's) were observed across the site. A permanent sedimentation basin (future retention pond) was constructed adjacent to the topsoil stockpile at the northwest corner of the site (**Observation Point 4**). Various swales, both permanent and temporary, were graded around the site to direct stormwater to this pond to allow for sedimentation to occur before exiting the site. In addition, drainage swales contained a combination of rock ditch checks, straw wattles, and rip rap to minimize erosion within and leaving the site. (**Observation Points 1, 2, 3**). A perimeter silt fence was observed around the site boundary as a final layer of protection.

Photo Description: Straw waddles and rip rap installed along the ditch adjacent to the eastern project boundary.

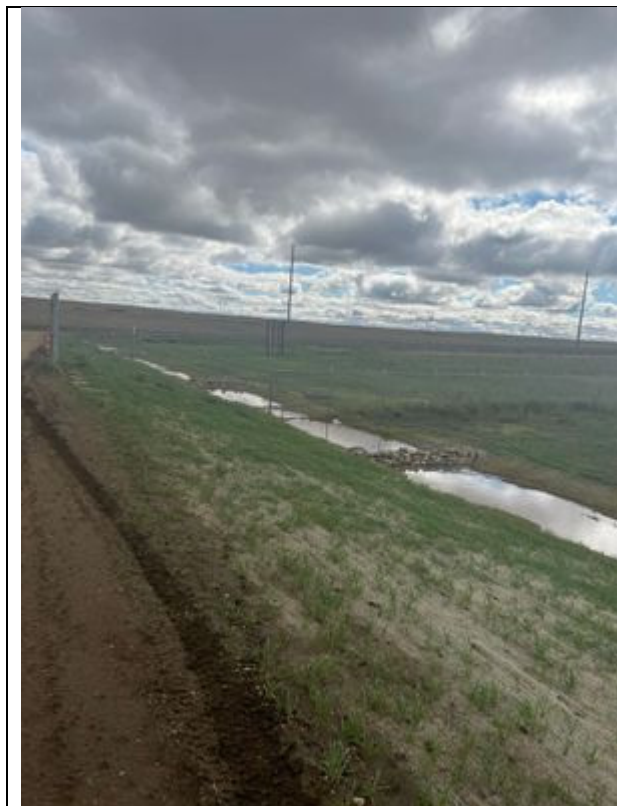
**Observation Point: 2**

Photo Description: Rock ditch checks installed along the drainage swale for water exiting the site into the eastern drainage ditch.

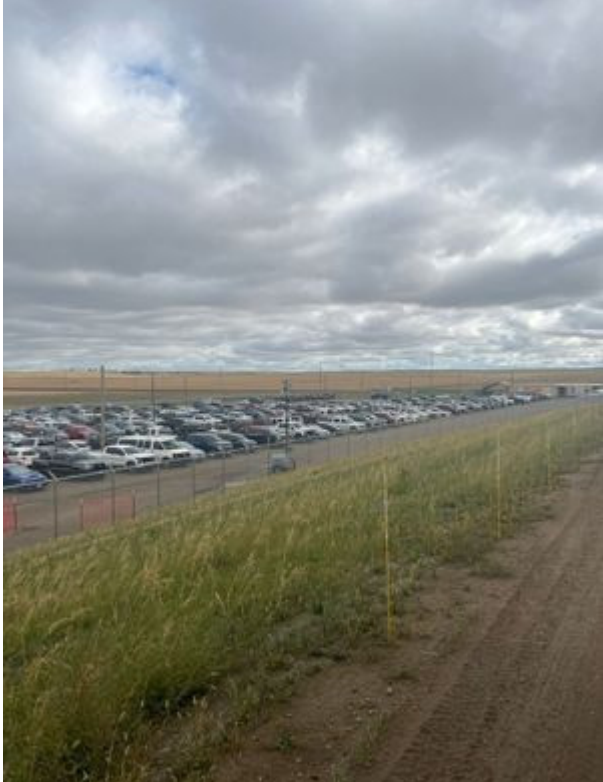
| | <p><b>Observation Point: 3</b><br/>Date Taken: September 15, 2026 11:46 AM<br/>Direction Photo is Taken: West</p> <p>Photo Description: Straw waddles placed along the upslope side of the central roadway embankment.</p> <p>Latitude: 48.32666359497431<br/>Longitude: -103.308013439612</p> |

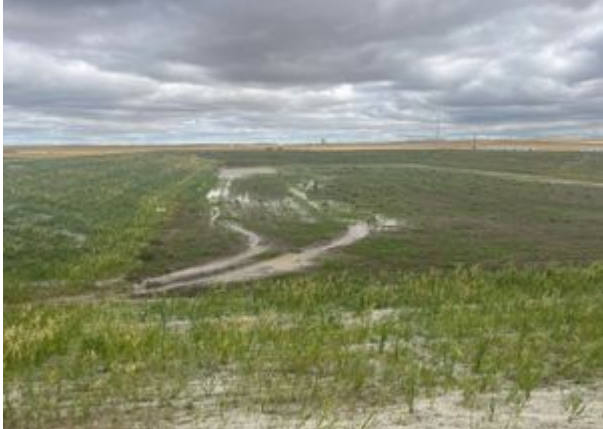
| | <p><b>Observation Point: 4</b><br/>Date Taken: September 15, 2026 11:48 AM<br/>Direction Photo is Taken: North</p> <p>Photo Description: Stormwater sedimentation basin/retention pond location.</p> <p>Latitude: 48.32657340155336<br/>Longitude: -103.3142316730335</p> |

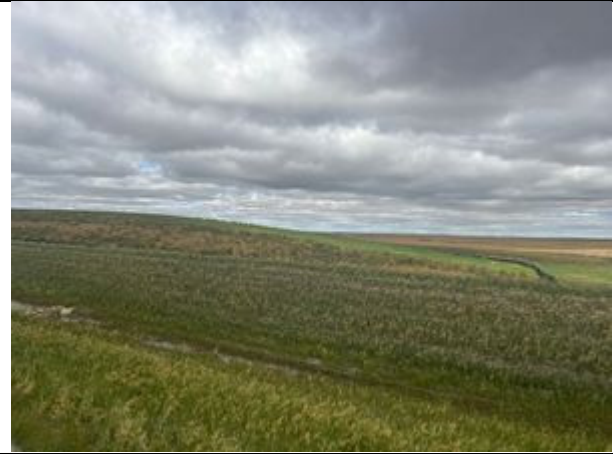
Due to the relatively long construction duration of this project in conjunction with it being constricted to a single area, handling of topsoil and subsoil primarily occurred during the early mass grading phase of the project and the site has been constructed to where minimal effort needs to be taken to manage the topsoil further. After the topsoil was stripped across the entire site, a stockpile was created at the northwest corner of the site (**Observation Points 5 & 6**), which was seeded and stabilized at the time of inspection. Similarly, a subsoil stockpile was created at the southeast corner of the site (**Observation Point 11**), which was actively being worked during the inspection and would continue to be for several months, and was therefore not seeded or stabilized. No mixing of topsoils and subsoils was observed during the inspection.

| | <p><b>Observation Point: 5</b><br/>Date Taken: September 15, 2026 11:51 AM<br/>Direction Photo is Taken: Northwest</p> <p>Photo Description: Seeded topsoil stockpile.</p> <p>Latitude: 48.32657462862308<br/>Longitude: -103.31499462483733</p> |

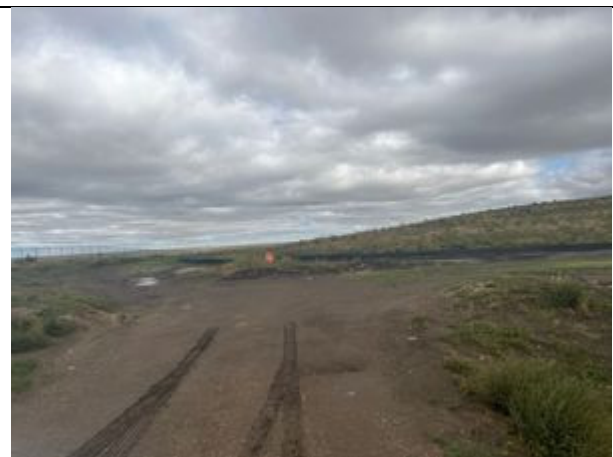
| | <p><b>Observation Point: 6</b><br/>Date Taken: September 15, 2026 11:53 AM<br/>Direction Photo is Taken: Northwest</p> <p>Photo Description: Seeded topsoil stockpile contained within site fence.</p> <p>Latitude: 48.32668862298344<br/>Longitude: -103.31906303776903</p> |

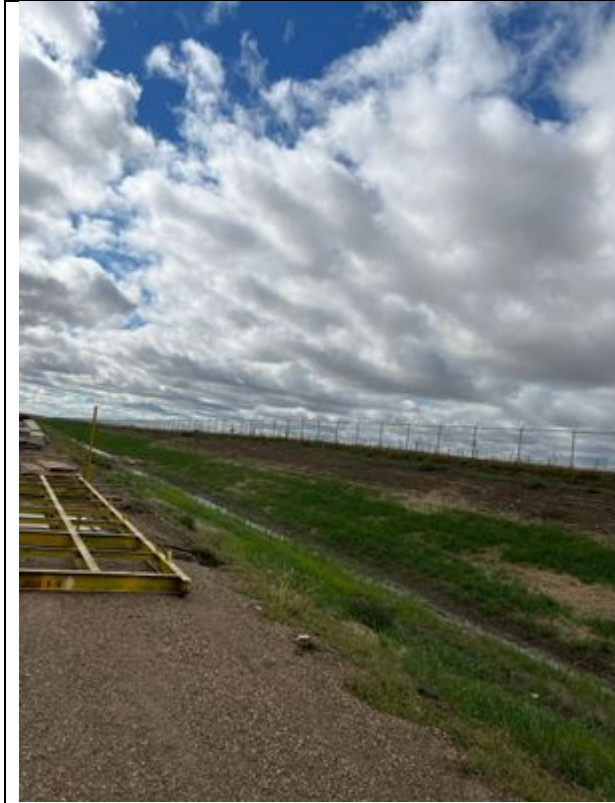
**Observation Point: 7**

At the time of inspection, a permanent perimeter fence had been installed around the site boundary, with silt fence placed along the outside of the fencing (**Observation Points 7, 13, 14**). The fencing appeared to be placed within the project boundary, which was verified through our GPS practices as described in Section 2.3. To the best of our knowledge, no work was being performed outside of the perimeter fencing.

Photo Description: Permanent fencing placed along western perimeter.

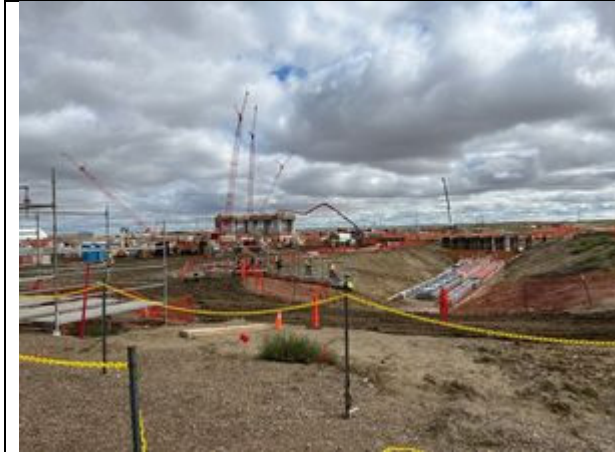
**Observation Point: 8**

During Stantec's inspection on September 15<sup>th</sup>, the site mass grading had been completed and construction of the generation station facility and subsidiary components were being constructed. At the time of inspection, approximately 500 workers were performing various construction activities across the site. These activities included installation of pilings, foundations, substation construction, duct bank construction, and steel erection of the generation station facility (**Observation Points 8, 9, 10**).

Photo Description: Overview of generation station under construction.

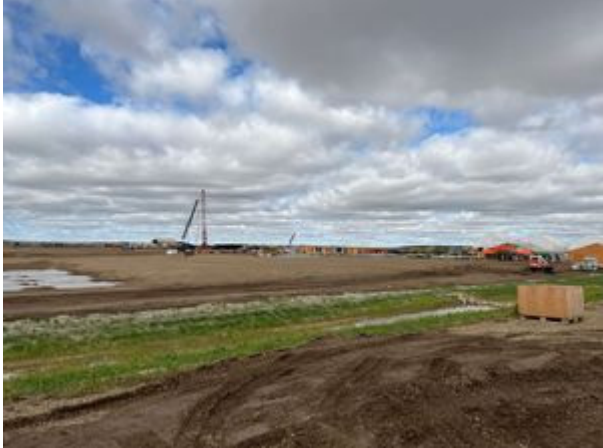
| | <p><b>Observation Point: 9</b><br/>Date Taken: September 15, 2026 12:04 PM<br/>Direction Photo is Taken: West</p> <p>Photo Description: Overview of laydown yard to the west of generation station location.</p> <p>Latitude: 48.32272450088192<br/>Longitude: -103.31331882806039</p> |

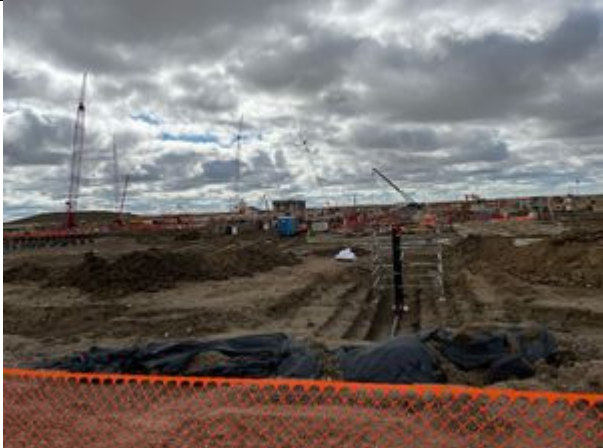
| | <p><b>Observation Point: 10</b><br/>Date Taken: September 15, 2026 12:07 PM<br/>Direction Photo is Taken: South</p> <p>Photo Description: Overview of generation station from north side.</p> <p>Latitude: 48.32593836344959<br/>Longitude: -103.31235573164608</p> |

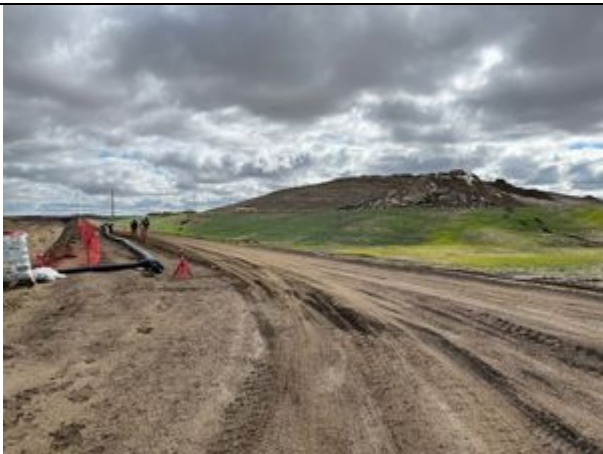
| | <p><b>Observation Point: 11</b><br/>Date Taken: September 15, 2026 12:11 PM<br/>Direction Photo is Taken: Southeast</p> <p>Photo Description: Active subsoil stockpile intended for filling site when building is complete.</p> <p>Latitude: 48.32241852648943<br/>Longitude: -103.3086743833162</p> |

- Stabilize the large subsoil stockpile at any point where it is determined it will not be actively worked for a period of 14 days or greater.
- Continue implementing BMPs and stockpile protection measures, especially if stockpiles are to be left over winter when spring melting conditions increase soil erosion.

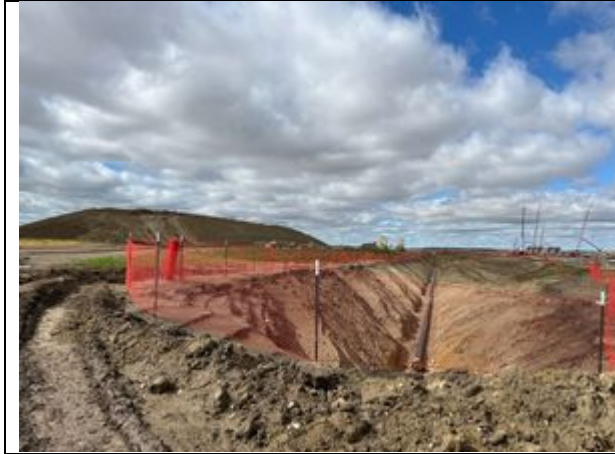
**Observation Point: 12**

Photo Description: Primary water pipeline feeding site.

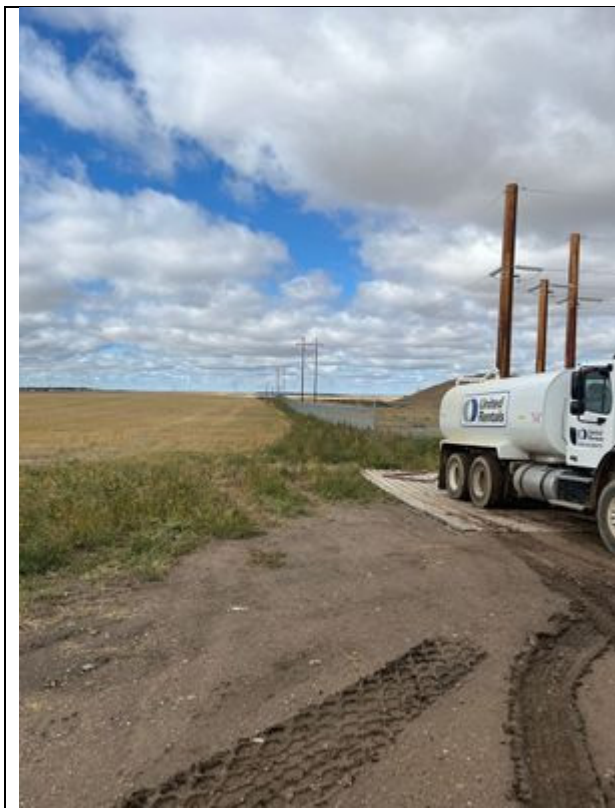
**Observation Point: 13**

Photo Description: South side perimeter fencing.

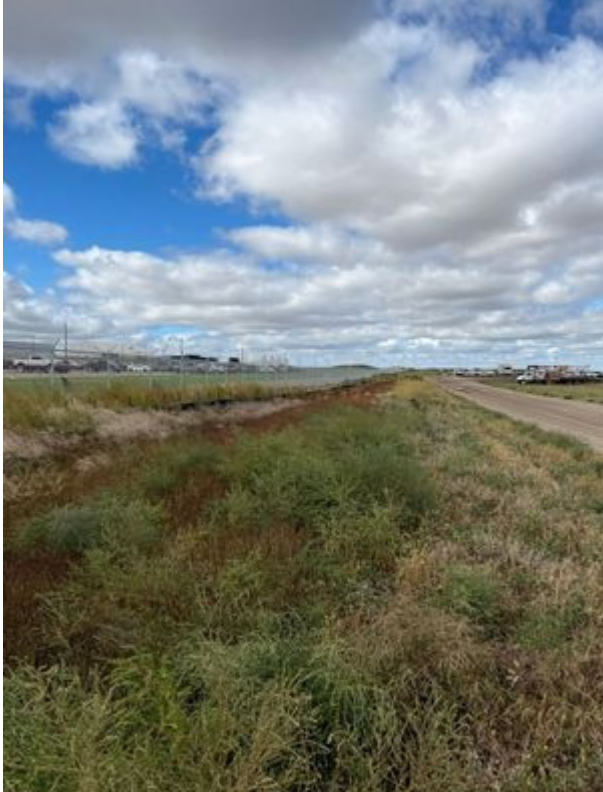
| | <p><b>Observation Point: 14</b><br/>Date Taken: September 15, 2026 12:22 PM<br/>Direction Photo is Taken: West<br/><br/>Photo Description: North side perimeter fencing.<br/><br/>Latitude: 48.32802791858808<br/>Longitude: -103.30539063100476</p> |
