**ONEOK Bakken 6-inch NGL Pipeline Project**

**Williams County**

**Construction Inspection Report**

***Docket Number: PU-25-172***

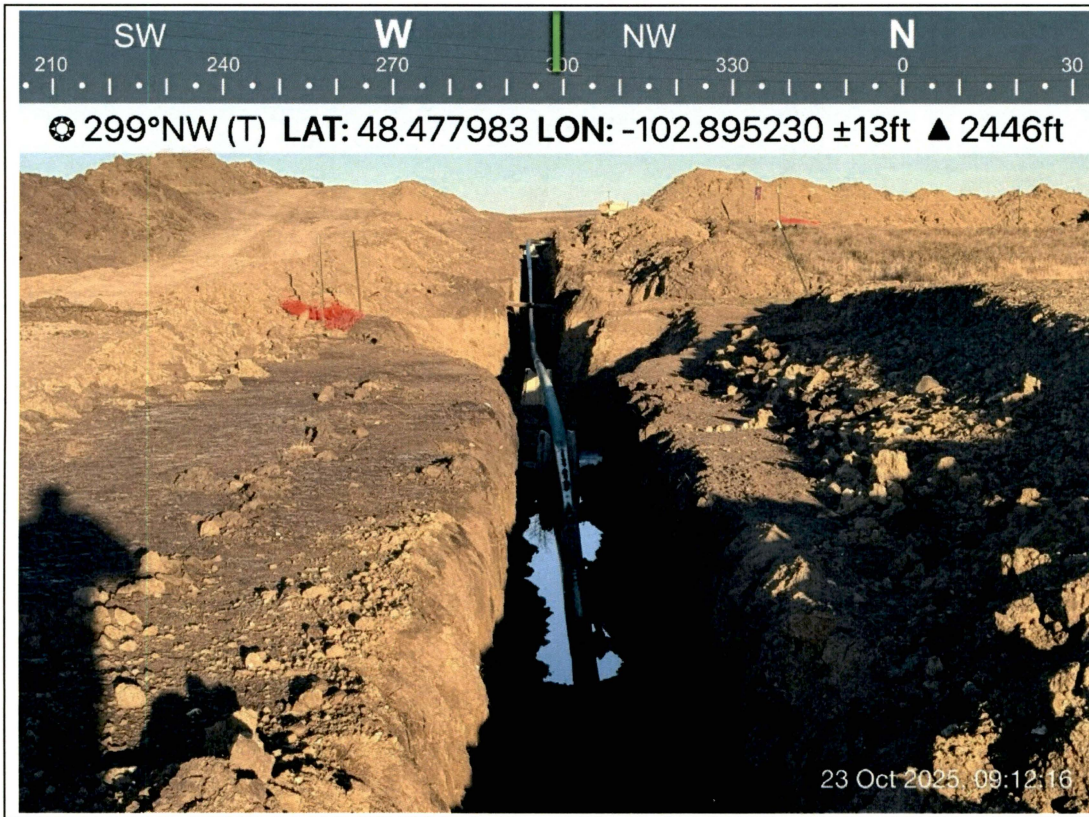
Photo #: 1

Description: Pipe lowered into ROW ditch to be coated and tied in.

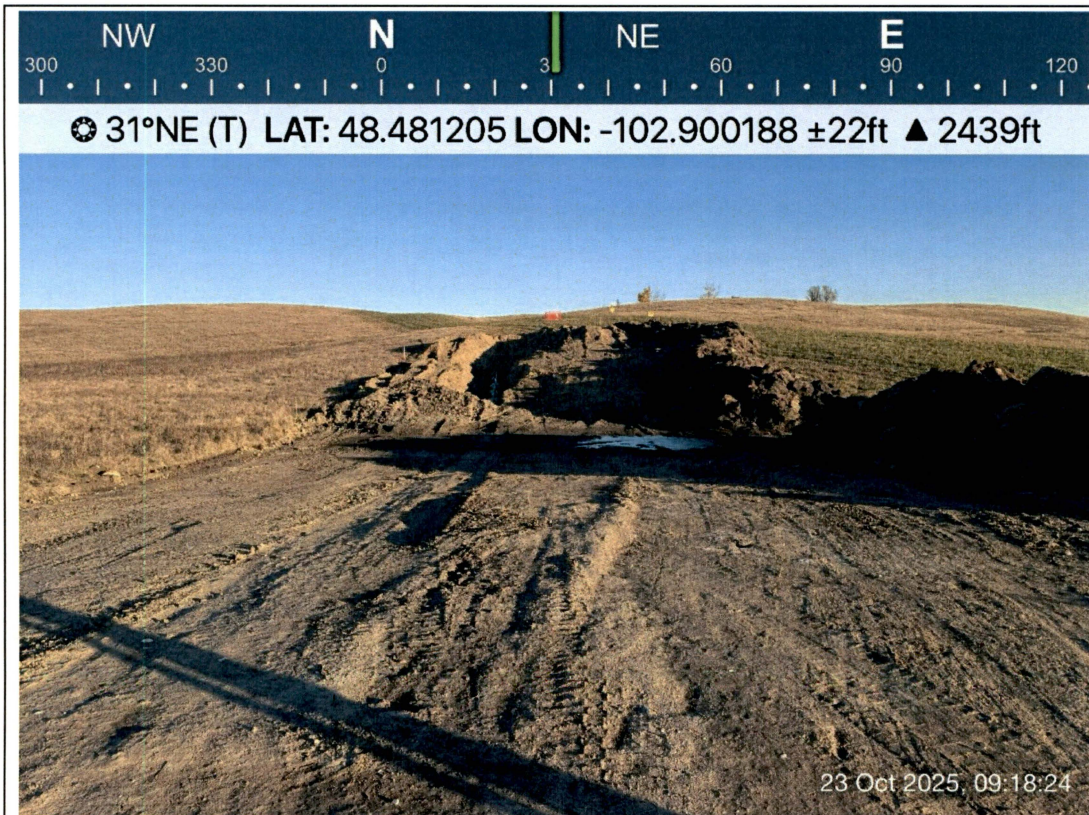
Photo #: 2

Description: Topsoil segregated at tie-in location for final reclamation.

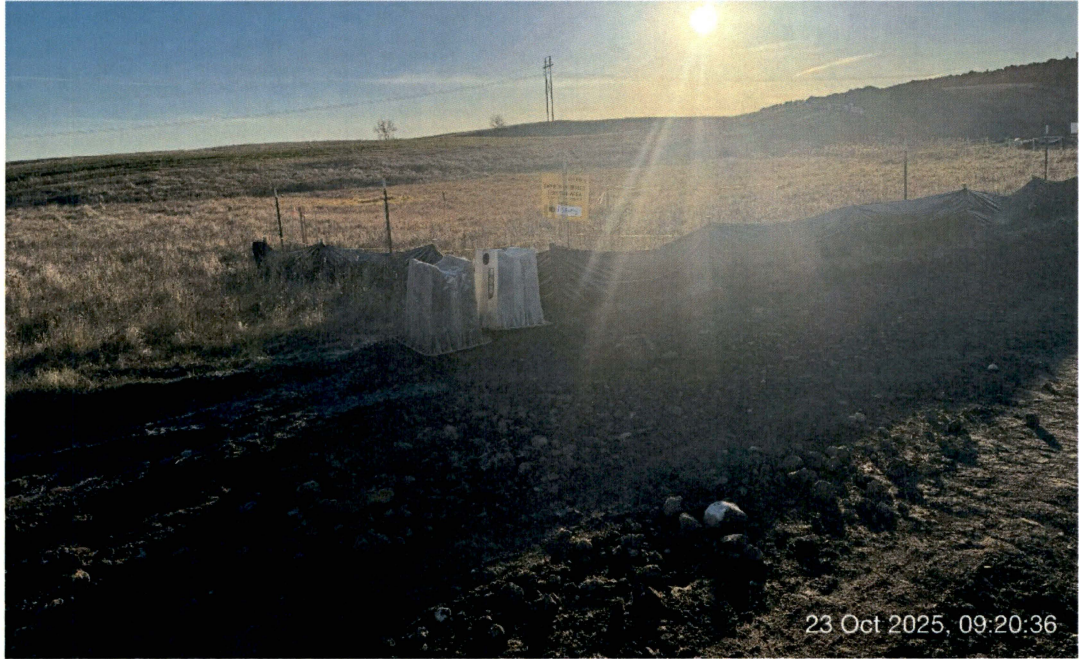
Photo #: 3

Description:  
Environmental  
Avoidance Area roped  
off with silt fence  
around perimeter.

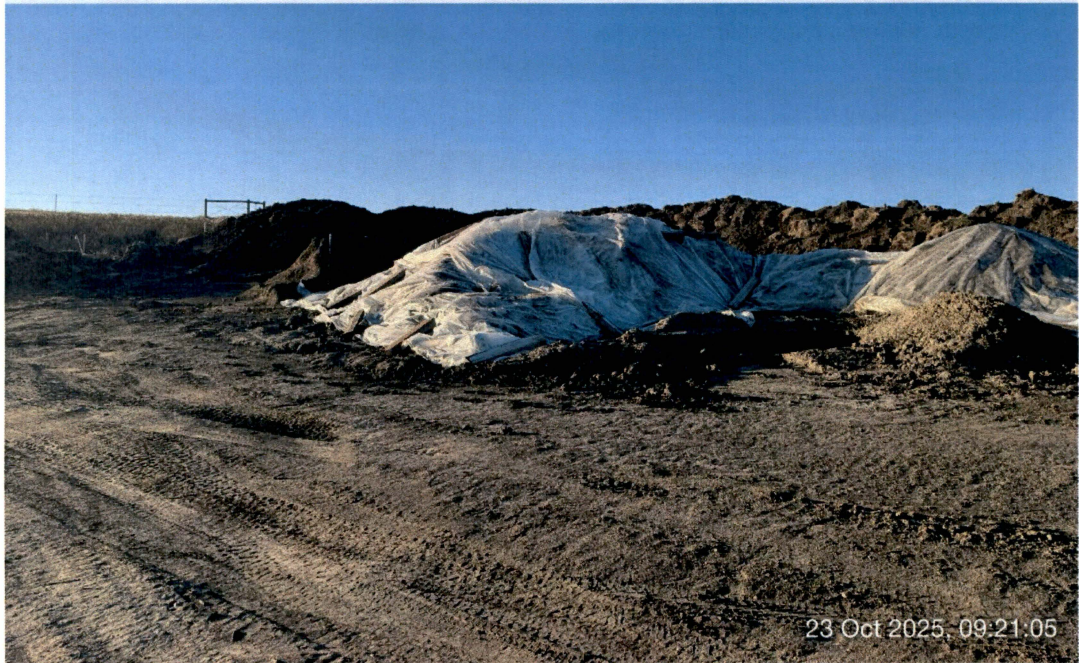
Photo #: 4

While excavating the pipeline trench along the ROW, ONEOK discovered an area with contaminated soil from a previously-e poly line within the Project ROW. ONEOK excavated the contaminated soil and segregated the contaminated soil from topsoil and subsoil piles and covered the removed contaminated soil with plastic to prevent further contamination. The source of the contamination had not been determined at the time of the inspection, but Mr. Gilreath stated that soil samples were collected and sent to a lab for analysis. The contaminated soil was to be removed and disposed of at hazardous material disposal facility as soon as possible. It appeared that all regulations and procedures were properly followed by ONEOK for this issue.

Description: Removed  
contaminated soil  
separated from topsoil  
and covered in plastic  
until it is hauled out for  
disposal.

Potential Issues	Recommendations
<b>Removal of Contaminated Soil</b>	The stockpile of contaminated soil will need to be properly removed for disposal at a hazardous material disposal facility as soon as feasible.
<b>SWPPP BMPs</b>	Silt fence, waddles and other erosion devices will need to be monitored until vegetation is reestablished along ROW.

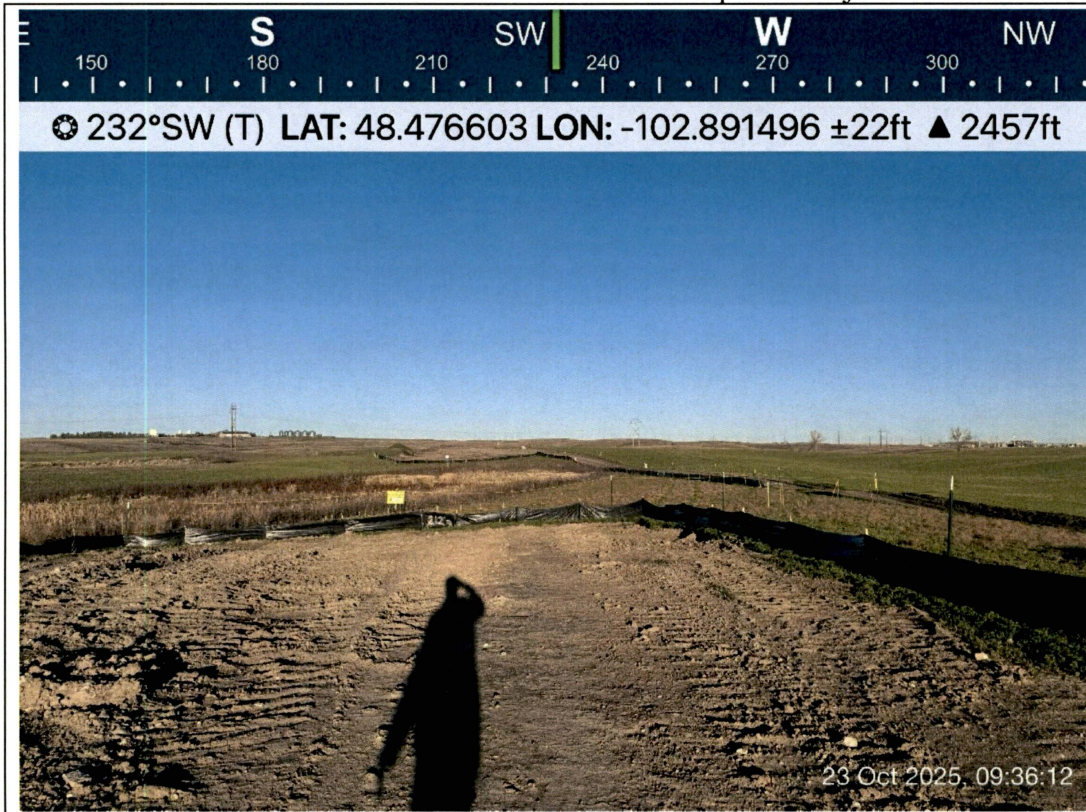
Photo #: 5  
Direction: Southwest  
Description: Silt fence and rope around perimeter of wetland area.  
Observer: Zach Peterson  
Date: 10/23/2025  
Latitude: 48.476603  
Longitude: -102.891496

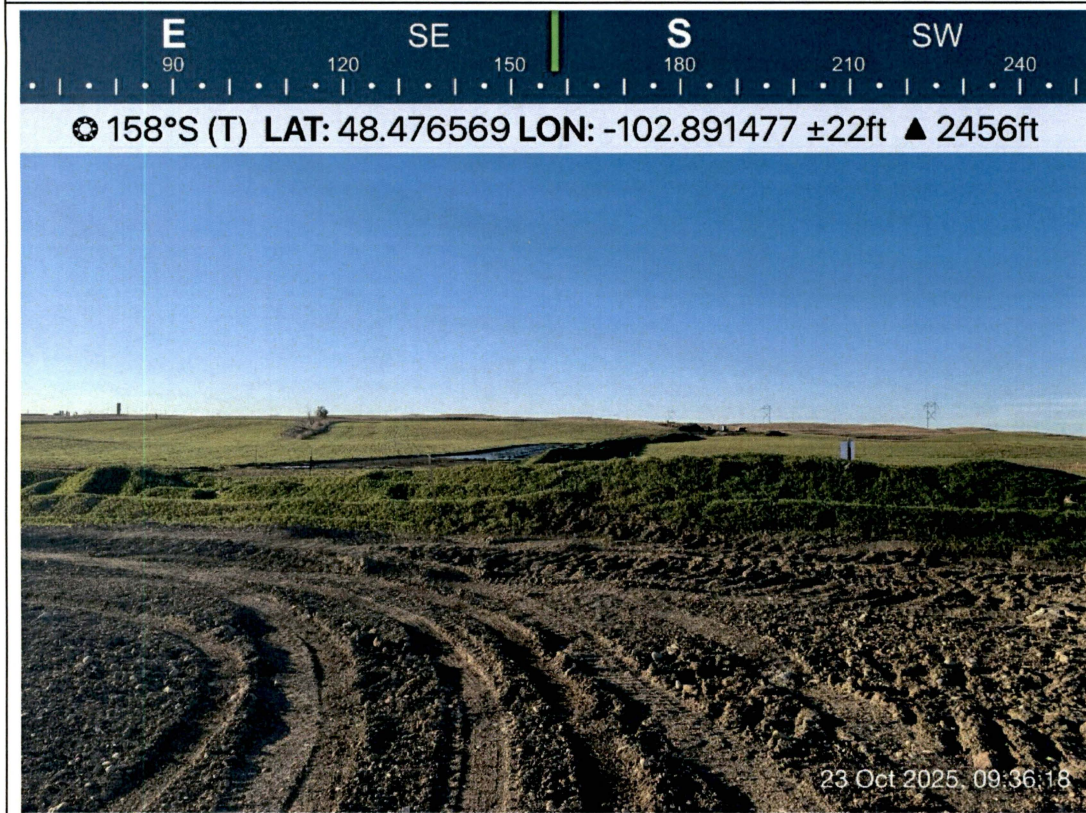
Photo #: 6  
Direction: Southeast  
Description: Backfilled ROW with topsoil piles next to alfalfa field for final reclamation.  
Observer: Zach Peterson  
Date: 10/23/2025  
Latitude: 48.476569  
Longitude: -102.891477

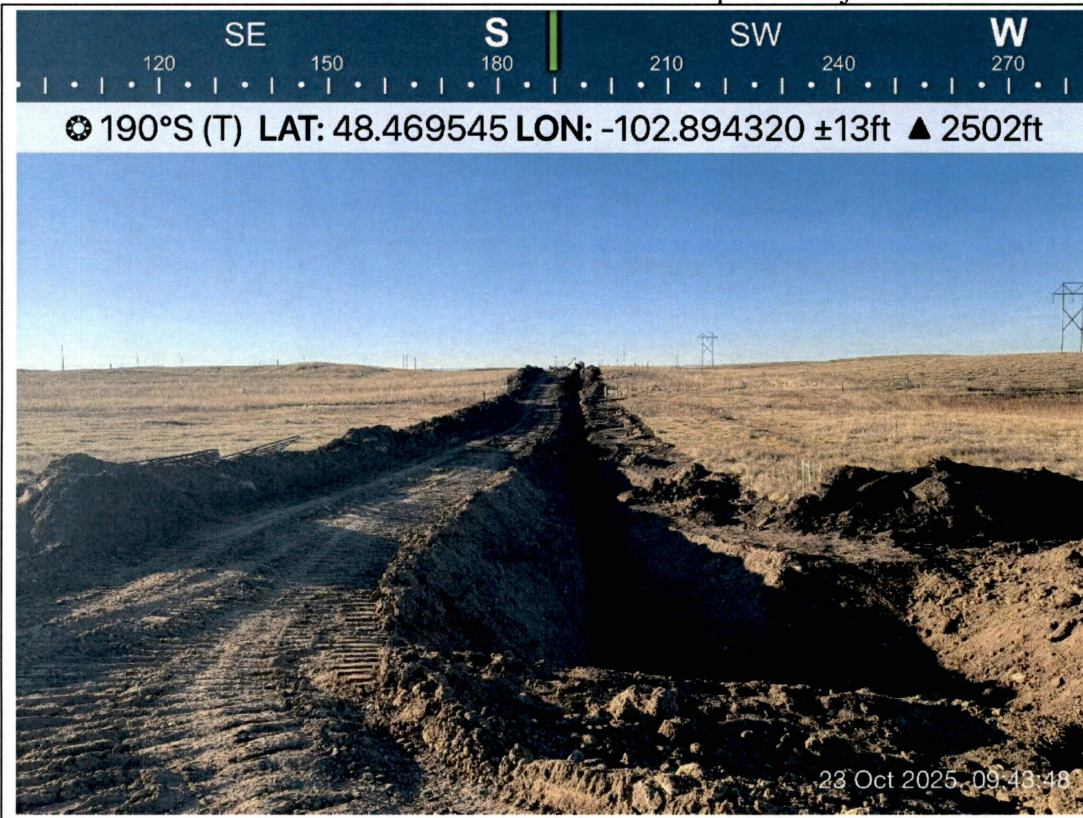
Photo #: 7

Description: Completed section of pipe lowered and ready to be backfilled.

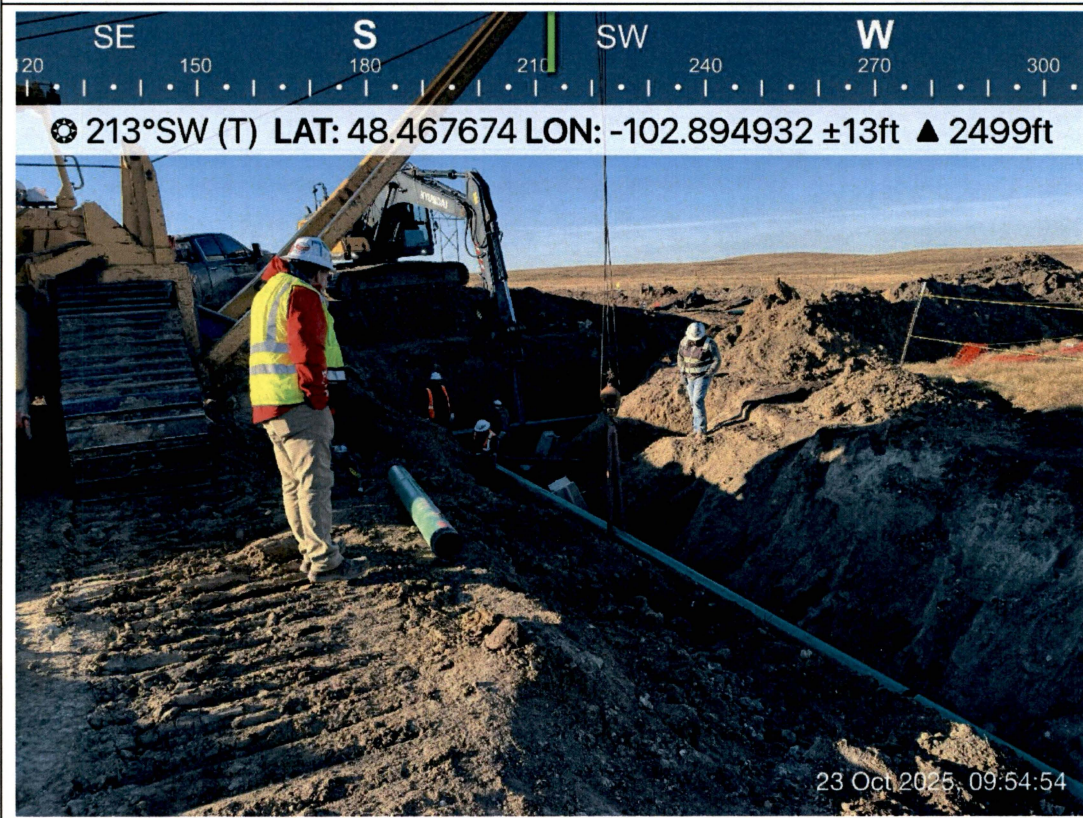
Photo #: 8

Description: Construction crews lowering pipe into ditched ROW.

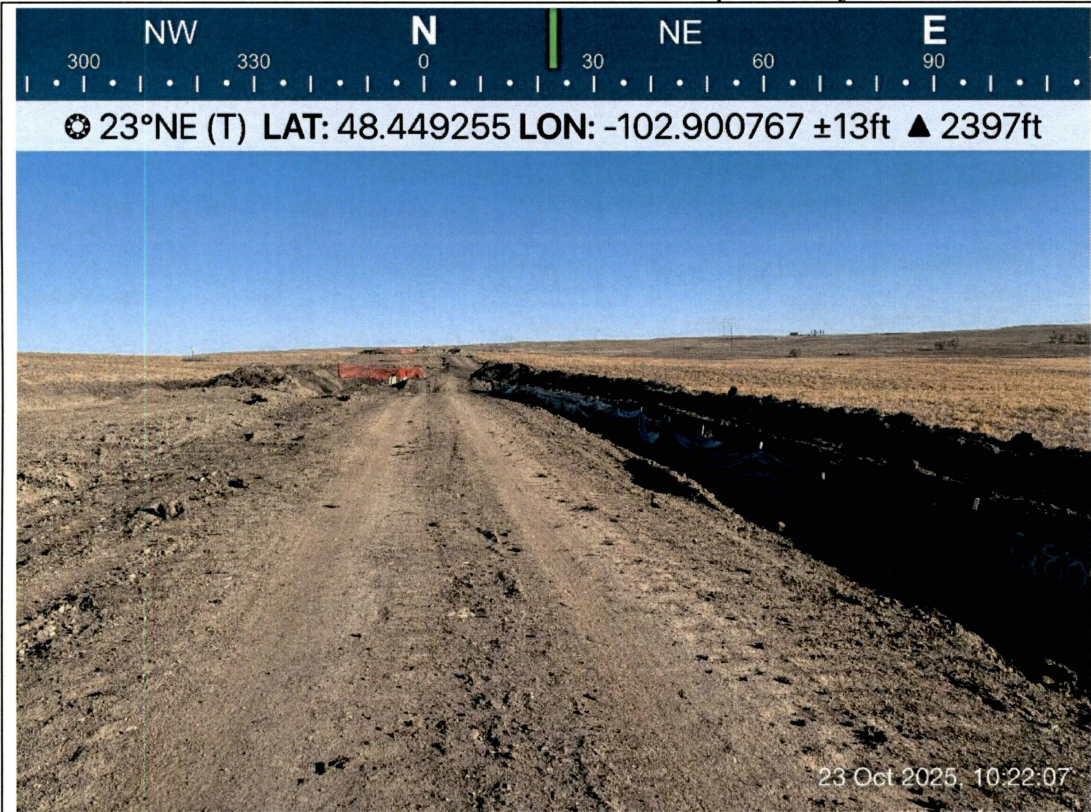
Photo #: 9  
Direction: North  
Description: Backfilled section of ROW with silt fence along perimeter of topsoil piles.  
Observer: Zach Peterson  
Date: 10/23/2025  
Latitude: 48.449255  
Longitude: -102.900767

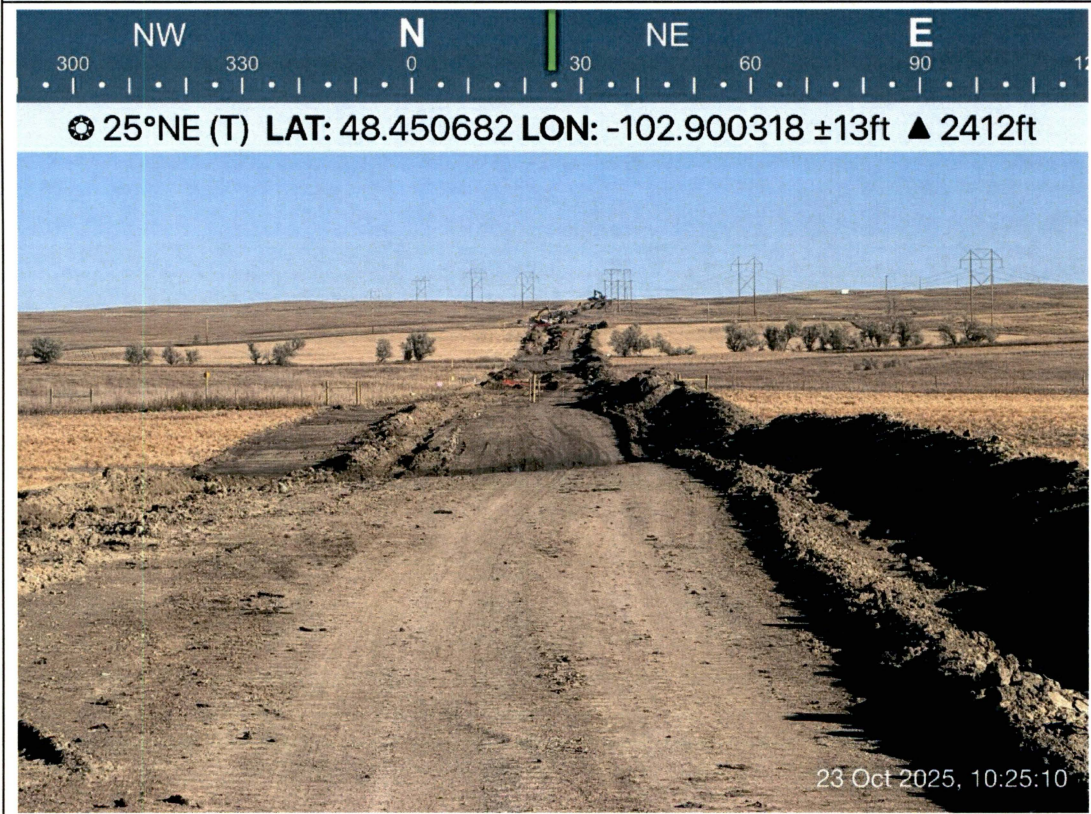
Photo #: 10  
Direction: Northeast  
Description: Backfilled ROW with equipment and construction crew working to the North.  
Observer: Zach Peterson  
Date: 10/23/2025  
Latitude: 48.450682  
Longitude: -102.900318
