# TOPSOIL STRIPPING REPORT

## Emmons Logan Energy Storage Case No. PU-25-209

May 5-6, 2026

**Houston Engineering, Inc.**  
3712 Lockport St.  
Bismarck, ND 58503  
Phone # 701.323.0200

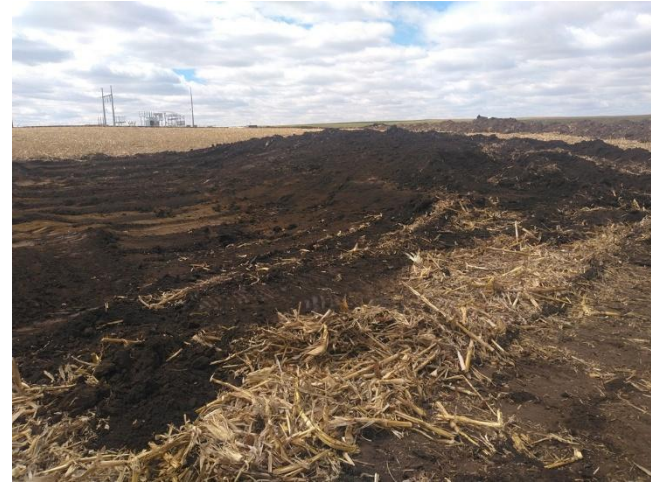
Inspector conducted a site visit on 5/6/26 to inspect the topsoil stripping and give feedback to the site superintendent and equipment operators on the topsoil stripping. Four sites were being stripped in preparation for the site grading and construction of the infrastructure for the energy storage facility. Inspector noted topsoil stripping depth at a portion of Site 1 was exceeding the depth necessary and getting into underlying soils. Inspections at Site 2, Site 3 and Site 4 determined that topsoil stripping was proceeding satisfactorily.

| Site 1 Looking South<br>Showing over depth removal | Site 1 Looking East<br>Showing segregated and stockpiled topsoil |

Upon seeing stripping depth at Site 1, inspector informed the operator that we did not want to mix subsoils with the topsoil and to exercise care not to get too deep.

Inspector discussed stripping depth with onsite Superintendent and the intent to strip to one foot depth or the full cultivated depth, whichever is greater. Reviewed stripping depth at all four sites with Superintendent to ensure compliance with Certification Relating to Order Provisions. Inspector pointed out over depth stripping at site 1 and recommended exercising care to not strip too deeply. Any over depth soils removed during stripping operations are to be separated and returned to general backfill. Inspector reviewed stripping operations at the other three sites and discussed satisfactory stripping depth at each site to be maintained for further stripping operations.

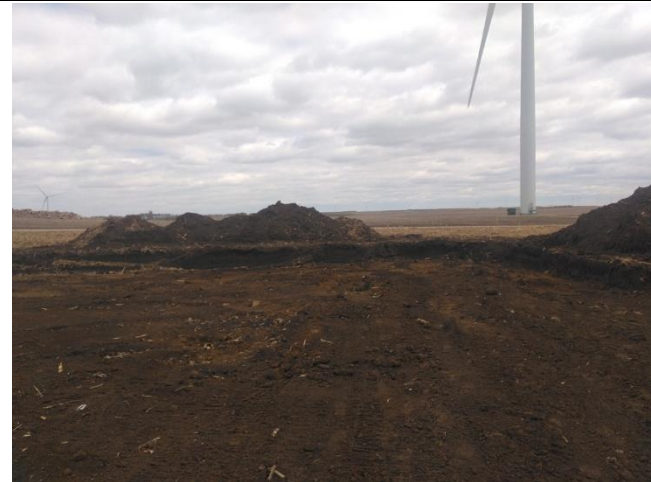
| Site 2 Looking North<br>Showing correctly stripped site | Site 2 Looking South<br>Showing segregated topsoil piles |

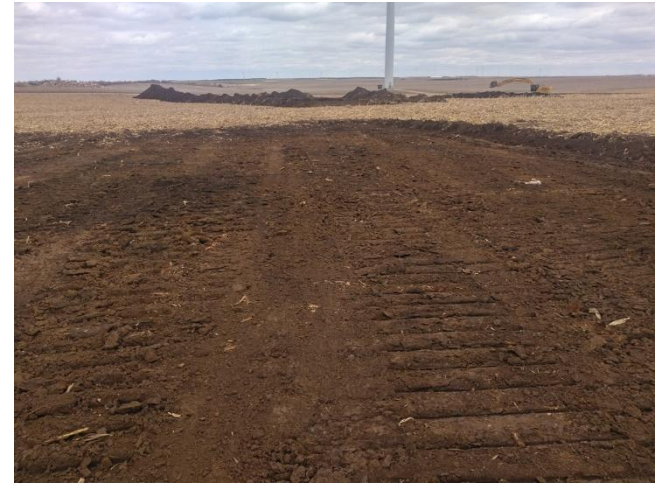
| <p>Site 3 Looking South</p> <p>Showing stripped site</p> | <p>Site 3 Looking North</p> <p>Showing stripped site and stockpiled topsoil</p> |

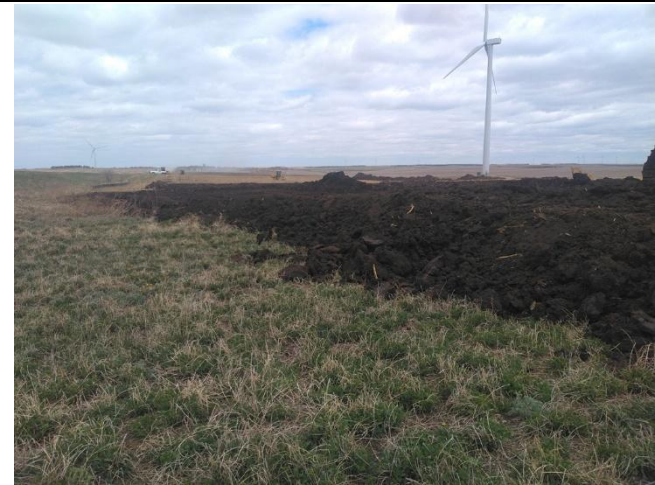
| <p>Site 4 Looking North</p> <p>Showing segregated topsoil</p> | <p>Site 4 Looking East</p> <p>Showing segregated topsoil</p> |
