INSPECTION REPORT

DATE OF INSPECTION: December 15, 2015

PERMITTEE - MINE: Coyote Creek Mine

PERMITS INSPECTED: NACC-1301, NACC-1302

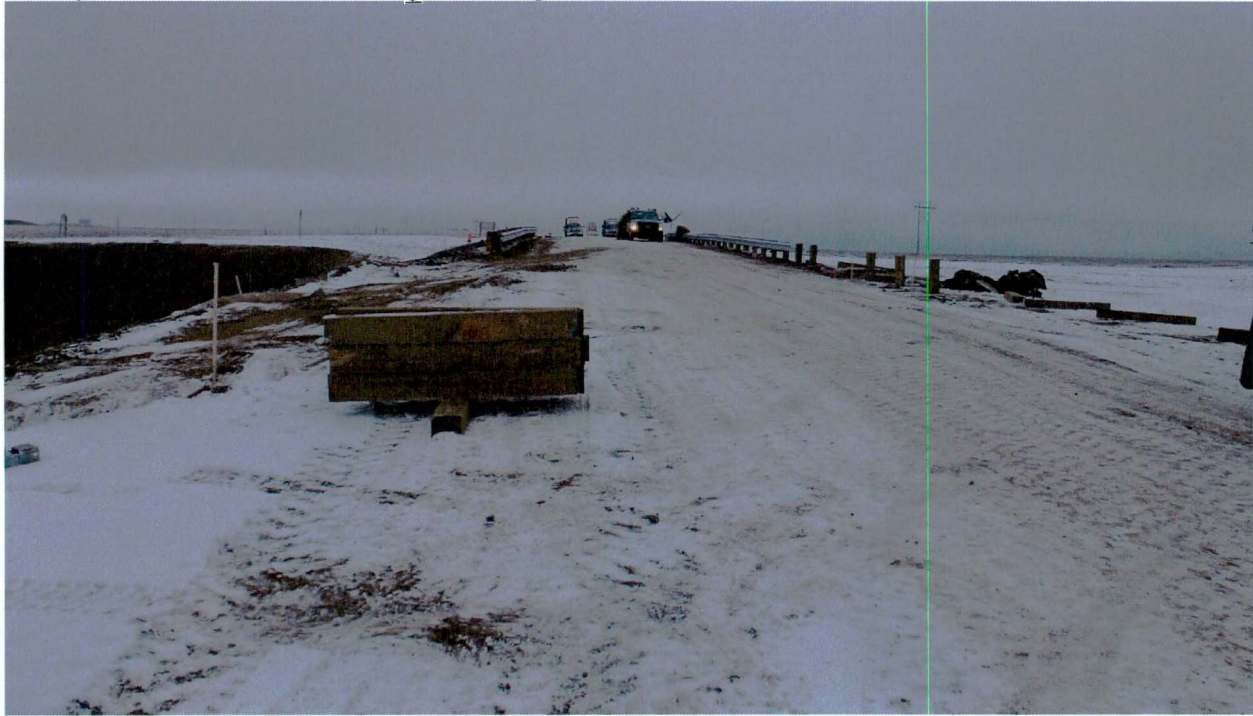
The County Road 12 haul road crossing was nearing completion. A scraper and dozer were shaping the ditch and road just to the north of the multi-plate structure in the SW1/4 of Section 18. Crews from Wanzek construction were completing finish details on the retaining wall. A contract crew with Dakota Fence was installing the guard rail on the section of County Road 12 built over the multi-plate grade separation structure.

County Road 12 haul road crossing near completion
