# Basin Electric Power Cooperative

Wheelock and Tande to Saskatchewan 230 kV Transmission  
Line, Divide, Mountrail, and Williams Counties

Case No. PU-25-283/284

Topsoil Removal Inspection Report

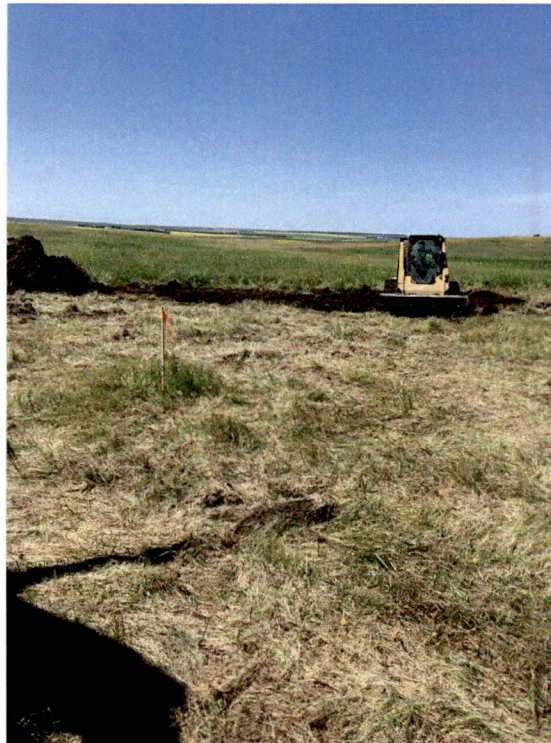
**Photo Number:** 1

**Notes:** Stripping operations

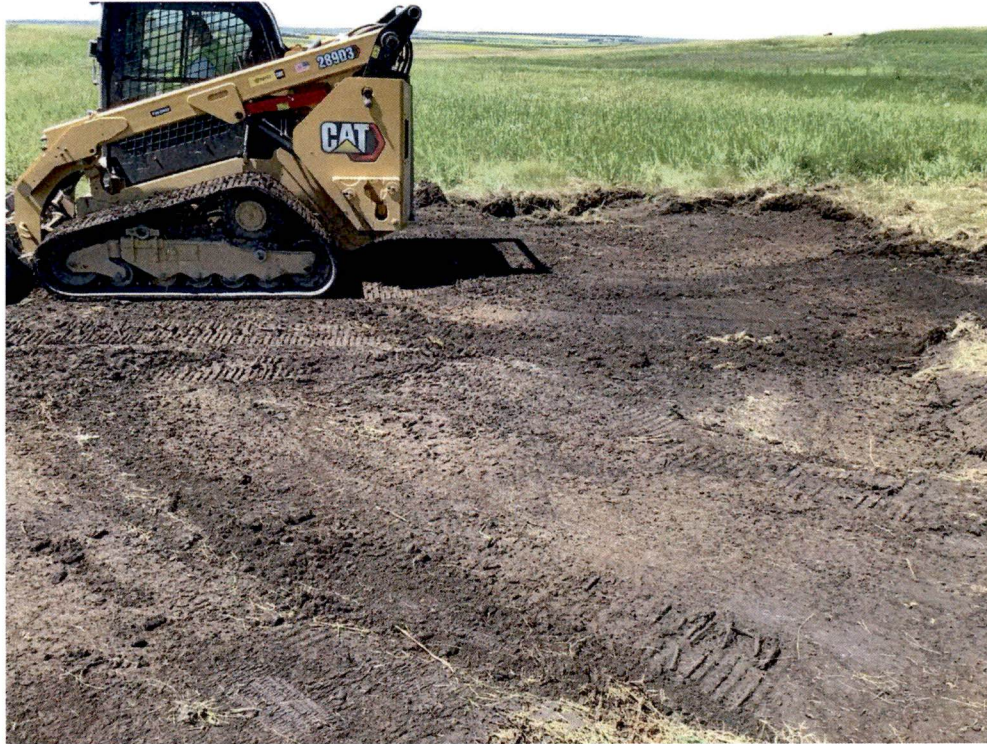
**Photo Number:** 2

**Notes:** Topsoil layer change evidence, top soil is dark brown, while subsoil is a lighter brown.

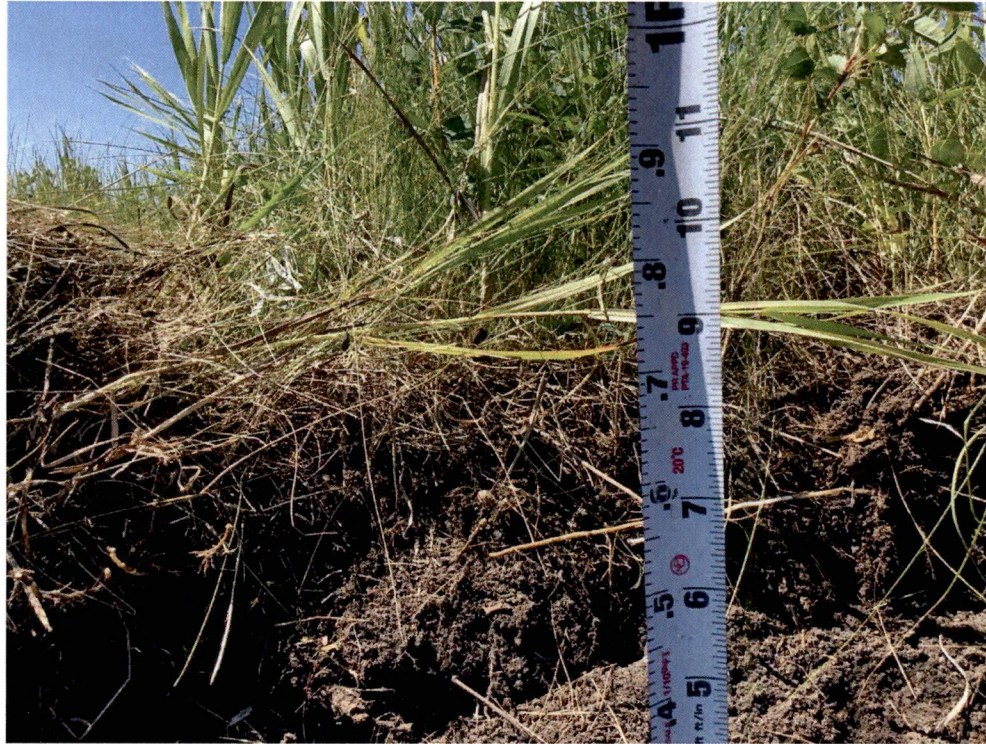
**Photo Number:** 3

**Notes:** Topsoil depth check of spoil pile: 8"

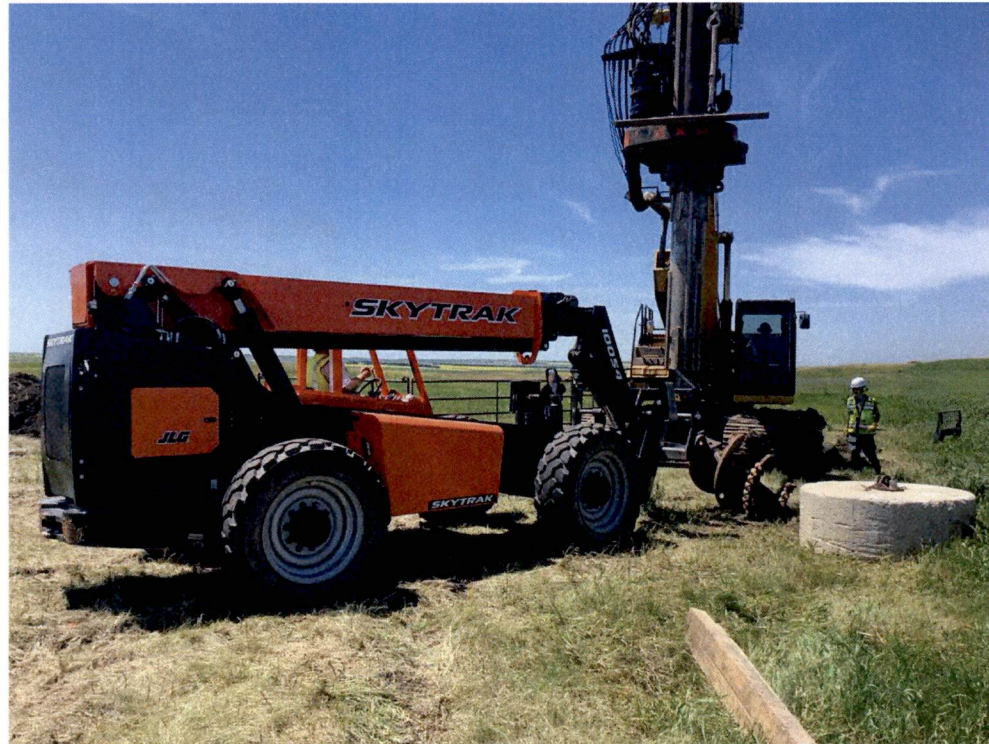
**Photo Number:** 4

**Notes:** JLG SKYTRAK LOADER 10054 loading small augur bit onto the EX 90 attachment for the excavator to begin pilot hole boring.

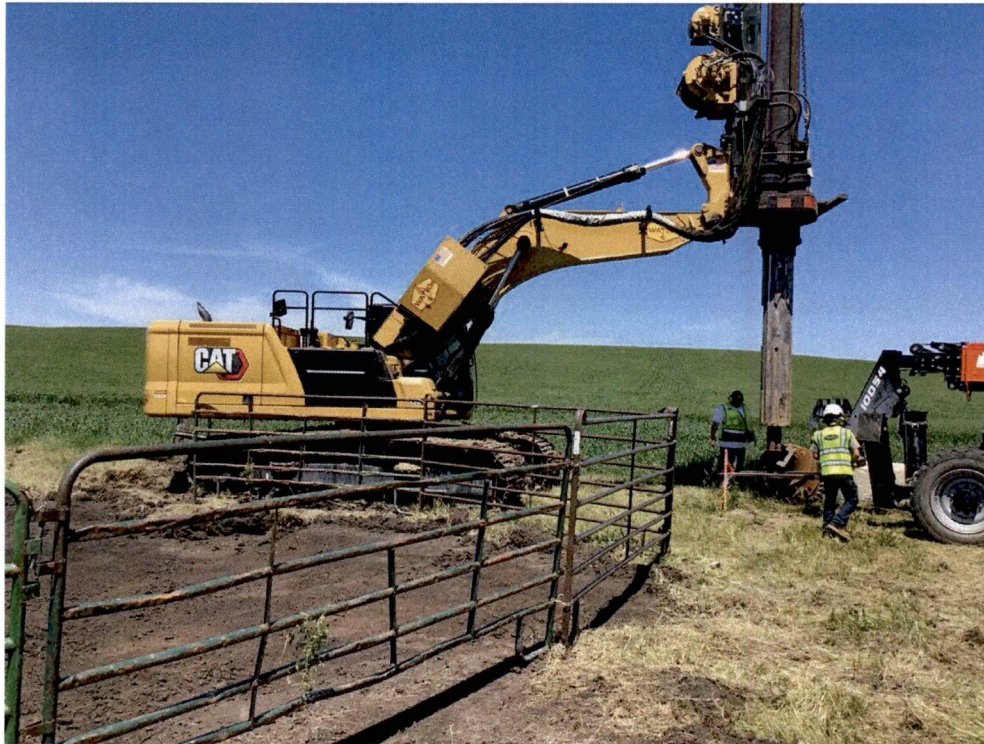
**Photo Number:** 5

**Notes:** CAT 336 excavator with EX90 augur attachment carrying a 3' diameter bore augur. 9' augur will be used once pilot hole is made.

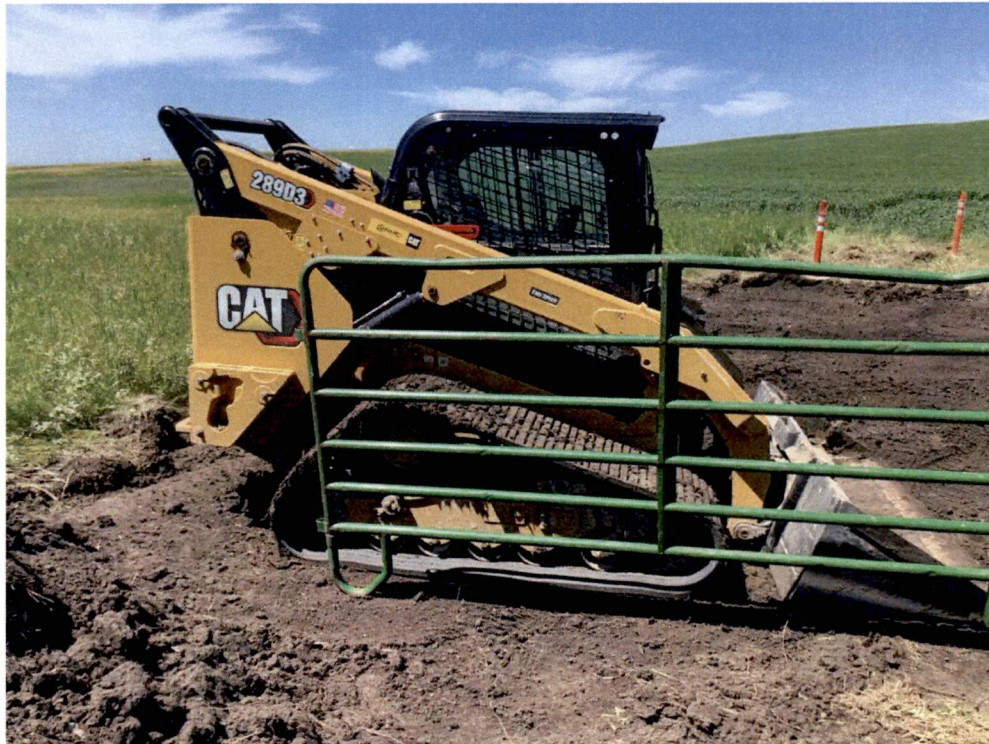
**Photo Number:** 6

**Notes:** CAT 289D3 skid steer that was used to prep spoil pile mat.

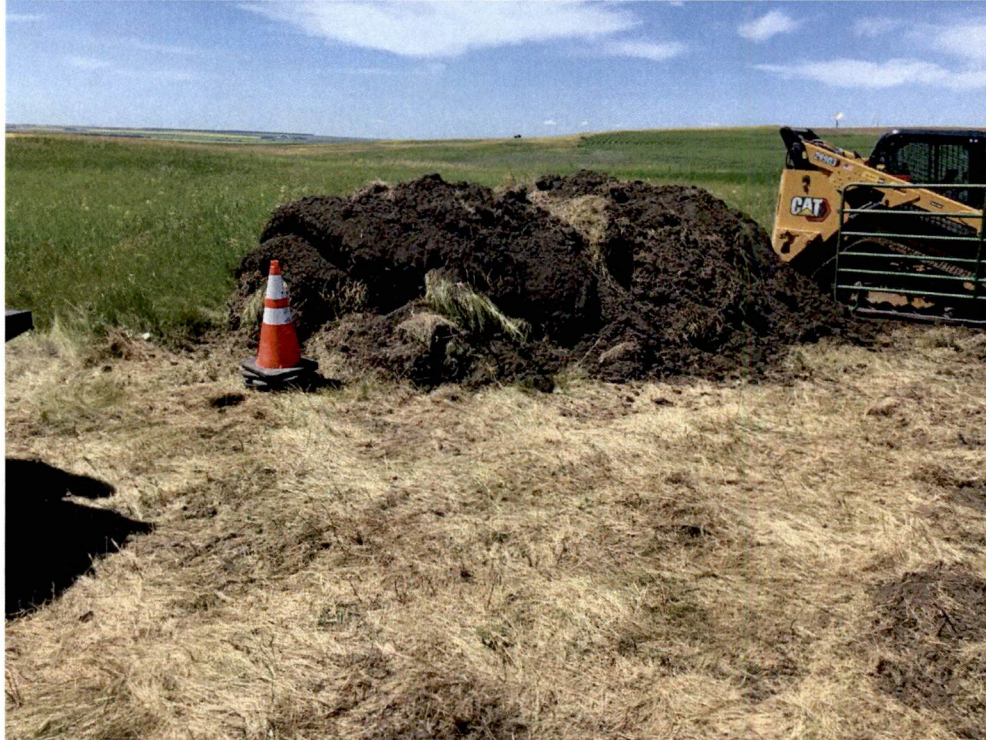
**Photo Number:** 7

**Notes:** Topsoil storage pile. Material to be replaced once spoil is hauled off site, inspector to monitor spoil pile to ensure no mixing of soils.

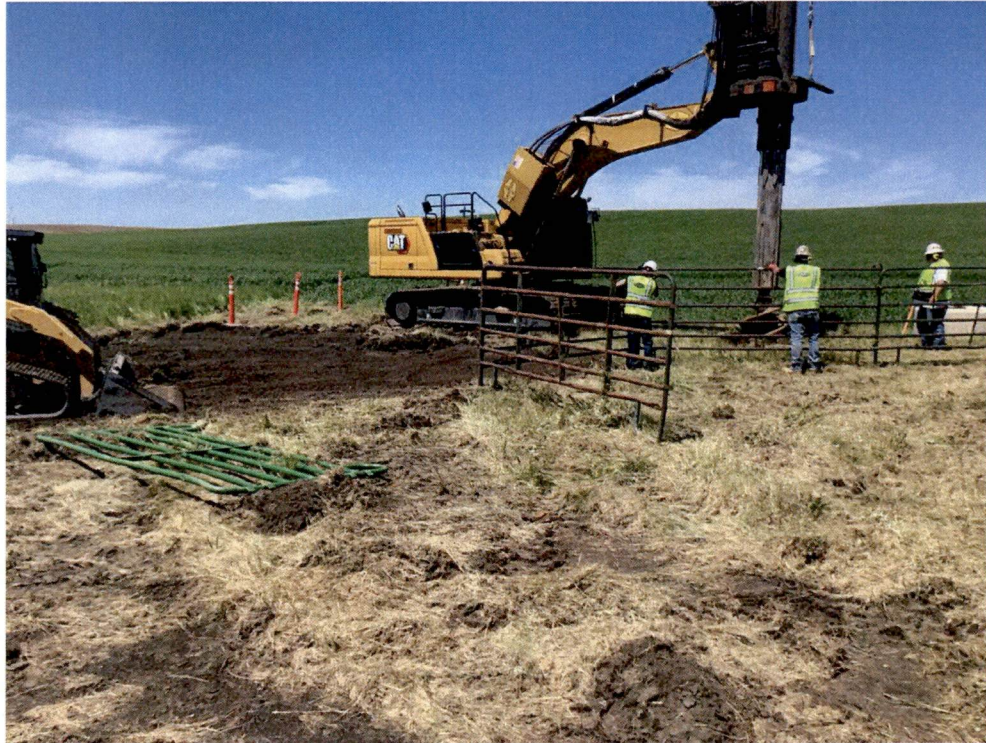
**Photo Number:** 8

**Notes:** Crew using delineators and cattle fence to denote cordoned area of swing radius of excavator.

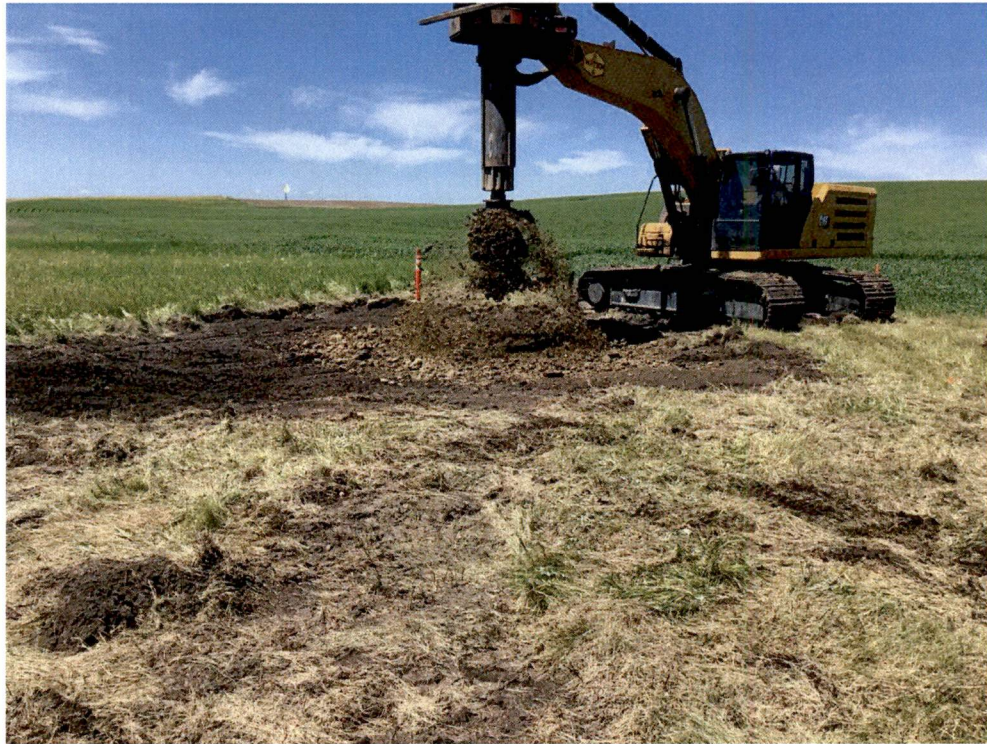
**Photo Number:** 9

**Notes:** Crew dumping spoil on prepped spoil mat. New subsoil layer is light brown

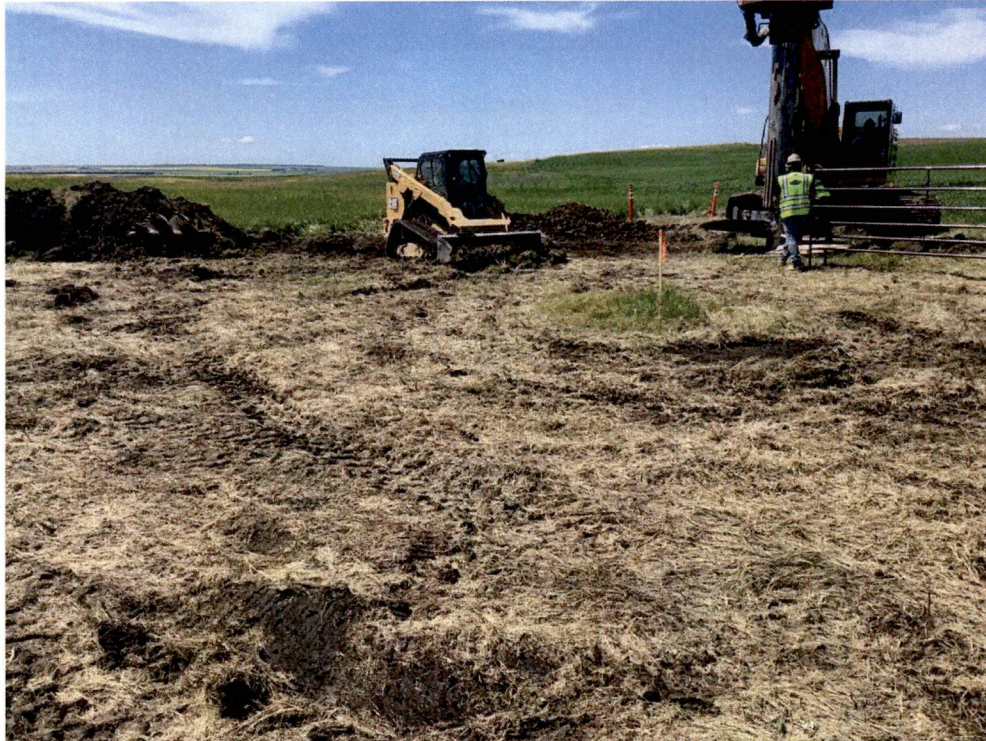
**Photo Number:** 10

**Notes:** Skid steer operator stripping more topsoil to extend spoil mat area for spoil material.

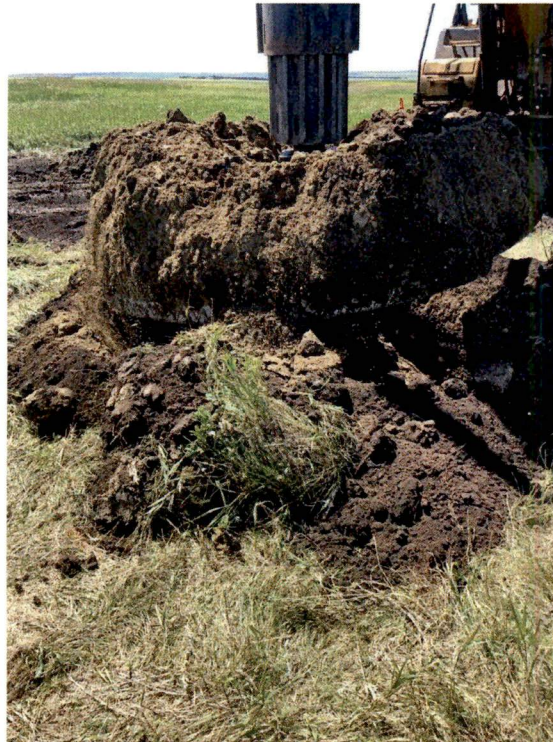
**Photo Number:** 11

**Notes:** Crew switches to 9' augur and begins drilling pier hole. Subsoil is a light brown loam with lots of rocks in it.

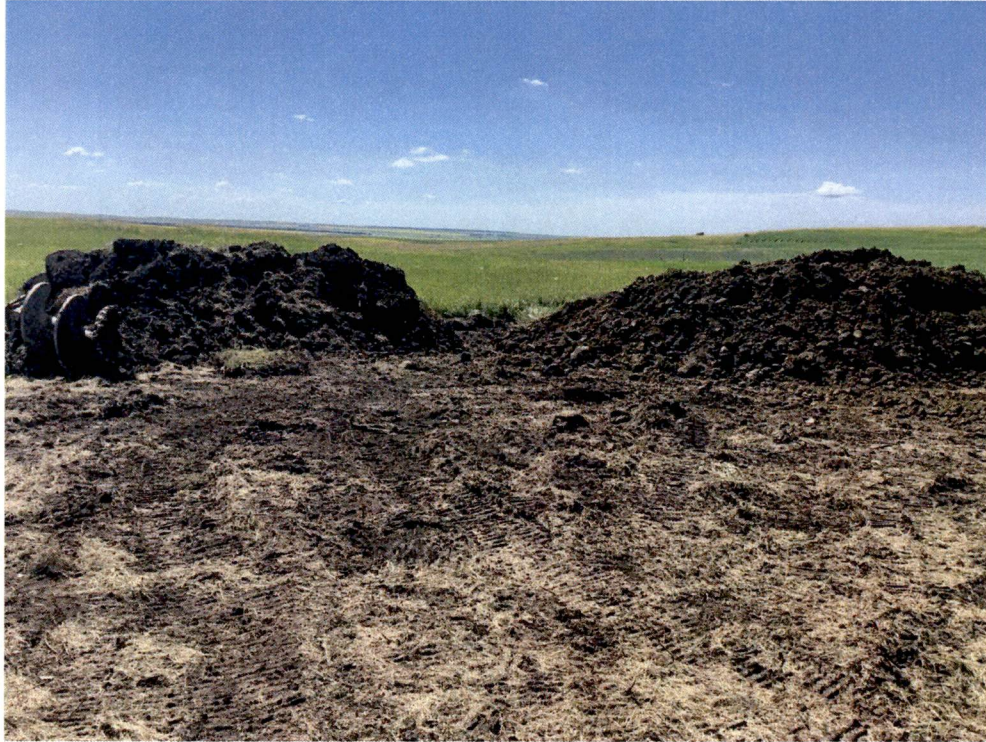
**Photo Number:** 12

**ISSUES REQUIRING RESOLUTION:** Inspector noticed that contractor underestimated the amount of spoil that would come out of the foundation bore hole, as excavated material got close to topsoil pile (within 10') and the spoil mat that had been stripped was completely filled, with some materials starting to edge into the undisturbed grass. (See P12)

| P12 - Possible Issue: Potential Segregation Loss | |

**Notes:** Spoil pile is getting closer to topsoil storage pile. Crew should consider expanding spoil mat to account for extra material or move storage pile further away.

**PROPOSED RESOLUTION(S):** Inspector recommends expanding the spoil mats by at least 5' in all directions, and storing topsoil further away from the stripped spoil mat.

**Comments:** Overall, site meets the siting laws, findings of fact and conclusions of law and order, with the following recommendations: for future spoil piles and mats, plan on stripping topsoil an extra 10-15' wide to ensure material doesn't spill onto native ground.

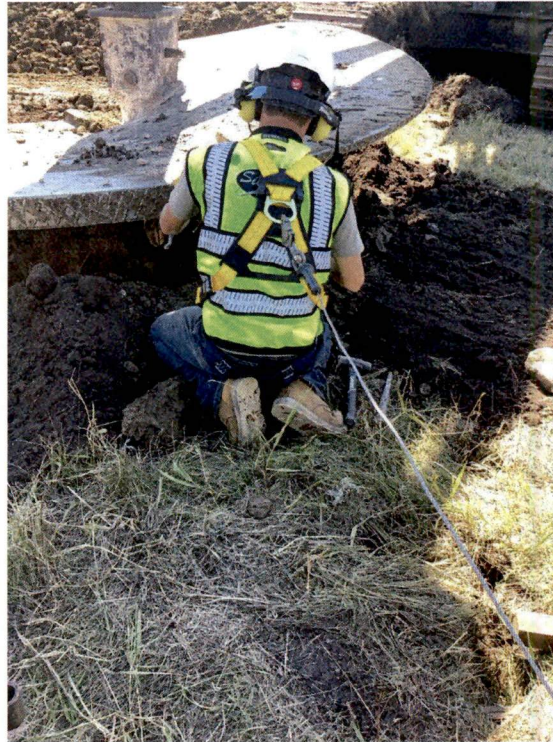
**Photo Number:** 13

**Notes:** SITE SAFETY: laborer is wearing a personal fall arrest system (PFAS) while clearing spoil from 9' augur bit.

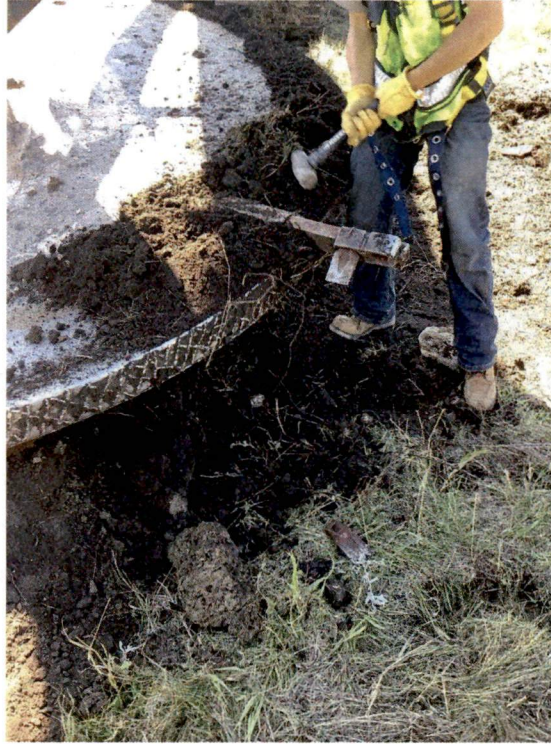
**Photo Number:** 14

**Notes:** Crew uses a chisel piece slotted into the edge of the 9' augur to screed off built up material from the rim of the pier hole.

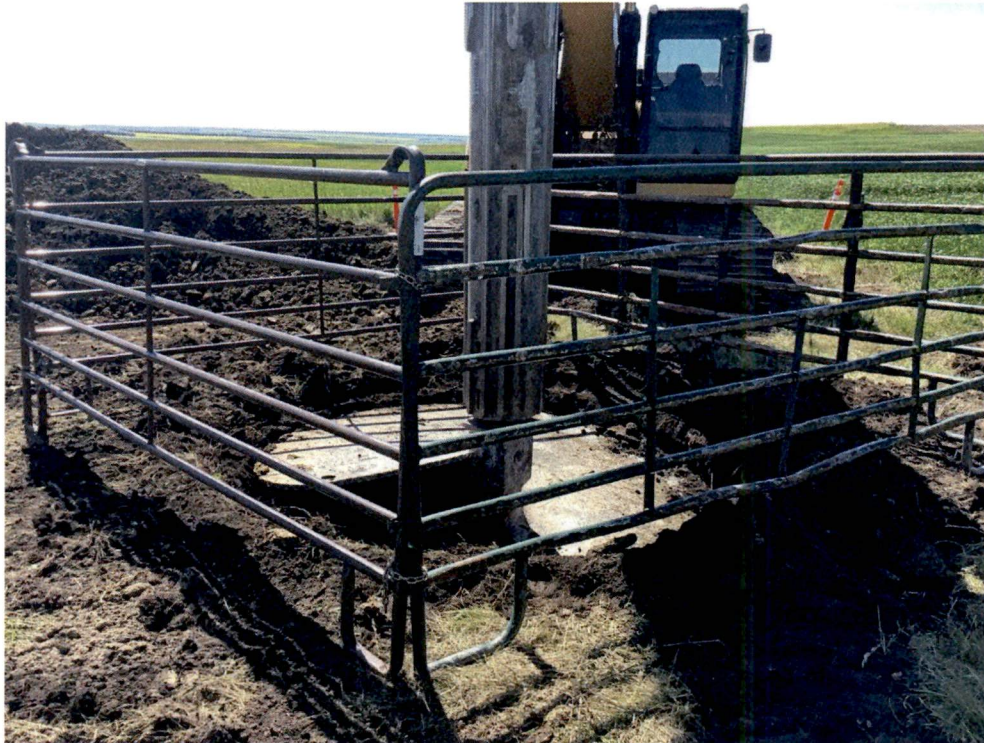
**Photo Number:** 15

**Notes:** Crew finishes for day at 1619. They cordon off the bore hole with cattle fence and plan on putting in rebar and forms tomorrow, with concrete scheduled for 1200.
