202.5 MW Longspur Wind Project & 230 kV Transmission Line  
Morton and Mercer Counties

Case No. PU-25-304/305

Topsoil Removal Inspection Report

September 4, 2026

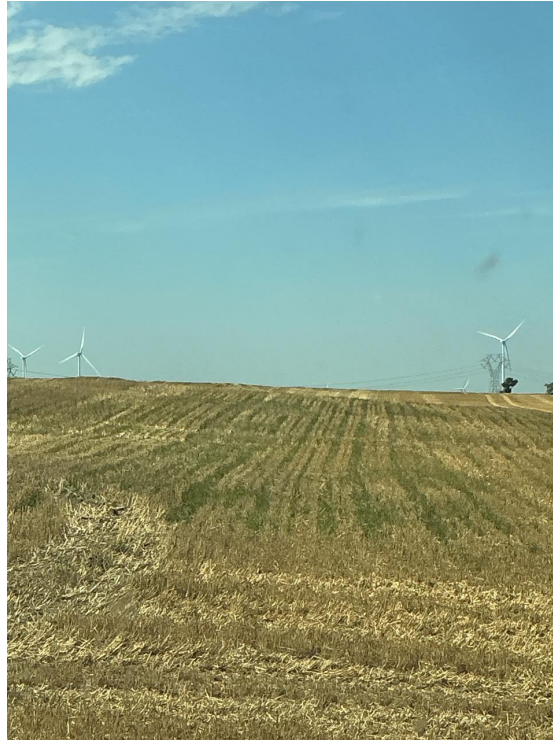
**Photo Number:** 1

**Notes:** Dry, cut wheat field. Agricultural land conditions prior to construction activities.

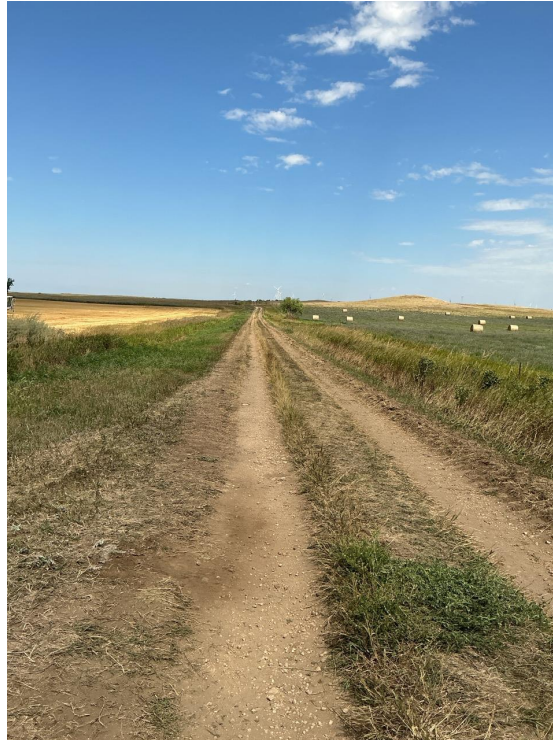
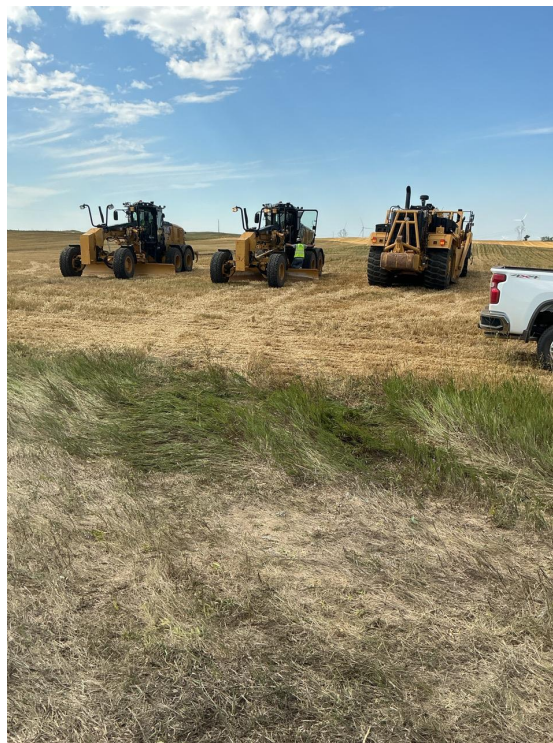
**Photo Number:** 2-3

**Notes:** Access road to west

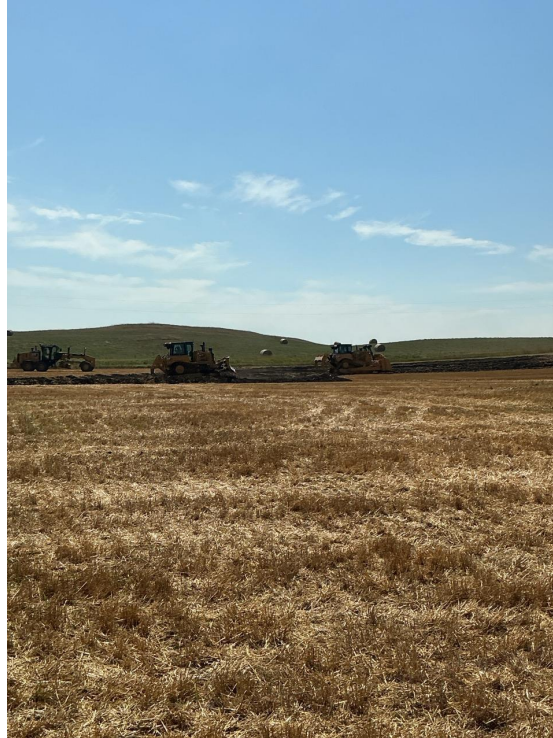
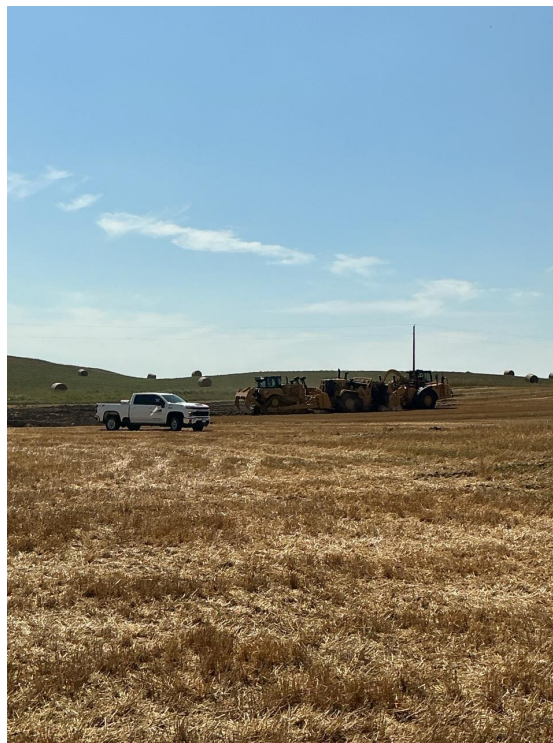
**Photo Number:** 4-5

**Notes:** Stripping activities

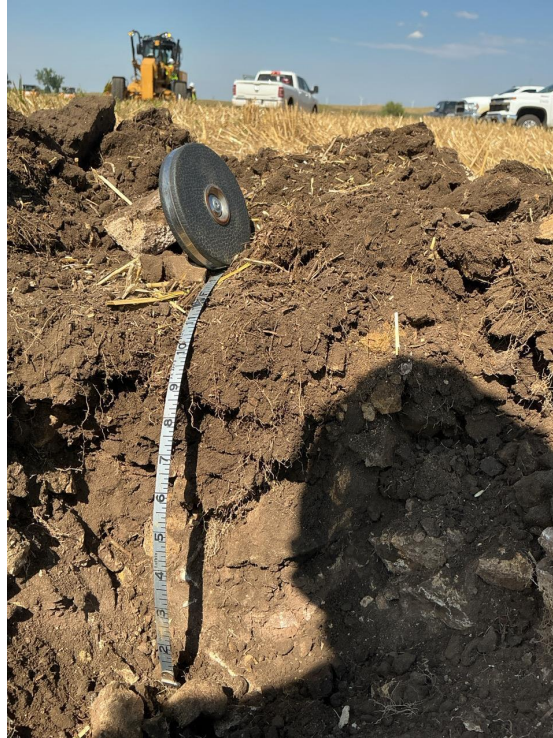
**Photo Number:** 6

**Notes:** Topsoil measures at 11 inches in this location (average depths of 12 inches) adjacent to field entrance, silty soils with a lot of rocks likely due to proximity of field entrance.

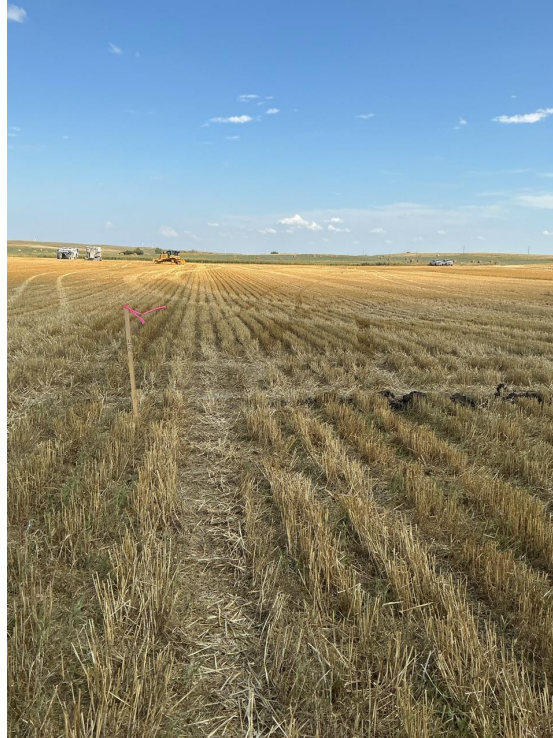
**Photo Number:** 7

**Notes:** Stake and soil cut with dozer along staked west line.

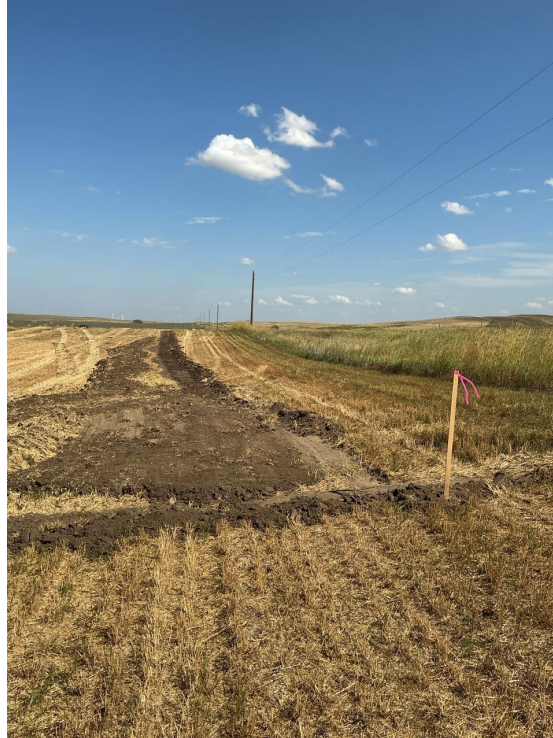
**Photo Number:** 8

**Notes:** Stripping operations and site grading.

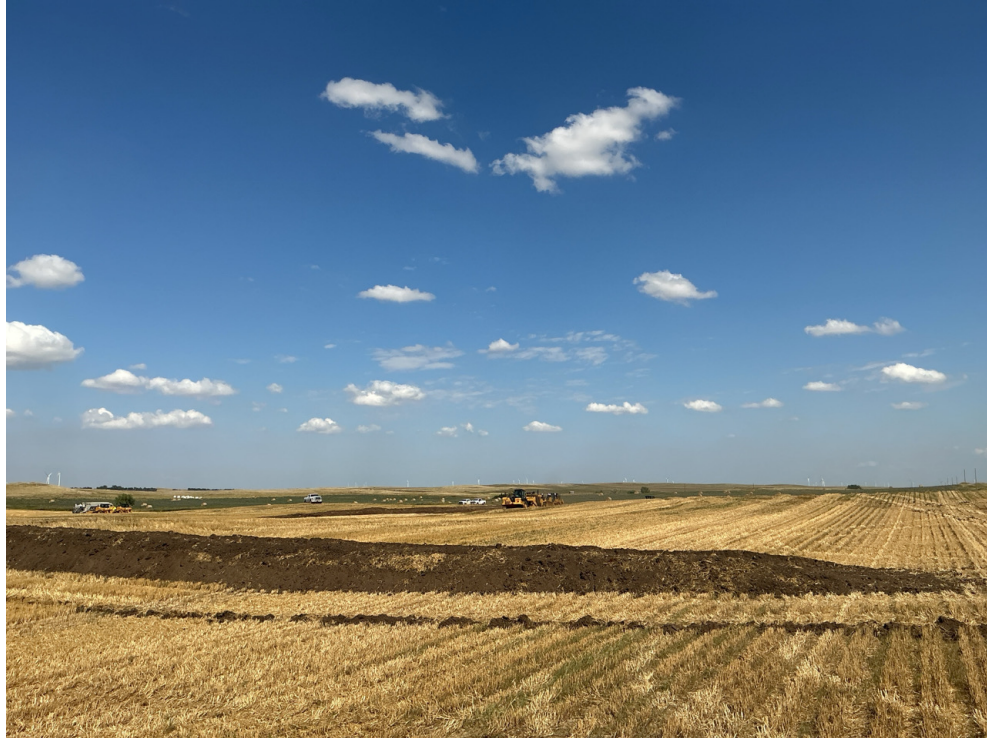
**Photo Number:** 9

**Notes:** South western corner of site showing the south end of the topsoil stockpile. No erosion control in place at this time.

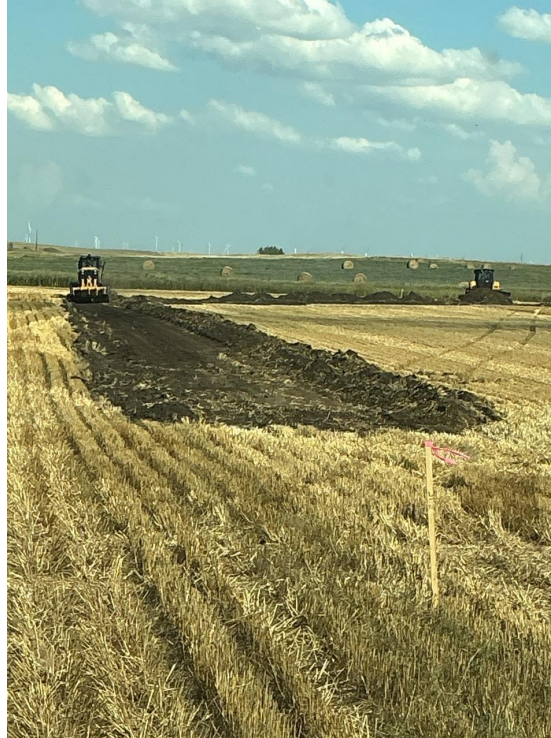
**Photo Number:** 10

**Notes:** Motor grader stripping material. Ditch was cut in along the survey line with D6 dozer prior to motor grader stripping

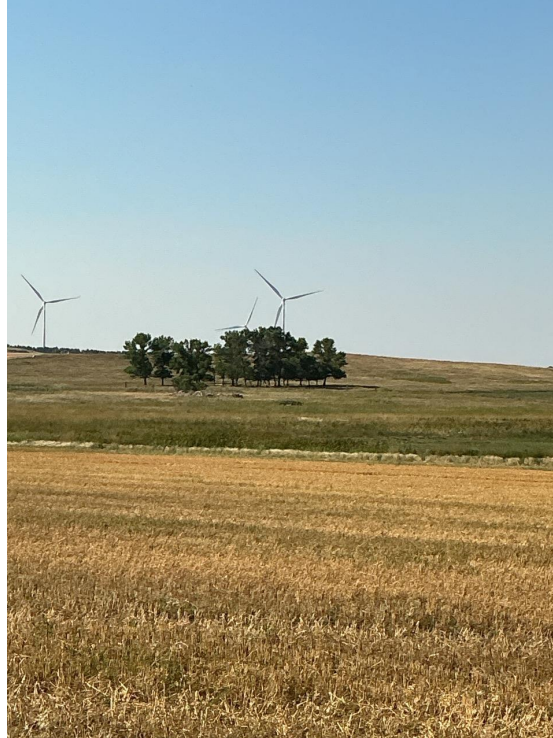
**Photo Number:** 11

**Notes:** North of site is low with wetlands and visible cattails.

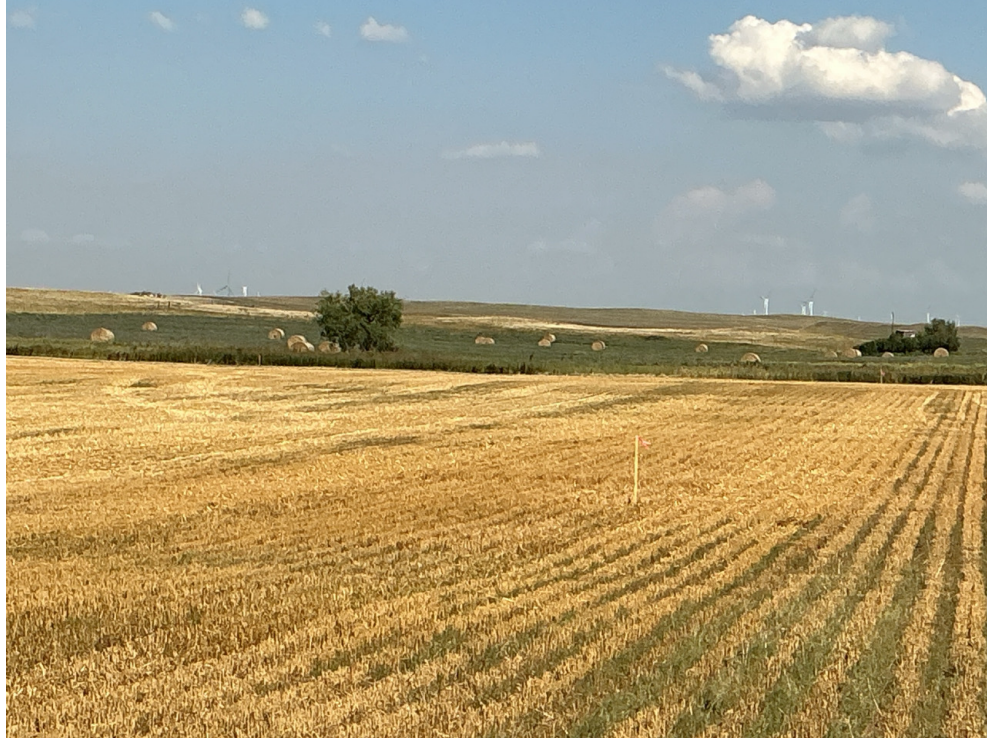
**Photo Number:** 12

**Notes:** Stakes for O&M location, north of laydown yard

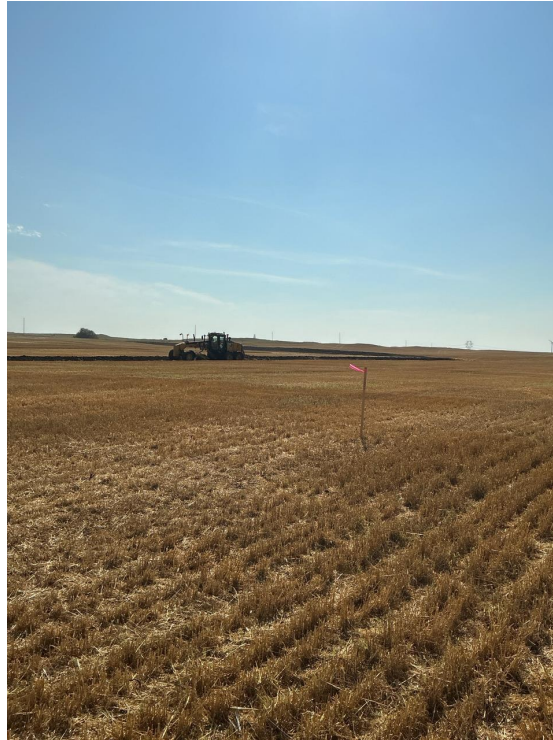
**Photo Number:** 13

**Notes:** Looking at corner stake west of laydown yard for O&M and stripping continues in the background.

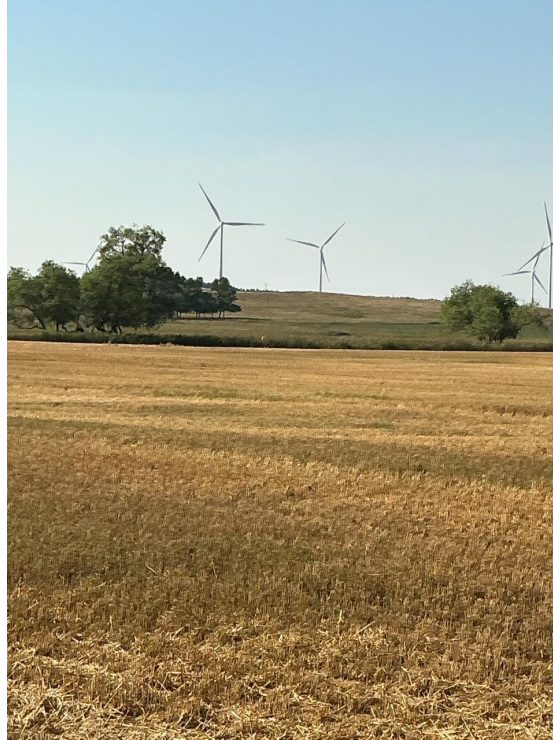
**Photo Number:** 14

**Notes:** Existing land surface and vegetation conditions documented prior to construction activities in this region.

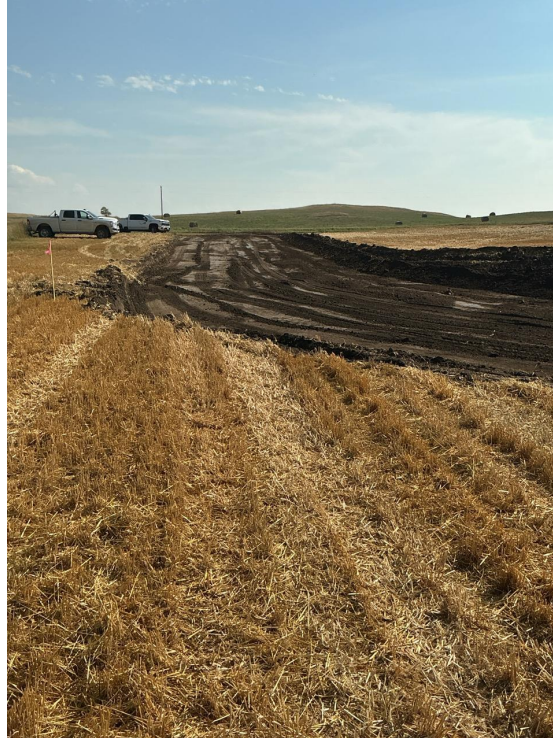
**Photo Number:** 15

**Notes:** Stripping operations

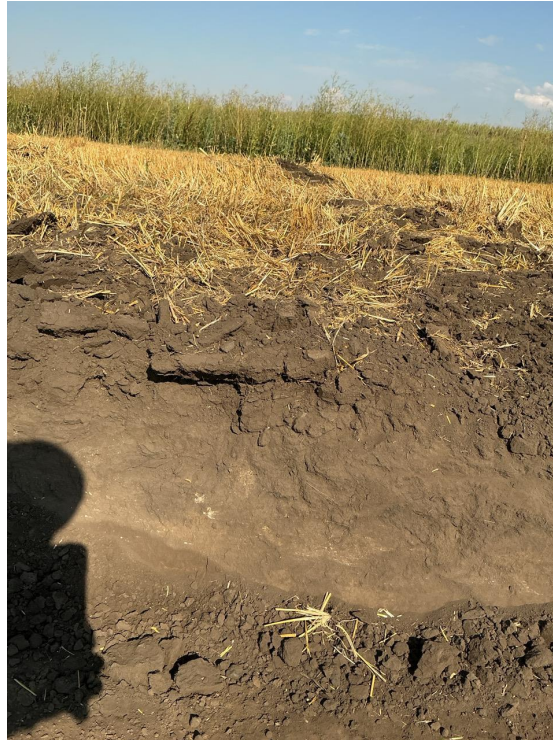
**Photo Number:** 16

**Notes:** Soil delineation from topsoil to sub soil

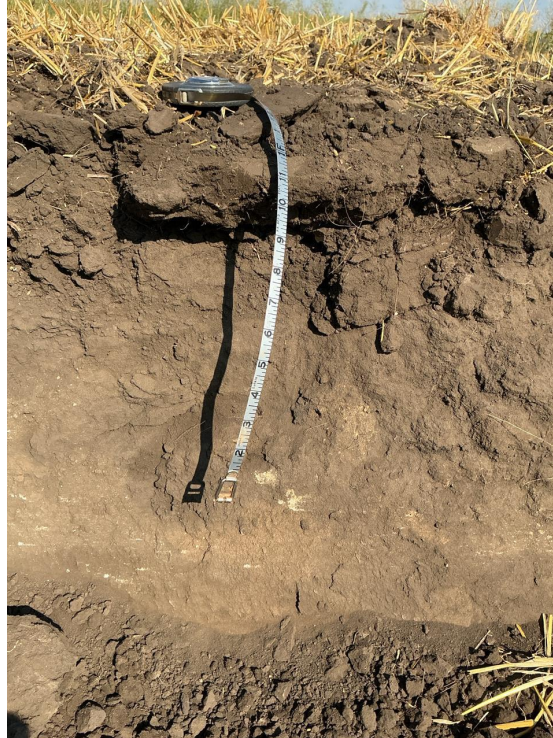
**Photo Number:** 17

**Notes:** Measuring depth to soil delineation which is pretty consistent at 11 - 12 inches

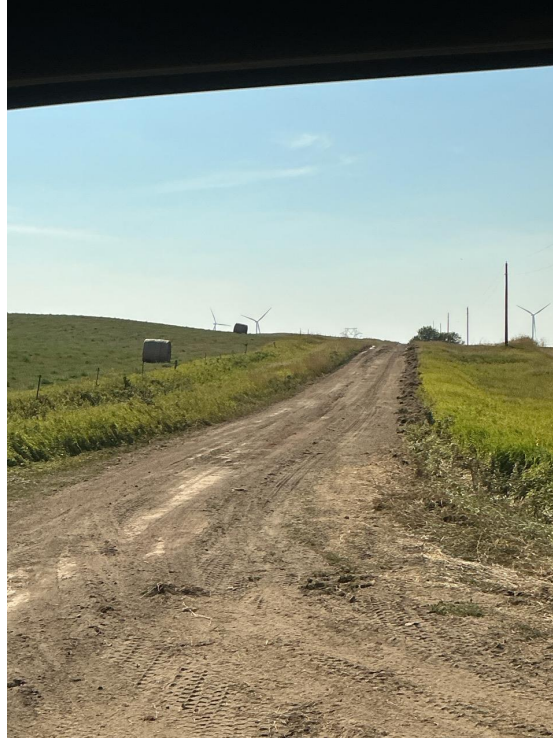
**Photo Number:** 18

**Notes:** Access road mitigation along 32nd St

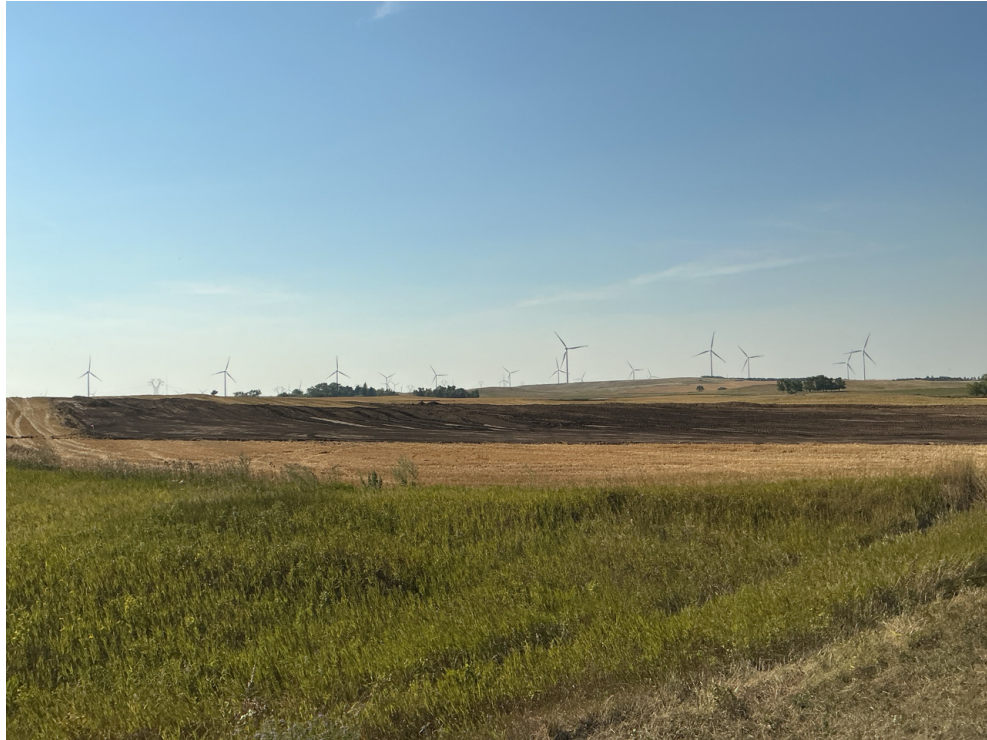
**Photo Number:** 19

**Notes:** End of day stripping on site at lay down yard area.
