PU-26-022
Minnkota Power Cooperative
Agassiz Transmission Line &
Substation
Topsoil Inspection Report

June 8, 2026

North Dakota Public Service Commission
600 E. Boulevard Avenue
Bismarck, ND 58505-0480

Stantec Consulting Services Inc.
3303 Fiechtner Drive, Suite 100
Fargo, ND 58103

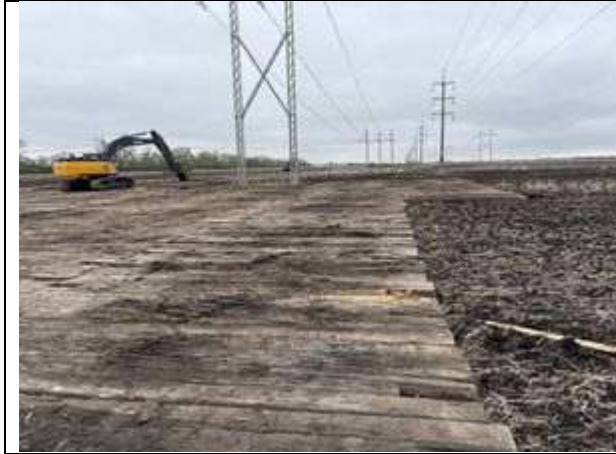
Observation Point: 1
Date Taken: May 18, 2026 2:02 PM
Direction Photo is Taken: North

Photo Description: Initial timber mat installation

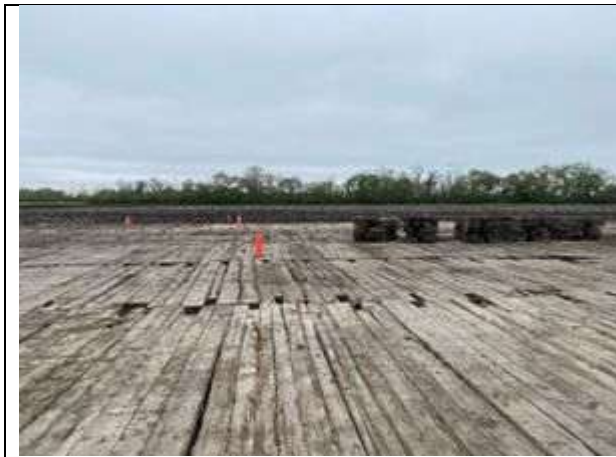
Observation Point: 2
Date Taken: May 18, 2026 2:03 PM
Direction Photo is Taken: West

Photo Description: Initial timber mat installation

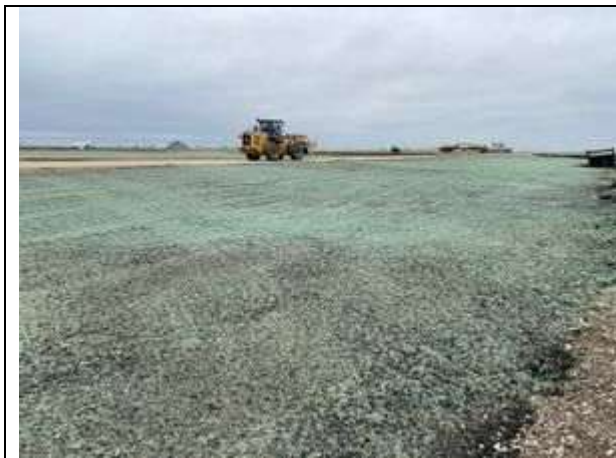
Observation Point: 3
Date Taken: May 18, 2026 2:32 PM
Direction Photo is Taken: Southeast

Photo Description: Recently seeded topsoiled area between laydown yard and substation

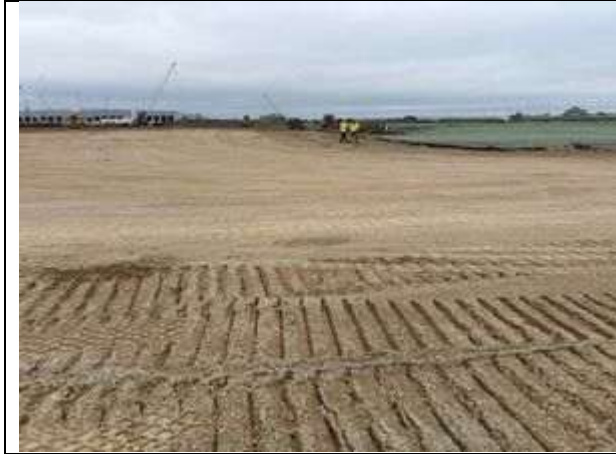
Observation Point: 4
Date Taken: May 18, 2026 2:35 PM
Direction Photo is Taken: East

Photo Description: South side of substation footprint. Appropriate grading

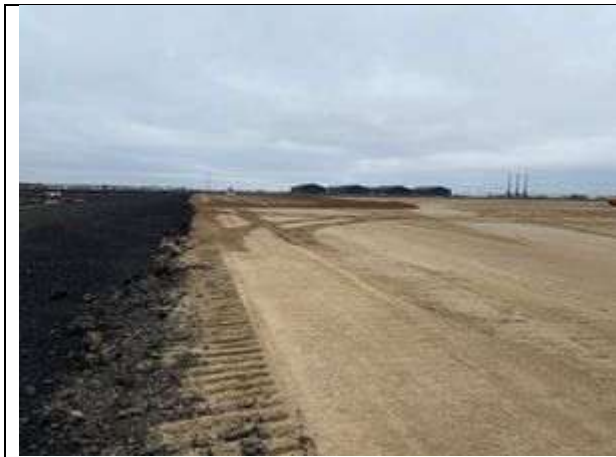
Observation Point: 5
Date Taken: May 18, 2026 2:35 PM
Direction Photo is Taken: North

Photo Description: Edge of graded and filled substation

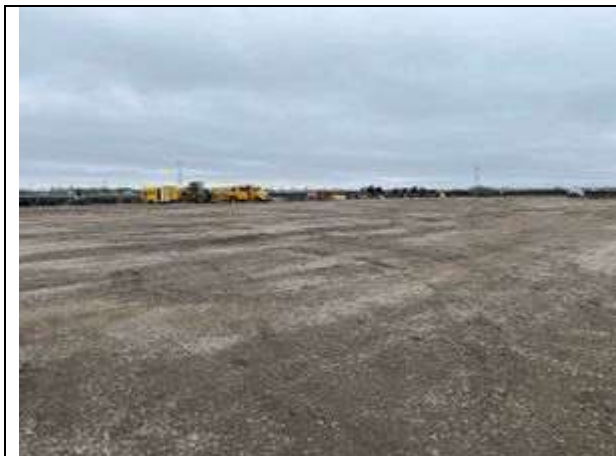
Observation Point: 6
Date Taken: May 18, 2026 2:36 PM
Direction Photo is Taken: Northwest

Photo Description: Gravel Laydown yard area.

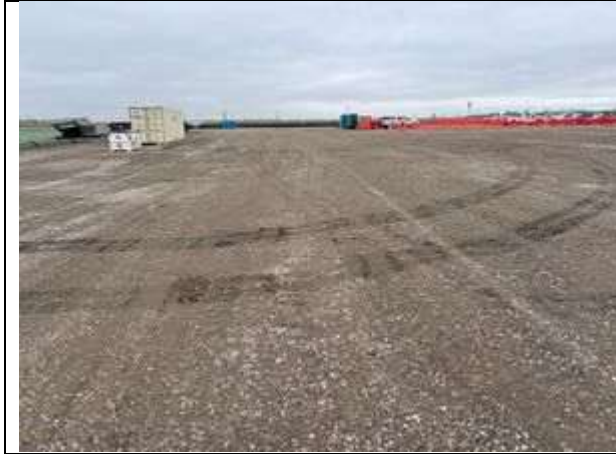
Observation Point: 7
Date Taken: May 18, 2026 2:37 PM
Direction Photo is Taken: South

Photo Description: Gravel lay down yard

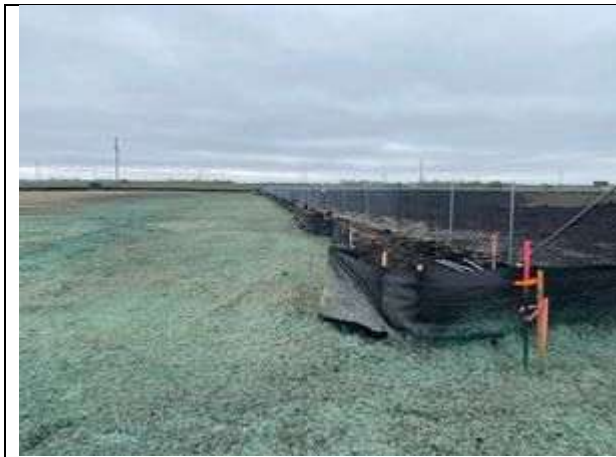
Observation Point: 8
Date Taken: May 18, 2026 2:38 PM
Direction Photo is Taken: West

Photo Description: Ovelooking project boundary.

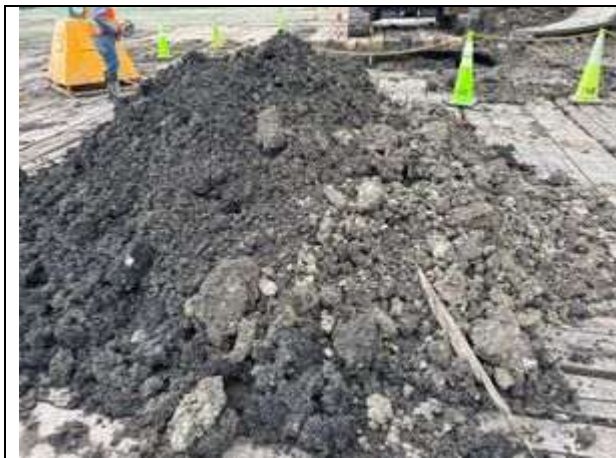
Observation Point: 9
Date Taken: May 18, 2026 2:45 PM
Direction Photo is Taken: North

On the May 18th inspection, topsoil was removed and stockpiled away from subsoil stockpiles at foundation locations. Stripped topsoil was noted to have included some minor subsoil. Stantec discussed this with BMcD to prevent further excess subsoil mixing. Stantec suggested ceasing drilling at the soil's color change and removing the darkest topsoil. At the substation, placement of sand and grading had already commenced prior to Stantec's arrival. Large topsoil stockpiles were observed outside of the project area to the north. Silt fence was installed surrounding the substation and some areas of the project had recently been seeded. No soil erosion issues were observed.

Photo Description: Topsoil on top of matting with some mixed subsoil

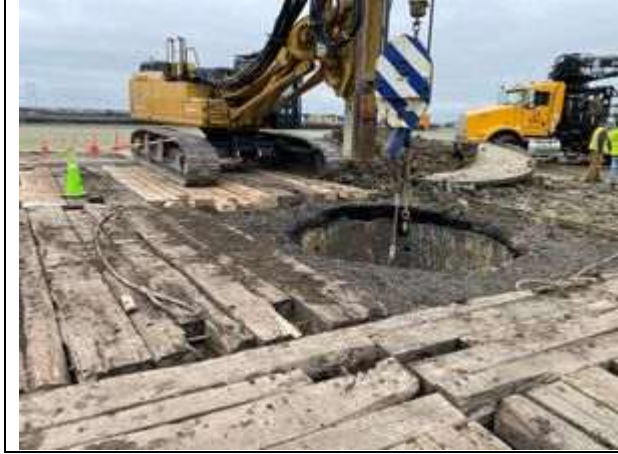
Observation Point: 10
Date Taken: May 18, 2026 2:45 PM
Direction Photo is Taken: Northeast
Photo Description: Foundation drilling.
Latitude: 46.96373939894807
Longitude: -96.86771106828358

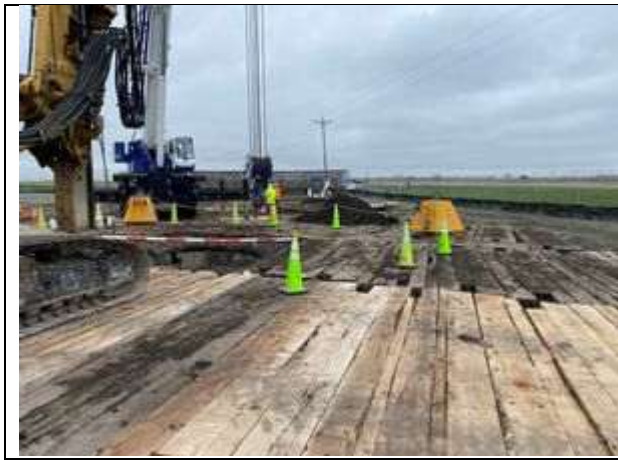
Observation Point: 11
Date Taken: May 18, 2026 2:49 PM
Direction Photo is Taken: South
Photo Description: Overlooking foundatuo
drilling
Latitude: 46.96391097392932
Longitude: -96.8677533752428

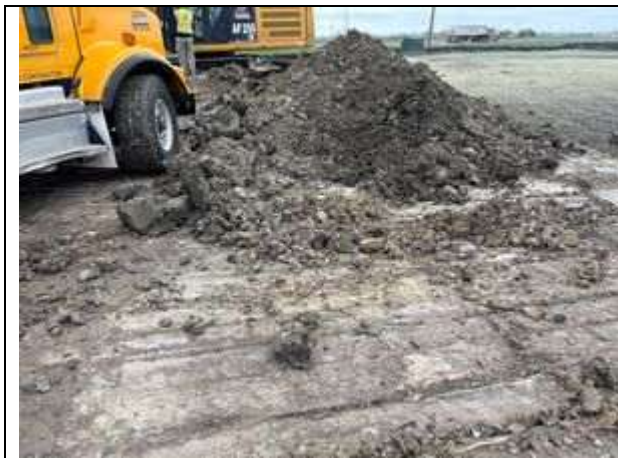
Observation Point: 12
Date Taken: May 18, 2026 2:52 PM
Direction Photo is Taken: West
Photo Description: Subsoil pile from
foundation drilling
Latitude: 46.96387863791154
Longitude: -96.86747630332546

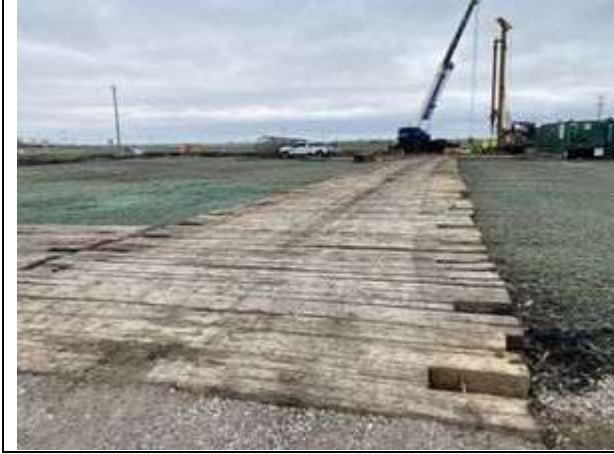
Observation Point: 13
Date Taken: May 18, 2026 2:53 PM
Direction Photo is Taken: West
Photo Description: Timber mats insatlld leading to foundation
Latitude: 46.96365795587475
Longitude: -96.8666523095924

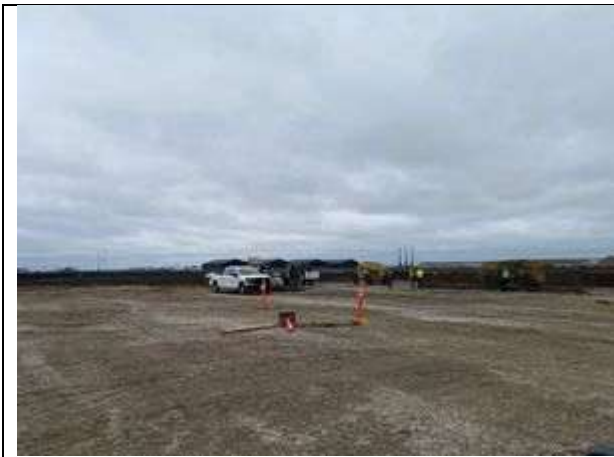
Observation Point: 14
Date Taken: May 18, 2026 3:00 PM
Direction Photo is Taken: Northeast
Photo Description: Foundation prep work
Latitude: 46.9651937236298
Longitude: -96.8660536294999

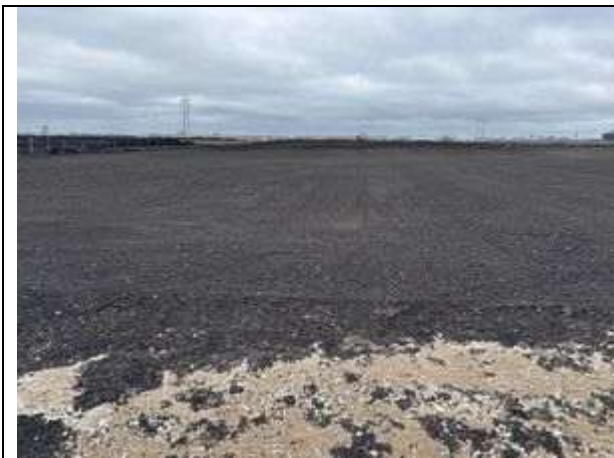
Observation Point: 15
Date Taken: May 18, 2026 3:01 PM
Direction Photo is Taken: North
Photo Description: Topsoil stockpile in background as described by Burns and Mac
Latitude: 46.96566426559077
Longitude: -96.86632600034454

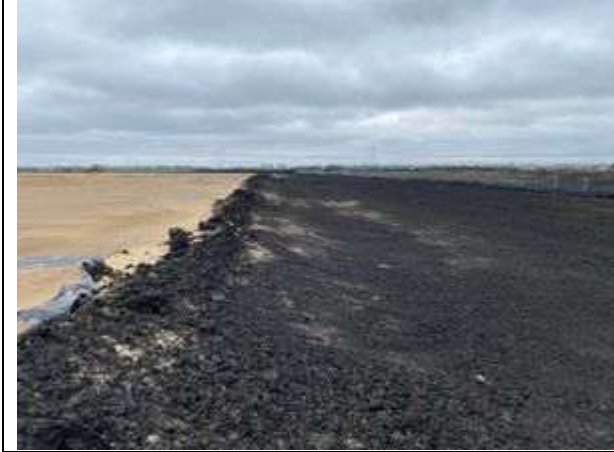
Observation Point: 16
Date Taken: May 18, 2026 3:08 PM
Direction Photo is Taken: West

Photo Description: edge of sand fill and topsoil at north end of proposed substation

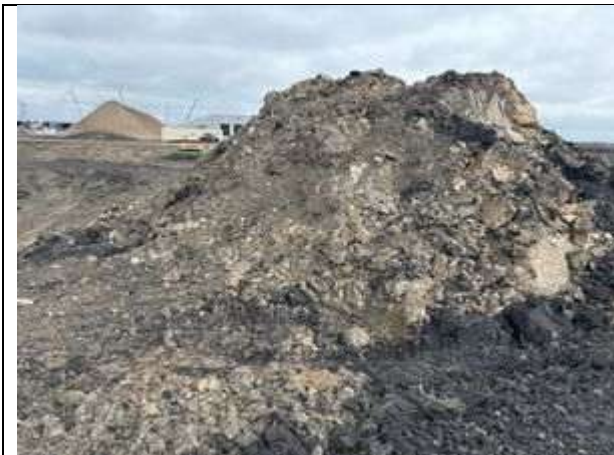
Observation Point: 17
Date Taken: May 18, 2026 3:08 PM
Direction Photo is Taken: Southeast

Photo Description: Subsoil stockpile

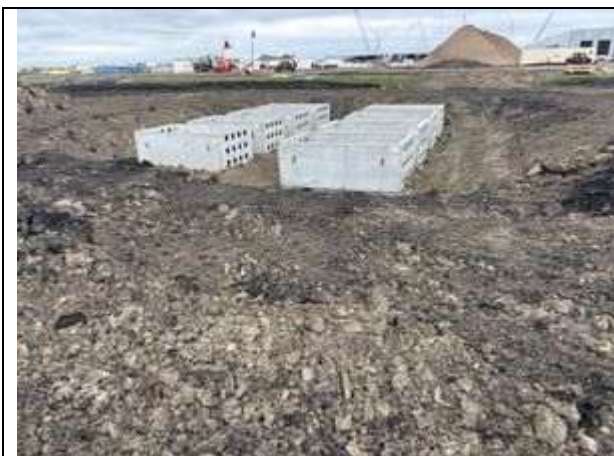
Observation Point: 18
Date Taken: May 18, 2026 3:09 PM
Direction Photo is Taken: East

Photo Description: Excavation area

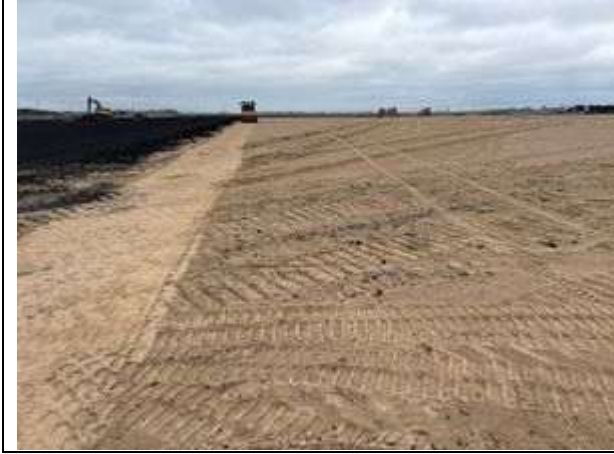
Observation Point: 19
Date Taken: May 18, 2026 3:11 PM
Direction Photo is Taken: South

Photo Description: Edge of fill for substation

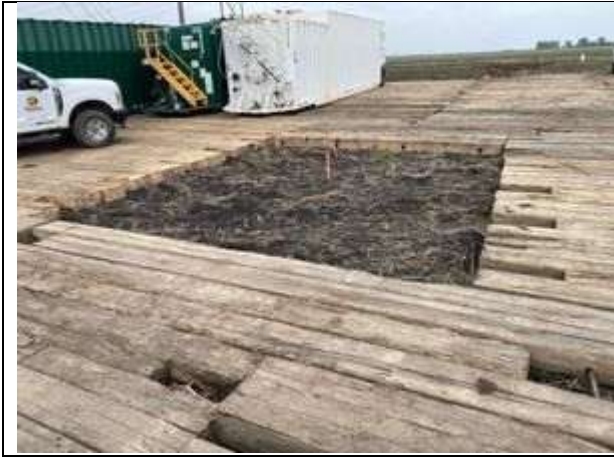
Observation Point: 20
Date Taken: June 1, 2026 2:54 PM
Direction Photo is Taken: Northeast

Photo Description: Proposed foundation

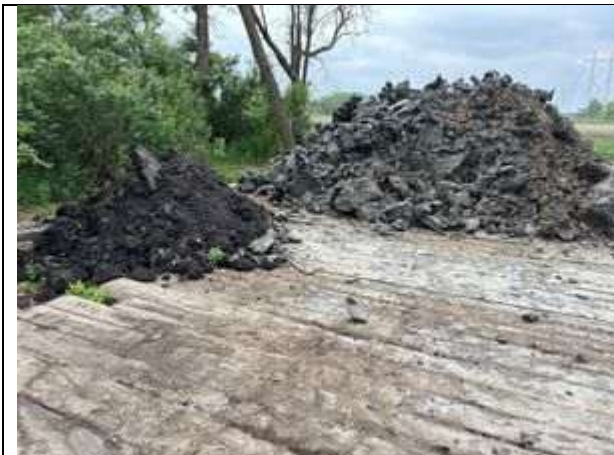
Observation Point: 23
Date Taken: June 1, 2026 3:02 PM
Direction Photo is Taken: West

During the 2nd inspection, conducted on June 1st, 2026, Stantec observed appropriately stockpiled top and subsoil at the 3rd and 4th active foundation drillings. Photos are enclosed in the attached photo log.

Photo Description: Appropriately stockpiled

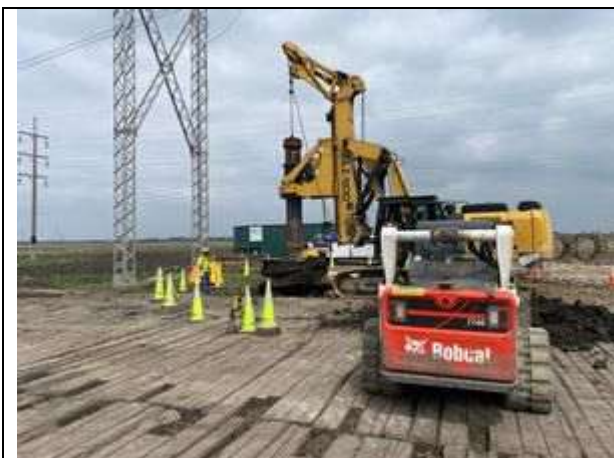
Observation Point: 24
Date Taken: June 1, 2026 3:09 PM
Direction Photo is Taken: East

Photo Description: Appropriately Stripped topsoil during drill for foundation

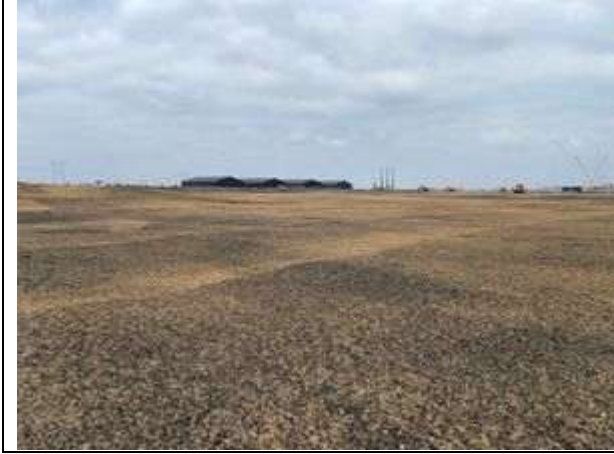
Observation Point: 25

Photo Description: Recently seeded topsoil
