**PU-26-022**  
**Minnkota Power Cooperative**  
**Agassiz Transmission Line &**  
**Substation**  
**Construction Inspection Report**

File No. 227709053

August 6, 2026

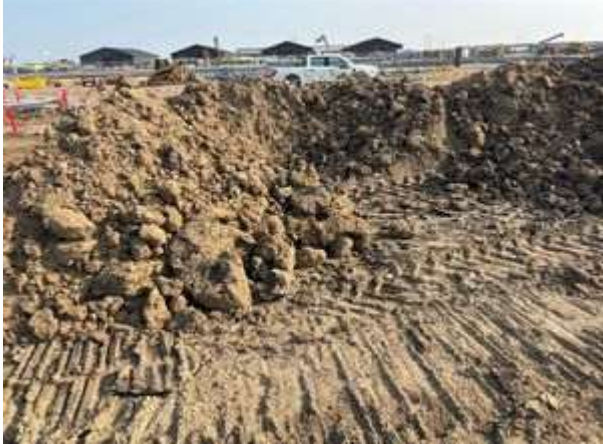
| | <p><b>Observation Point: 1</b><br/>Date Taken: July 23, 2026 8:51 AM<br/>Direction Photo is Taken: North</p> <p>Photo Description: Appropriate subsoil stockpile associated with a trench, minor topsoil inclusions</p> <p>Latitude: 46.96630294421889<br/>Longitude: -96.86266536825696</p> |

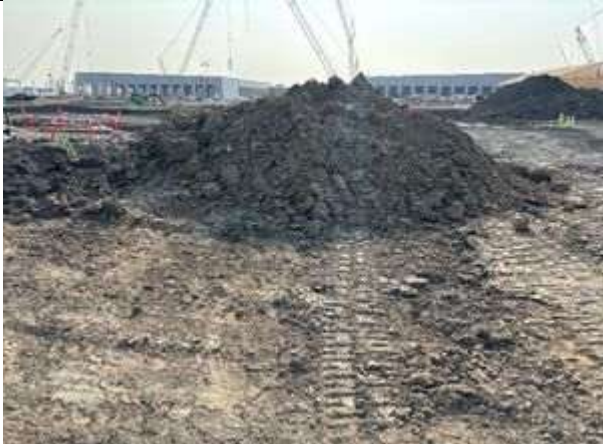
| | <p><b>Observation Point: 2</b><br/>Date Taken: July 23, 2026 8:53 AM<br/>Direction Photo is Taken: East</p> <p>Photo Description: Appropriate subsoil stockpile associated with a trench, minor topsoil inclusions</p> <p>Latitude: 46.96637610118573<br/>Longitude: -96.8623656793281</p> |

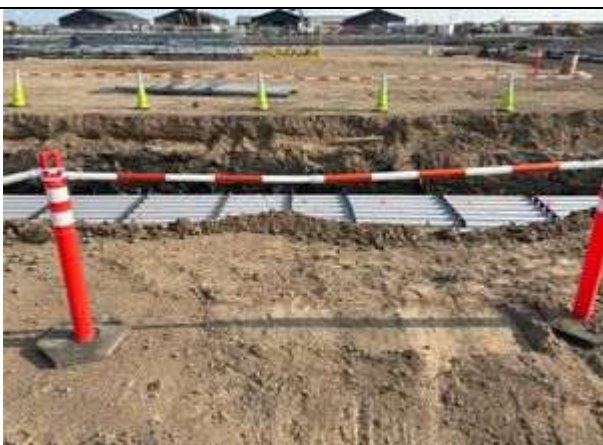
| | <p><b>Observation Point: 3</b><br/>Date Taken: July 23, 2026 8:54 AM<br/>Direction Photo is Taken: North</p> <p>Photo Description: Approximately 48 inches of sand and gravel on top to grade site near trench</p> <p>Latitude: 46.96639735118978<br/>Longitude: -96.86245097930075</p> |

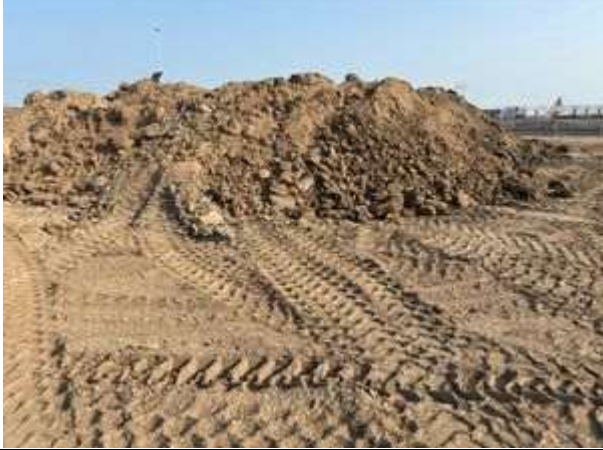
| | <p><b>Observation Point: 4</b><br/>Date Taken: July 23, 2026 8:57 AM<br/>Direction Photo is Taken: Northwest</p> <p>Photo Description: Large subsoil stockpile, some construction materials like concrete and fabric observed</p> <p>Latitude: 46.96642040136255<br/>Longitude: -96.8646715626779</p> |

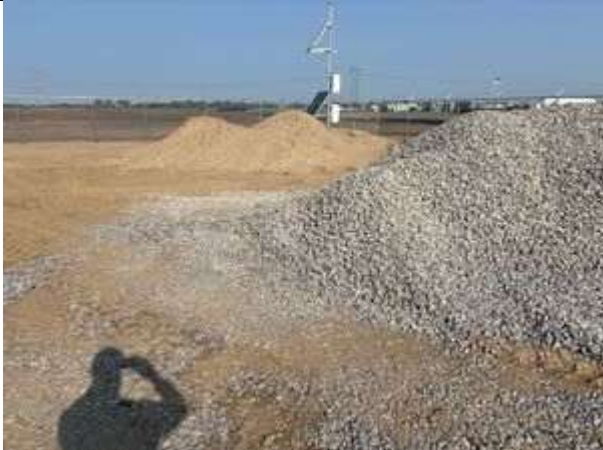
| | <p><b>Observation Point: 5</b><br/>Date Taken: July 23, 2026 9:01 AM<br/>Direction Photo is Taken: Northwest</p> <p>Photo Description: Rock and sand stockpile</p> <p>Latitude: 46.9666463843395<br/>Longitude: -96.86474754561858</p> |

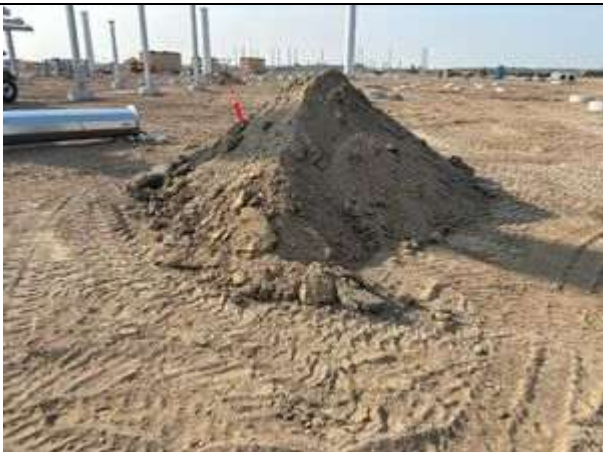
| | <p><b>Observation Point: 6</b><br/>Date Taken: July 23, 2026 9:03 AM<br/>Direction Photo is Taken: Southeast</p> <p>Photo Description: Adequate subsoil and sand excess from active construction</p> <p>Latitude: 46.96599056836811<br/>Longitude: -96.86404289592572</p> |

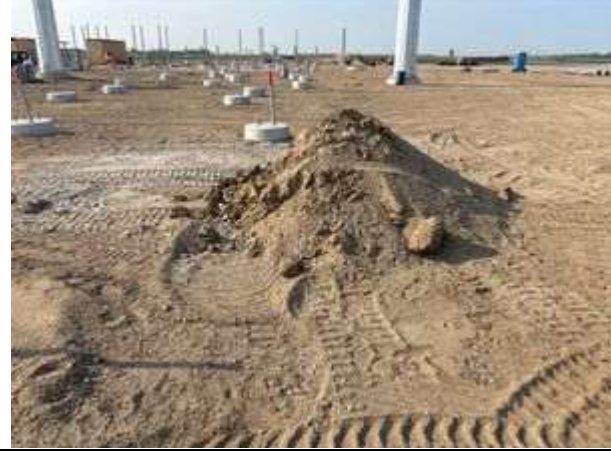
| | <p><b>Observation Point: 7</b><br/>Date Taken: July 23, 2026 9:05 AM<br/>Direction Photo is Taken: South</p> <p>Photo Description: Subsoil spoil, no topsoil observed</p> <p>Latitude: 46.96568113438411<br/>Longitude: -96.8637418290619</p> |

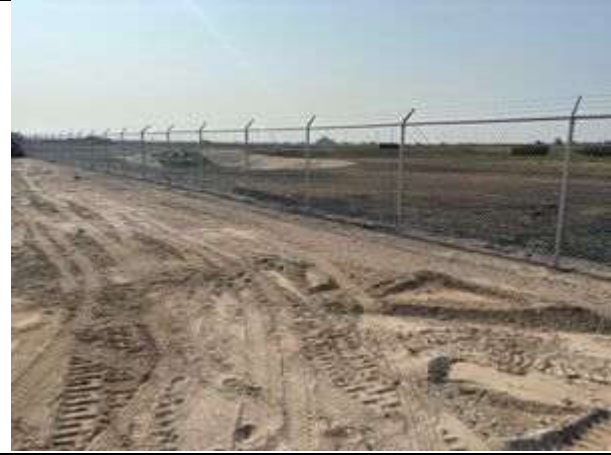
| | <p><b>Observation Point: 8</b><br/>Date Taken: July 23, 2026 9:18 AM<br/>Direction Photo is Taken: Southeast</p> <p>Photo Description: Seeded area beyond fence</p> <p>Latitude: 46.96445040162428<br/>Longitude: -96.86477589598155</p> |

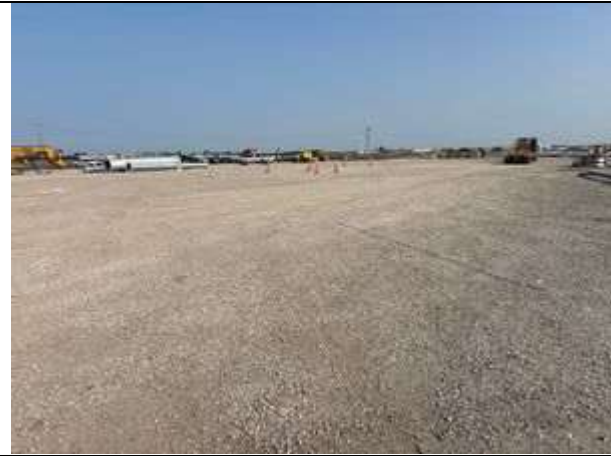
| | <p><b>Observation Point: 9</b><br/>Date Taken: July 23, 2026 9:20 AM<br/>Direction Photo is Taken: Northwest</p> <p>Photo Description: Parking and laydown area</p> <p>Latitude: 46.96471515165147<br/>Longitude: -96.86555011172103</p> |

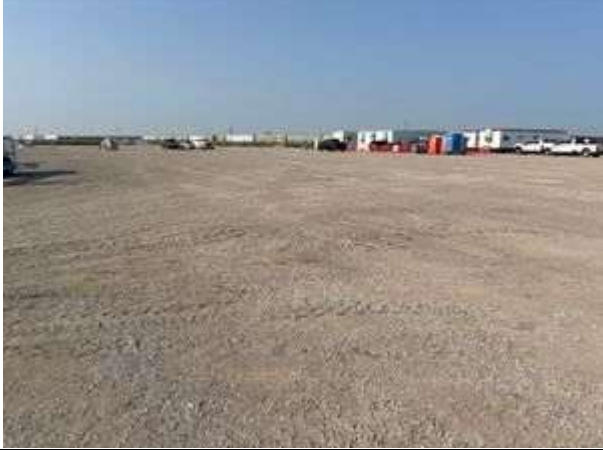
| | <p><b>Observation Point: 10</b><br/>Date Taken: July 23, 2026 9:21 AM<br/>Direction Photo is Taken: Southwest</p> <p>Photo Description: Parking area and trailers</p> <p>Latitude: 46.9647049346561<br/>Longitude: -96.8655920287111</p> |

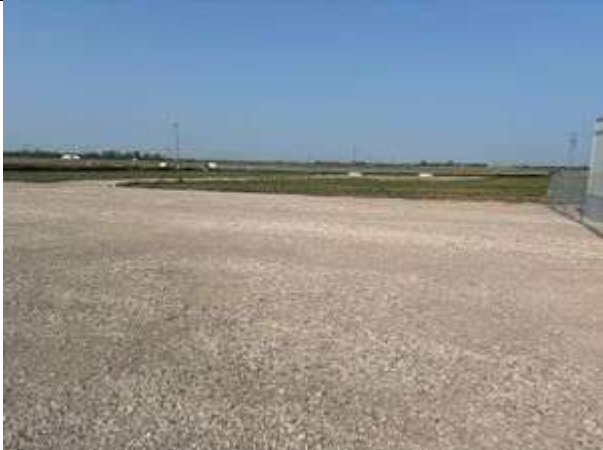
| | <p><b>Observation Point: 11</b><br/>Date Taken: July 23, 2026 9:25 AM<br/>Direction Photo is Taken: West</p> <p>Photo Description: Silt fence observed, 2 completed foundations, no stockpiles of soil remain</p> <p>Latitude: 46.96389978481579<br/>Longitude: -96.86630037864965</p> |

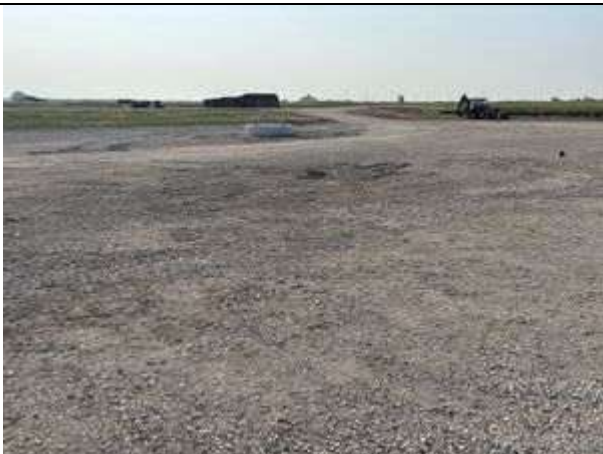
| | <p><b>Observation Point: 12</b><br/>Date Taken: July 23, 2026 9:26 AM<br/>Direction Photo is Taken: Southeast</p> <p>Photo Description: 1 completed foundation, no soil stockpiles remain</p> <p>Latitude: 46.96387638479221<br/>Longitude: -96.86596482874714</p> |

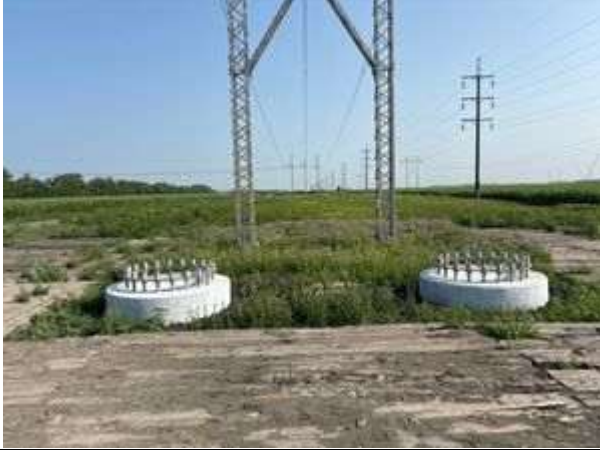
| | <p><b>Observation Point: 13</b><br/>Date Taken: July 23, 2026 9:44 AM<br/>Direction Photo is Taken: North</p> <p>Photo Description: All foundations finished on west side of interstate, soil replaced</p> <p>Latitude: 46.95023307111696<br/>Longitude: -96.87315731204588</p> |

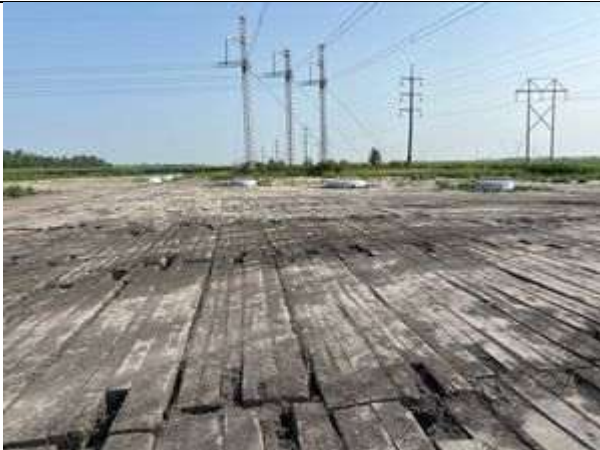
| | <p><b>Observation Point: 14</b><br/>Date Taken: July 23, 2026 9:48 AM<br/>Direction Photo is Taken: North</p> <p>Photo Description: Several foundations completed, no soil stockpiles remain</p> <p>Latitude: 46.95170490393878<br/>Longitude: -96.87329887875809</p> |

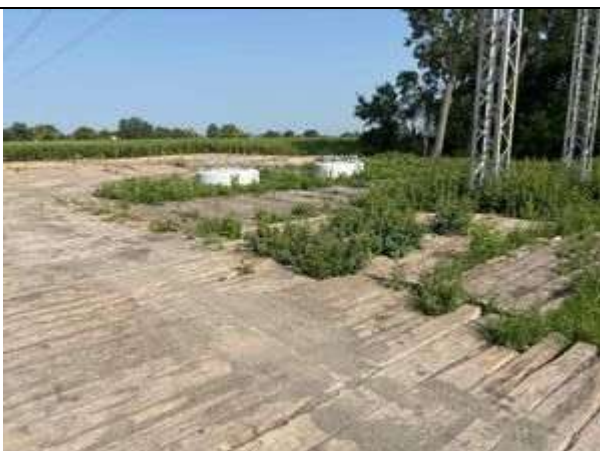
| | <p><b>Observation Point: 15</b><br/>Date Taken: July 23, 2026 9:52 AM<br/>Direction Photo is Taken: Northwest</p> <p>Photo Description: 2 foundations finished</p> <p>Latitude: 46.95226392103581<br/>Longitude: -96.87543412806875</p> |

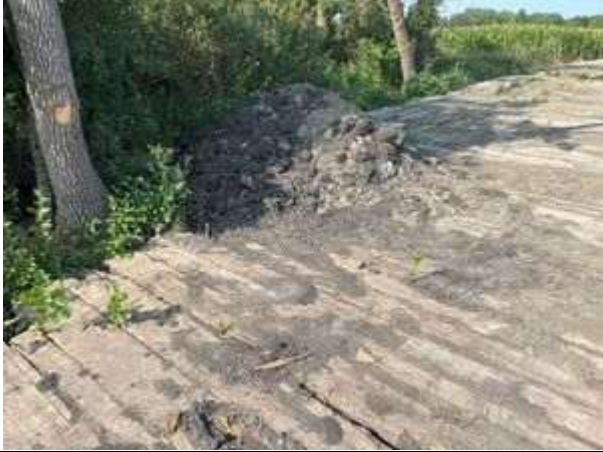
| | <p><b>Observation Point: 16</b><br/>Date Taken: July 23, 2026 9:53 AM<br/>Direction Photo is Taken: Southwest</p> <p>Photo Description: Small stockpile of topsoil, subsoil mixed in</p> <p>Latitude: 46.95223715405104<br/>Longitude: -96.87558316103176</p> |

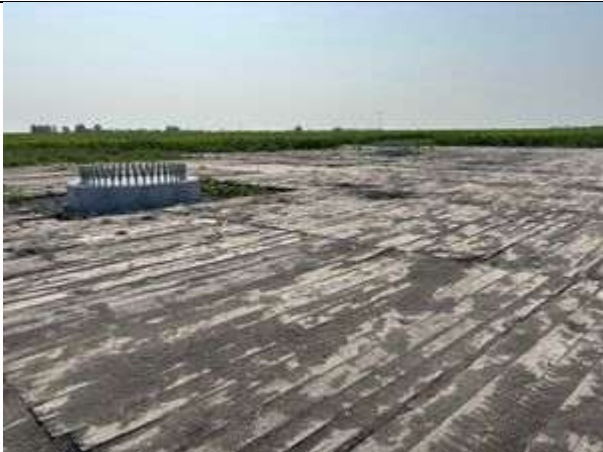
| | <p><b>Observation Point: 17</b><br/>Date Taken: July 23, 2026 9:58 AM<br/>Direction Photo is Taken: Southeast</p> <p>Photo Description: 2 foundations finished</p> <p>Latitude: 46.95227174476391<br/>Longitude: -96.8720111720212</p> |

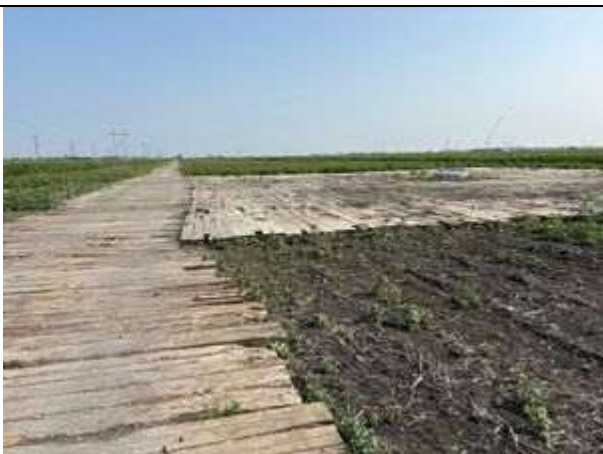
| | <p><b>Observation Point: 18</b><br/>Date Taken: July 23, 2026 10:01 AM<br/>Direction Photo is Taken: North</p> <p>Photo Description: 1 foundation finished, several more to the north</p> <p>Latitude: 46.95387515254809<br/>Longitude: -96.87189136778397</p> |

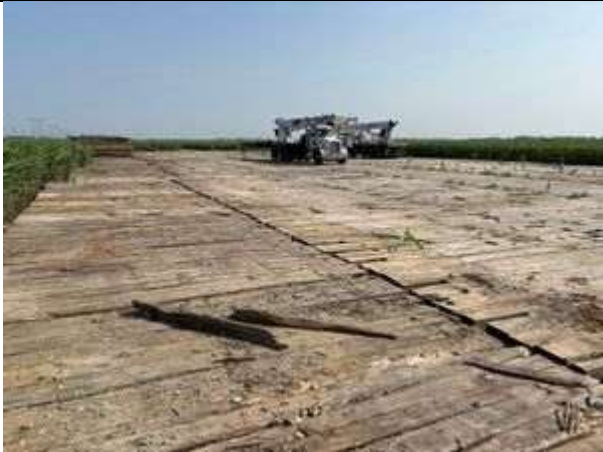
| | <p><b>Observation Point: 19</b><br/>Date Taken: July 23, 2026 10:06 AM<br/>Direction Photo is Taken: North</p> <p>Photo Description: Laydown area, staging timber mats</p> <p>Latitude: 46.95055489897246<br/>Longitude: -96.87185417835467</p> |
