To: Tina Bartunek Iberdrola Renewables 1125 NW Couch Street, Suite 700 Portland OR 97209	
From: Joyce Pickle	Project: Rugby Wind Project
Date: September 28, 2011	Job No: 170841

RE: Tree Replacement Memo for Rugby Wind Project, Pierce County, North Dakota – Second Year of Three Years of Monitoring

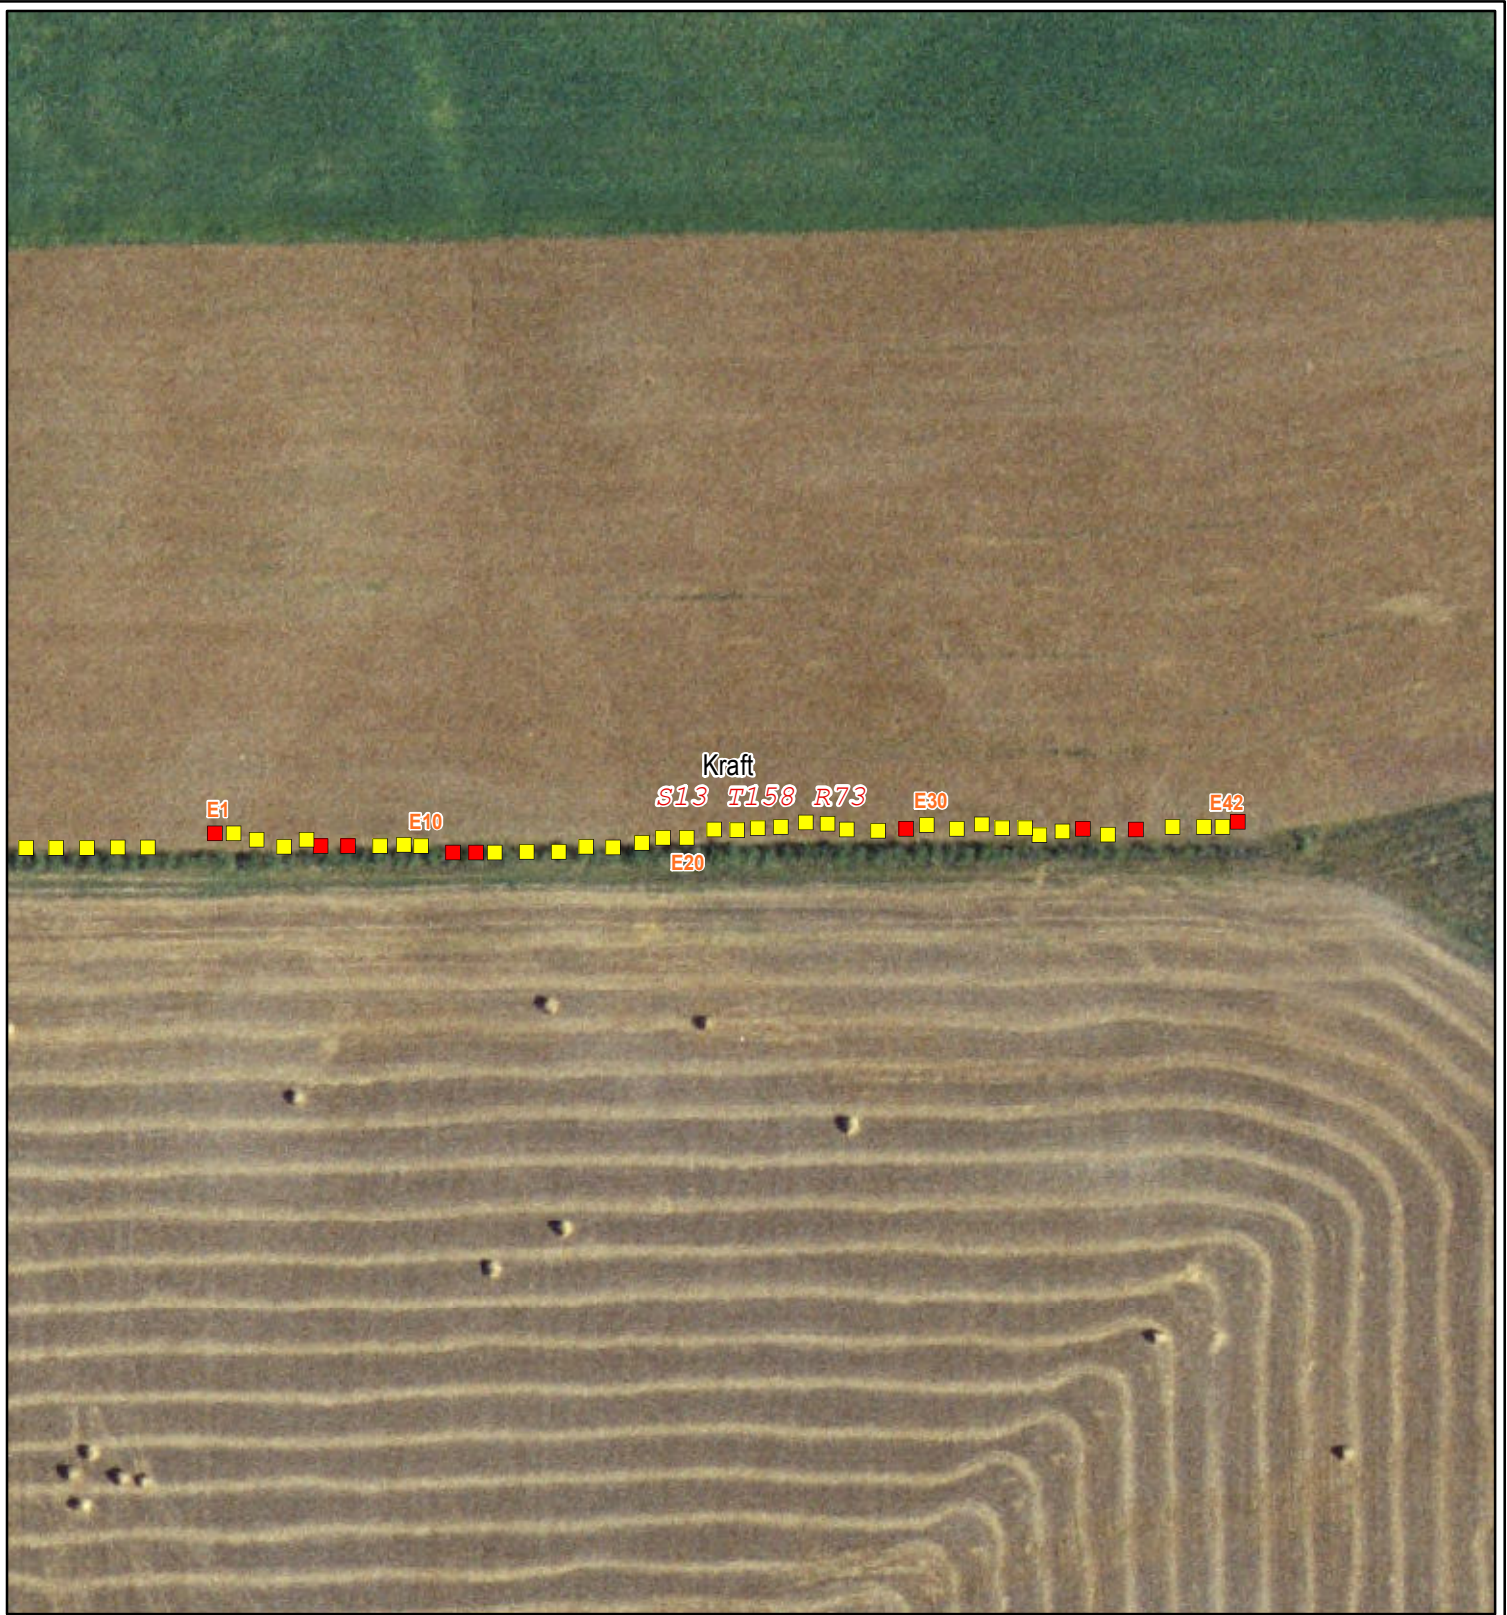
**Kraft
Property
Area: E**

Kraft	S12 T158N R73W (Site 8)	Underground Cabling	4 Green Ash	35 total	S13 T158N R73W (Area E)	71 Blue Spruce – 62 live, 9 dead
	S12 T158N R73W (Site 9)	Underground Cabling	10 Green Ash			
	S12 T158N R73W (Site 10)	Access Road	21 Green Ash			
Kukla	S18 T158N R72W (Site 11)	Overhead Transmission	10 Green Ash	25 total	S13 T158N R73W (Area F)	30 Lilacs – 29 live, 1 dead
	S18 T158N R73W (Site 12)	Access Road	5 Evergreens 5 Choke Cherry, 5 Willow		S18 T158N R72W (Area G)	15 Ponderosa Pine, 5 Willow – all live
Total	289 Trees Removed			541 Live Trees Replaced, 42 Dead Trees

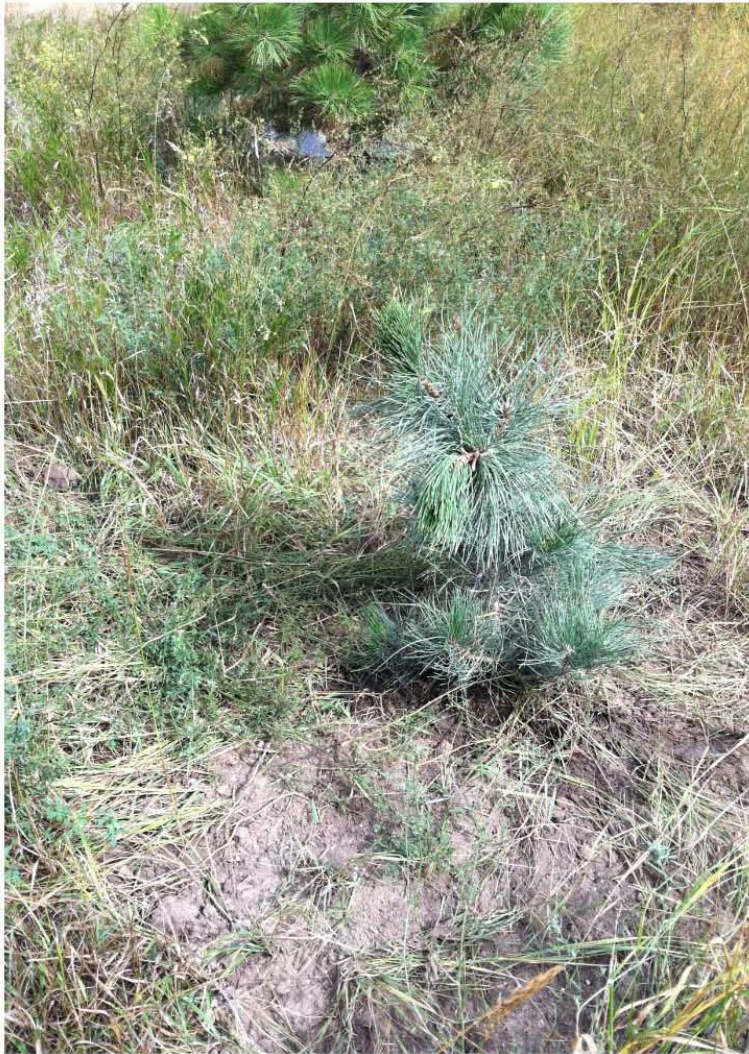
Photo 1: Ponderosa Pine on Kukla Property

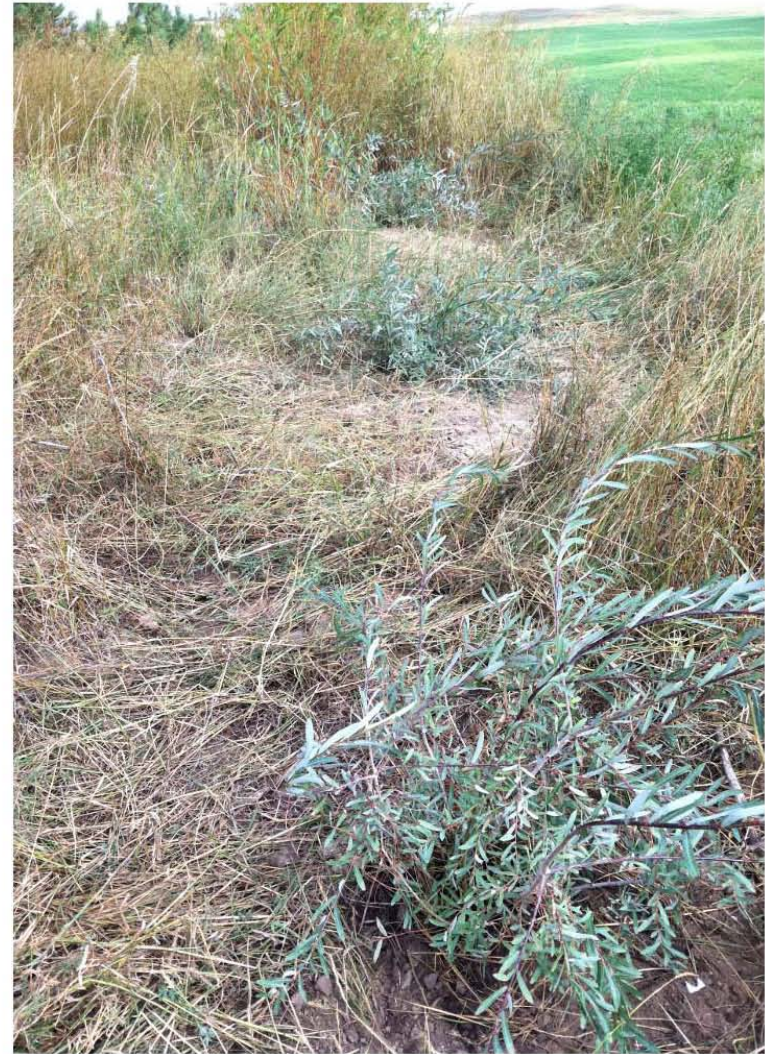
Photo 2: Willows on Kukla Property
