Reference: **2016 Tree and Shrub Mitigation Monitoring Report
 CapX2020 Fargo-St. Cloud 345 kV Transmission Line
 Case No. PU-07-759
 Cass County, North Dakota**

2016 North Dakota Tree and Shrub Mitigation Monitoring Report

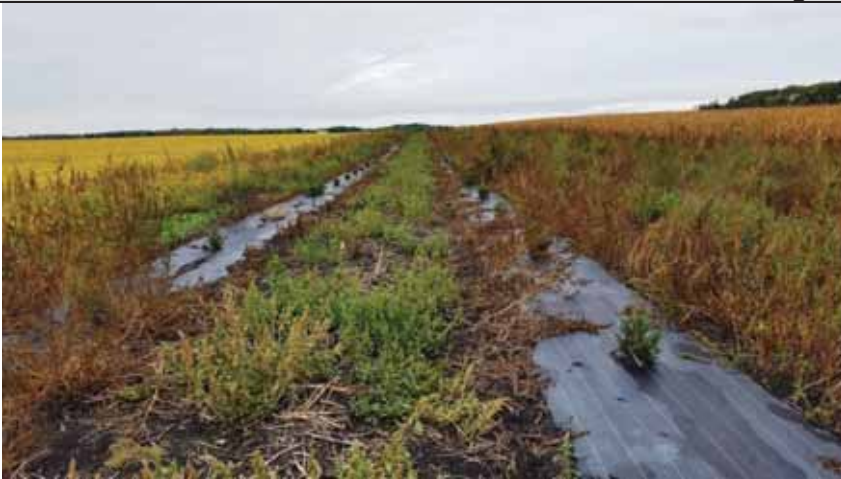
Photo 1

Rows 1 and 2 looking west. Light weed pressure from between the rows and within the fabric cuts.

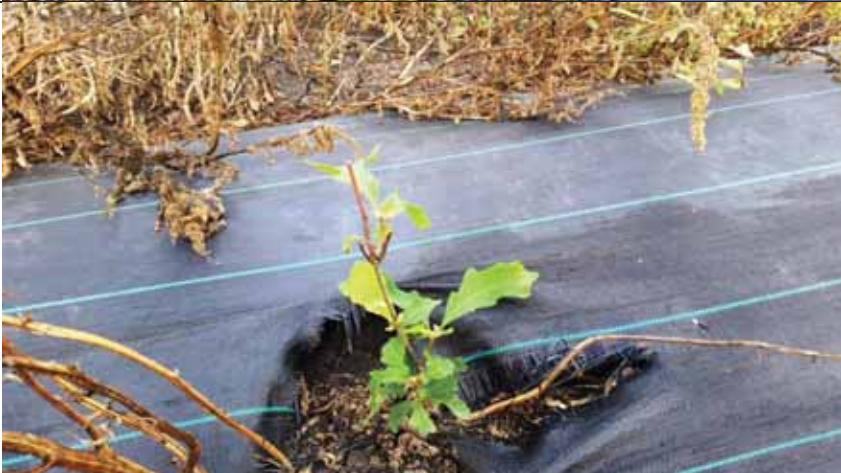
Photo 2

Small Bur Oak topped from animal browsing.

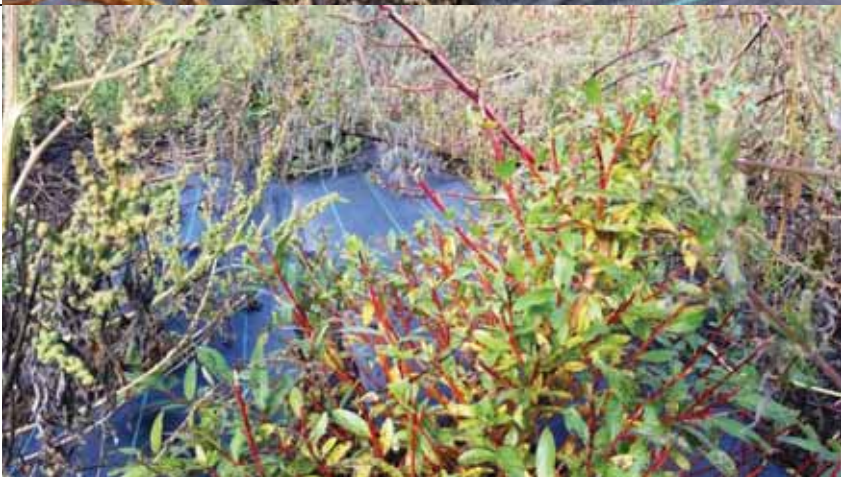
Photo 3

Flame willow growing well with signs of animal browsing.

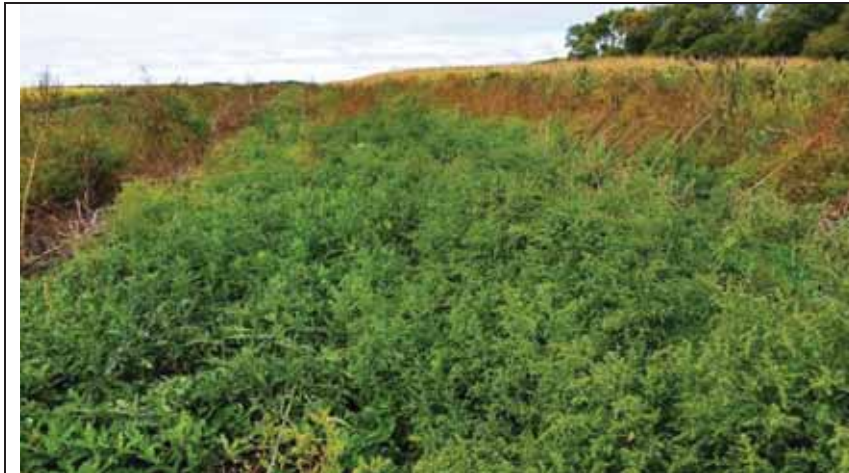
Photo 4

Heavy weed pressure on the east end of the rows. Weeds are growing in from between the rows and smothering the planted species (see photo 5)

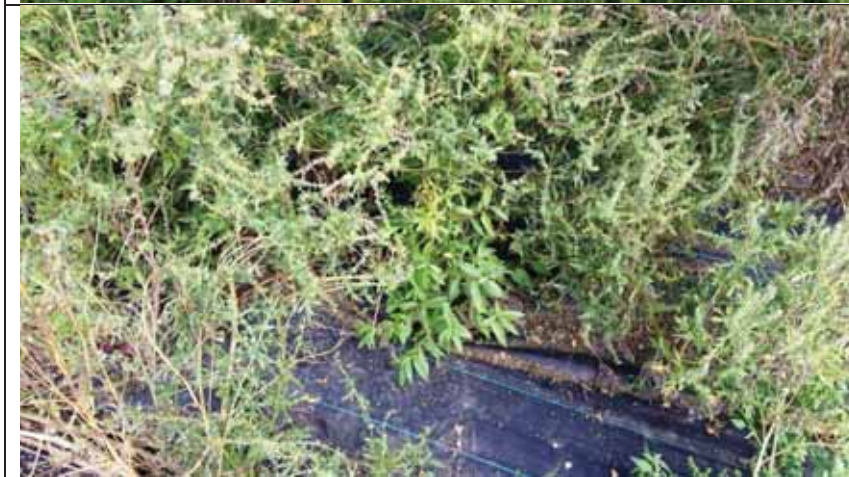
Photo 5

Flame willow surviving under the weed growth. Exposed by pulling weeds away from the fabric row.

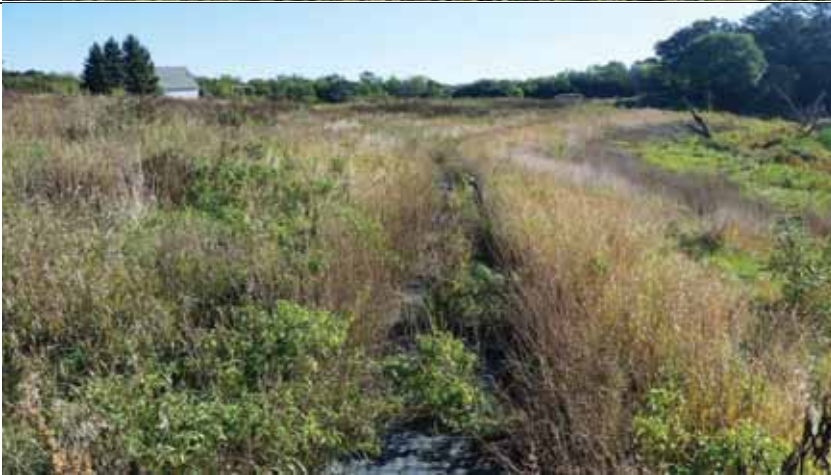
Photo 8

Site overview of rows 10-18, which had moderate weed pressure. Multiple species of weeds were growing in the rows with the tress.

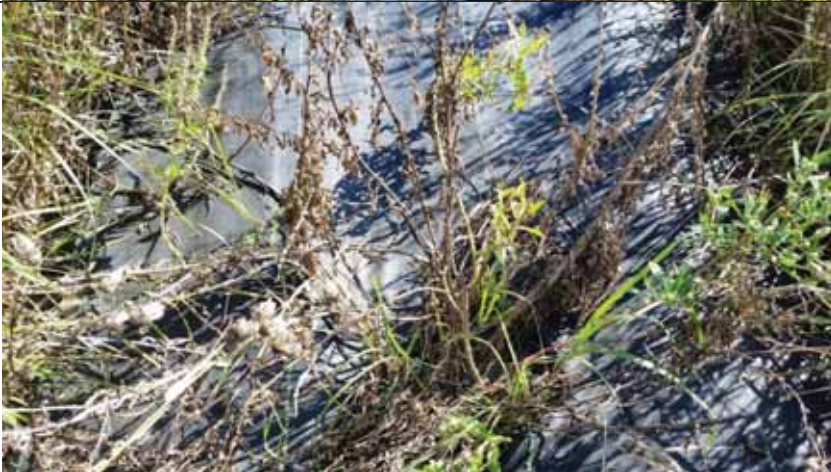
Photo 9

Small willow growing in weeds.

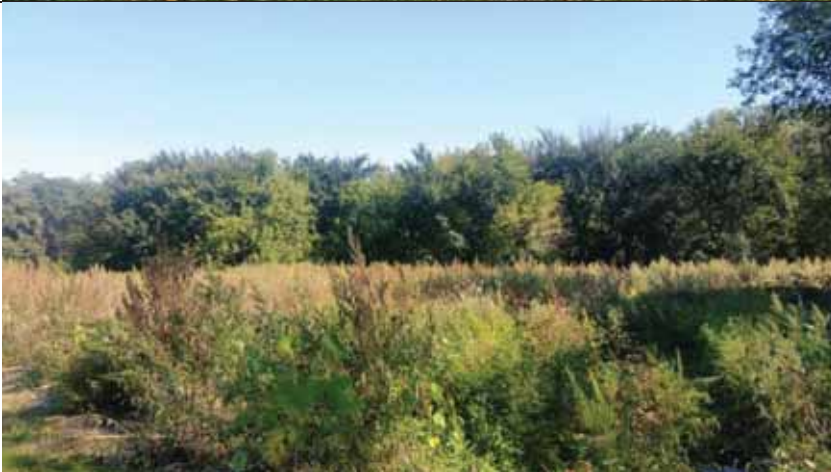
Photo 12

Field overview photo, site over run with common field pests, mainly beggars tick, giant ragweed and cocklebur.

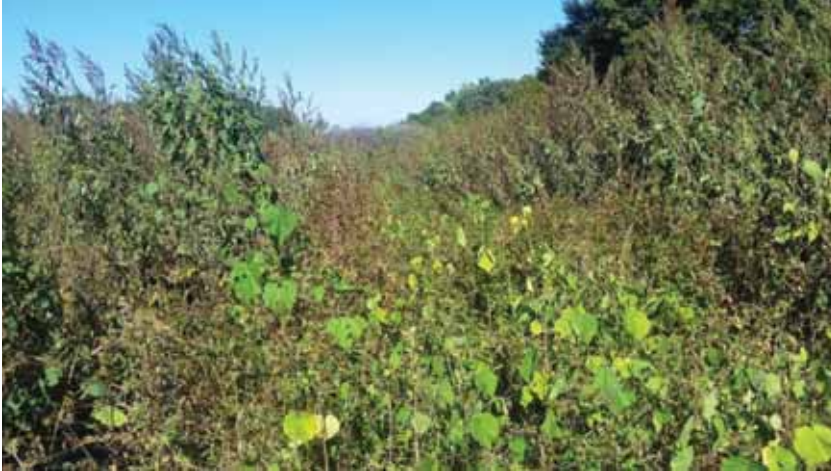
Photo 13

Photo of weed growth between rows.

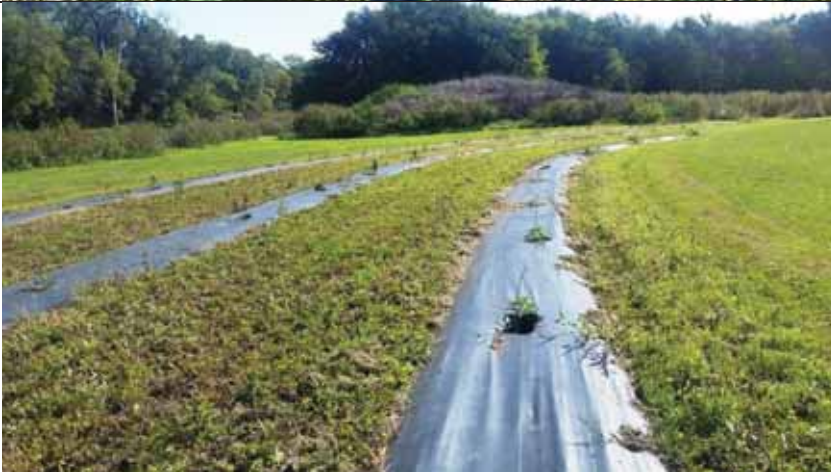
Photo 15

Partially maintained rows on the west half of the field.

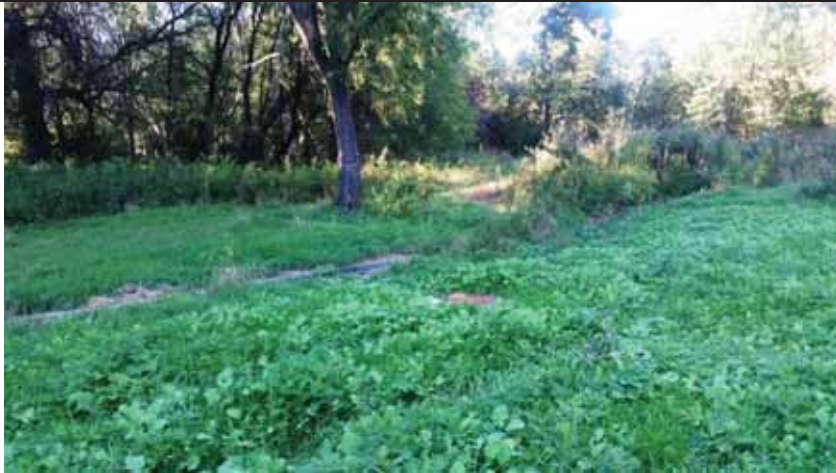
Photo 16

Rows 1-3 located in a deer food plot.

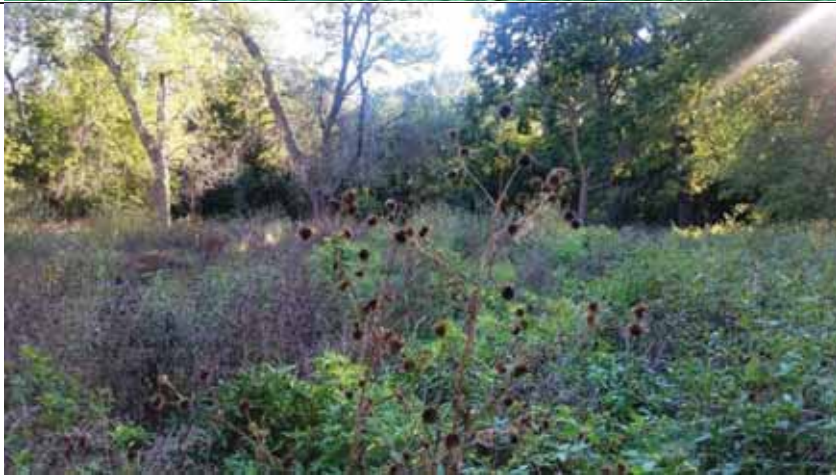
Photo 17

Remaining rows of plot 4 are overrun with weeds.

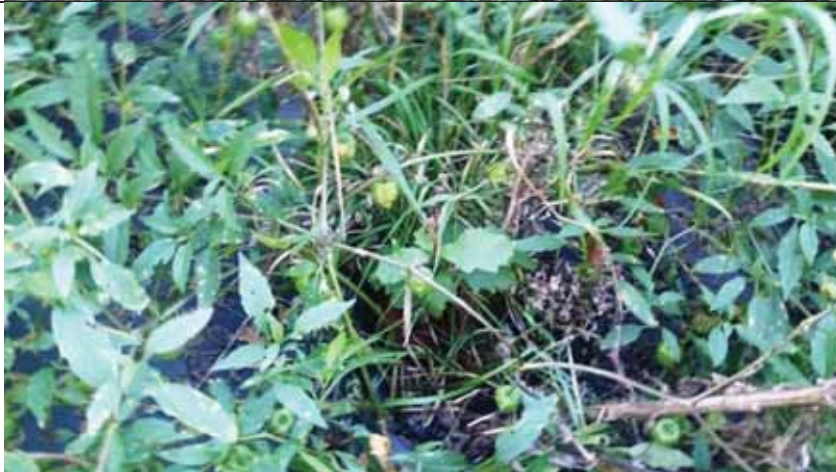
Photo 18

Oak growing with weeds growing in the row.

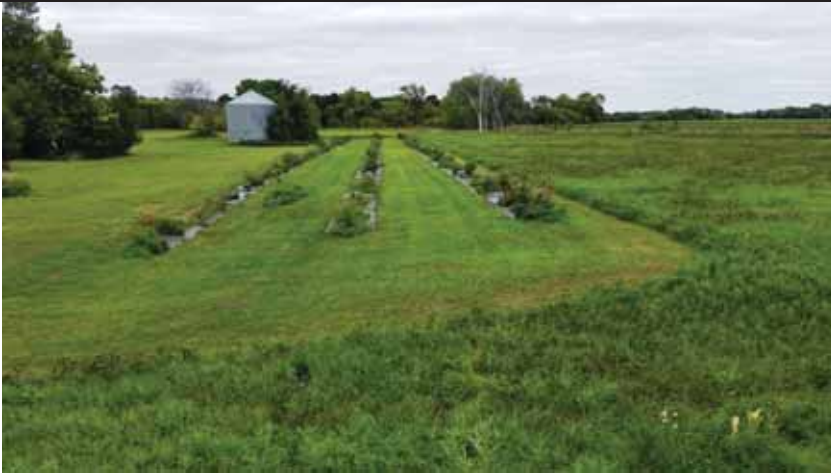
Photo 25

Site overview looking north. Rows are mowed between, but no weeding has been done around the planted trees.

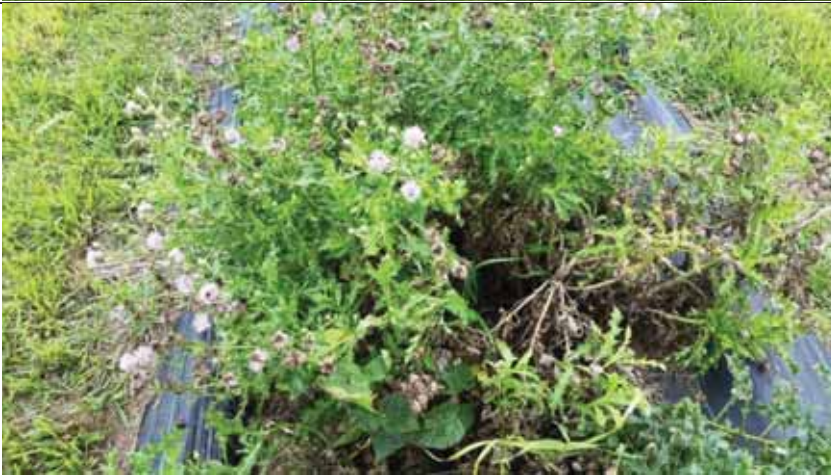
Photo 26

Canada thistle and other weeds were observed in the rows. Little leaf Linden is at the bottom of the photo under the thistle.

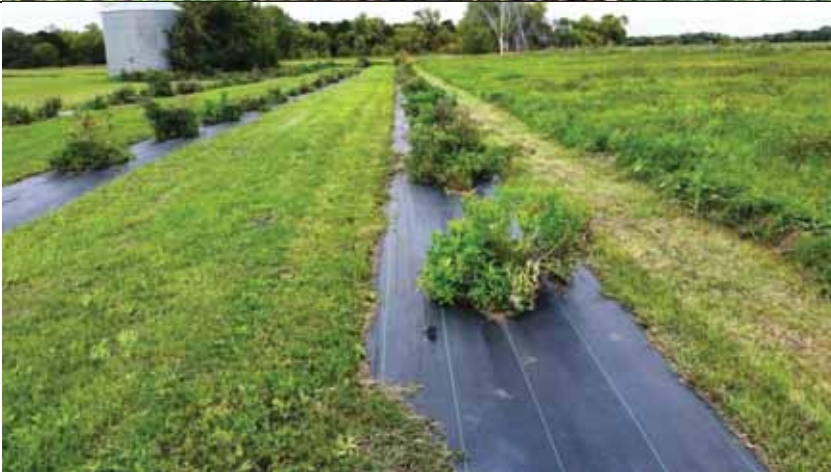
Photo 27

Spruce trees covered by weeds.

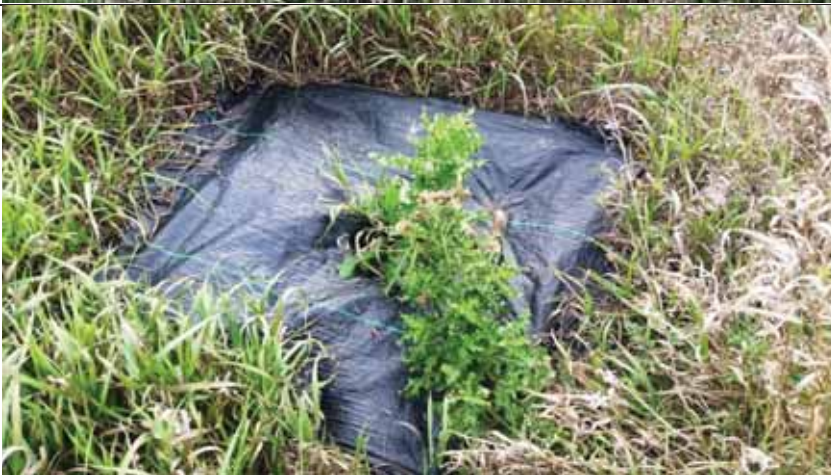
Photo 29

Trees planted by hand with fabric squares. Planting in photo had little outside weed pressure, but Canada thistle and brome growing in the fabric. No surviving tree observed.

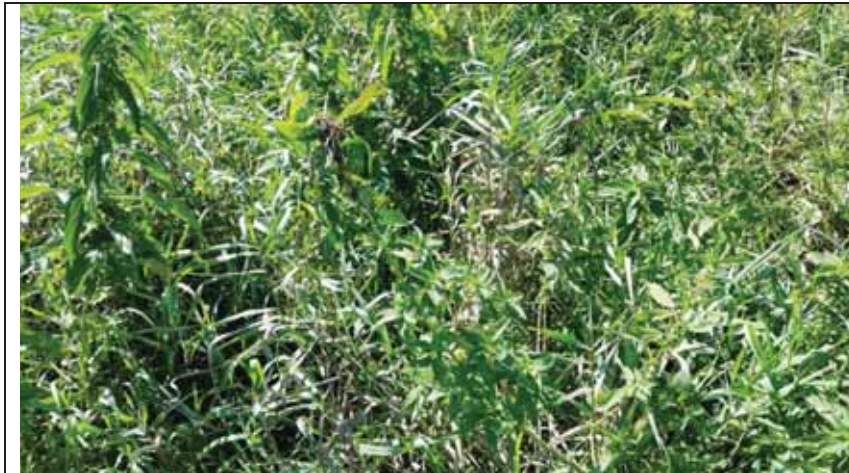
Photo 31

Locating plantings was difficult as weeds were overgrowing the fabric squares.

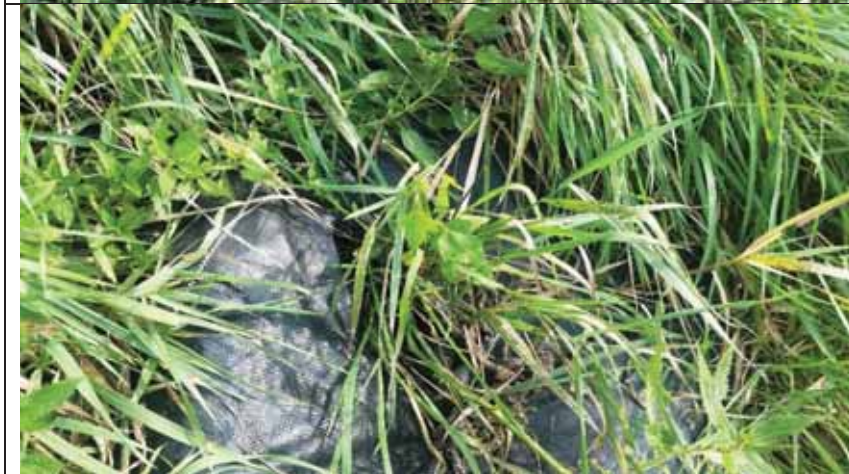
Photo 33

Maple struggling to grow with smooth brome growing in and around the fabric.

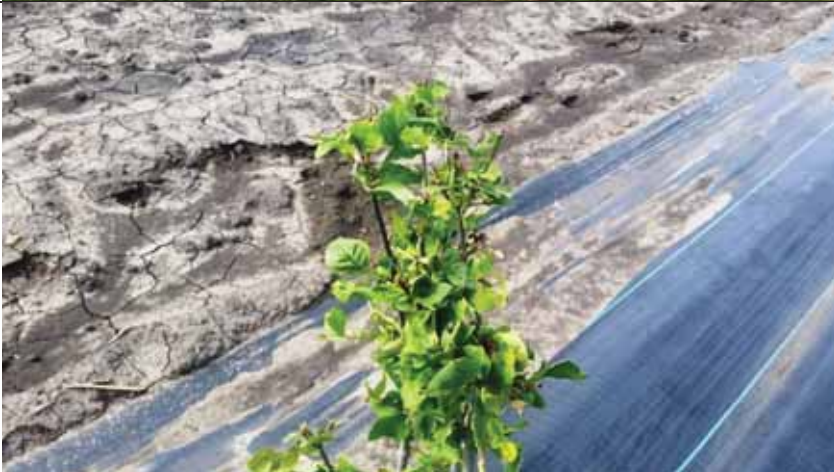
Photo 36

Browsed green ash tree.

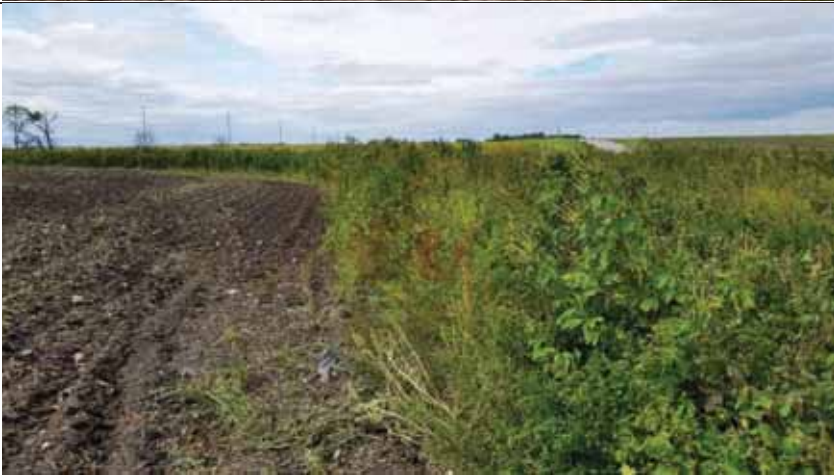
Photo 38

Site over view looking southwest. Heavy weed pressure in and between the rows.

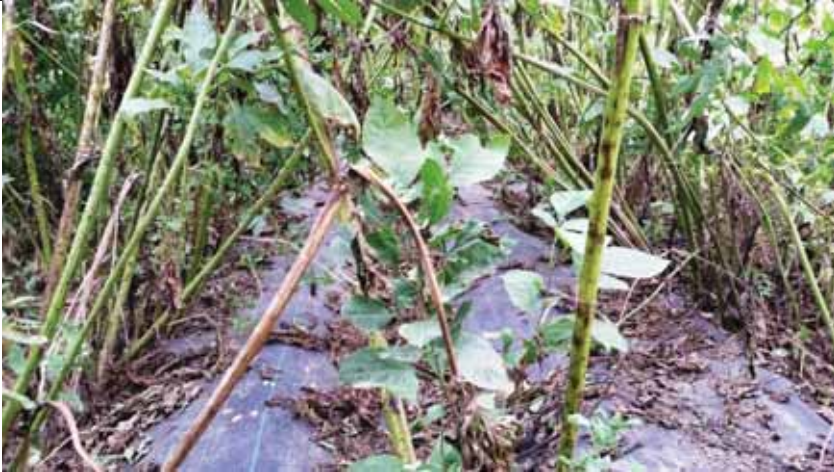
Photo 39

Green ash tree growing under the giant ragweed canopy.

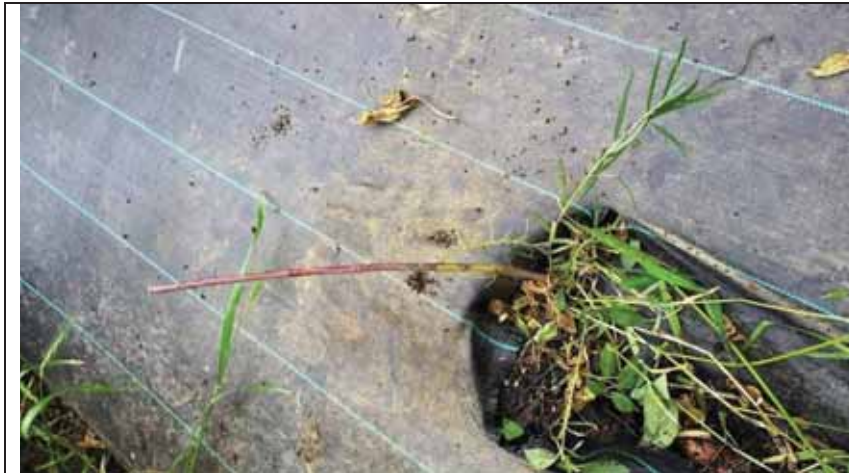
Photo 37

Sandbar willow growing from the ground. The original stem was dead.

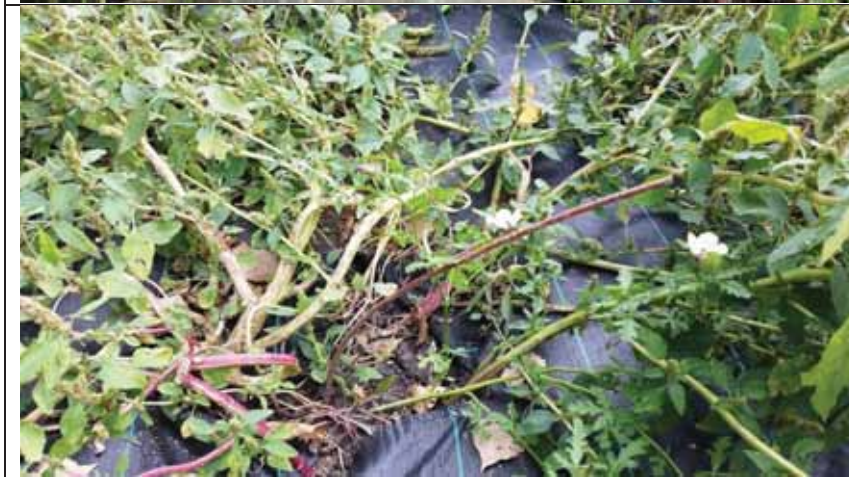
Photo 38

Willow stem has no growth and was considered dead. Heavy weed pressure growing in the fabric.

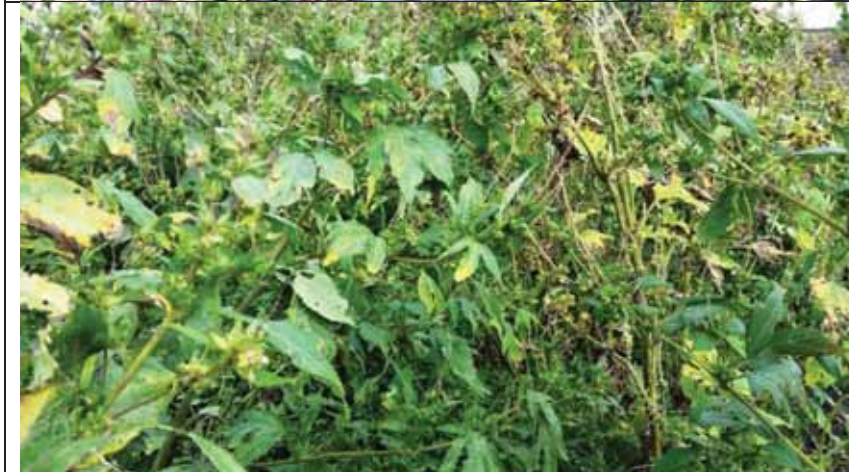
Photo 39

Giant ragweed filled in over the rows.
