Reference: **2017 Tree and Shrub Mitigation Monitoring Report
CapX2020 Fargo-St. Cloud 345 kV Transmission Line
Case No. PU-07-759, Cass County, North Dakota**

This is the second of three annual Tree and Shrub Mitigation Monitoring Reports for the 33 mile section of CapX2020 Fargo-St. Cloud 345 kV Transmission Line (CapX) located in Cass County, North Dakota.

APPENDIX A: Photo Log

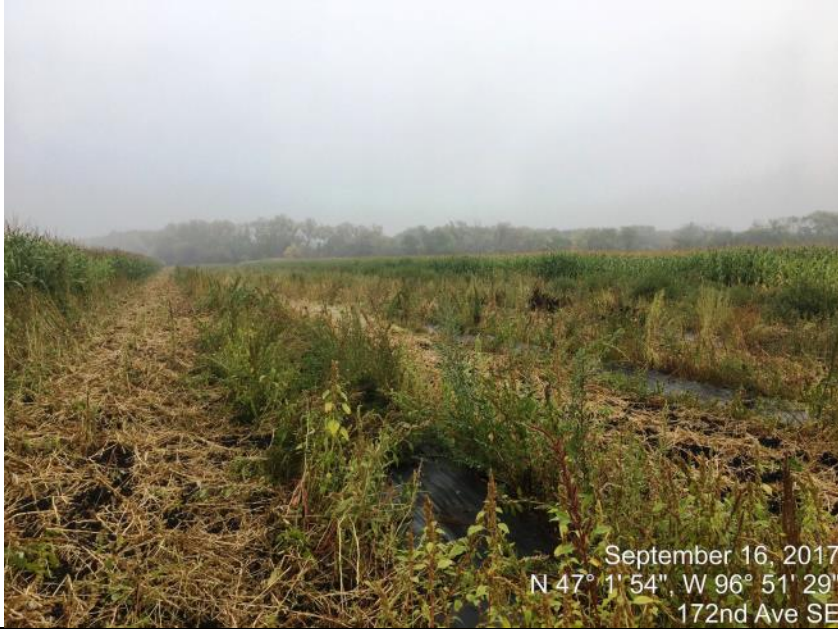
Photo 1

Site overview looking north from the southwest corner of the field. Although competing vegetation has been mowed between the rows, vegetation was growing along the edge of the fabric and in the row with the trees.

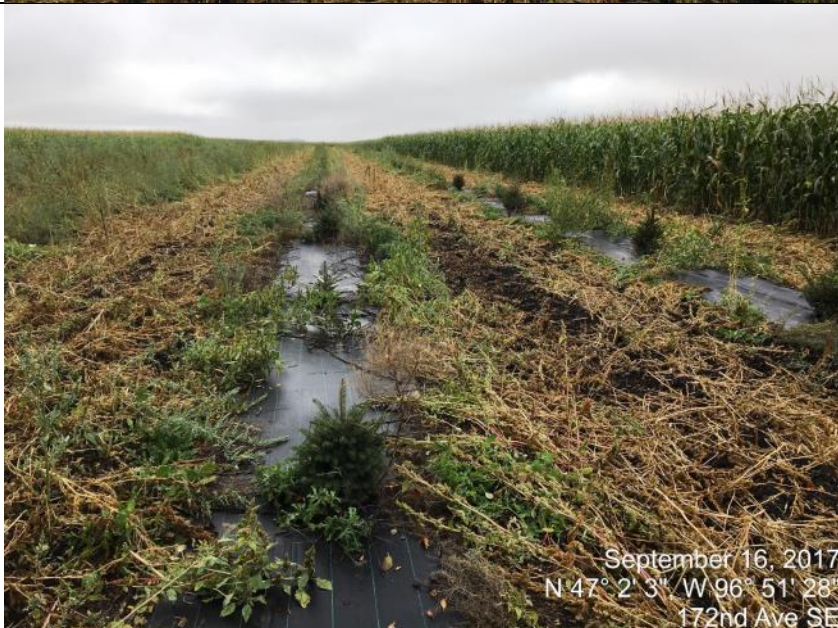
Photo 3

Spruce trees in rows 1 and 2 had the highest survival rate of the field.

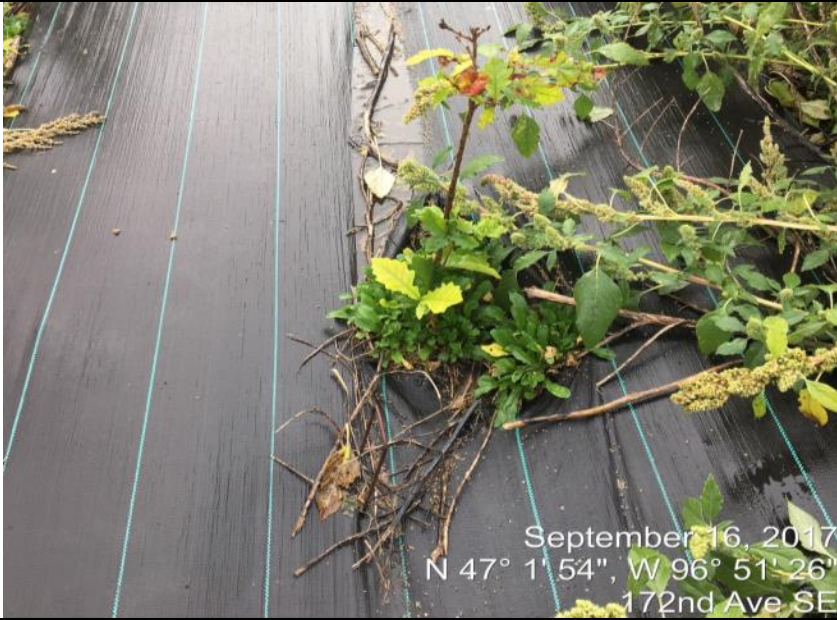
| Description: Bur oak with new growth at the base of the tree. | |

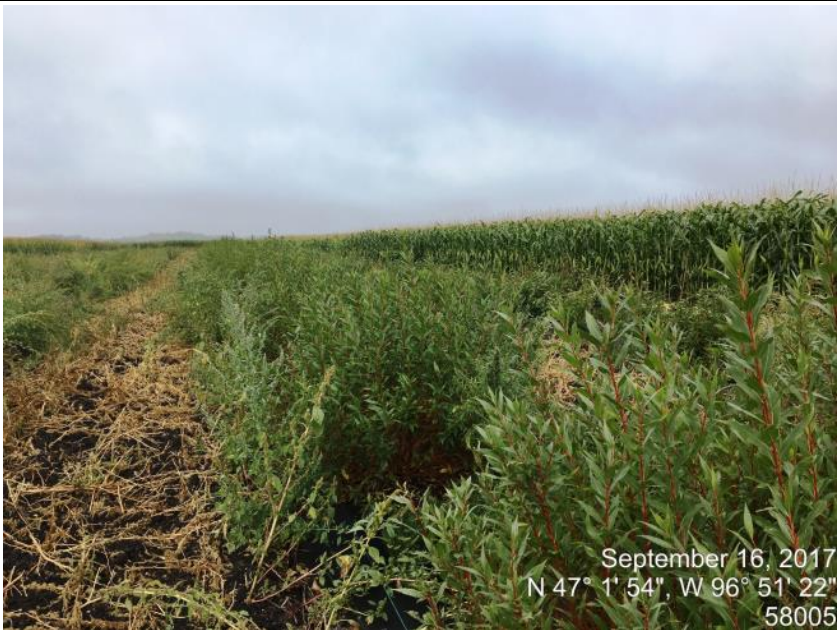
| Description: Flame willow growing well in the west half of the field. | |

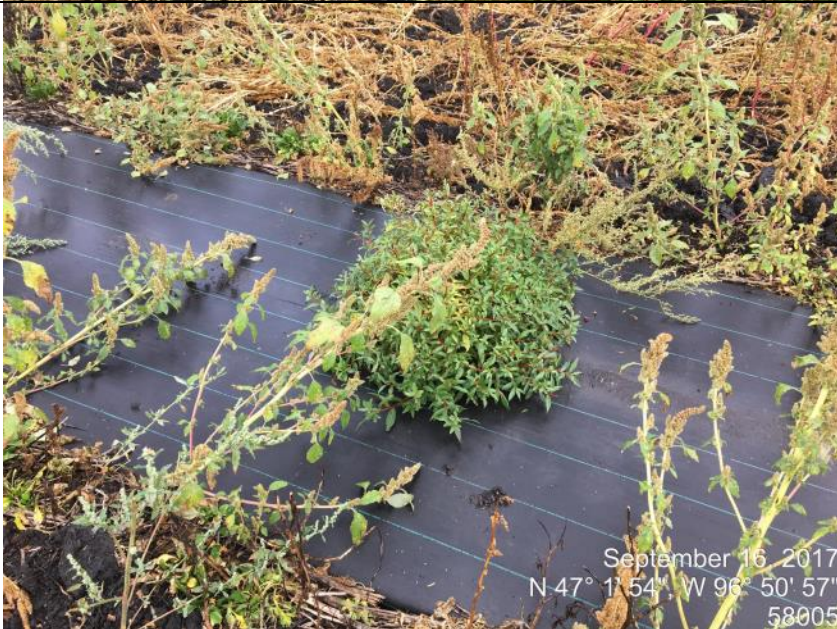
| Description: Flame willow and other species were not growing as well in the east half of the field. | |

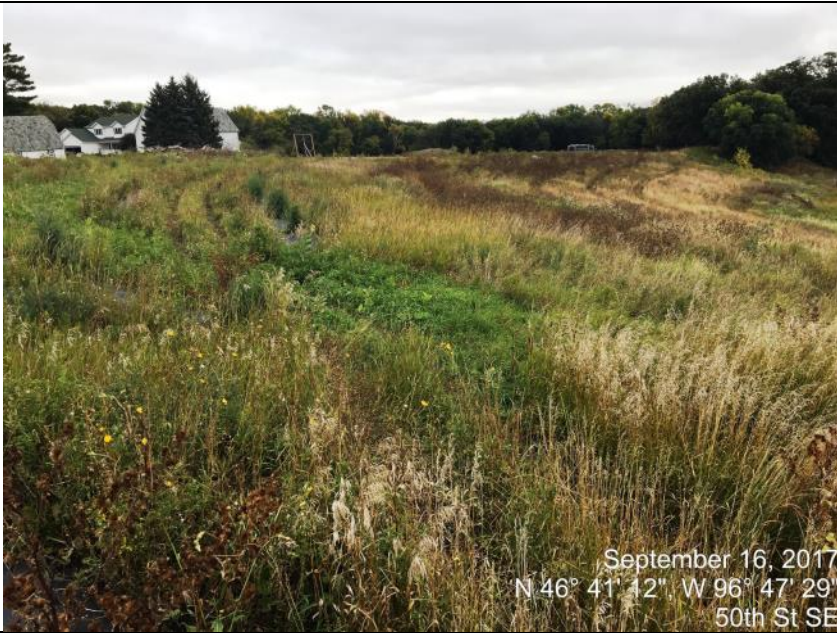
Photo 7

Site overview of looking northeast. Rows were overgrown with completing vegetation between and in the fabric.

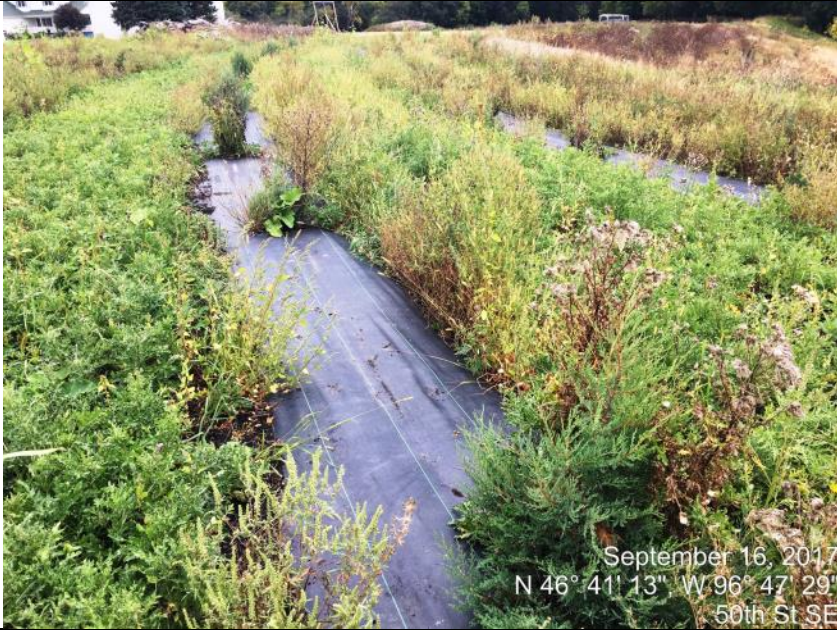
Photo 8

Rocky mountain junipers survived well from 2016.

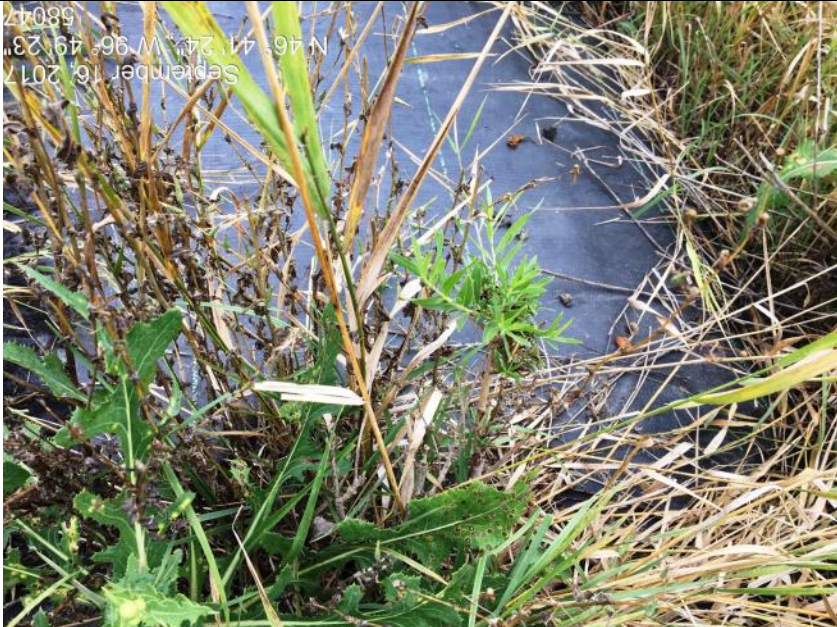
Photo 9

Sandbar willows were struggling to compete with other vegetation and showed little growth.

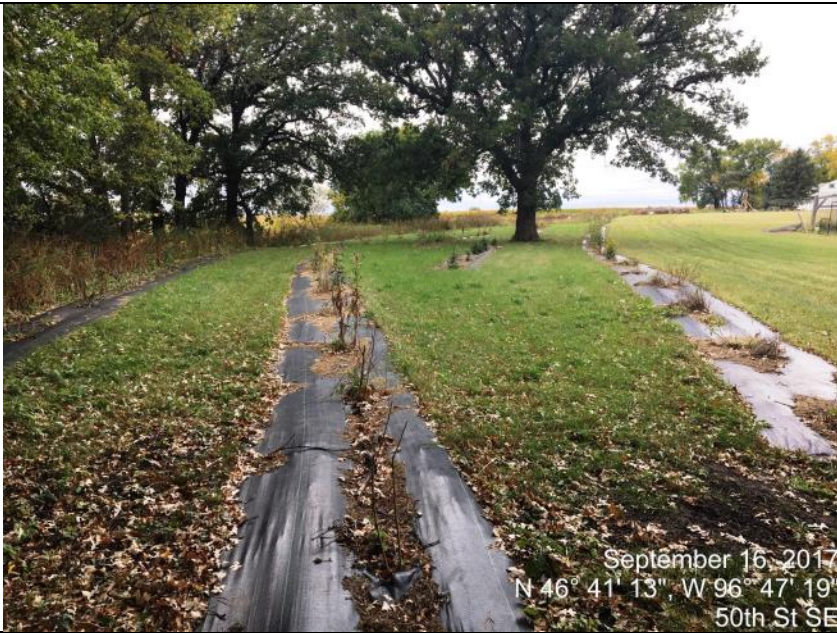
Photo 10

Trees in Field 1 showed little to no growth from the previous year.

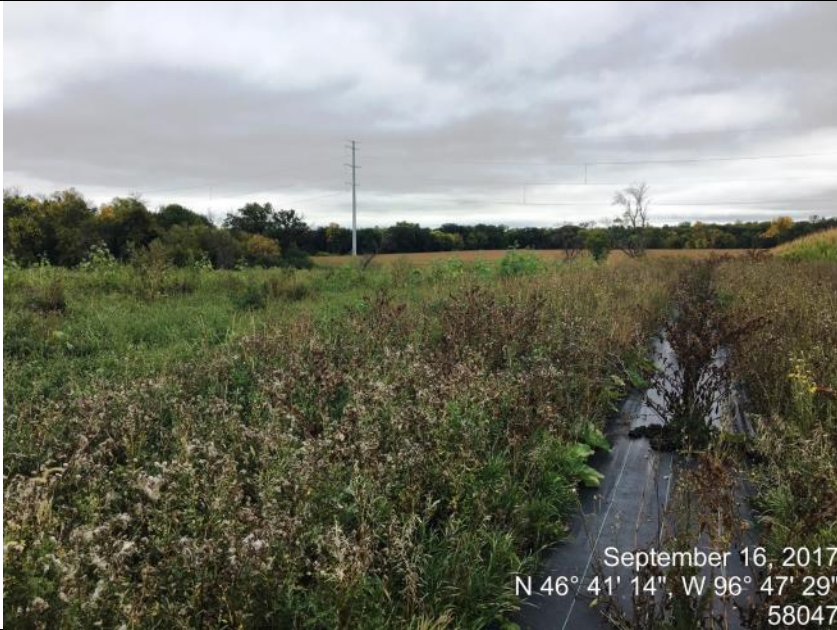
Photo 11

Rows were not maintained and fabric was in good shape.

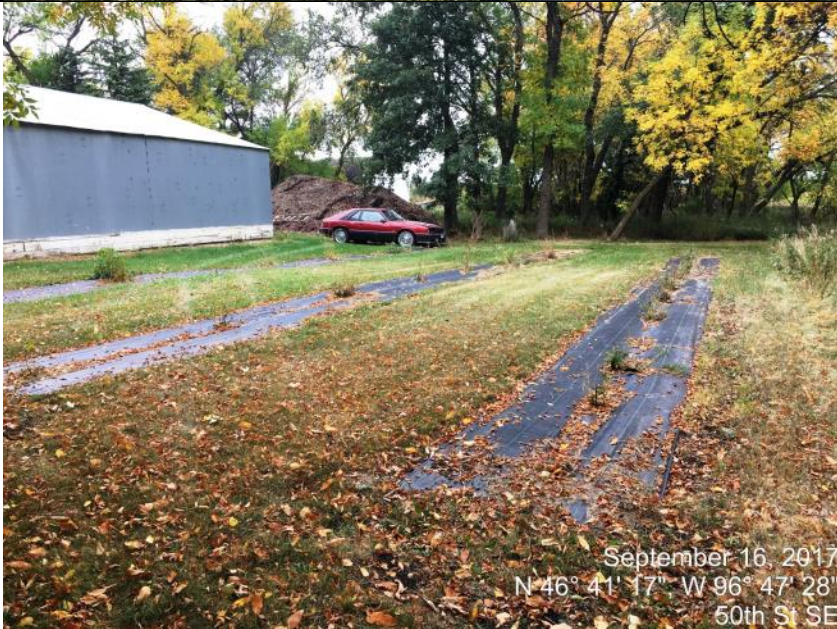
Photo 12

Field overview photo of rows 1-4, trees remain small even with low weed pressure.

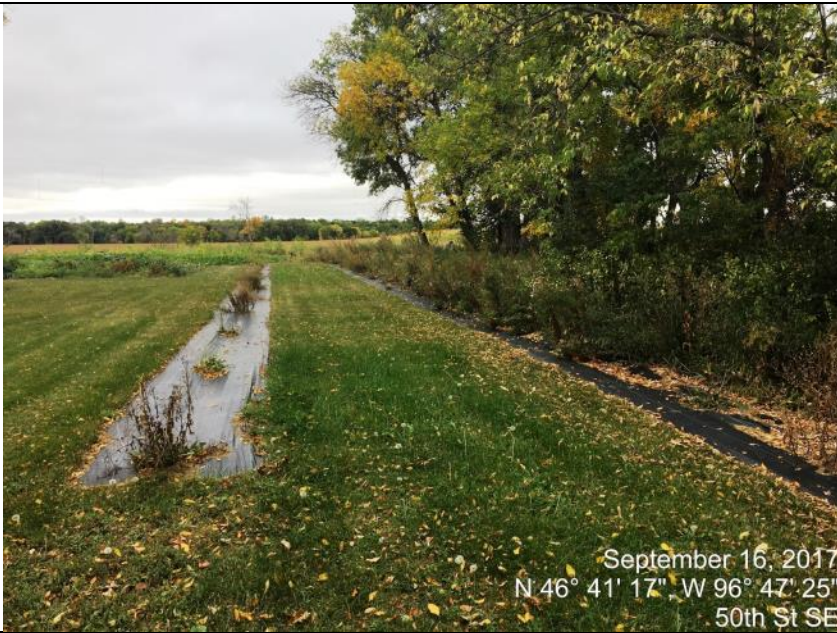
Photo 13

Field overview photo of rows 5-6, trees remain small.

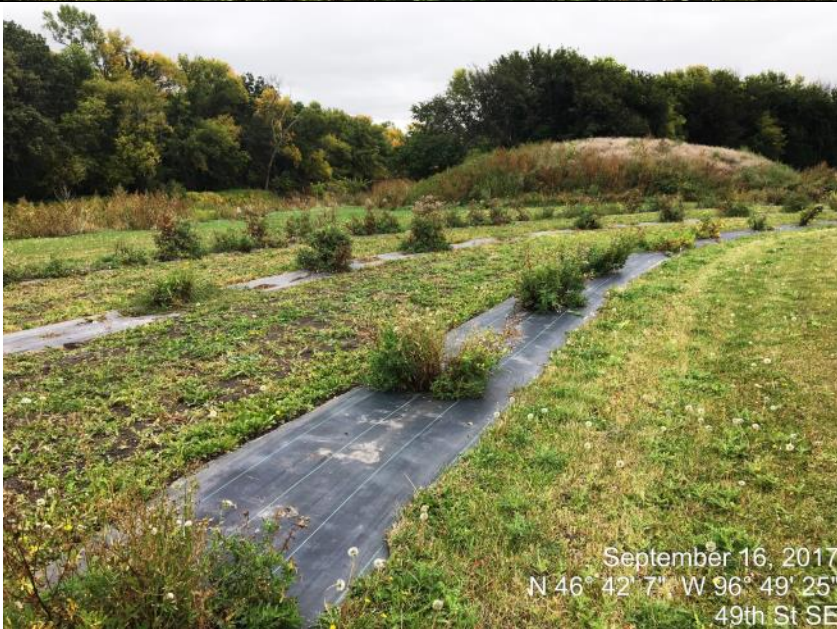
Photo 15

Field overview from the west side looking east. Trees had high competition in the fabric (see photo 16)

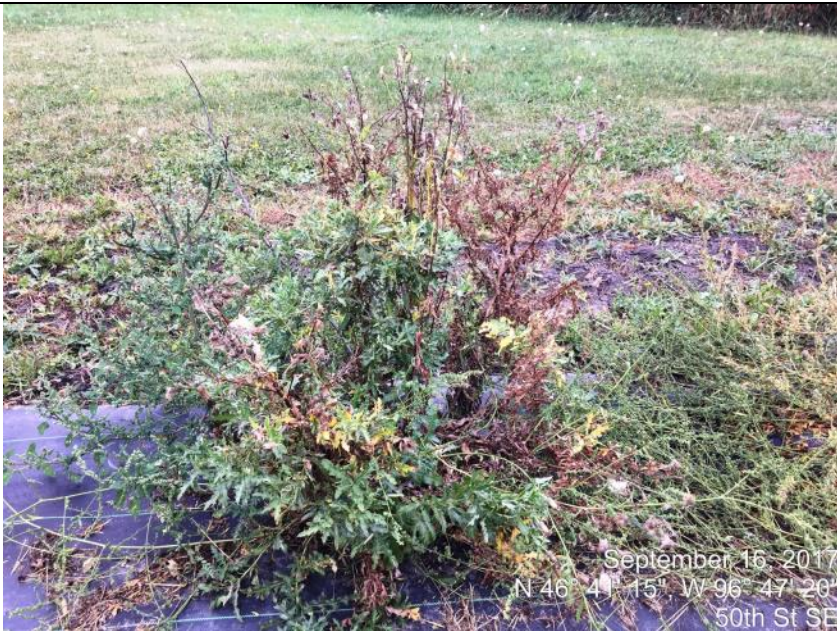
Photo 16

Bur oak trees were less than a foot tall with a few leaves and completely enclosed by competing vegetation (Canada thistle, dandelion, sow thistle and other crop pests).

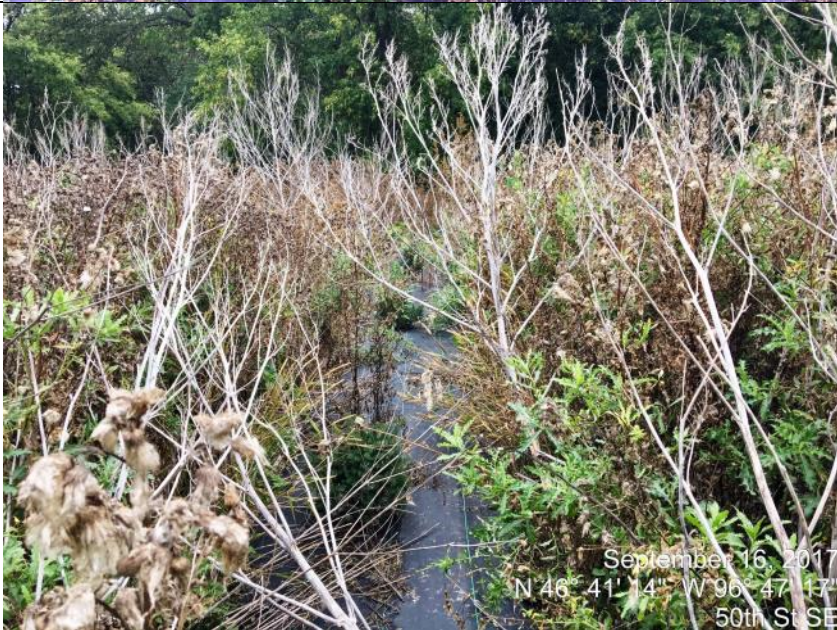
Photo 17

Although the fabric row was in good condition, competing vegetation from between the rows would suppress the trees.

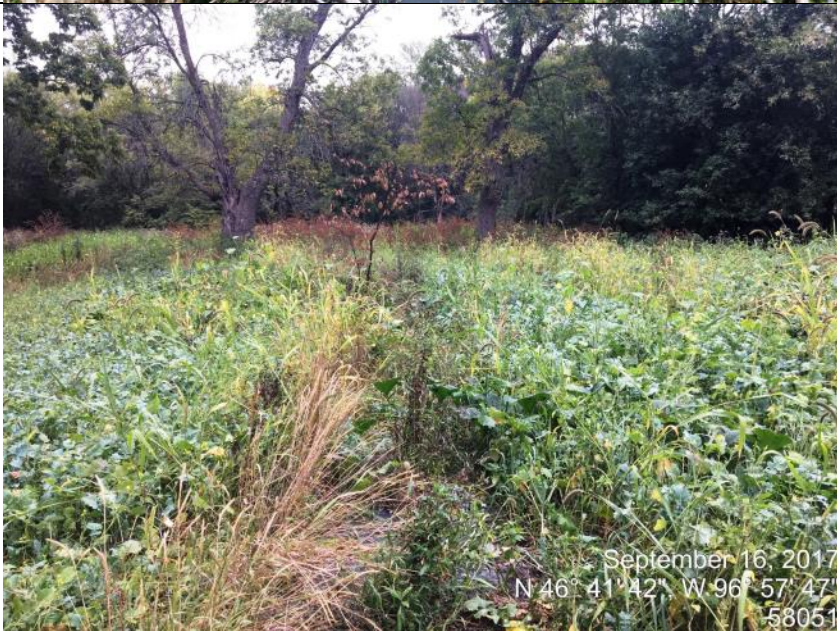
Photo 18

Deer food plot planted between the rows of trees on the south half of the field.

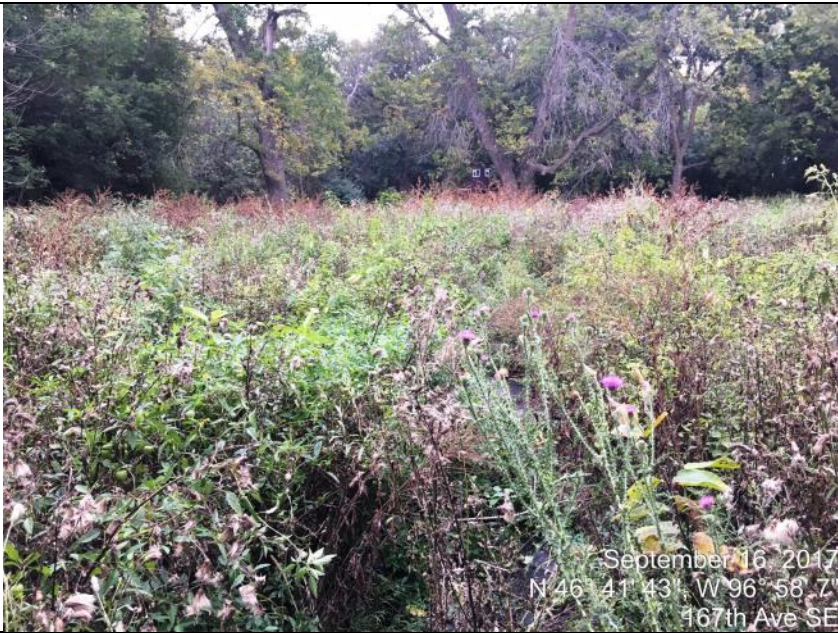
Photo 19

Fabric rows covered by competing vegetation.

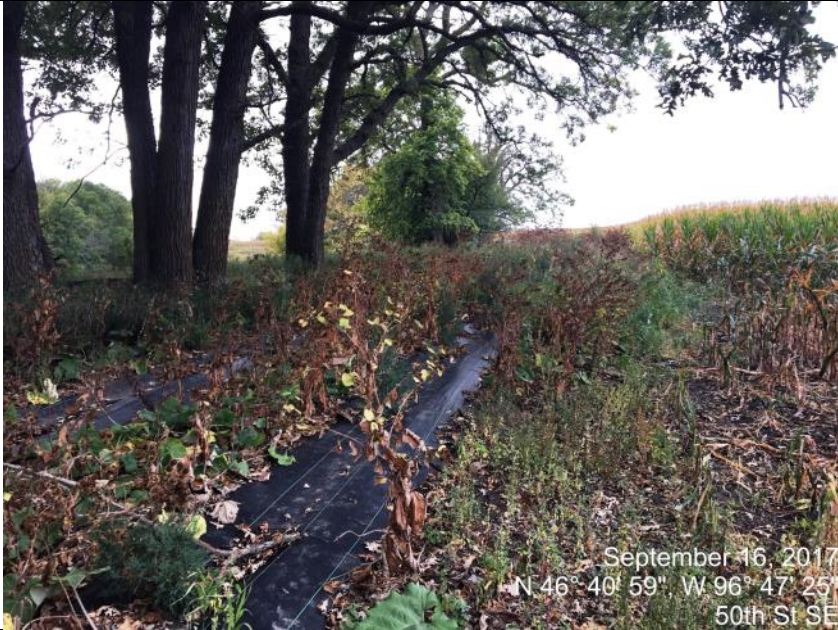
Photo 20

Rows had less completion under the field edge tree canopy.

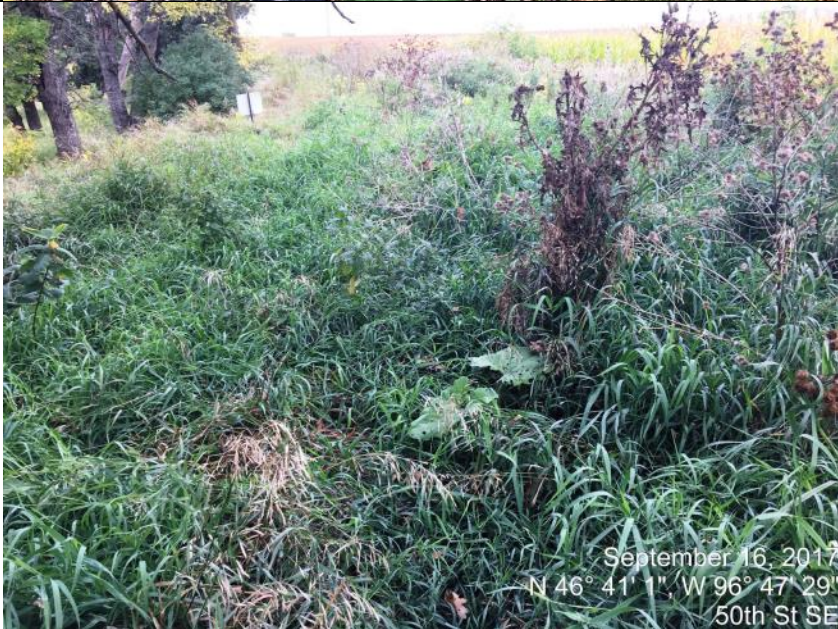
Photo 21

Open areas had grass growth over the fabric and green ash.

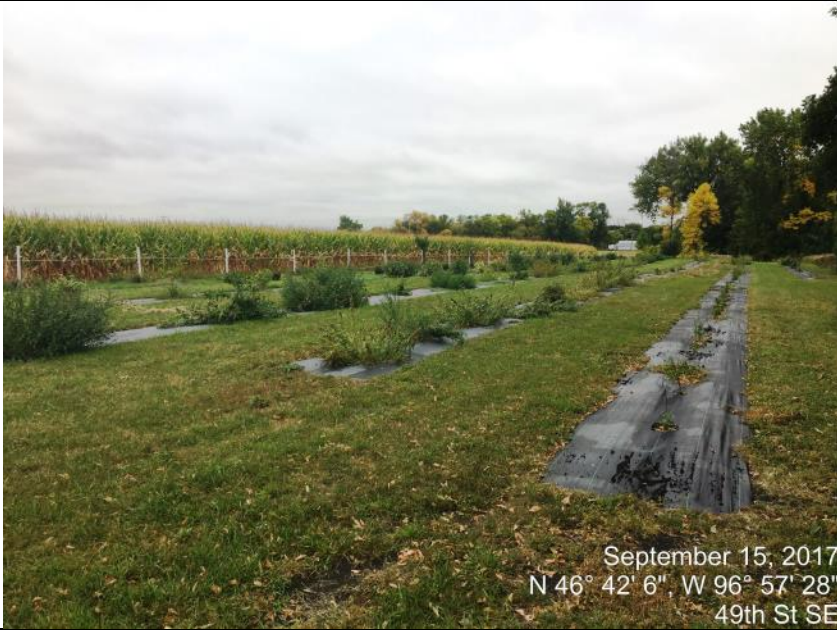
Photo 22

Field 1 looking north, rows well maintained, but had some areas of high weed pressure in with the trees in the fabric.

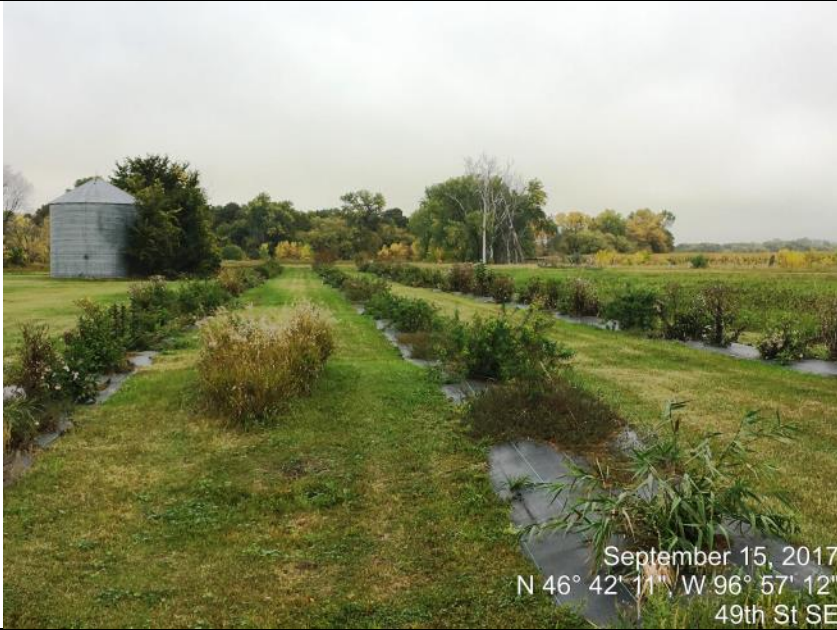
Photo 25

Site overview looking north. Rows are mowed between, but no maintenance has been done around the planted trees.

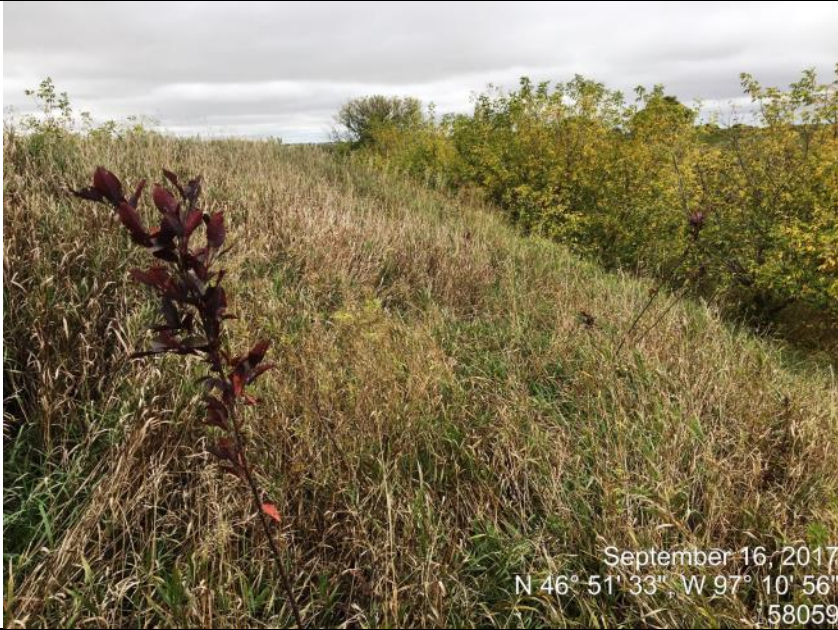
Photo 28

Two surviving amour chokecherry.

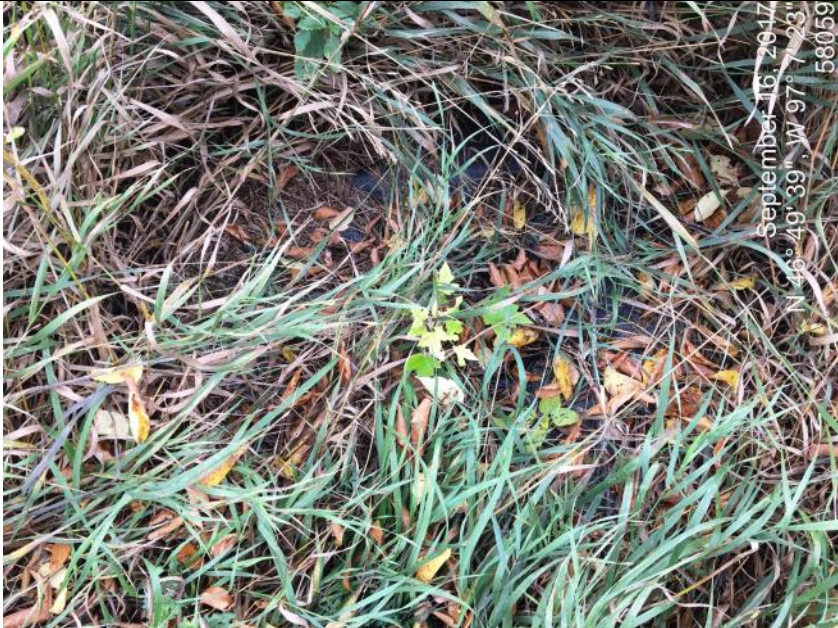
Photo 29

All silver maple observed growing in 2017 were new sprouts from the roots with the original stem missing.

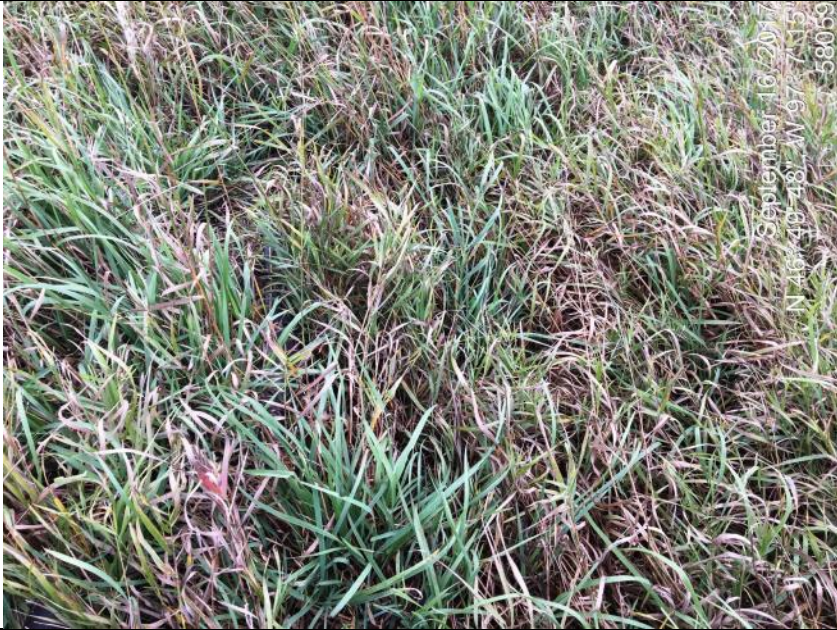
Photo 31

Fabric square covered with grass.

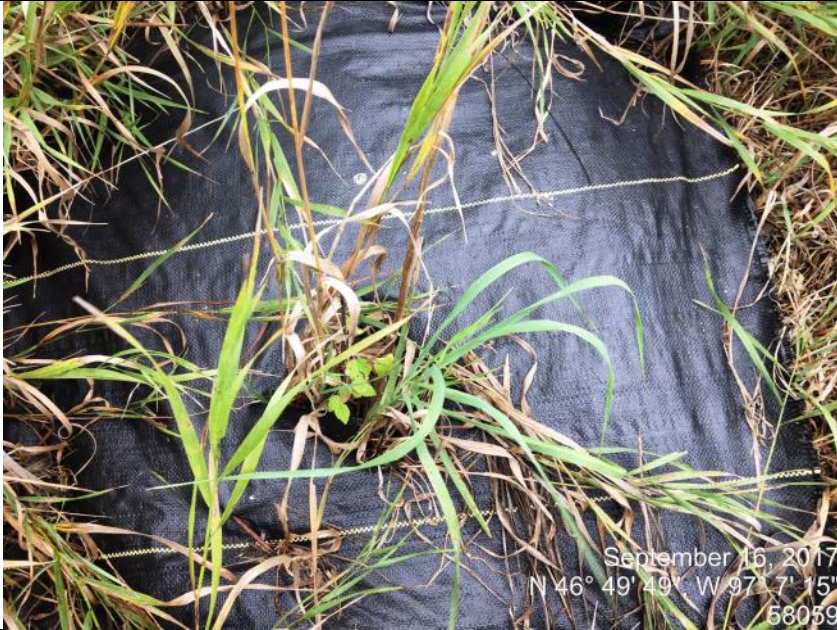
Photo 32

Extremely small silver maple observed.

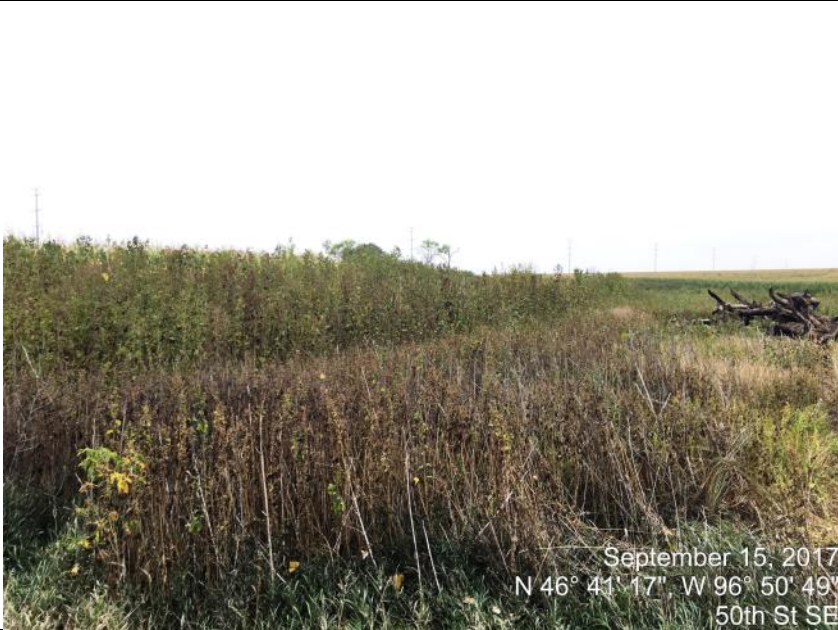
Photo 38

Site over view looking southwest. Heavy weed pressure in and between the rows.

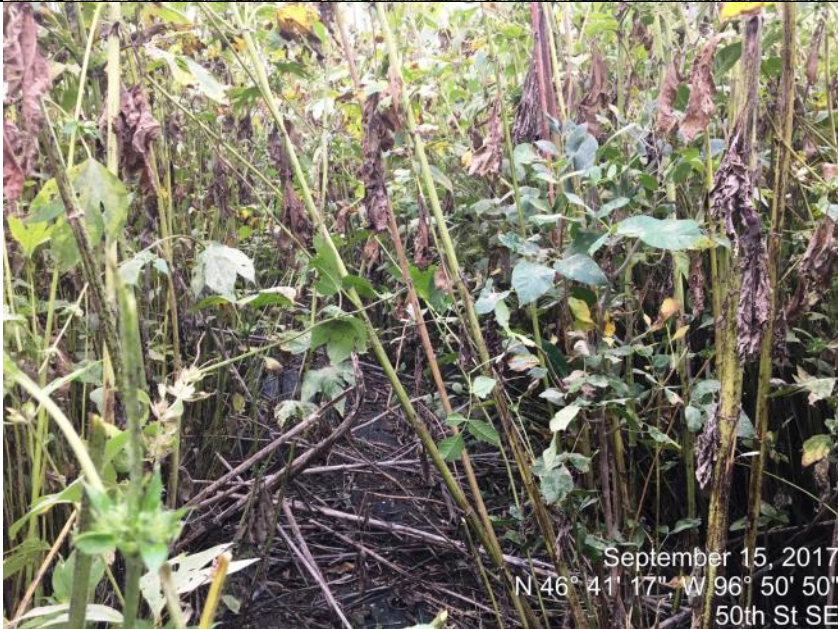
Photo 39

Green ash tree growing under the giant ragweed canopy with giant ragweed surrounding it in the fabric.

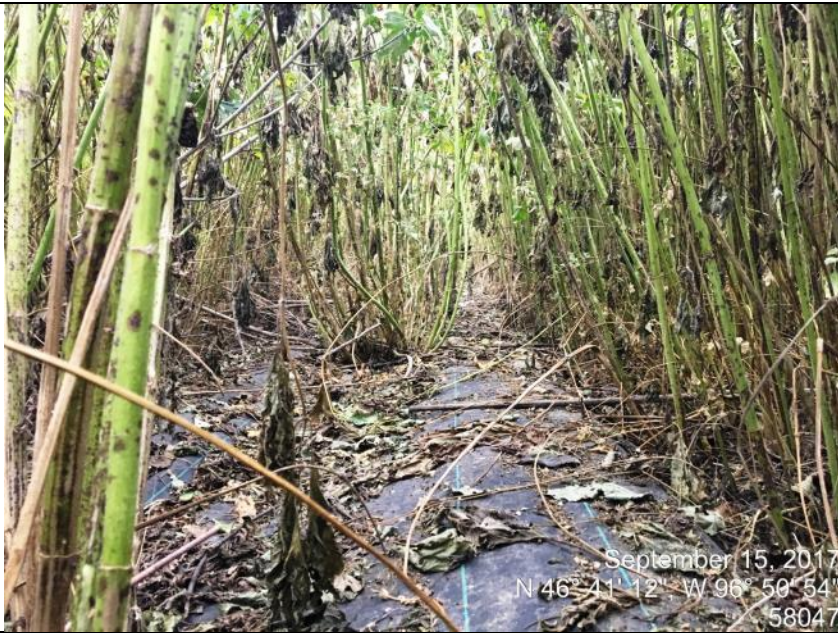
Photo 37

Typical giant ragweed growth in the rows.

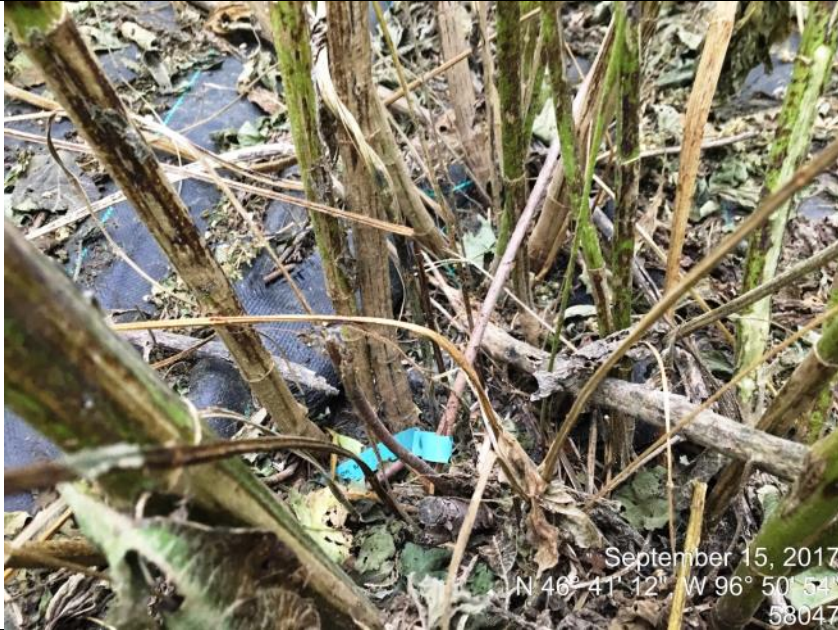
Photo 38

Dead sandbar willow stem, very few surviving willows observed.

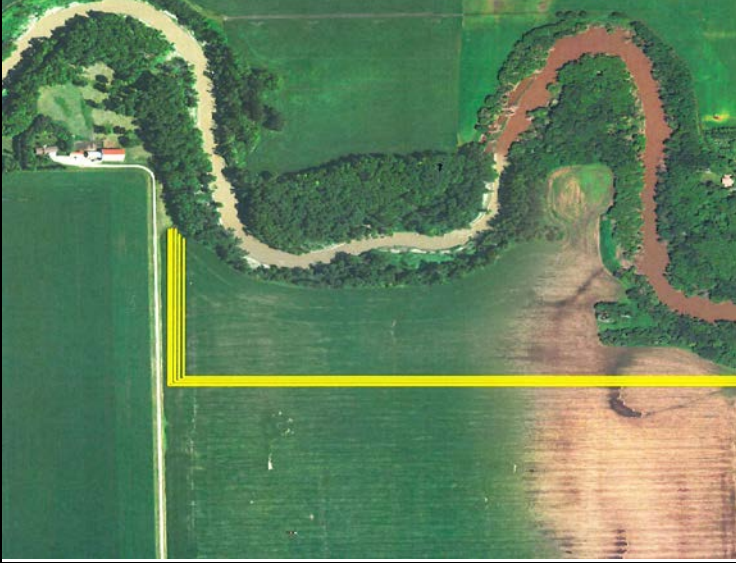
Additional Comments
 Heavy weed pressure on the eastern end of the rows rows. Very few spruce trees were found dead. Fabric held up well, weeds were found covering the fabric on the eastern half of the plot similar to 2016. Landowner tilled between the rows, but did not remove weeds from around the trees in the fabric. Tree growth on the eastern portion of the plot (the brown area on the map above) was stunted.

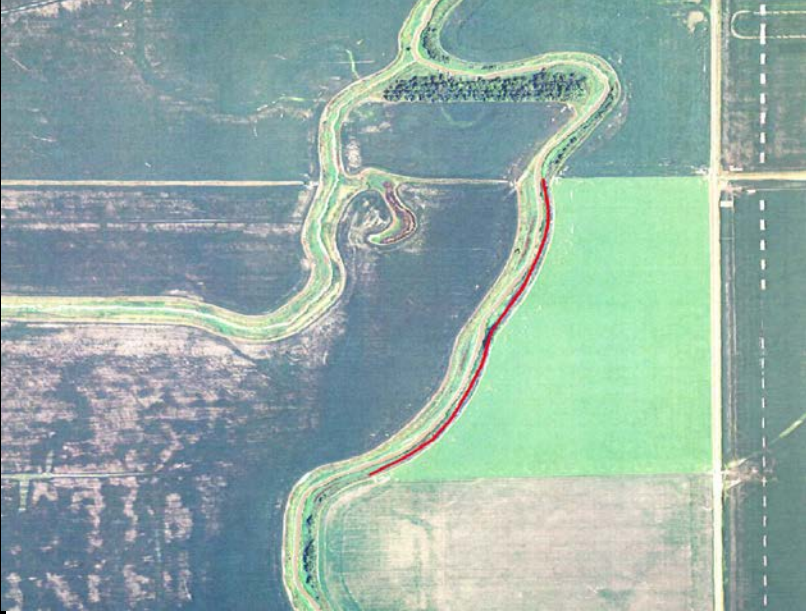
Extremely high pressure from plant competition with the tree stem missing the vast majority of fabric squares.
 One choke cherry that was counted as dead in 2016 year had leaves this year.
