Ashtabula III Wind Energy Center Post-Construction Inspection Report PU-10-147

Prepared for:

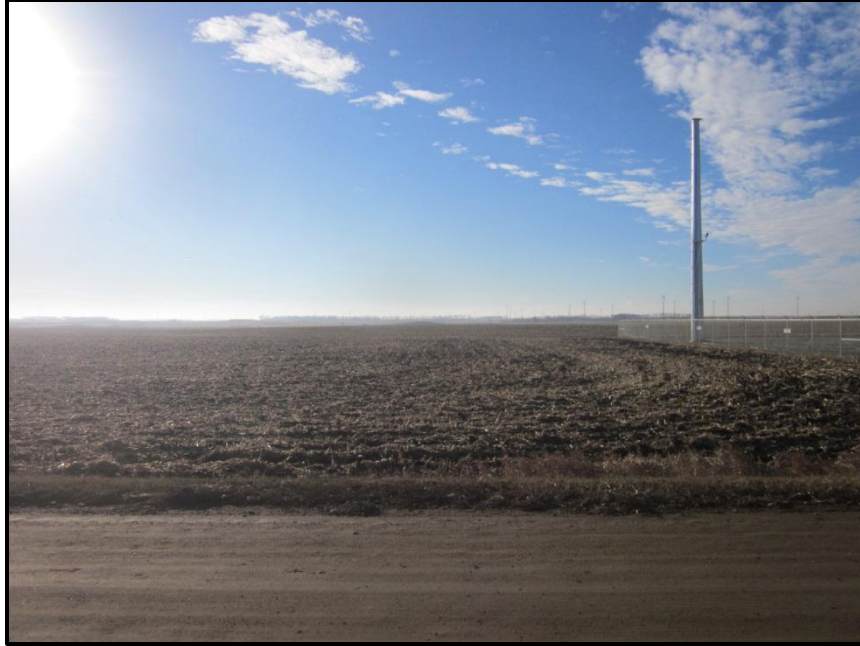
Photo 1. Direction: South. View of reclaimed staging/laydown area to the east of the new substation for Ashtabula III. This area is across the road from the existing O&M building and Ashtabula I substation, located in the southwest corner of Section 10, T142N, R57W. The cropland appeared to be in good condition with no concerns.

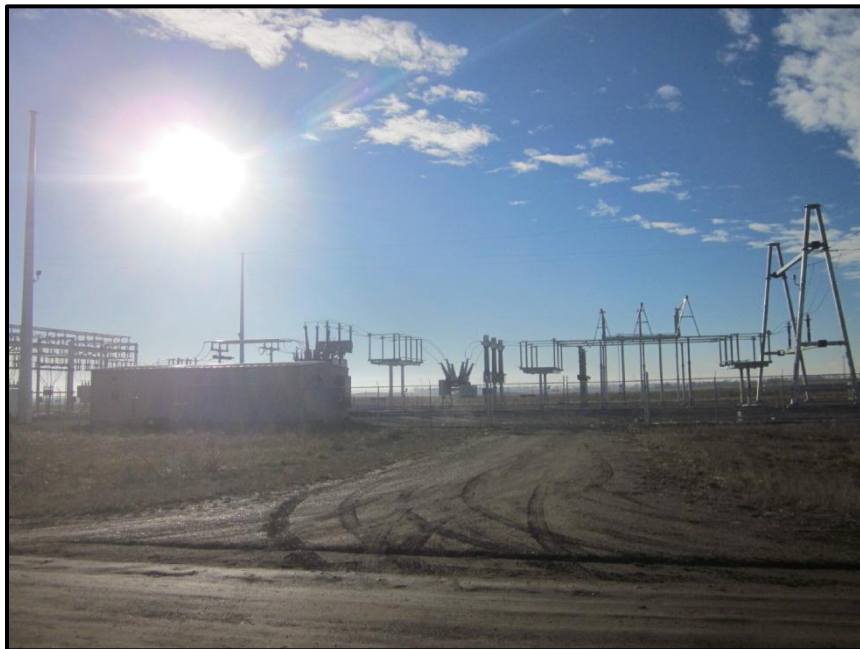
Photo 2. Direction: South/Southeast. New substation built for Ashtabula III.

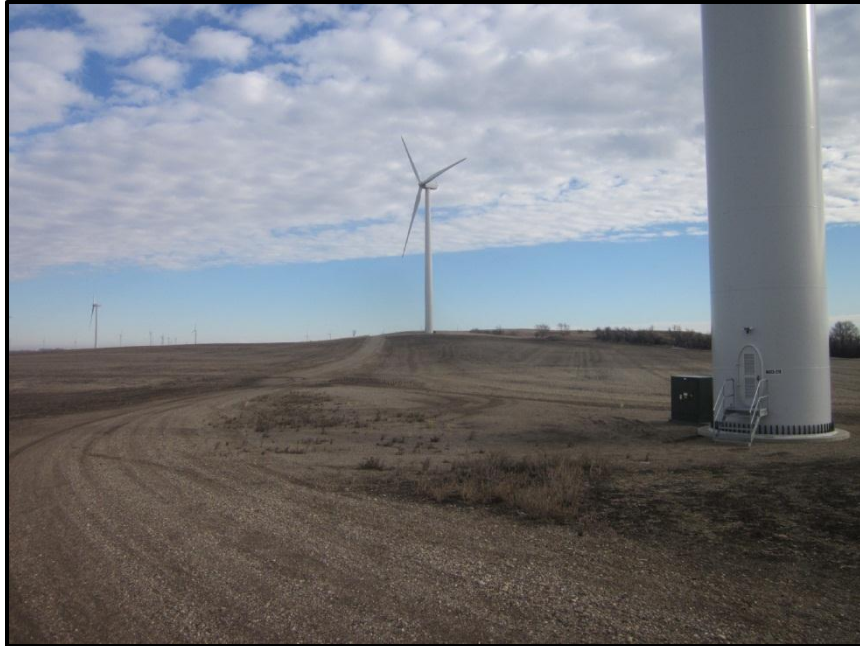
Photo 7. Direction: Northeast. View of the access road from the base of Turbine 278 to Turbine 279 in the distance. Cropland adjacent to the road and turbines was in good condition and had been satisfactorily reclaimed. There were small patches of annual weeds on the gravel pads at the turbine bases.

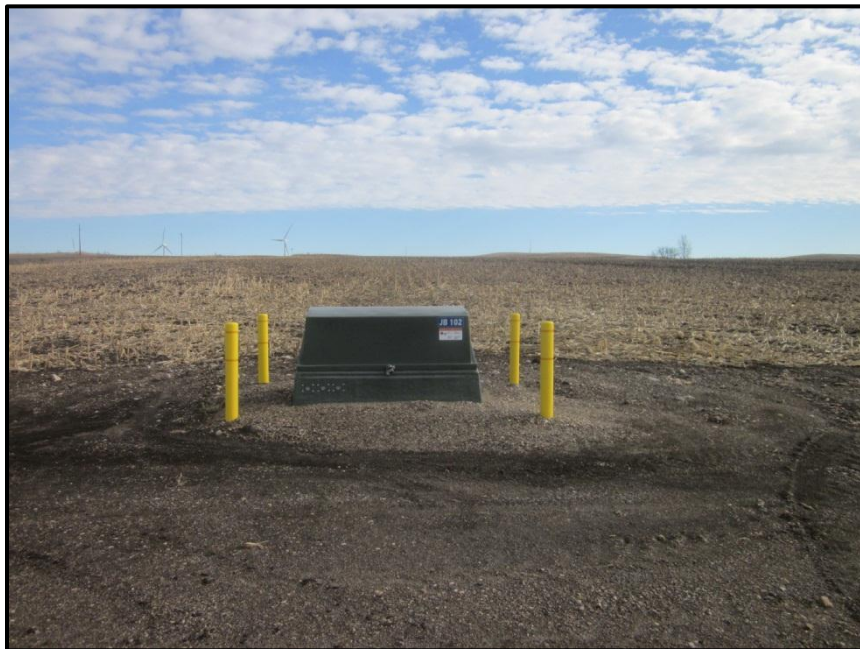
Photo 8. Direction: East. Junction box JB102 along 21st St SE showing typical conditions. Cement bollards and gravel were in place around the box with no indication of erosion or weeds. Safety warning signs were in place.

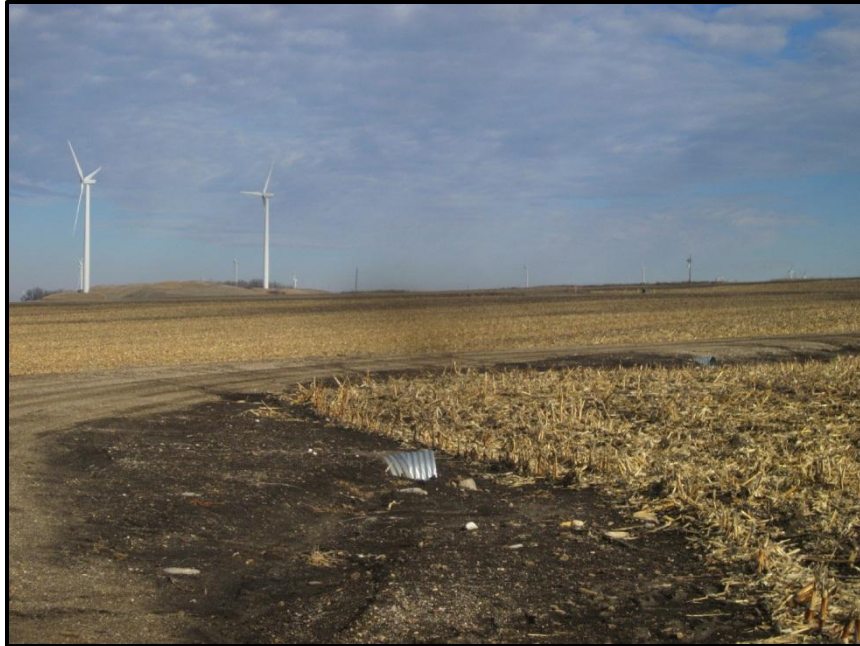
Photo 9. Direction: Northeast. The access road between Turbines 280 and 281, showing culverts installed to allow natural drainage within the cropland. There were no erosion or sedimentation concerns.

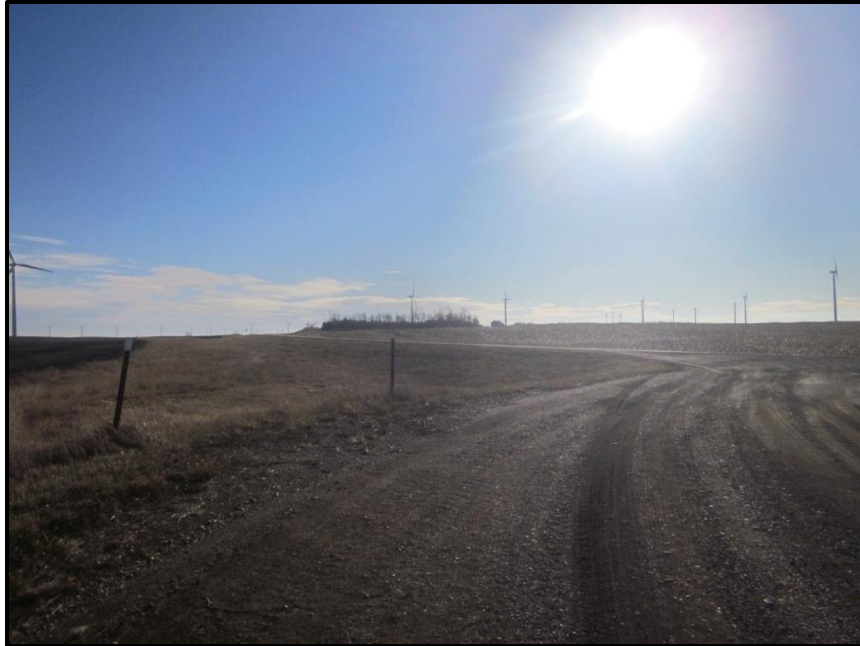
Photo 15. Direction: South/Southwest. Intersection of 122nd Ave SE with State Highway 26. This approach had been widened during the construction phase to accommodate the hauling of turbine sections. It had since been reclaimed back to its original width and was in good condition.

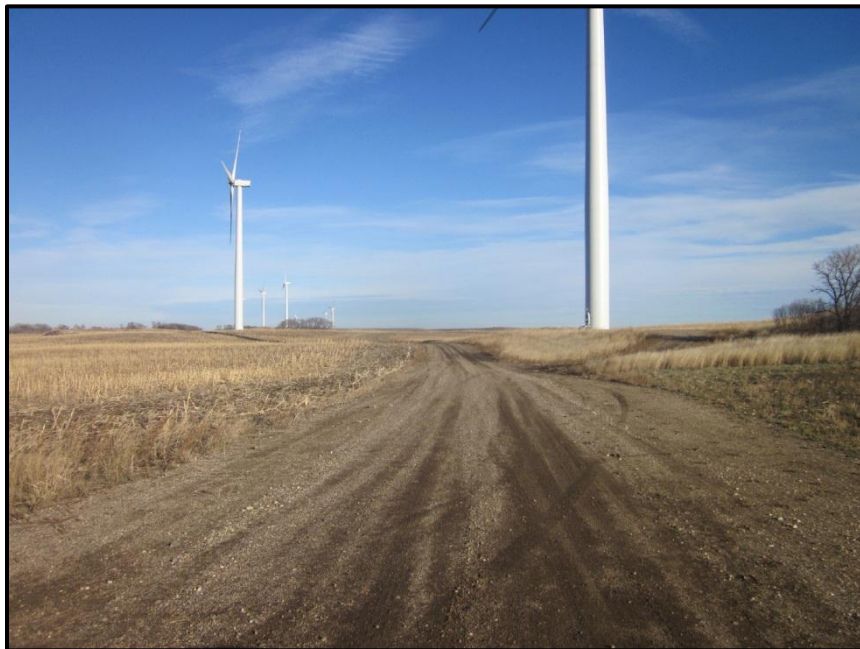
Photo 16. Direction: Northeast. Access road entrance to Turbines 246-247. Proper signs were in place. Cropland, roads, and towers were in good condition. The road near Turbine 247 in the distance had been adjusted to avoid a wetland basin.

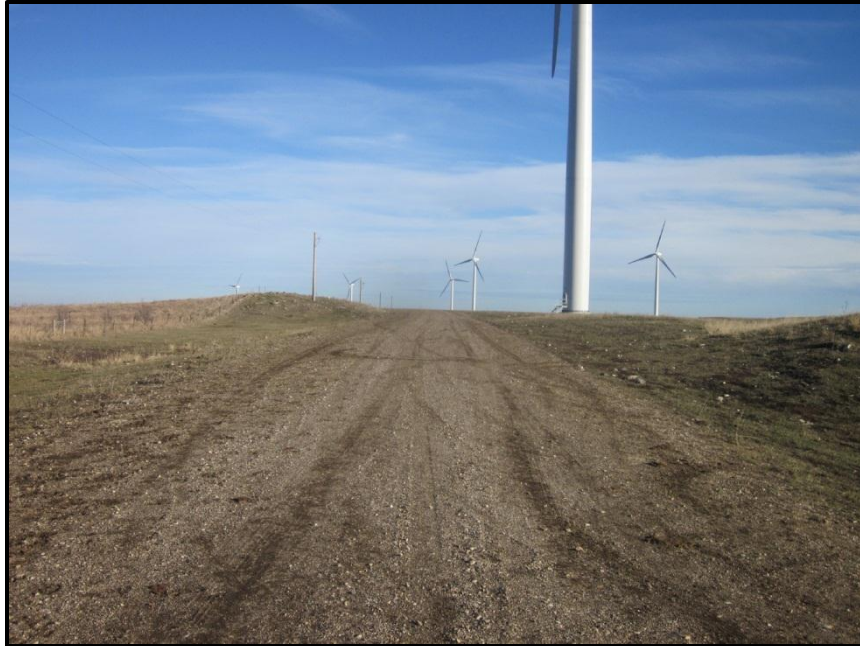
Photo 17. Direction: East. Access road entrance to Turbines 248-250. The edges of the road had been reclaimed but the dense growth of seeded grasses typical of other areas was not present here. This could have been due to the heavy grazing in this pasture.
