**RE: Tree and Shrub Survival Report for ND PSC Case No. PU-10-630 (Plains All American Pipeline, L.P. Bakken North Pipeline)**

## Tree and Shrub Survival Report for the Bakken North Pipeline Project, Williams County, North Dakota

ND PSC Case No. PU-10-630

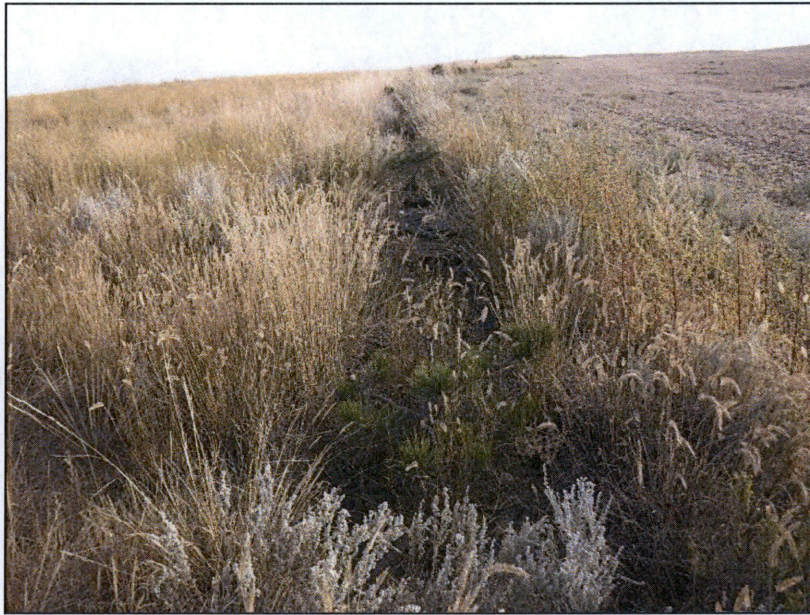
The plantings for each landowner were revisited August 30, 2016. Replanted trees were in fair to poor condition with damage noted from deer and other wildlife. Additionally, the fabric weed barrier was often damaged or overgrown with vegetation making it difficult to observe some of the smaller tree and shrub plants (Figures 1 and 2). Conifer and shrub species fared better than large deciduous species. 100% of the green ash (*Fraxinus pennsylvanica*) trees observed were counted as dead. There was no foliage observed and branches were dry and brittle with peeling bark. Transplant shock or possible herbicide damage are possible contributing factors. Trees or shrubs which had any portion of living plant material were considered alive. Of the 1,031 trees that were replanted in the fall of 2014 and spring of 2015, 329 were alive during the August survey (Appendix A). Since the number of trees originally planted greatly exceeded the 2:1 planting requirement, the current survival rate is above the required 75% (294 trees) at 84%.

**Figure 1. Ponderosa pine row located on Bradley and Marilyn Olson property, facing north (photo taken August 30, 2016).**

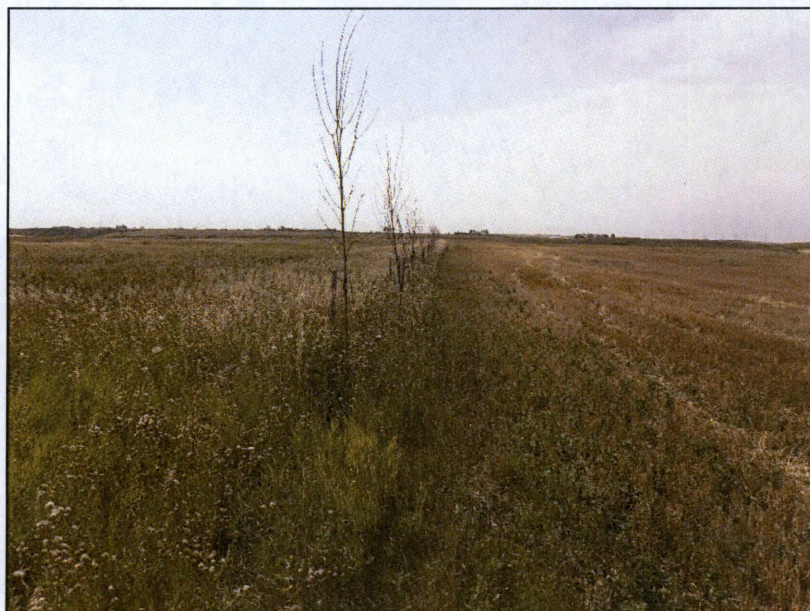
**Figure 2. Green ash row located on Bradley and Marilyn Olson property, facing west (photo taken August 30, 2016).**
