Vantage Pipeline US LP Weekly Report for the week ending August 24, 2013

Case Number PU-11-109

PSC Weekly Report

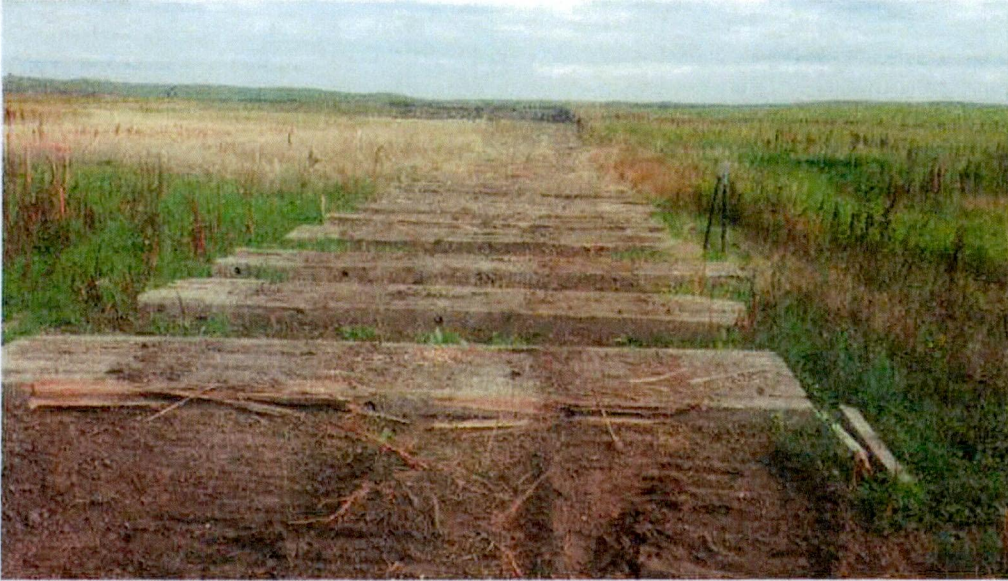
August 20 - matting places at wetland crossing in bore location at MP25.59.

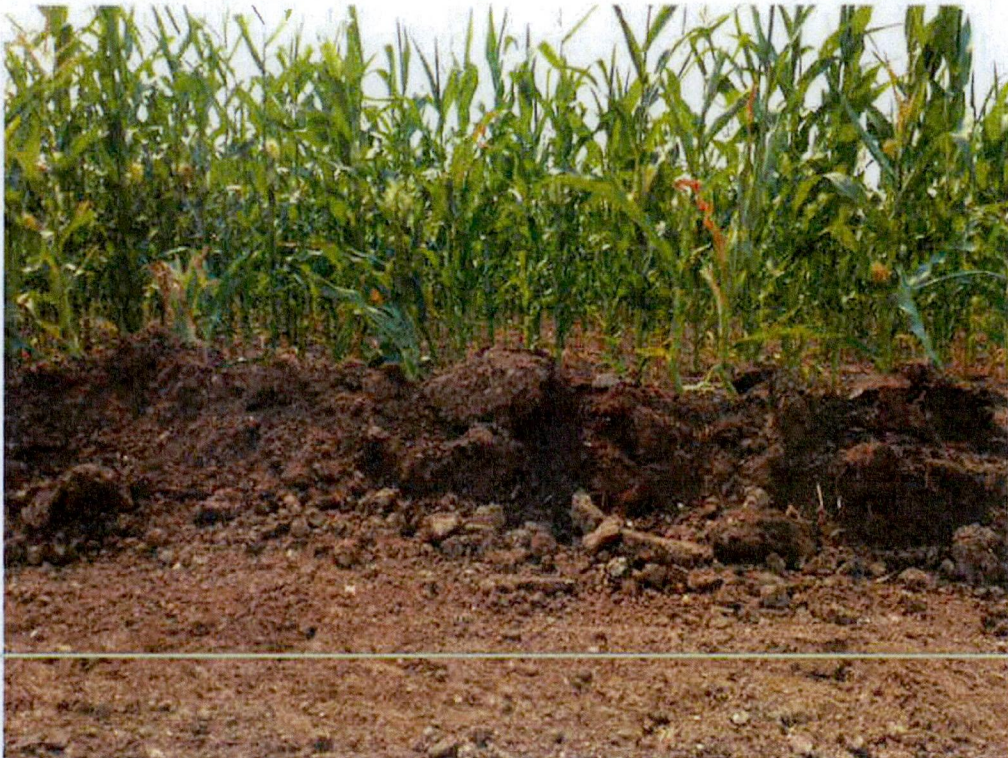
August 17 - Topsoil stripping at MP10.83 in corn field.

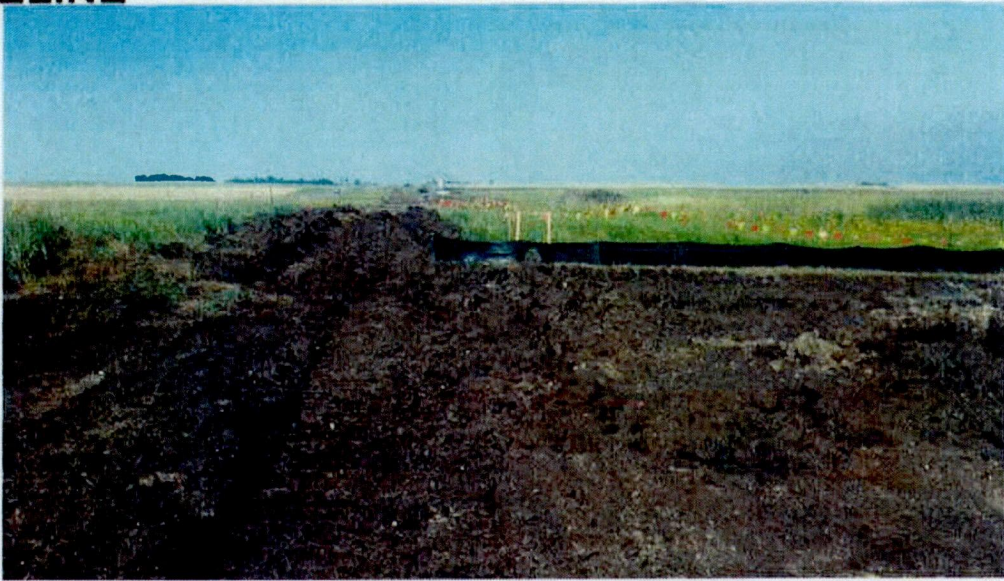
August 21 - Soft soils encountered adjacent to wetland where matting is needed.

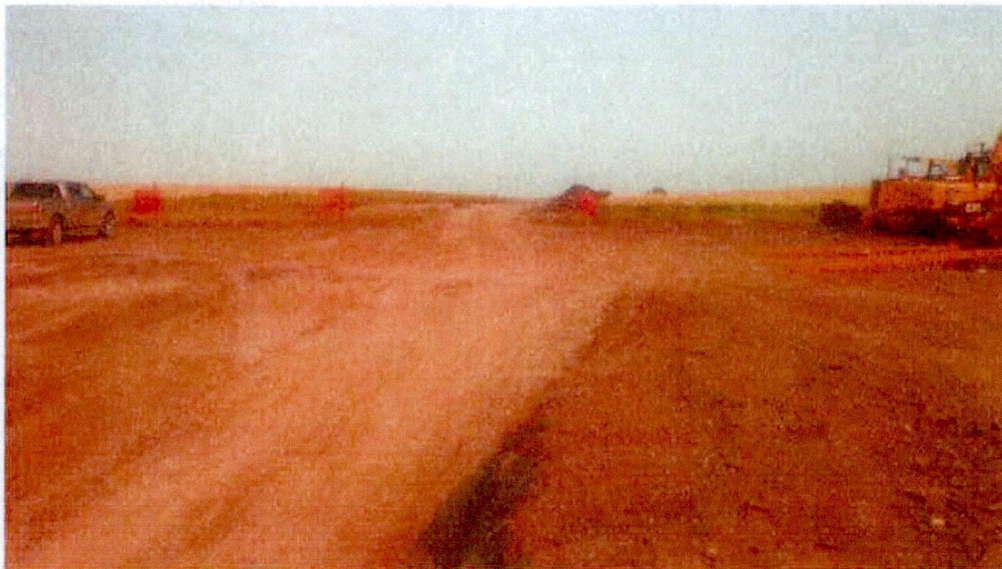
Photo 1 – Grading and stripping at startup 14+72 looking north.

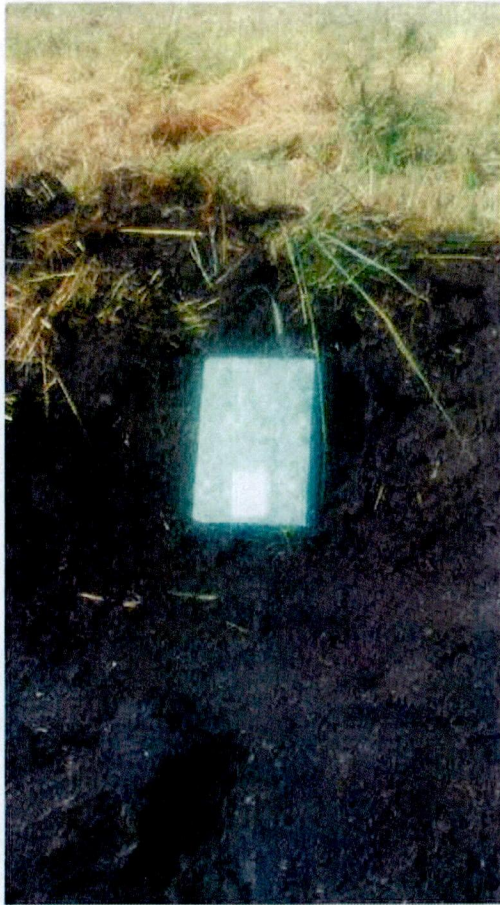
Photo 2 – Top soil stripping approximately 12 inches.

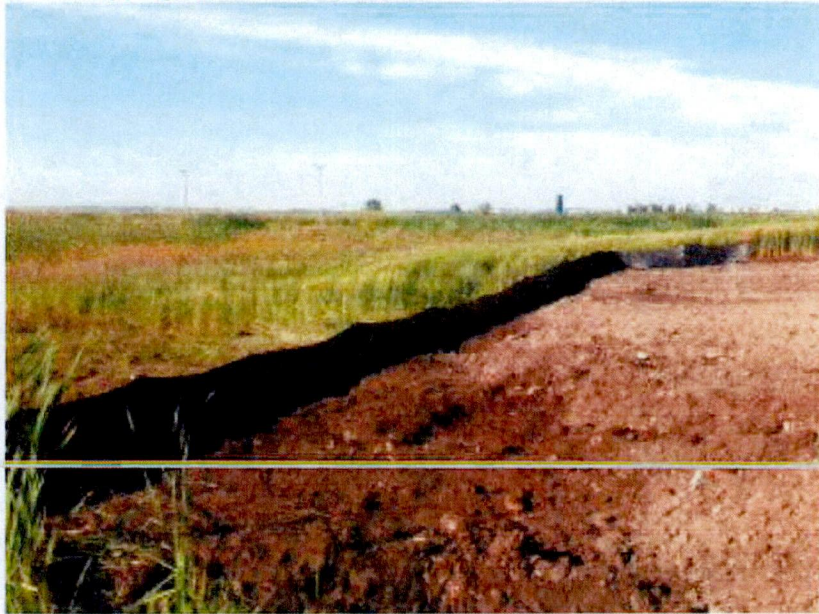
Photo 3 - Silt fence installation along adjacent wetland area.

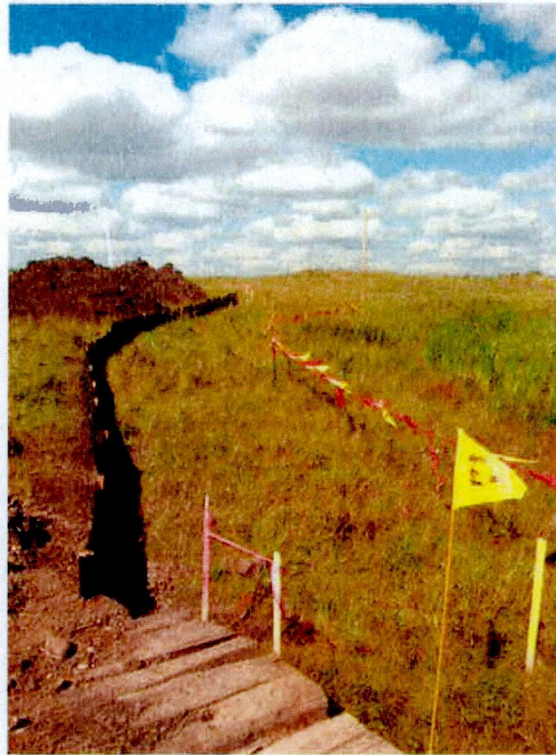
Photo 4 – Silt fence tie in to timber matting.
