PSC Weekly Report

Vantage Pipeline US LP Weekly Report for the week ending November 9, 2013

Case Number PU-11-109

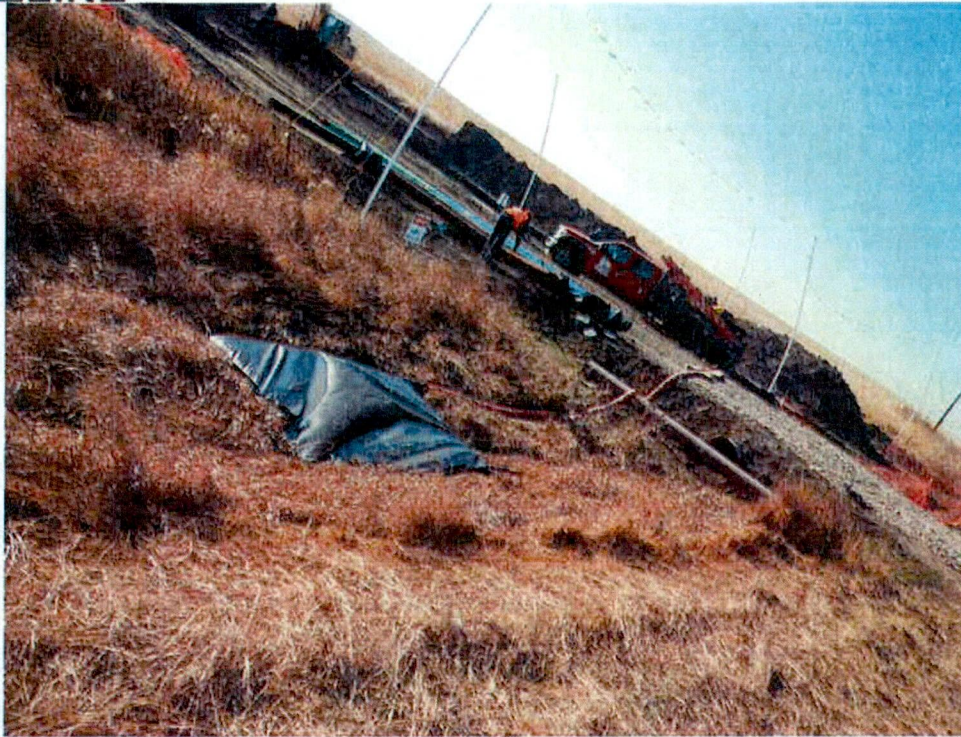
Storm water from past precipitation events continues to be removed from boring pits, trenches, and within low spots along the ROW. Water is being removed by pumping water into sediment bags that are placed in heavily vegetated areas for water dispersion and in some cases placed behind an existing silt fence where space is limited. Michel's environmental crew is systematically addressing details of any required maintenance noted during stormwater inspections.

Stormwater dewatering activities from tie-in excavation along ROW.

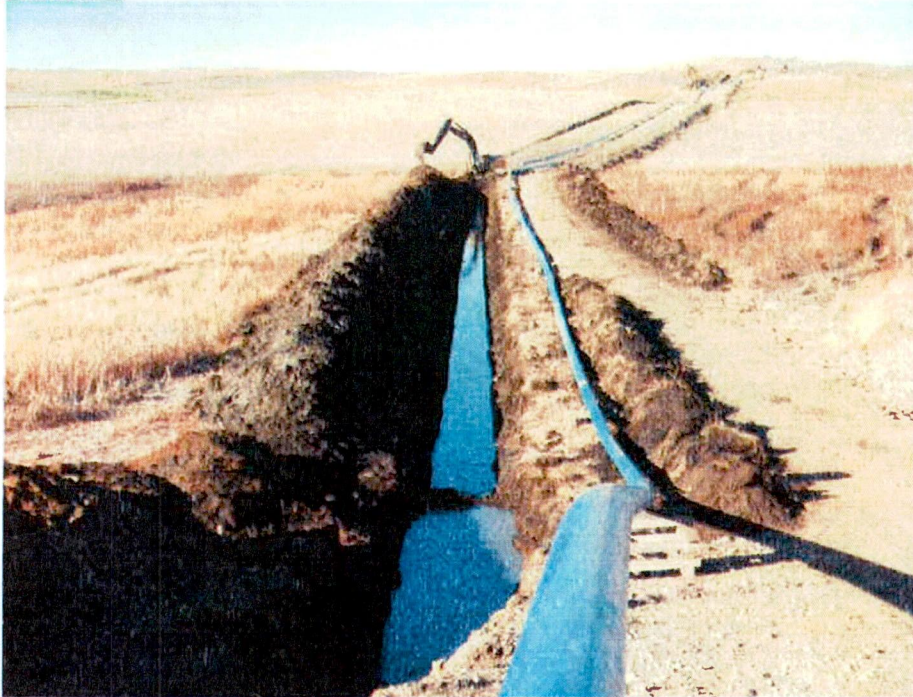
Trenching activities through wetland area at MP 65.65.

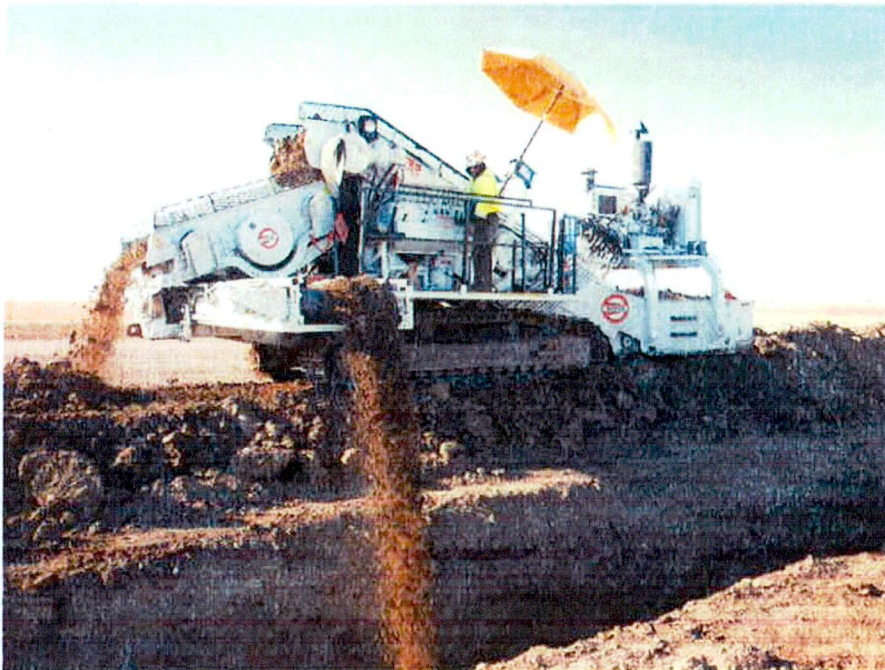
Padding/backfilling along ROW near MP 61.

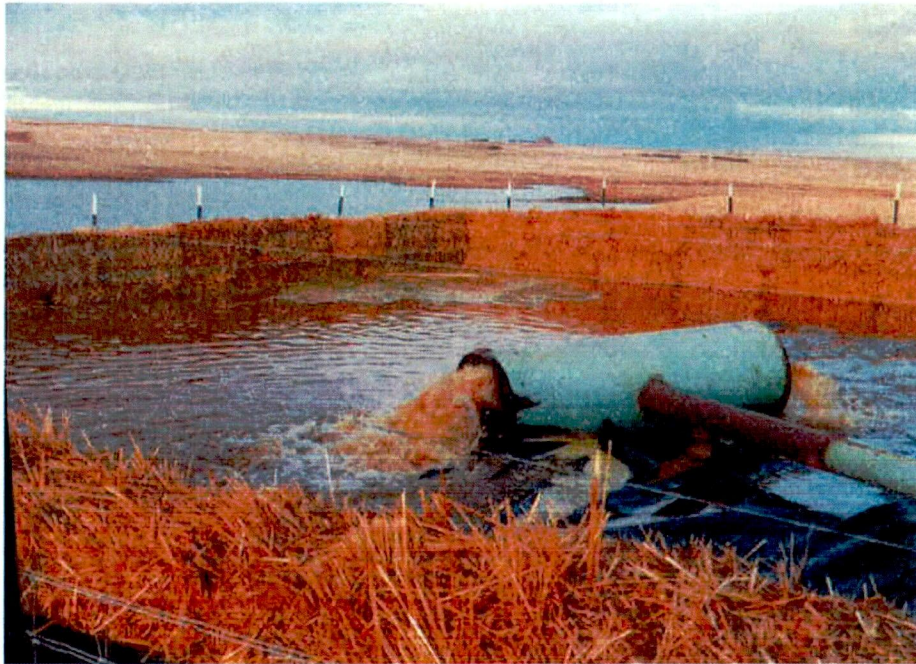
Hydrostatic testing discharge to the energy dissipation dewatering structure.
