-Info-Public Service Commission

Good afternoon Patrick. Attached is the latest field inspection report for the ONEOK Garden Creek II & III project that we completed earlier this fall.

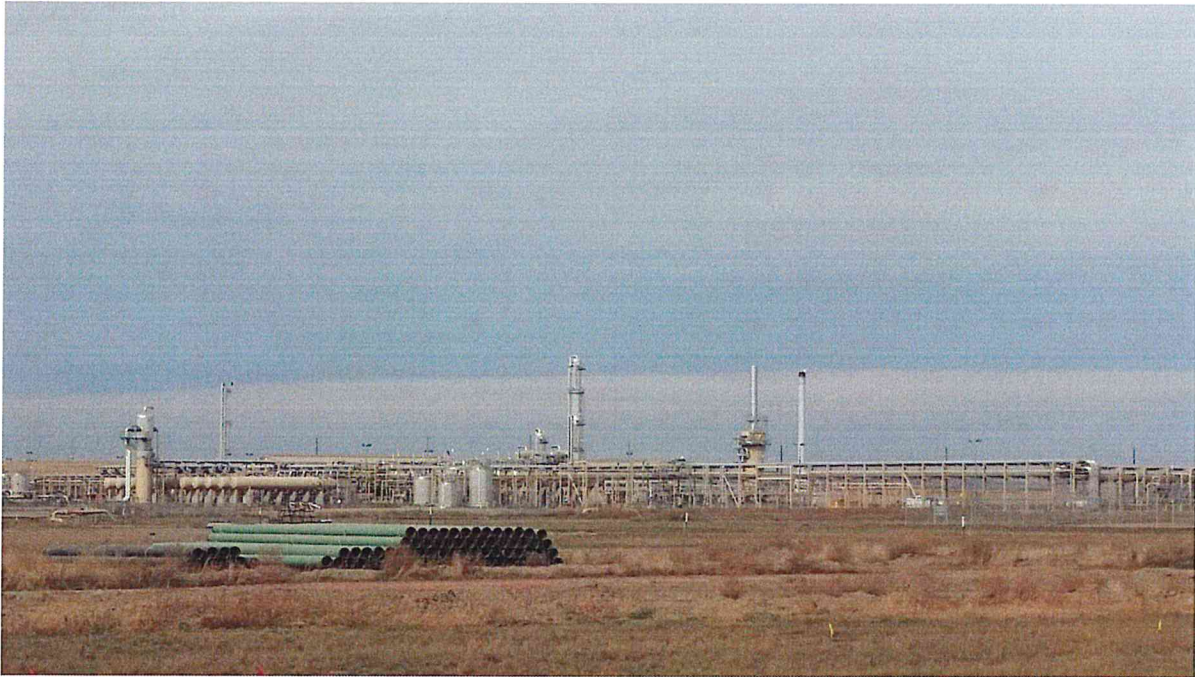
Figure 1. View from the southeast corner of GC III looking northwest
