# 250kV DC Transmission Line Reroute Post-Construction Inspection Report PU-14-121

*Prepared for:*  
**North Dakota Public Service  
Commission**

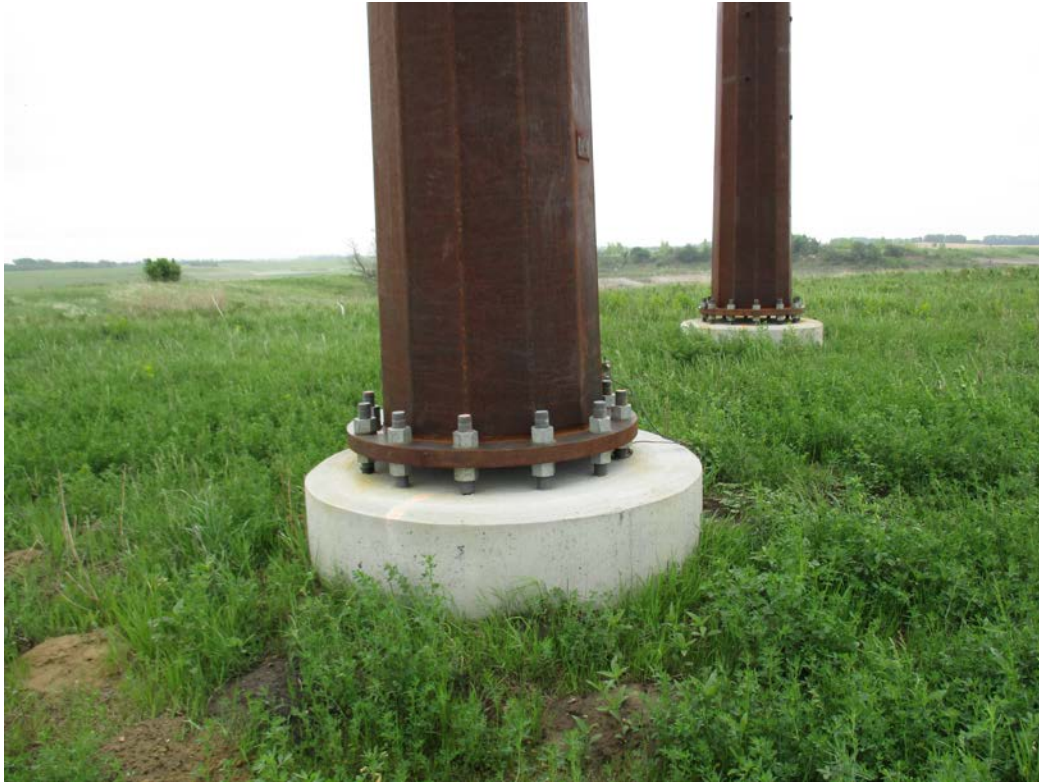
**Above: Photo 3 (Structure 1391, Point 426) – Structure bases with vegetation around bases and some small soil mounds, shown on the left side of photo.**

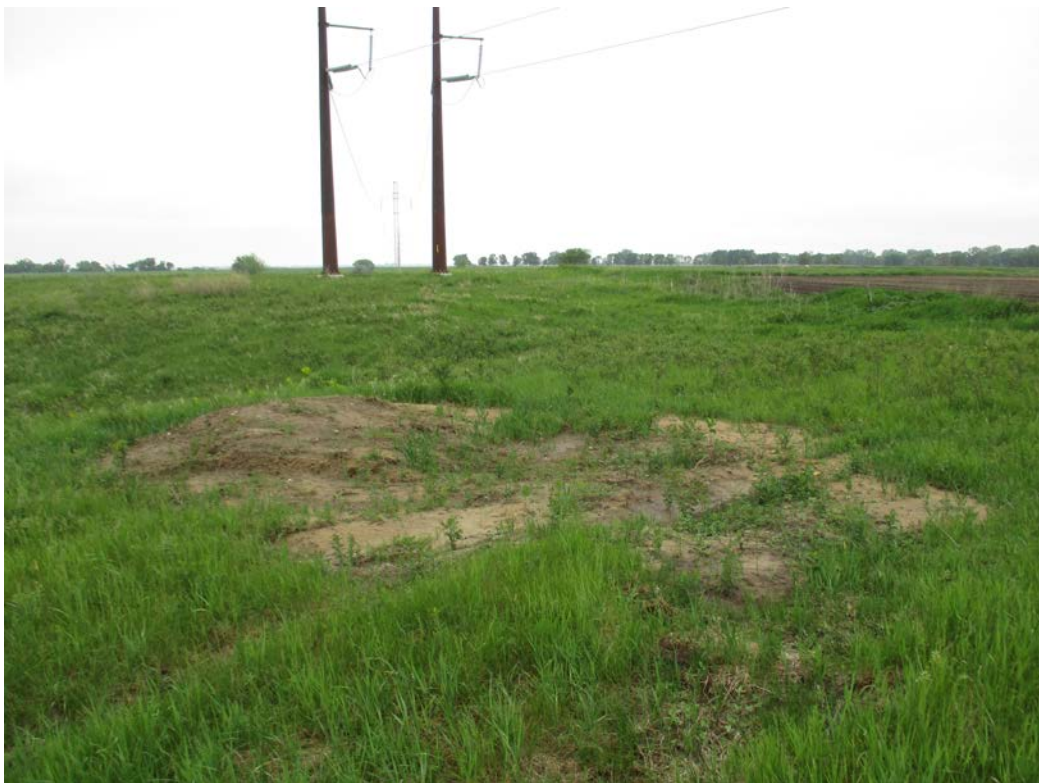
**Below: Photo 4 (Point 427) – Disturbed soil pile with little vegetation, appears to be from previous transmission line structure, on west end of reroute. The new transmission line structure is observed behind disturbed area. Looking west.**

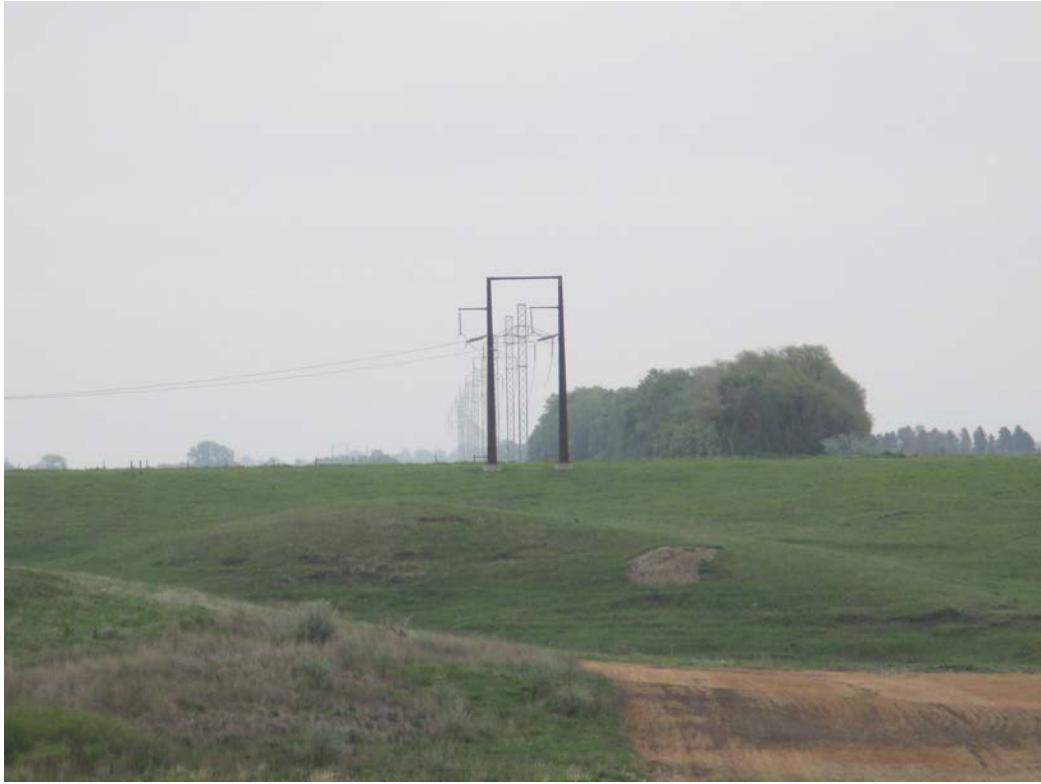
**Above: Photo 5 (Near structure 1395) – Disturbed soil area on east end of reroute. Observe the new structure and previous transmission line structures behind disturbed area. Unknown if soil disturbance is from old structure or something else. Looking east.**

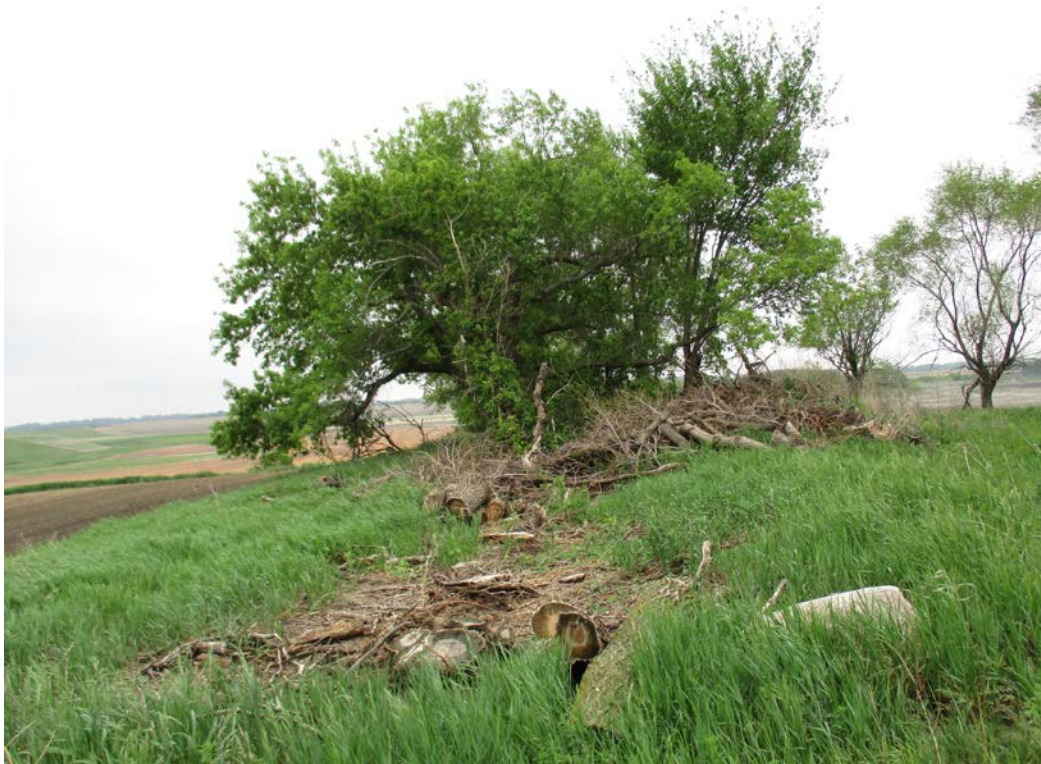
**Below: Photo 10 (Structure 455) – Trees and shrubs were cut down in the tree row, assumed for transmission line reroute work.**

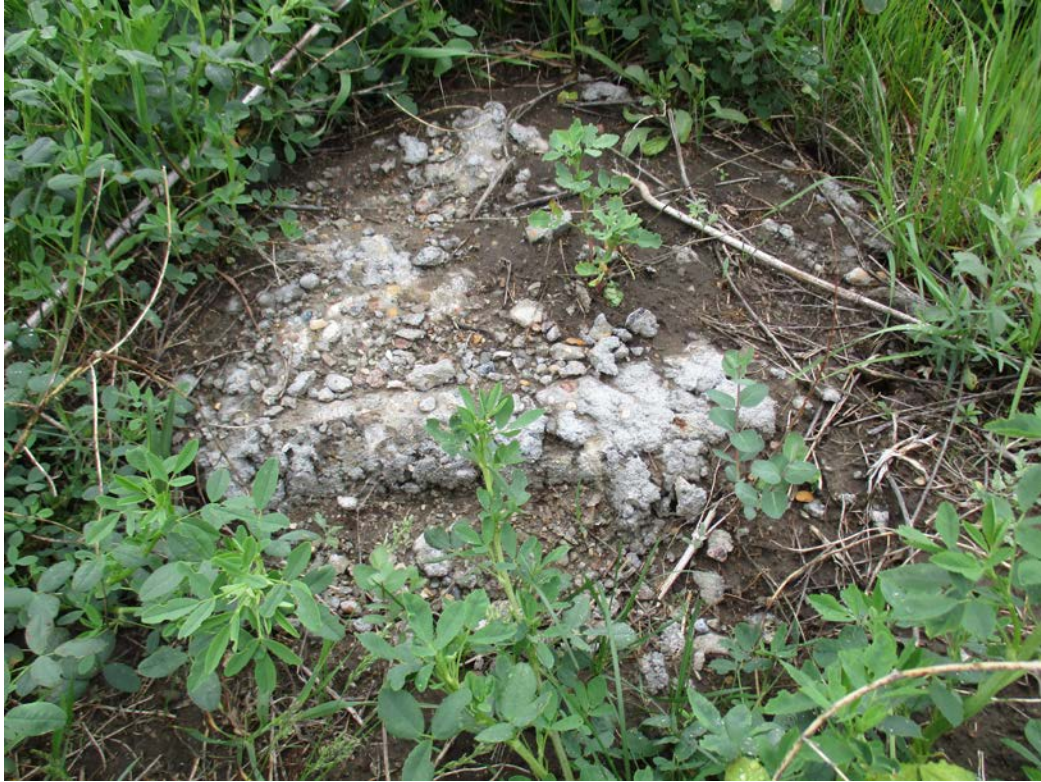
**Above: Photo 11 (Structure 1391B, Point 429) – Small amount of concrete waste observed slightly uphill of structure.**

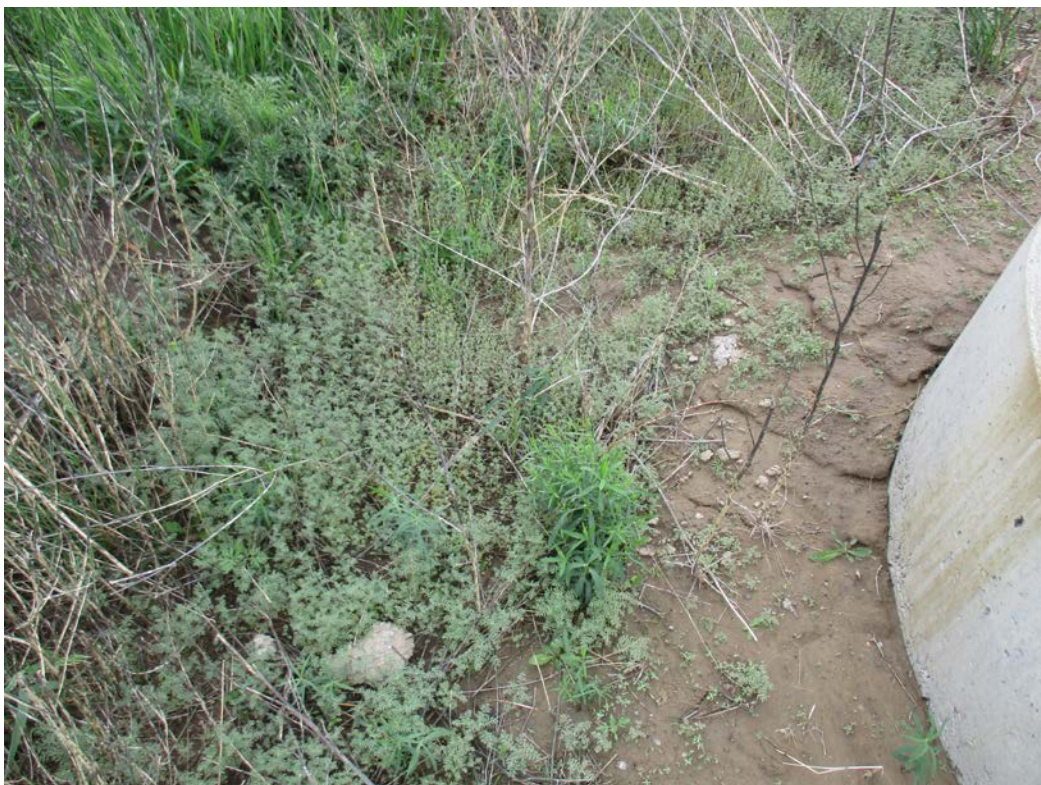
**Below: Photo 12 (Structure 1391D Point 431) – Observe small chunks of concrete waste and small flow paths forming around structure base.**
