TARGA BADLANDS LLC NEW TOWN TO STANLEY PIPELINE: TREE AND SHRUB SURVIVAL REPORT 2017

MOUNTRAIL COUNTY, NORTH DAKOTA

NDPSC Case Number: PU-14-625

September 27, 2017

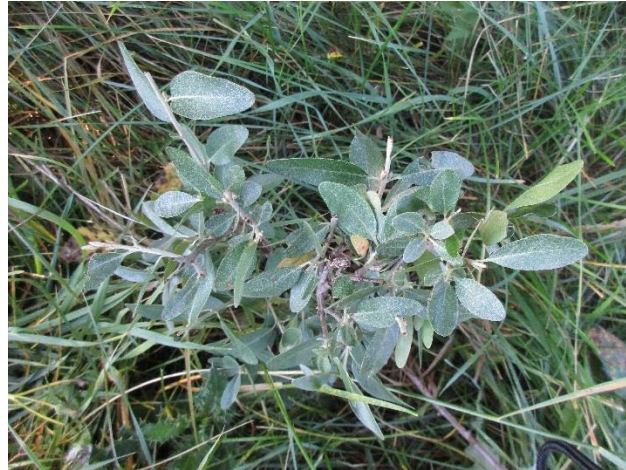
PHOTO 1

View of evidence of livestock grazing on silver buffaloberry planting at North Dakota Game and Fish location. Broken leaves and stems were apparent throughout the plant. One silver buffaloberry planting out of four was located.

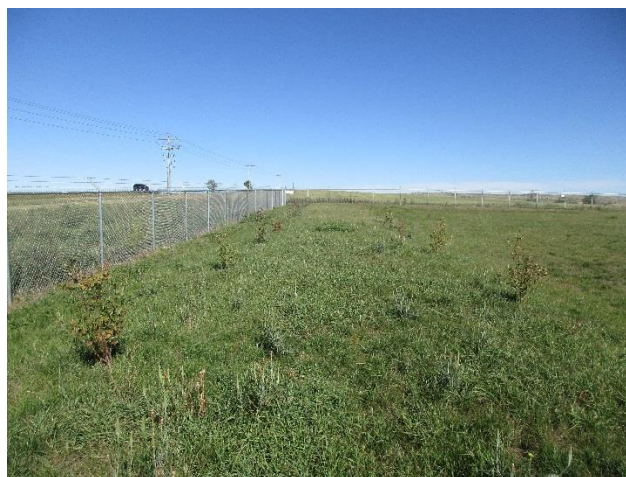
PHOTO 3

View of downy hawthorn planting at Targa Resources location. Plants averaged three feet in height, all plantings were alive at the time of Golder's assessment.

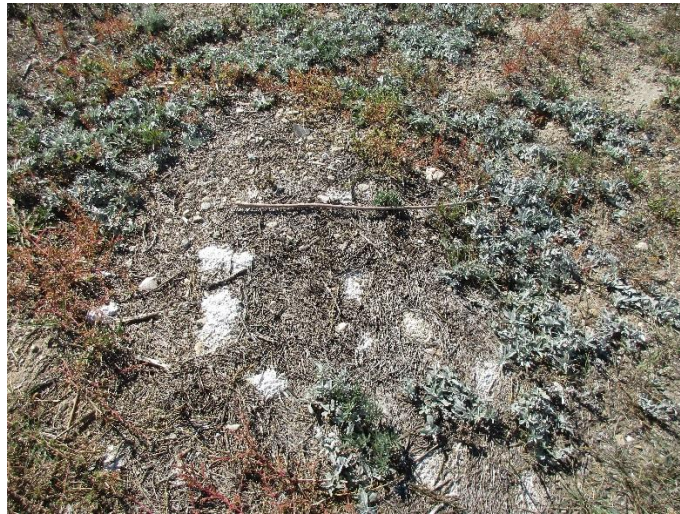
PHOTO 4

Two green ash (*Fraxinus pennsylvanica*) plantings were recorded as dead during Golder's survey efforts. Mortality of one green ash at the New Town location is attributed to damage during snow removal efforts as the stem was broken at the base. Mortality of one green ash tree at the Lahtinen residence is assumed to be due to natural causes, as no indicators of mechanical damage or grazing were observed.

View of a dead green ash planting at the City of New Town location. Green ash likely damaged during snow removal.

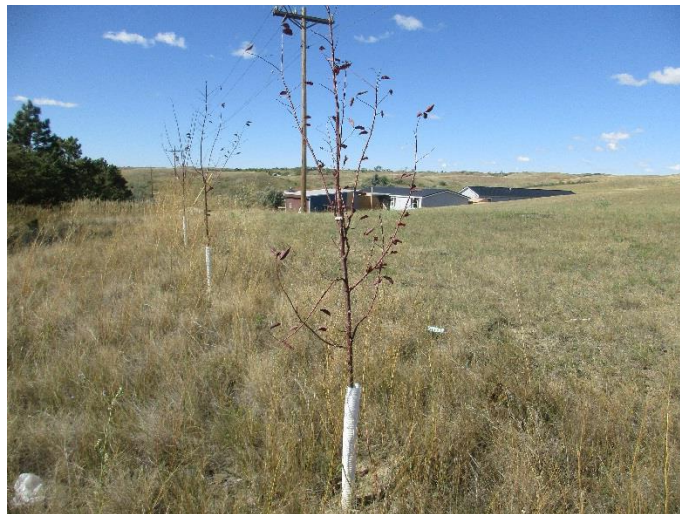
PHOTO 5

Moe property. At the Moe property 36 of the 37 chokecherry plantings were located and alive. No evidence of tree planting or removal was noted at the location of the missing Canada red chokecherry tree.

View of canada red chokecherry plantings at Moe residence. Thirty-six of 37 plantings were located and classified as alive. No evidence of damage around planting locations was recorded.

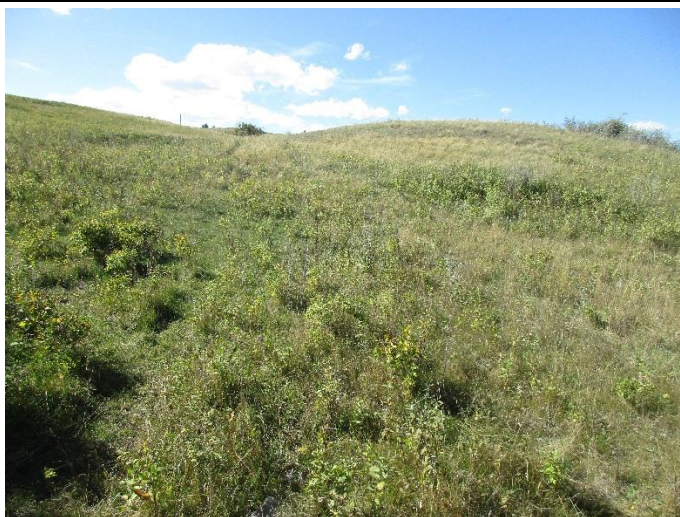
PHOTO 6

View of silver buffaloberry plantings on Littlefield property. Four of nine plantings located and classified as alive. Cattle activity around planting location makes grazing a likely cause of silver buffaloberry mortality.

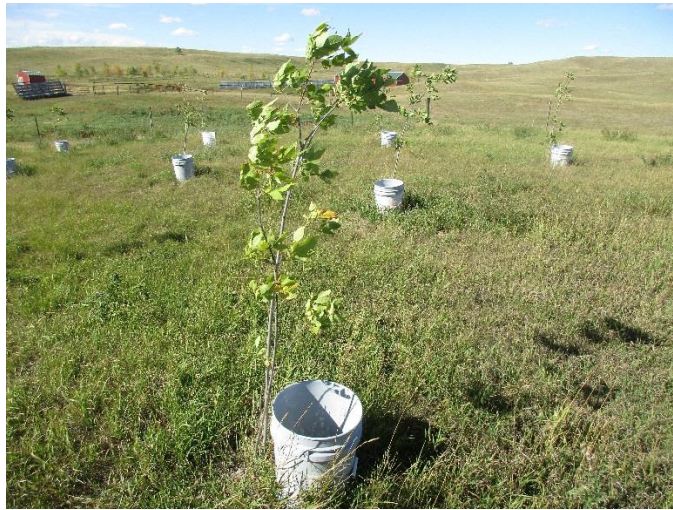
PHOTO 7

View of green ash plantings at Locken residence. Five-gallon buckets are used by the Lockens to collect rain water. A Locken family member told Golder that he watered each planting throughout summer.

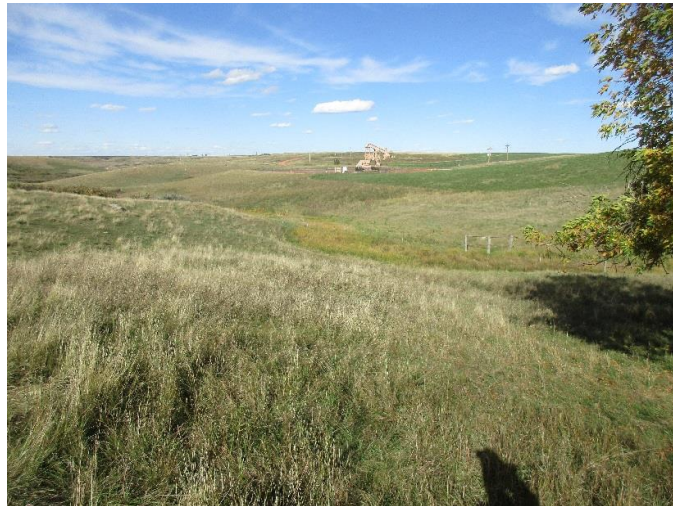
PHOTO 8

View of Ness property where 15 silver buffaloberry shrubs were planted. None of the plantings were located during Golder's assessment. Evidence of cattle activity on the property makes grazing a likely cause of silver buffaloberry mortality.

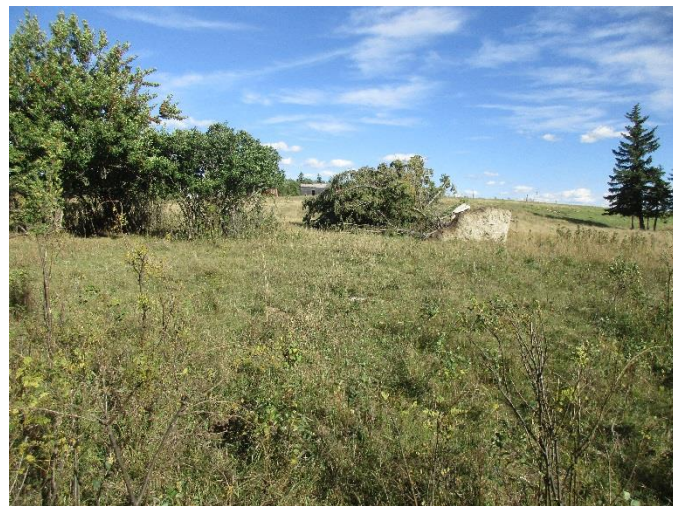
PHOTO 9

View of silver buffaloberry plantings on Lahti location. None of the plantings were located. Evidence of cattle activity on the property makes grazing a likely cause of silver buffaloberry mortality at this location.

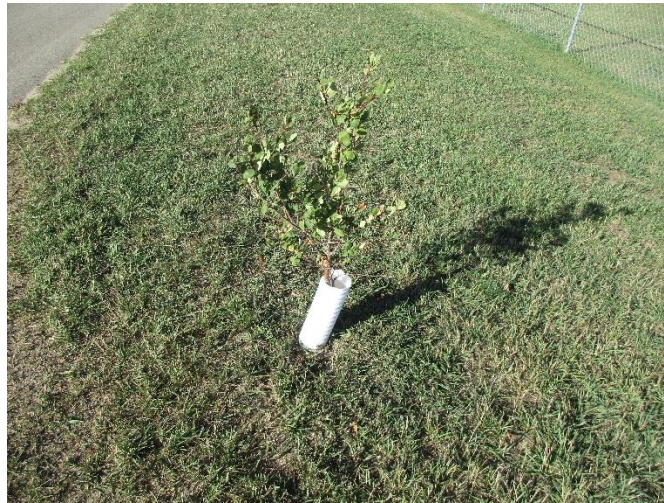
PHOTO 10

View of downy hawthorn plantings at the Stanley cemetery/dog park location. All seven plantings were classified as alive during Golder's September 2017 assessment.
