**SECOND ANNUAL MONITORING REPORT OF
TREE AND SHRUB SURVIVAL
FOR THE DAKOTA ACCESS PIPELINE**

Prepared for:
Dakota Access, LLC

Submitted by:
KC Harvey Environmental, LLC
376 Gallatin Park Drive
Bozeman, MT 59715

September 18, 2019

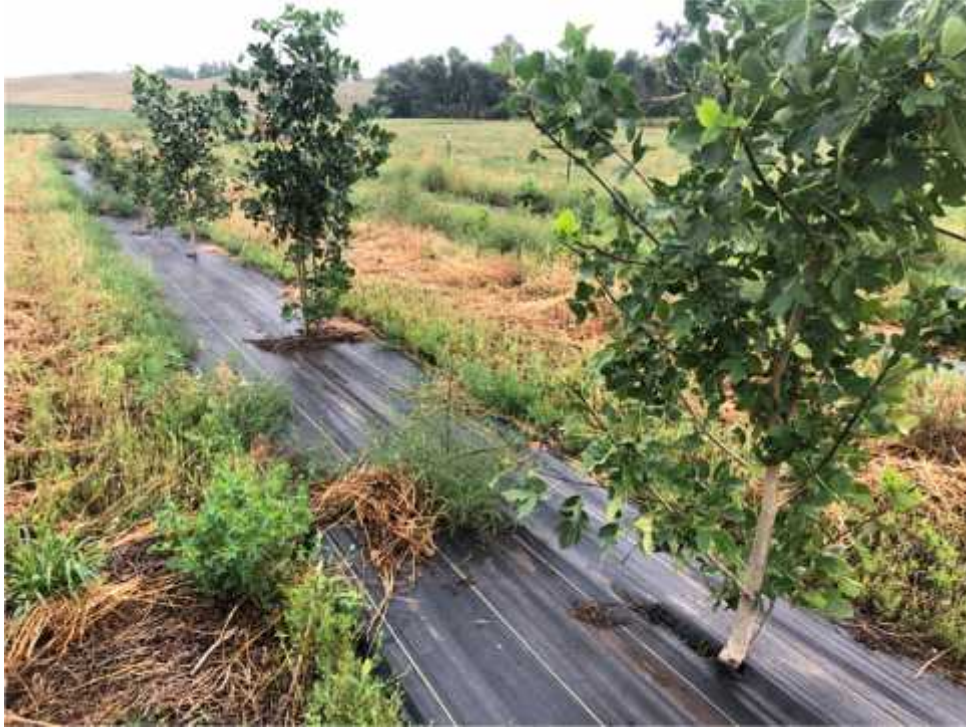
Figure 1. Green Ash Windrow established at the Robert Tuhy residence. Site has been established for 3 years.

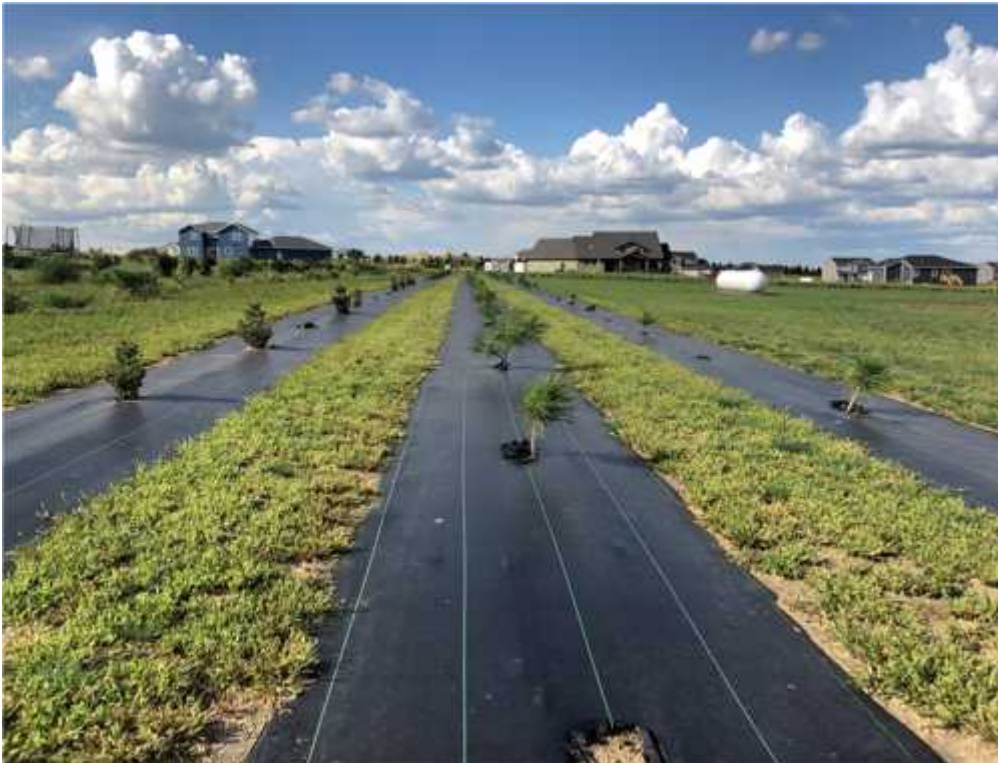
Figure 2. Second year's growth of Ponderosa Pine and Black Hill's Spruce at the Beth Sunday residence.

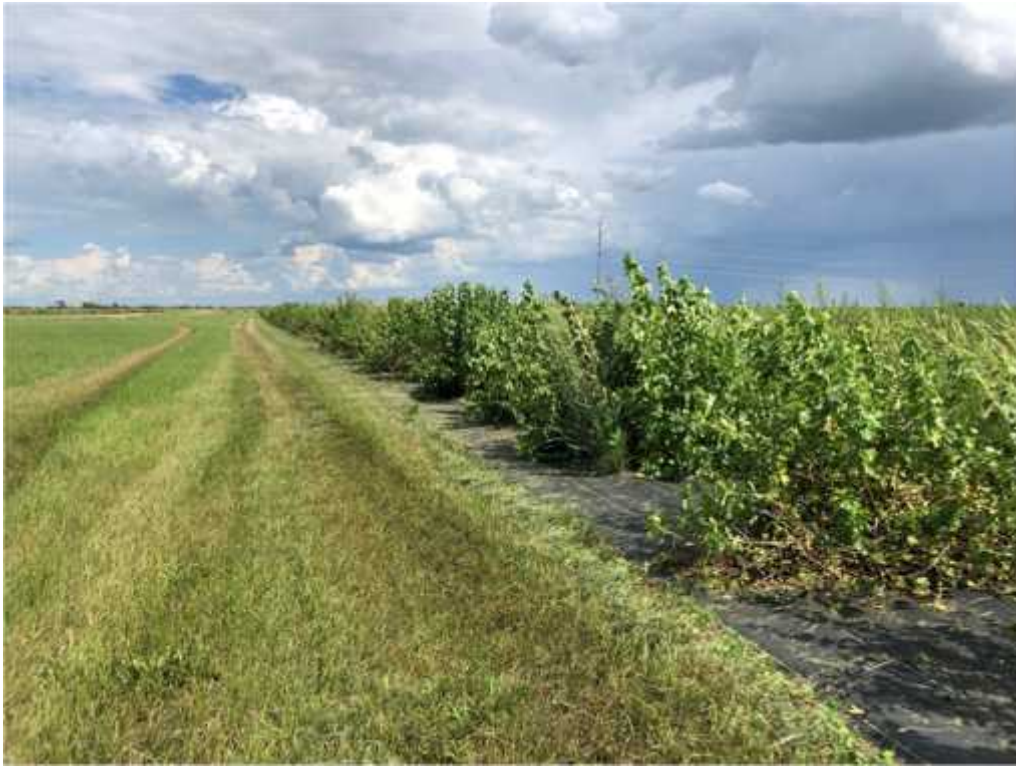
Figure 3. Golden Currant at the Karla/Allison Sheets residence

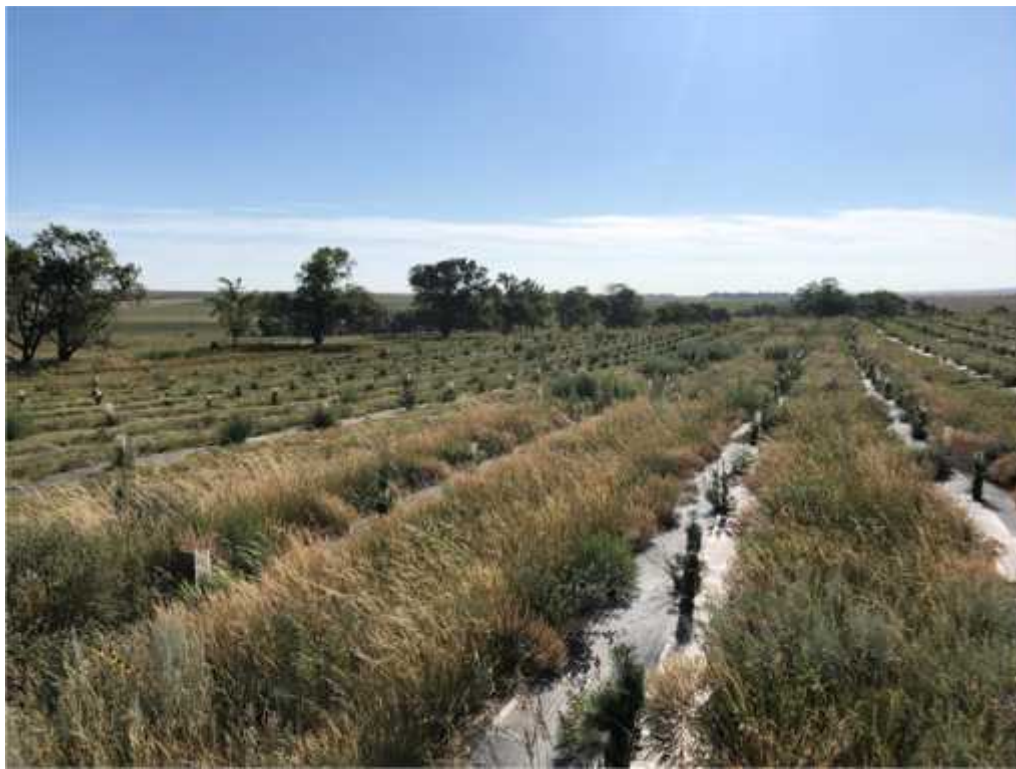
Figure 4. Second Year's growth of Scotch pine at the Randy Keller property.

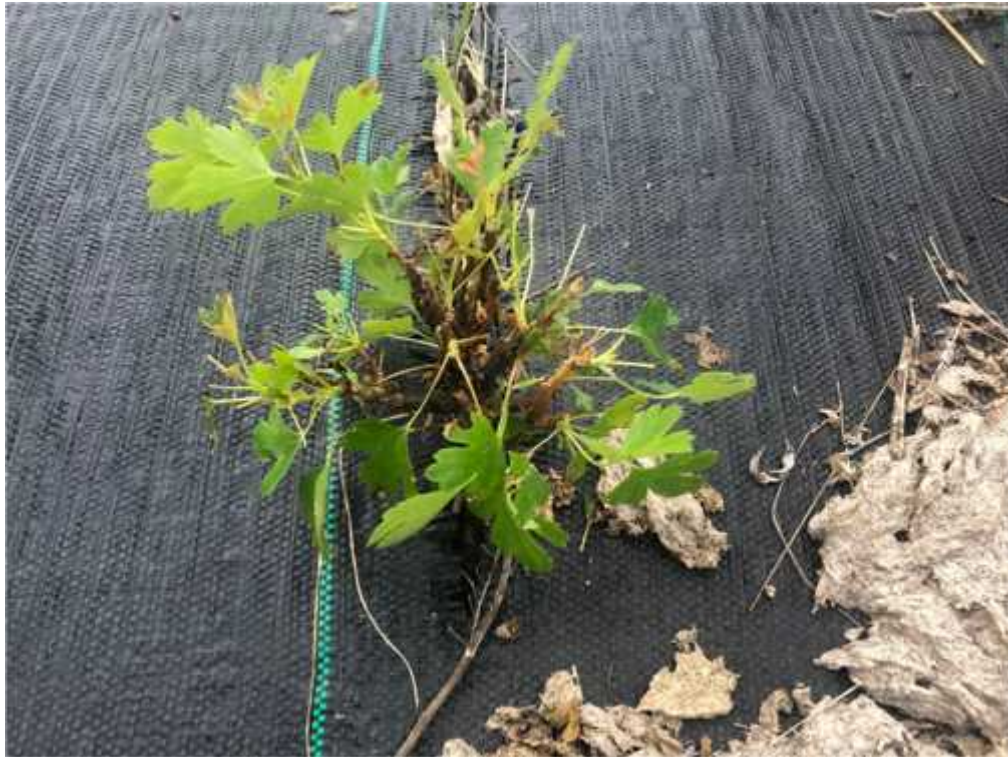
Figure 5. Example of Golden Current that has been impacted by wildlife browsing.

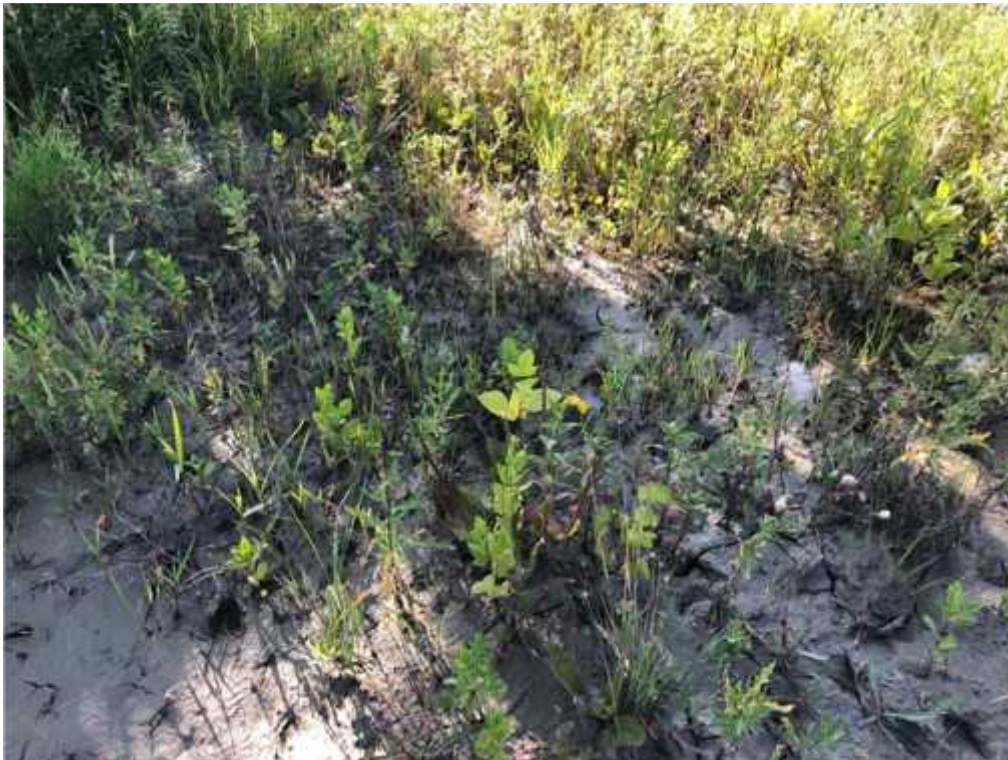
Figure 6. Natural Regeneration of multiple species on Rodney Wolf property.

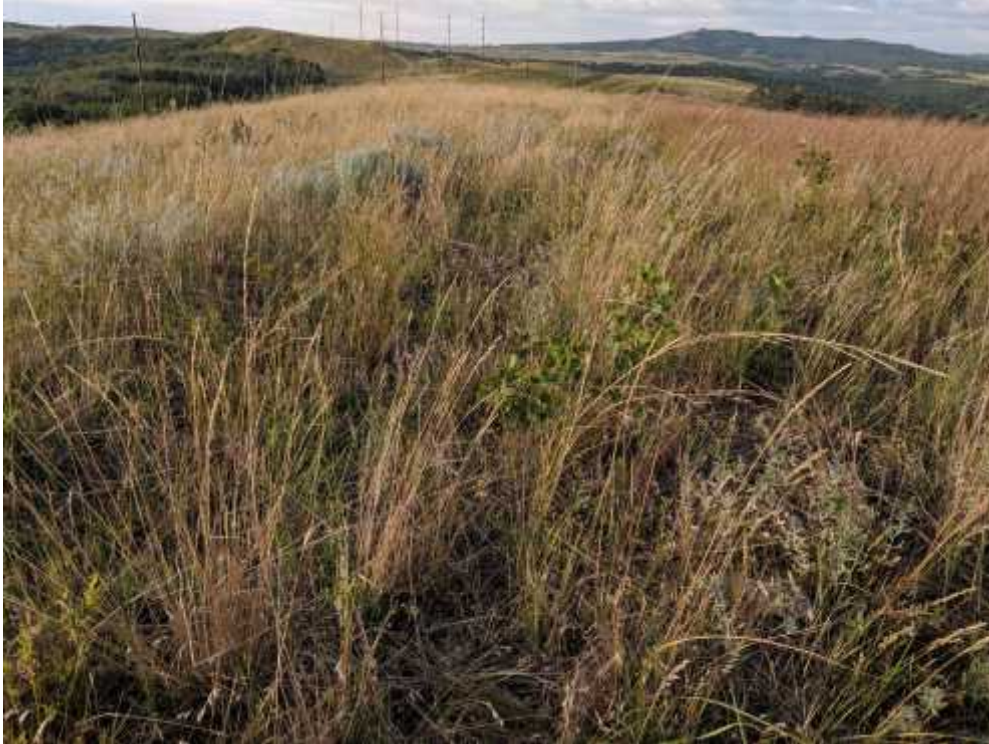
Figure 7. Natural regeneration of Quaking aspen and a variety of shrubs can be seen on the ROW, Ted Kupper property.

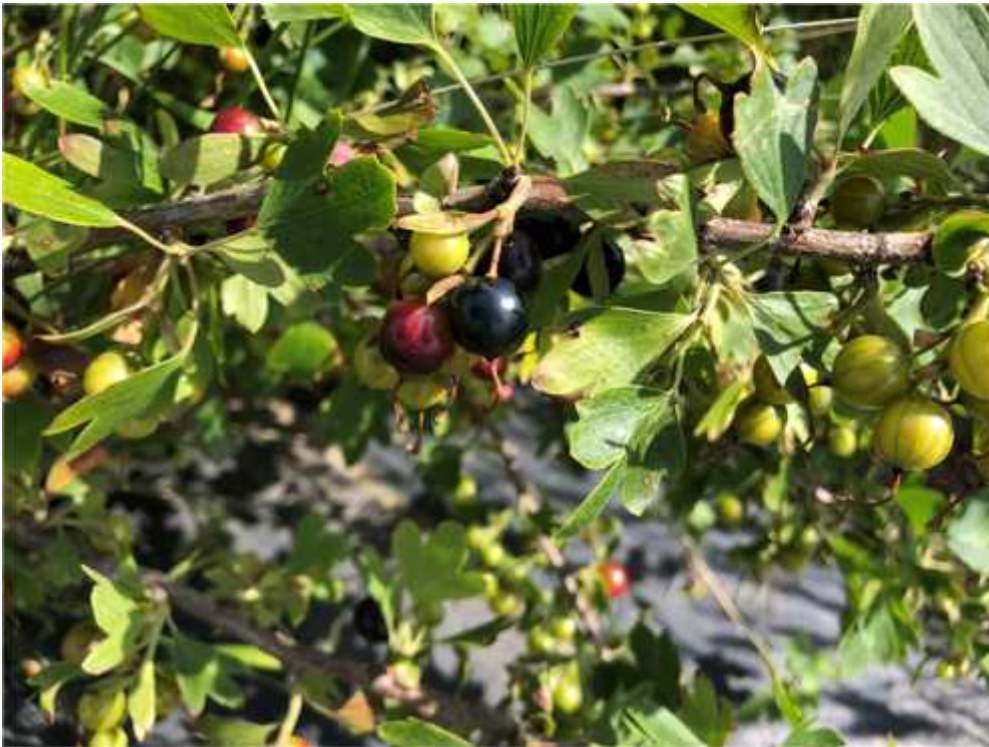
Figure 8. Ripe Currants on the Martin Ranch property.

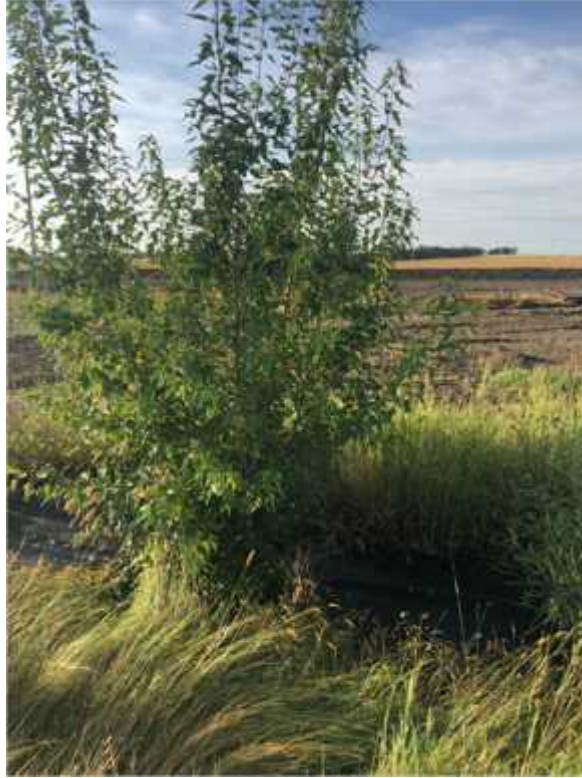
Figure 9. Amur Maple from the 2017 planting on Robert Reider property exceeds 8 feet in height.

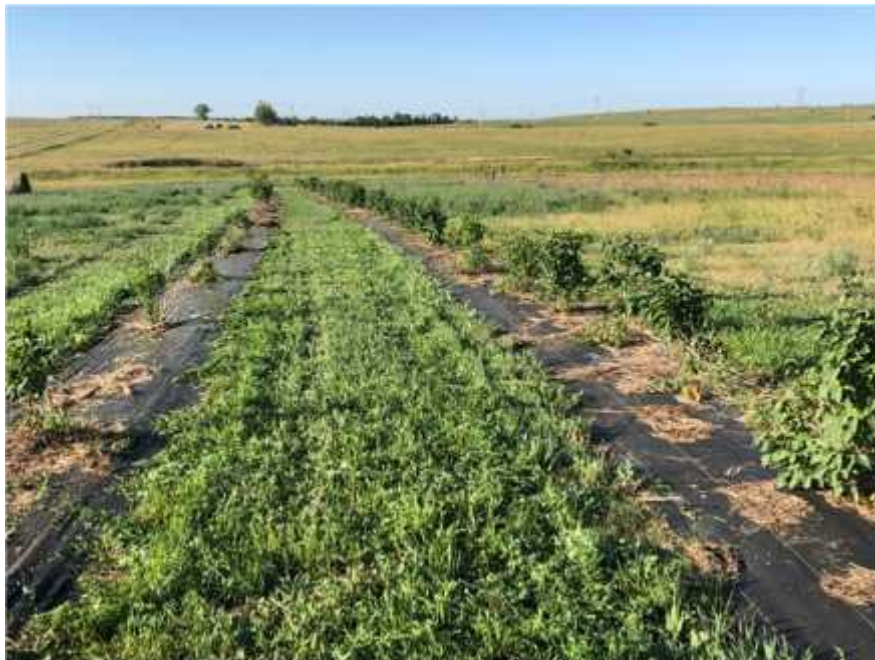
Figure 10. Common Lilac at Gerald Kadrmas property.
