**RE: Hess Corporation Depth of Cover River Crossing North Shore
Tree and Shrub Installation & Survival Rate Report**

2023 HESS DEPTH OF COVER RIVER CROSSING NORTH SHORE TREE AND SHRUB INSTALLATION & SURVIVAL RATE REPORT

Field Verification: Week of July 24, 2023

Report Issuance: September 8, 2023

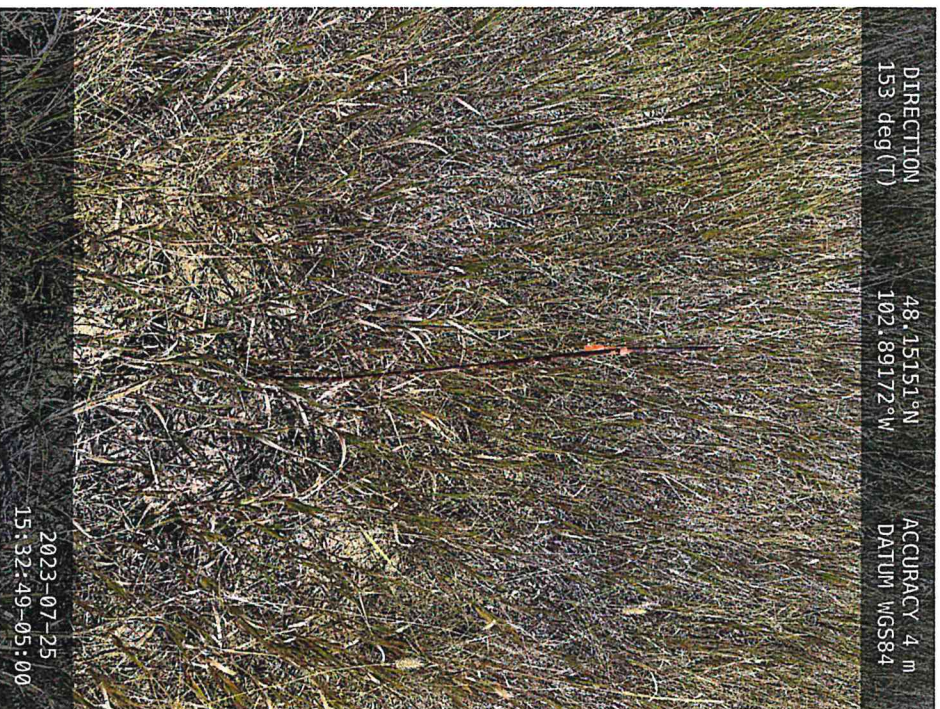
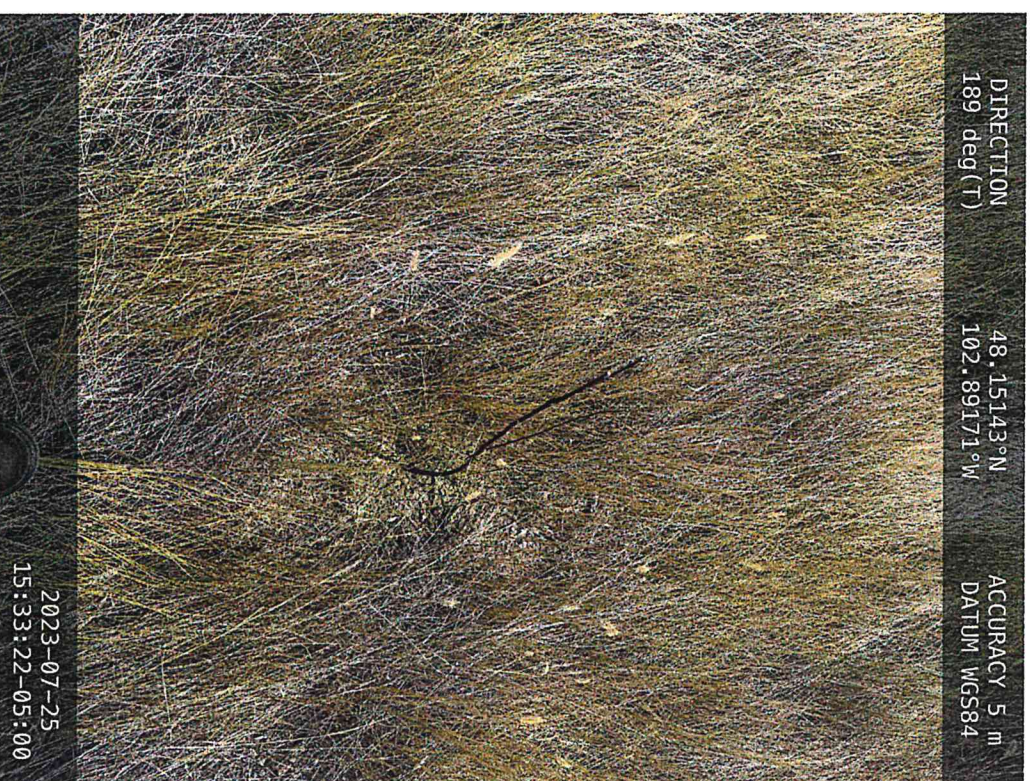
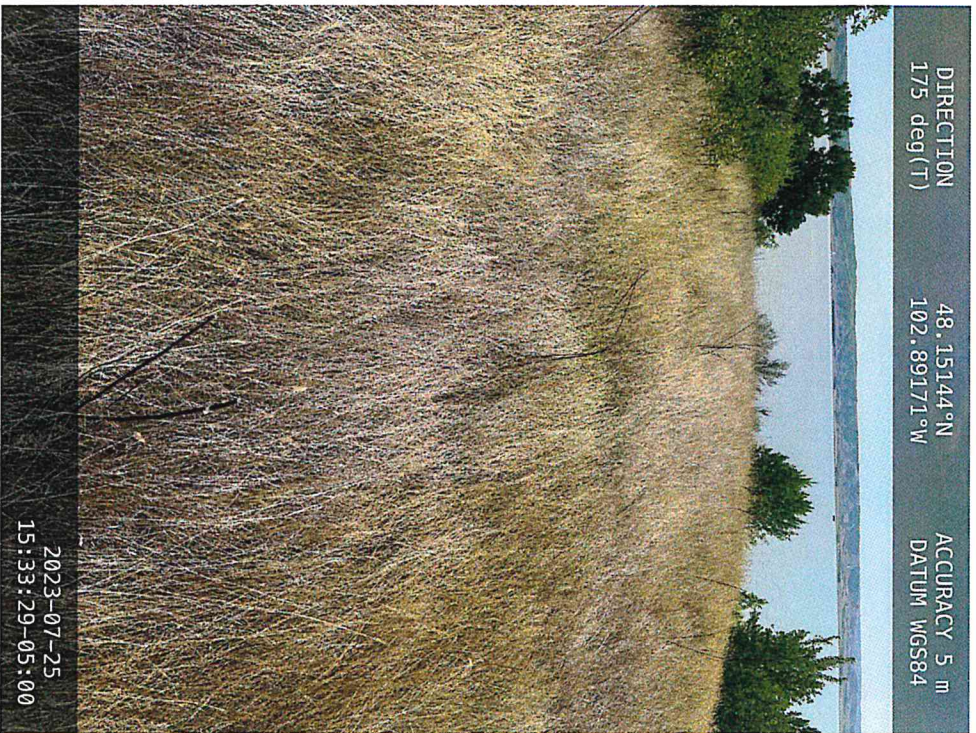
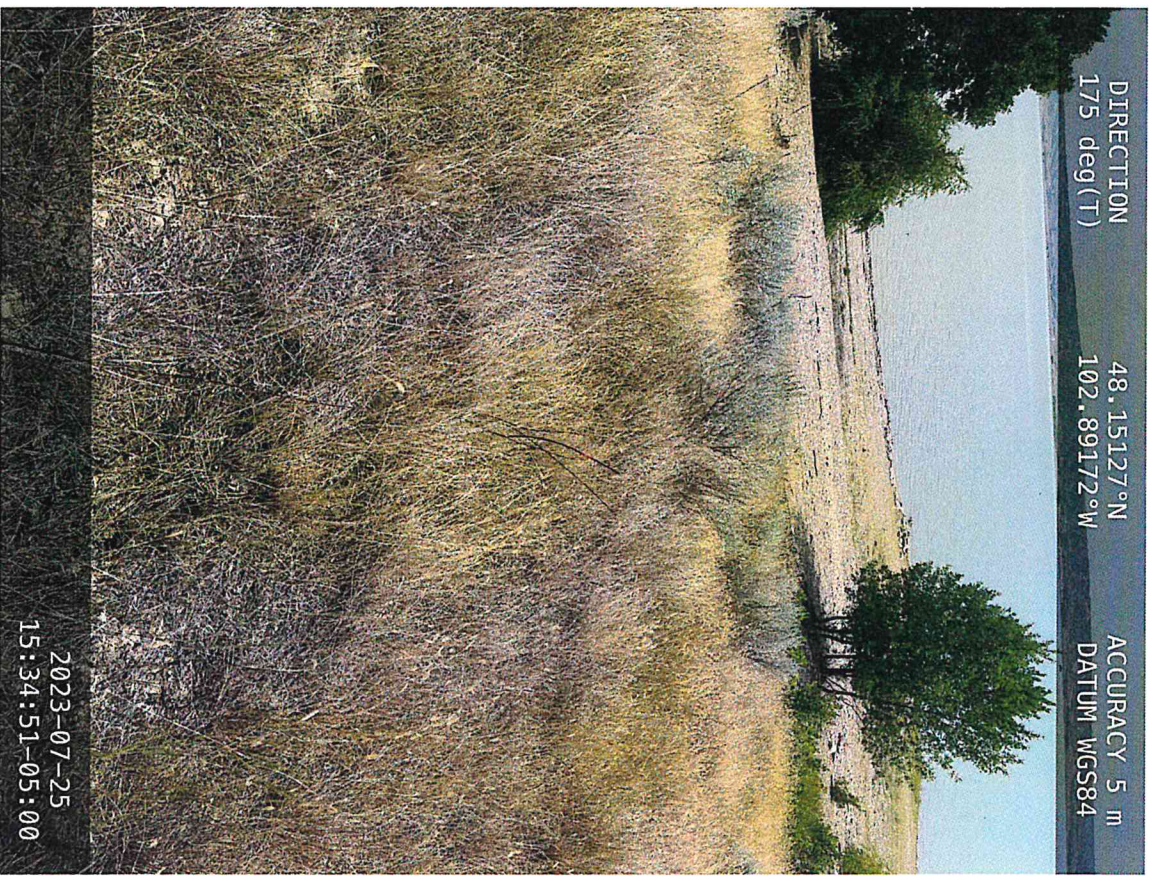
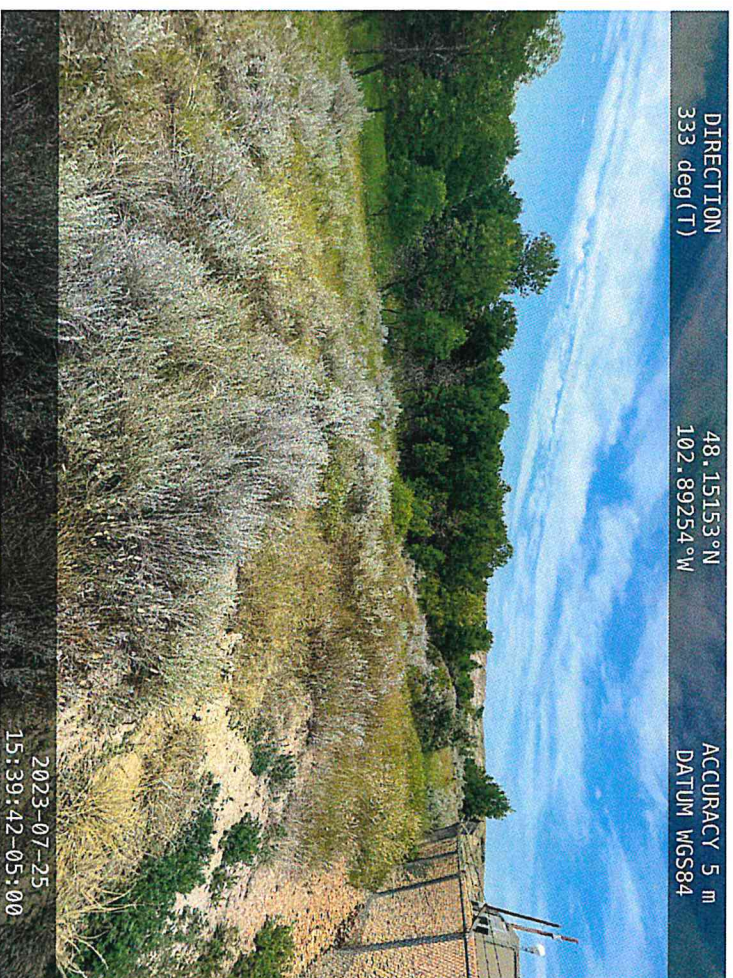
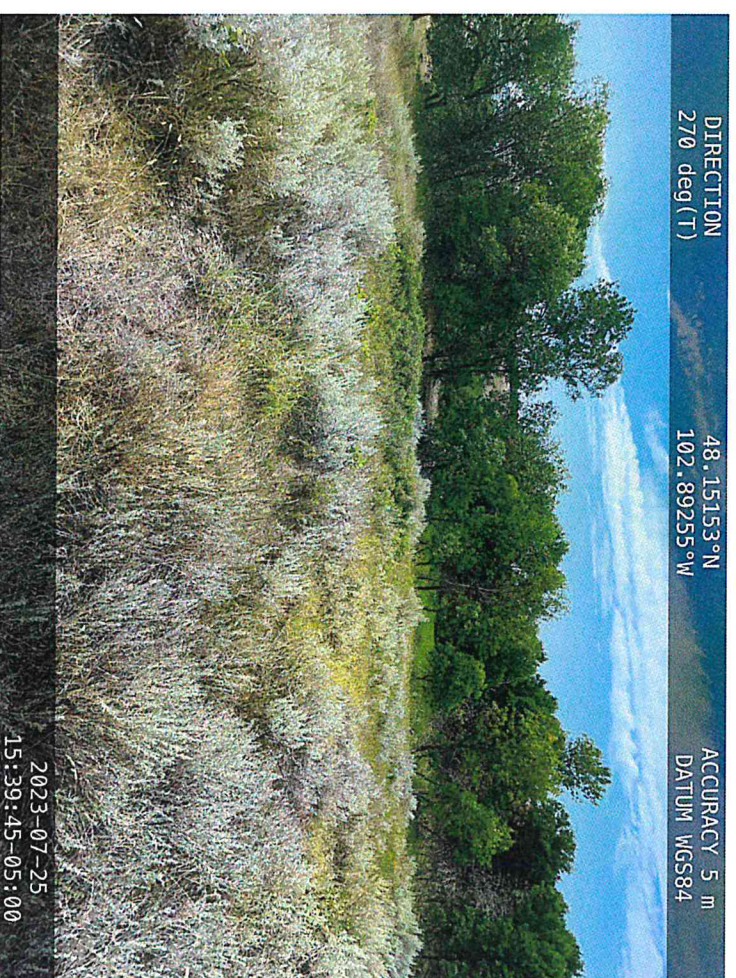
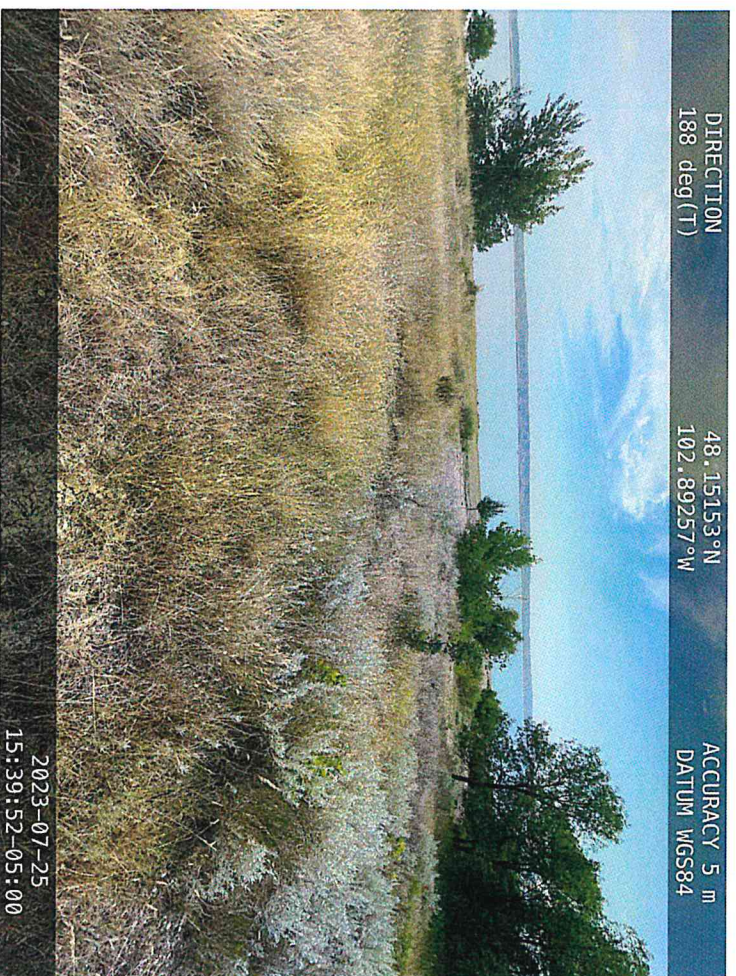
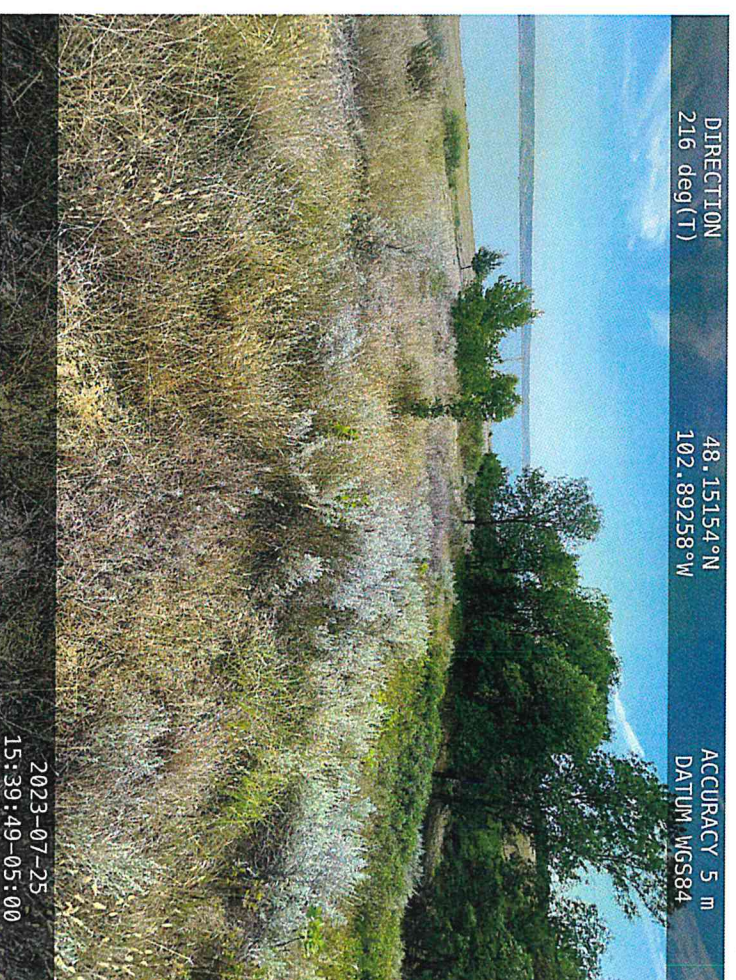
During the week of July 24, 2023, an inventory of trees and shrubs was conducted to determine the health of the June 2022 replacement process and to ensure a greater than 75% survival rate. It was determined that there was an 82% survival rate. Unfortunately, shortly after initial plantings, some of the species in rows 10-18 succumbed to animal predation. During year 2 (Summer 2024) of the inventory process of said plantings, trees/shrubs will be reevaluated. Table 2 lists the tree/shrub planting survival rate. Appendix D presents the pictures post construction (2021), after installation (2022) and after survival rate assessment (2023).

After Survival Rate Assessment Pictures (2023)
