Sacagawea 16-inch Pipeline Project As-Built Inspection Report PU-15-114

Prepared for:
**North Dakota Public Service
Commission**

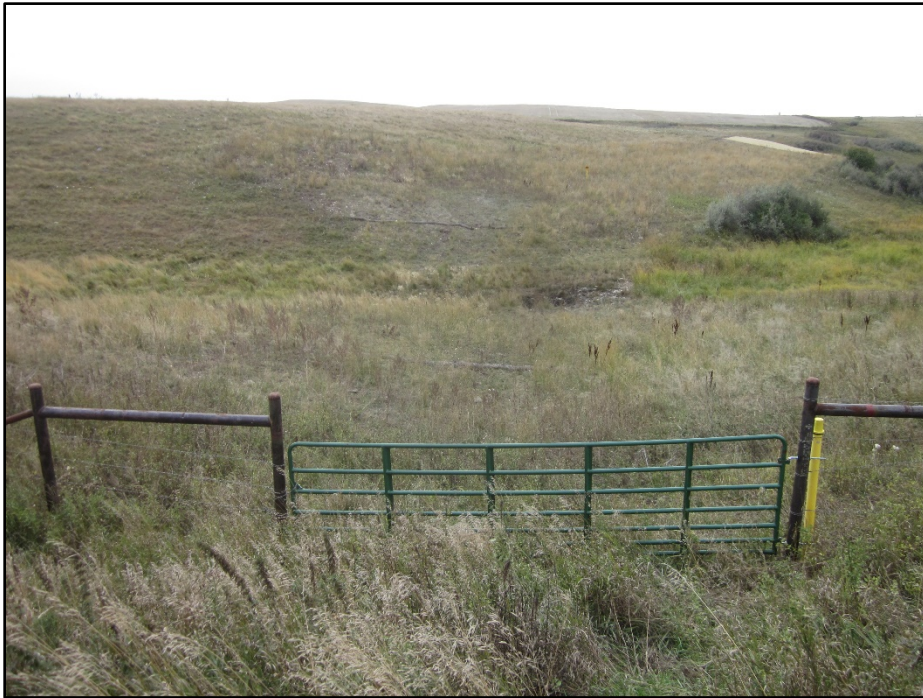
Photo 16. (GPS Point #616) Direction: South/Southwest. Pipeline ROW to the south, then veers to the southwest across rolling hills, along buffaloberry shrub patches. Erosion control logs and mats still in place on bare areas on steep sideslopes. Note fence and gate replaced.

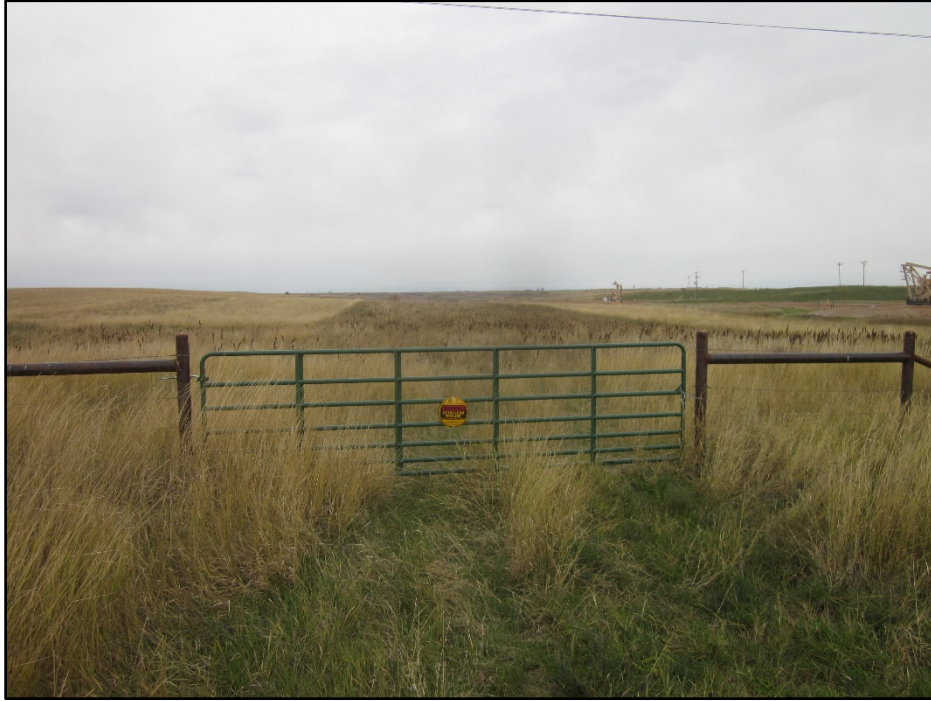
Photo 17. (GPS Point #617) Direction: North/Northeast. Pipeline ROW through planted introduced grass, likely CRP, to the north of 50th St NW. Vegetation growth in ROW was visibly different, with annual weed cover and some bare ground; however re-seeded grass cover was coming in and should establish over time.

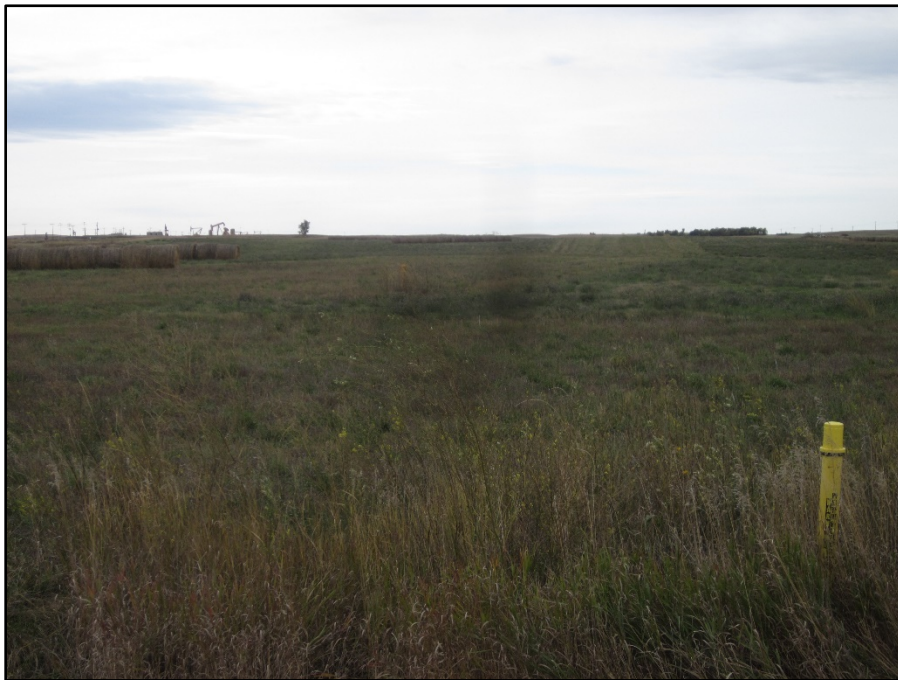
Photo 18. (GPS Point #617) Direction: South/Southwest. Pipeline ROW to the south of 50th St NW through alfalfa hayland. ROW was visibly different; grasses had been planted. This area had been noted as having noxious weeds during natural resource surveys.

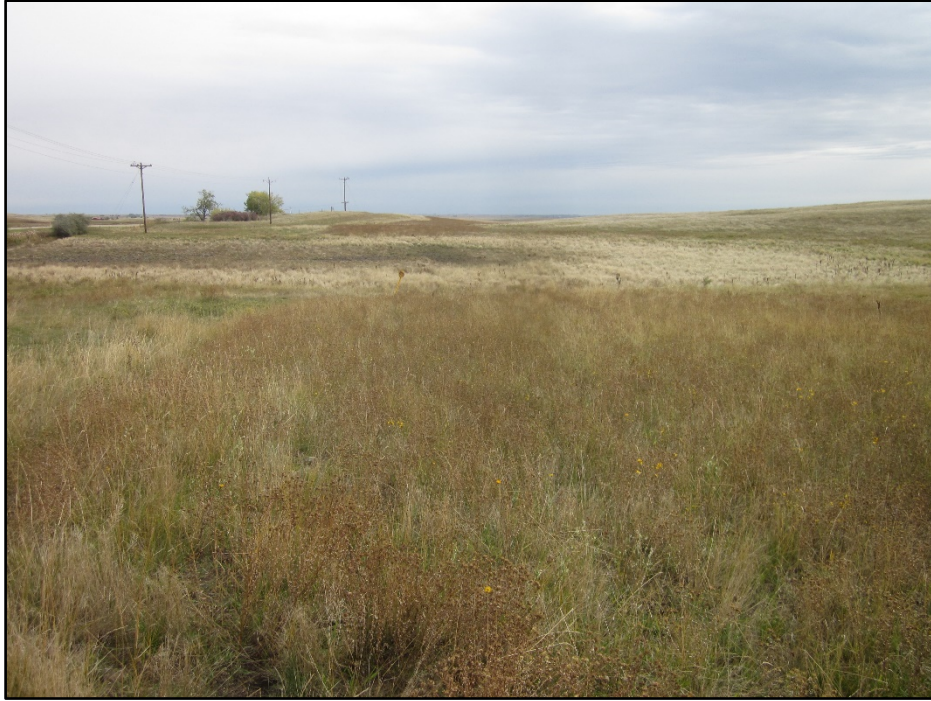
Photo 19. (GPS Point #619) Direction: East. Pipeline ROW through rangeland on state-owned surface lands, parallel on the south side of 46th St NW. Wetland basin on left had been trenched; wetland vegetation had established on margins, primarily foxtail barley. On the ROW, it appeared some planted grasses were coming in, though annual weed cover was also high. Dominant species included intermediate wheatgrass, sweetclover, curlycup gumweed, Canada bluegrass, and dandelion. Grazed this year.

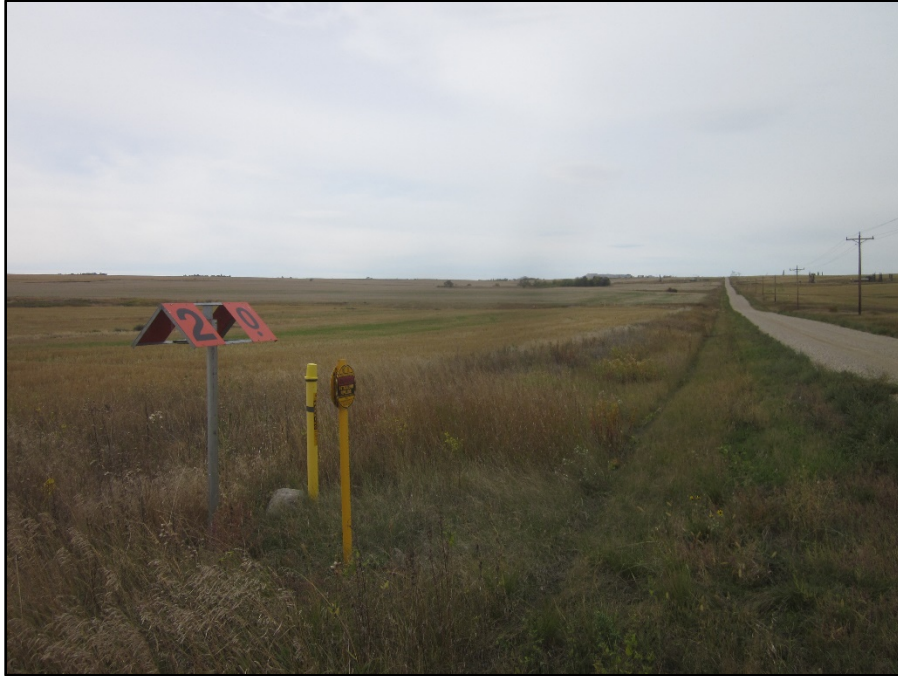
Photo 27. (GPS Point #627) Direction: West. Pipeline ROW parallels south side of 32nd St NW. Cropland stubble looked comparable in density within and outside ROW. Drainage crossing in distance (not clearly visible in photo) was repaired adequately and revegetated.

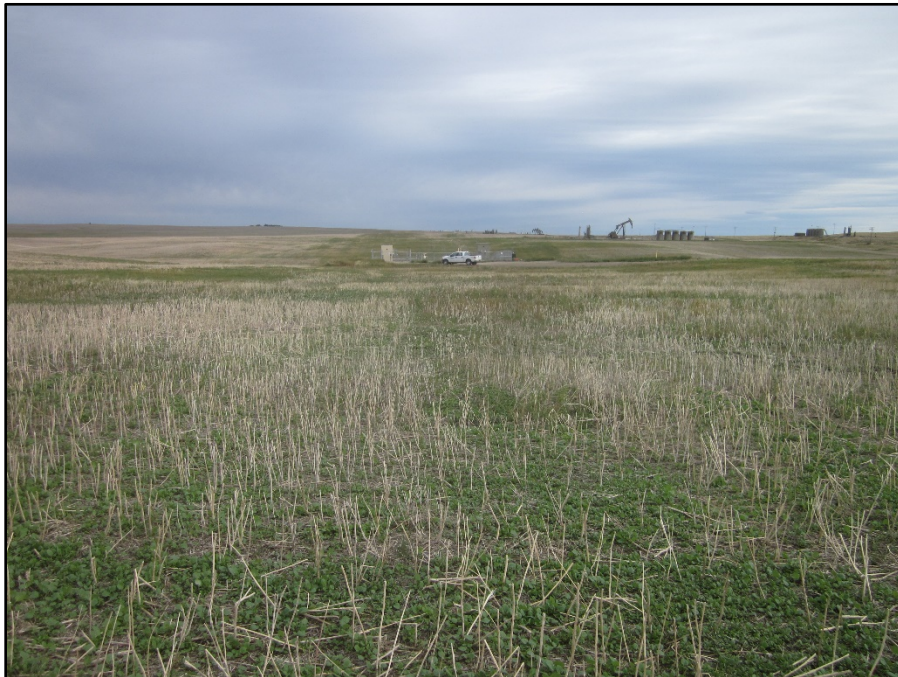
Photo 28. (GPS Point #628) Direction: East. Lake Sakakawea bore work space on east side of Lake. Valve setting is enclosed in locked fence (where pickup is parked). Kochia growth in the cropland (basal green plants) appeared denser in workspace area compared to the adjacent undisturbed area, though Canola stubble density appeared comparable. Surface soil color was dark indicating topsoil replacement. Some unevenness in contours in this area; Mr. Weiler indicated some dirt work had been done in spring 2017.

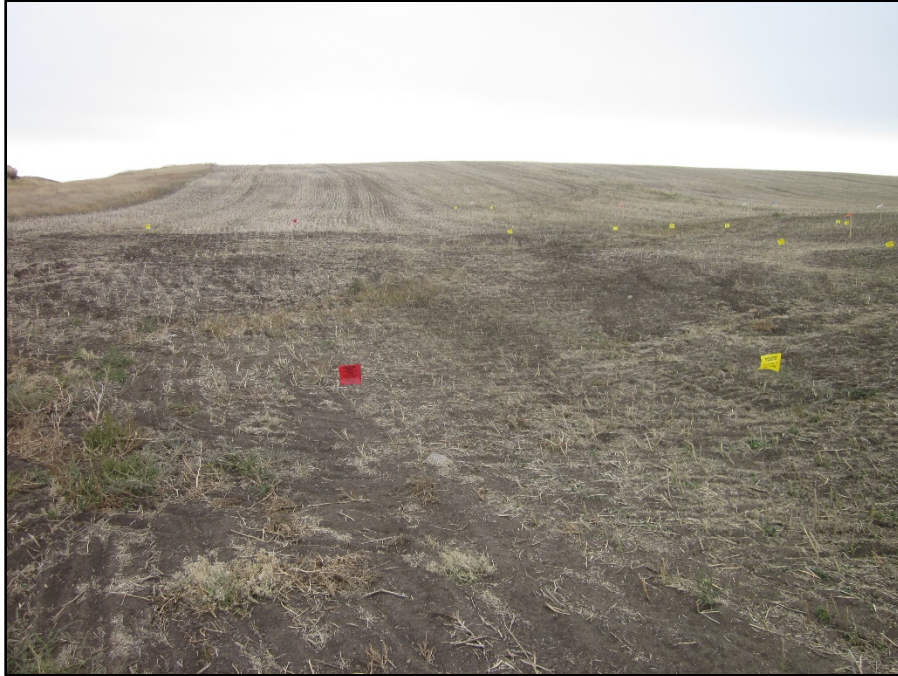
Photo 29. (GPS Point #629) Direction: South. Pipeline ROW through field, parallel to ND Highway 23 on west side. Multiple lines in parallel accessing or leaving the Keene Crude Oil Terminal over the hill.
