Plains Pipeline, LP

Highway 1804 Pipeline
Re-Route North Project
10" Crude Oil Pipeline Project
PU-15-614
KLJ#1216104

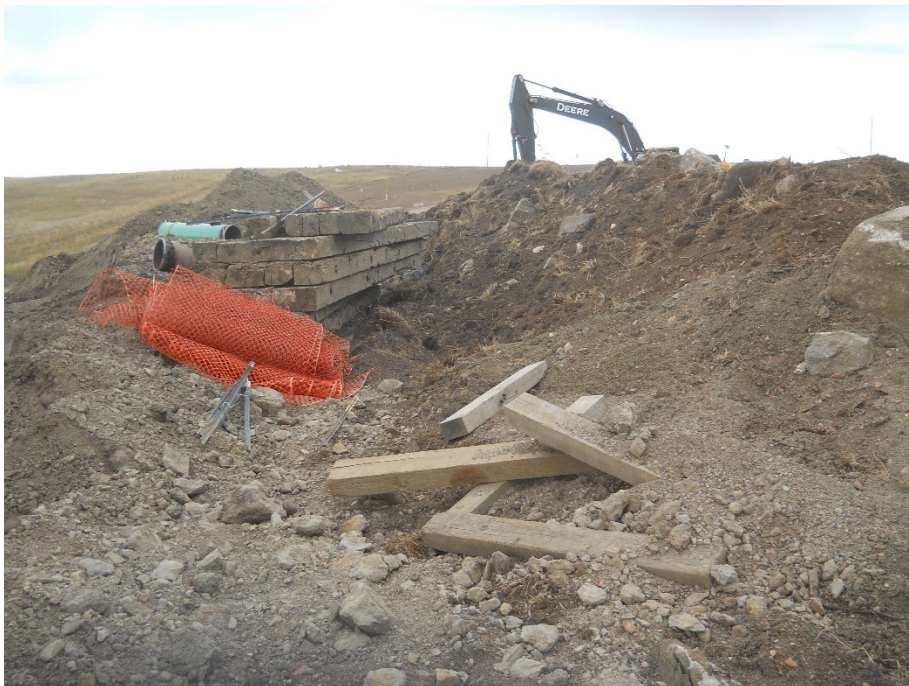
Photo 10: Located at station 126+00, looking south of graded Right of Way. Photo showing matts placed over Right of Way for access along easement. Topsoil pile has been pushed off edge of Right of Way as noted.

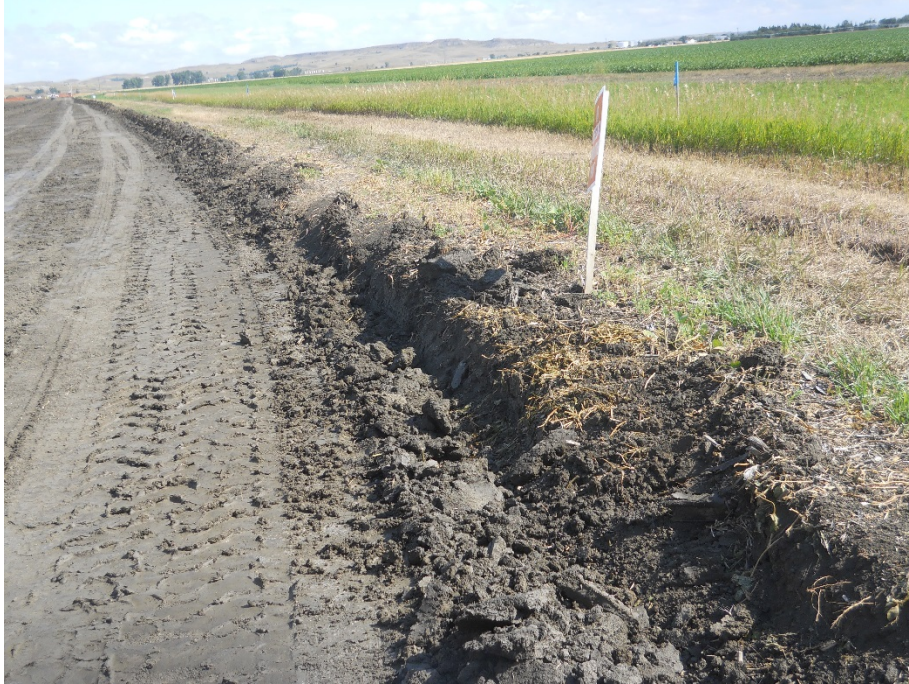
Photo 11: Located at station 127+00, looking north showing graded Right of Way with topsoil cut approximately 12 inches deep.

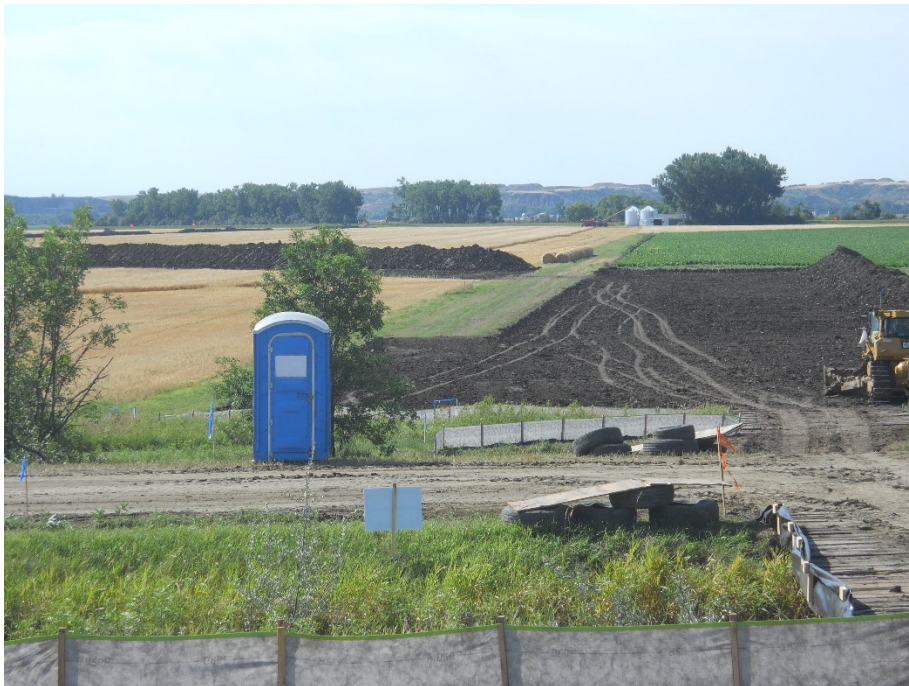
Photo 14: Located at station 140+00, showing graded Right of Way located at re-route south tie-in bench valve location. Right of Way is graded with topsoil push off on edge of Right of Way, as noted from photo. Silt fence BMP installed along Right of Way as required.
