NUSTAR PIPELINE (PU-15-674) Permit Compliance Final Inspection Report

TABLE OF CONTENTS

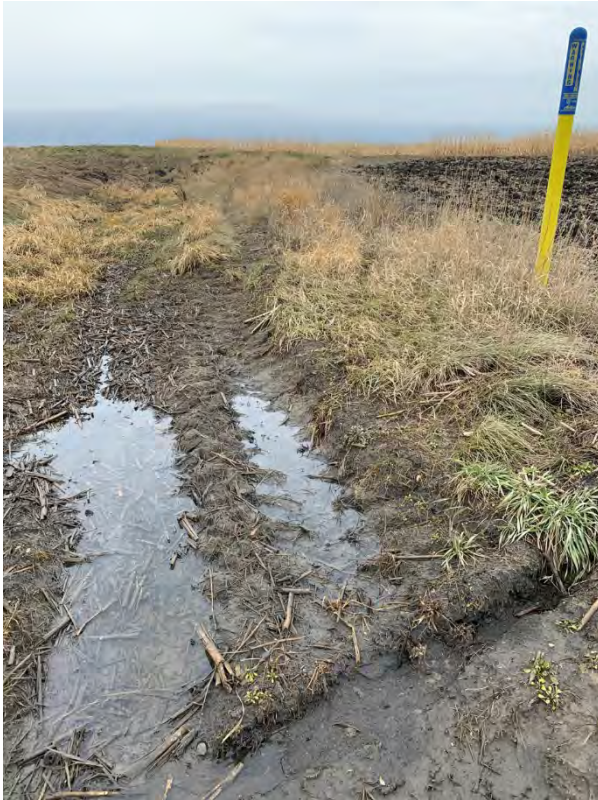
Photo 33: tire rutting, bare earth, seeding observed, revegetation appears in progress (near intersection of 35th St SE)

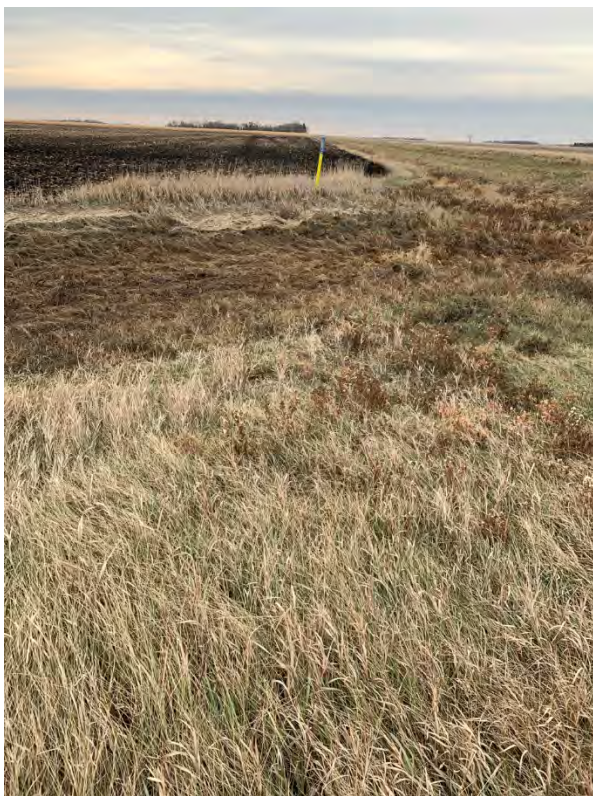
Photo 34: pipeline corridor adjacent to agricultural lands, revegetated areas (Section 33, T140N, R50W)

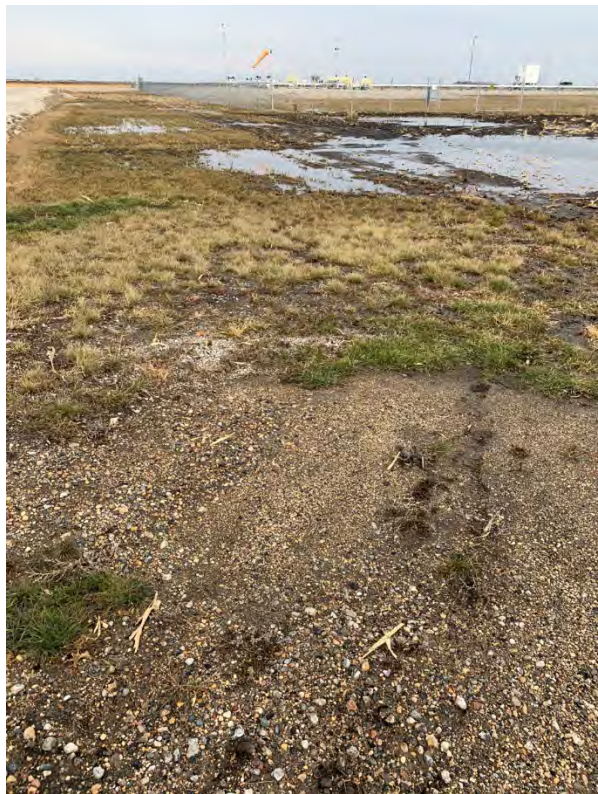
Photo 46: facing the new transmission facility, minor bare earth, seeding observed, revegetation in progress (Section 4, T139N, R50W)

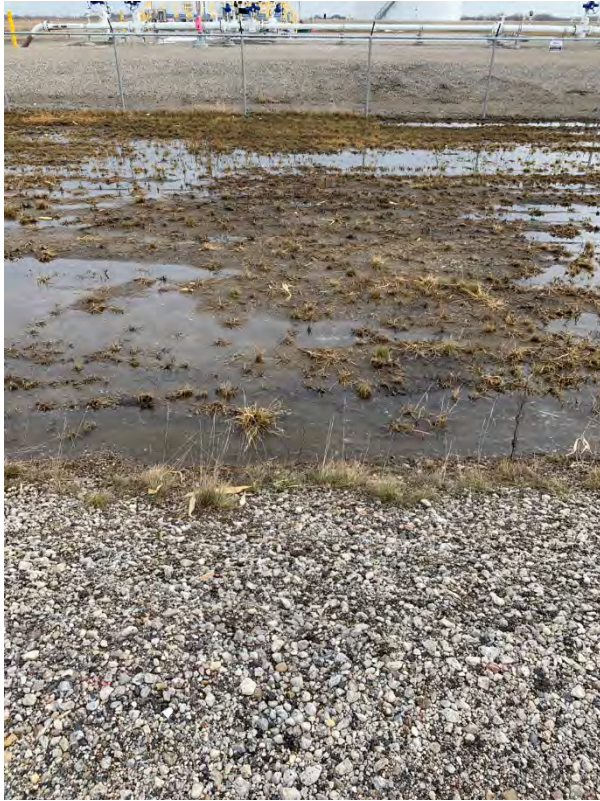
Photo 47: facing the new transmission facility, minor bare earth likely due to drowned out, revegetation in progress (Section 4, T139N, R50W)
