TREE & SHRUB SURVIVAL REPORT 2020

JOHNSON CORNER - ALEXANDER CRUDE OIL 8-INCH PIPELINE & TANK FACILITIES McKenzie County, North Dakota

Targa Badlands LLC

November 19, 2020

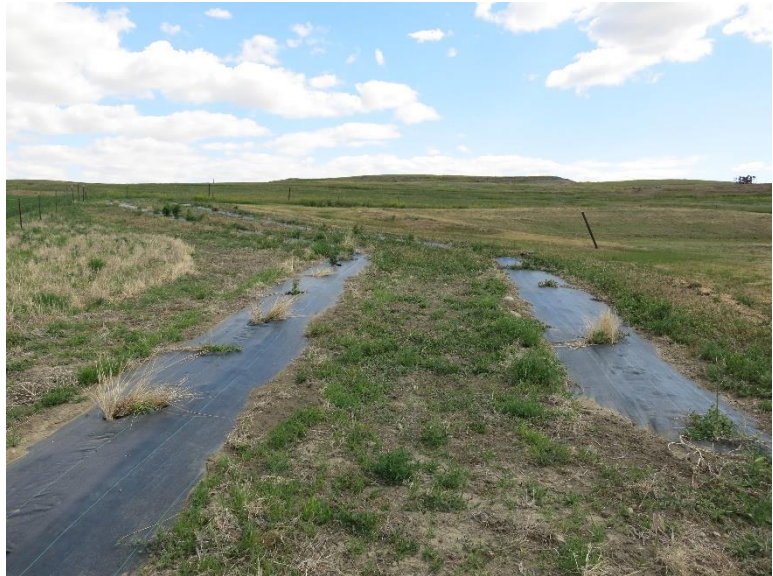
Photo 1 – View facing north east

Planting 1

Row 1 (left) - Siberian pea shrub (*Caragana arborescens*). A total of 27 seedlings were initially planted. Upon inspection only 14 remain with an average height of 17 inches.

Row 2 (right) - Green ash (*Fraxinus pennsylvanica*). A total of 16 seedlings were initially planted. Upon inspection only 10 remain with an average height of 14 inches.

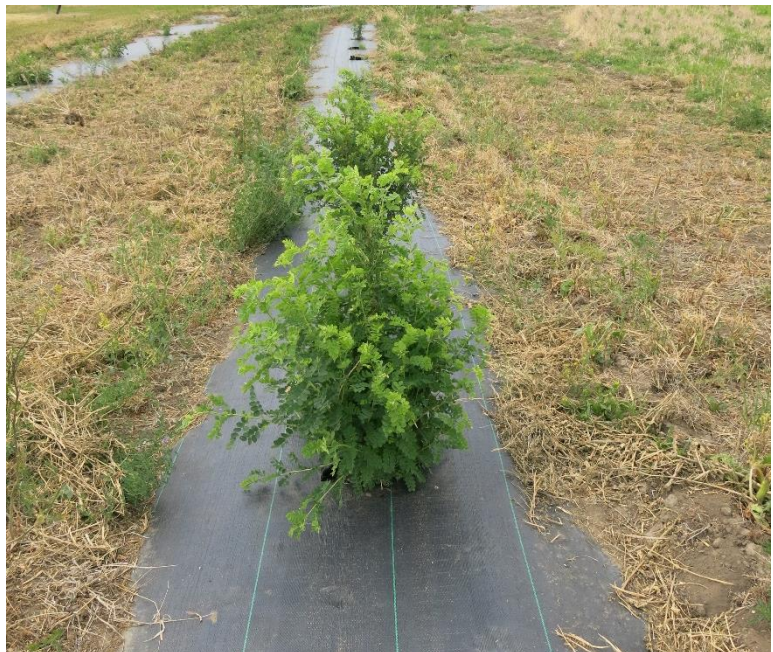
Photo 2 – View facing south east

Planting 1

Row 1 - Siberian pea shrub (*Caragana arborescens*). Showing health growth of 4 plants.

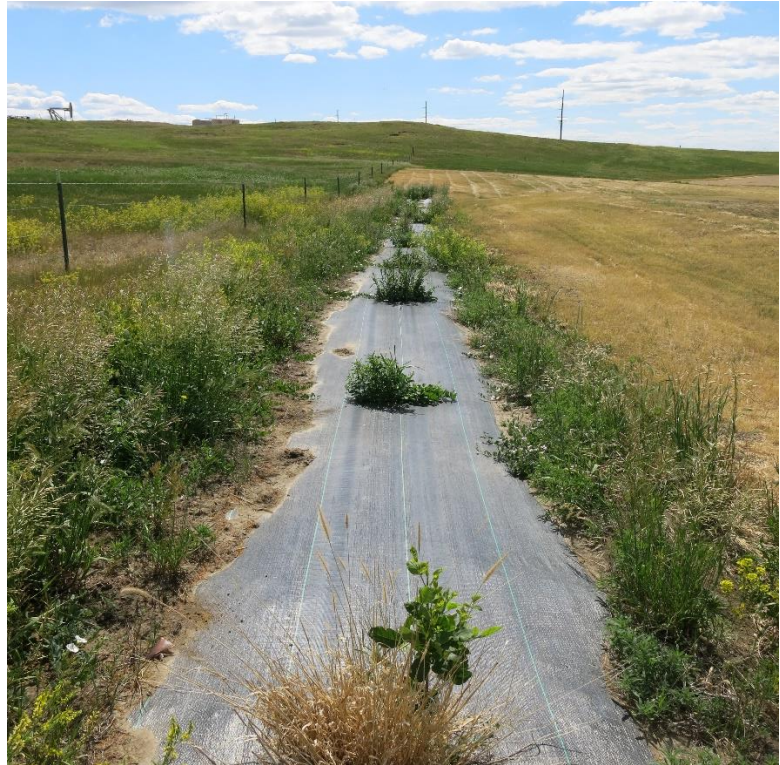
Photo 3 – View facing south east

Planting 2

Row 1 - Green ash (*Fraxinus pennsylvanica*). Initial planting totaled 12 seedlings. Upon inspection only 8 remain with an average height of 17 inches. Weed and grasses growing around plant removed when possible.

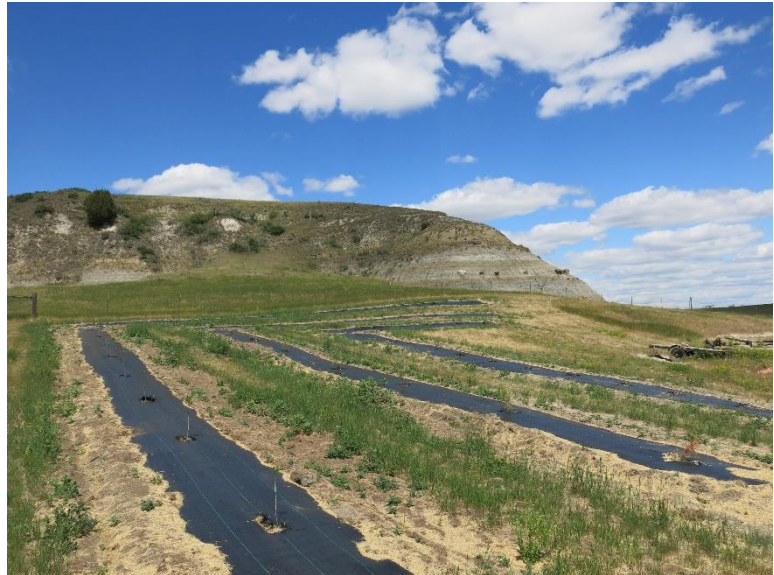
Photo 1 – View facing north east

Row 1 - Green ash (*Fraxinus pennsylvanica*). Total of 16 seedlings planted, of those 3 have died. Height of remaining averages 20 inches.

Row 2 – Ponderosa pine (*Pinus ponderosa*). Total of 13 seedlings planted, of those only 1 has died. Height of remaining averages 14 inches.

Row 3 – Common lilac (*Syringa vulgaris*). Total of 18 seedling planted, all remain alive with an average height of 13.6 inches.

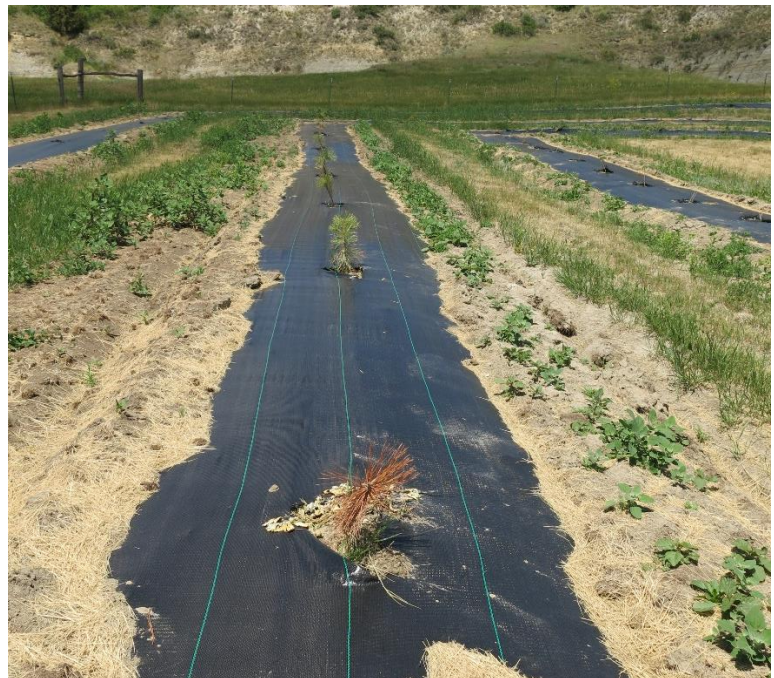
Photo 2 – View facing north

Row 2 – Showing one dead ponderosa pine. All rows have been covered with weed barrier and planting holes are clean.
