TREE & SHRUB SURVIVAL REPORT 2021

JOHNSON CORNER - ALEXANDER CRUDE OIL 8-INCH PIPELINE & TANK FACILITIES McKenzie County, North Dakota

Targa Badlands LLC

October 10, 2021

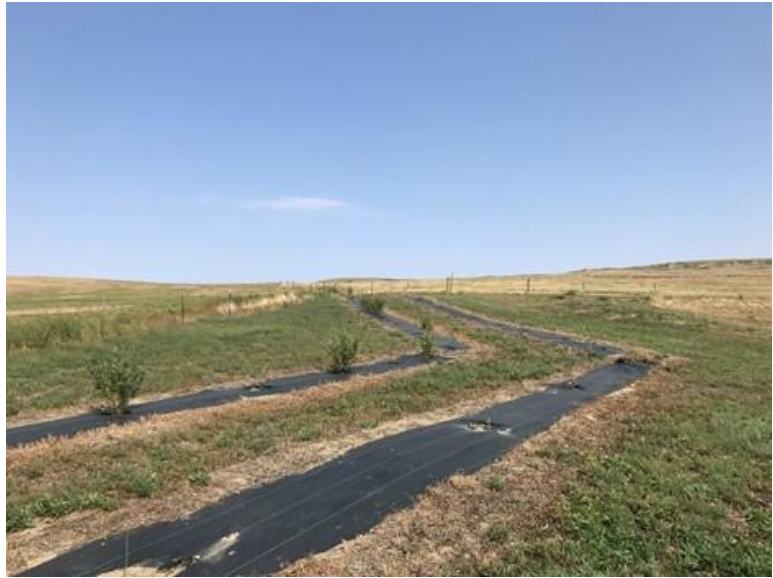
Photo 1 – View facing northeast

Planting 1

Row 1 (left) - Siberian Pea shrub (*Caragana arborescens*). Initial planting totaled 25 seedlings. Upon inspection only 21 remain with an average height of 22 inches.

Row 2 (right) - Green Ash (*Fraxinus pennsylvanica*). Initial planting totaled 15 seedlings. Upon inspection only 7 remain with an average height of 15 inches.

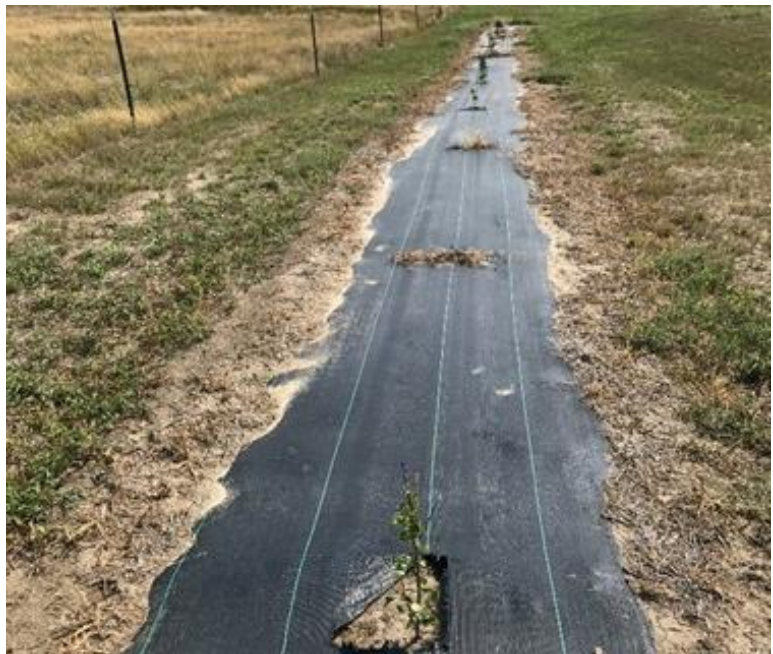
Photo 2 – View facing southeast

Planting 2

Row 1 - Green Ash (*Fraxinus pennsylvanica*). Initial planting totaled 12 seedlings. Upon inspection only 6 remain with an average height of 20 inches.

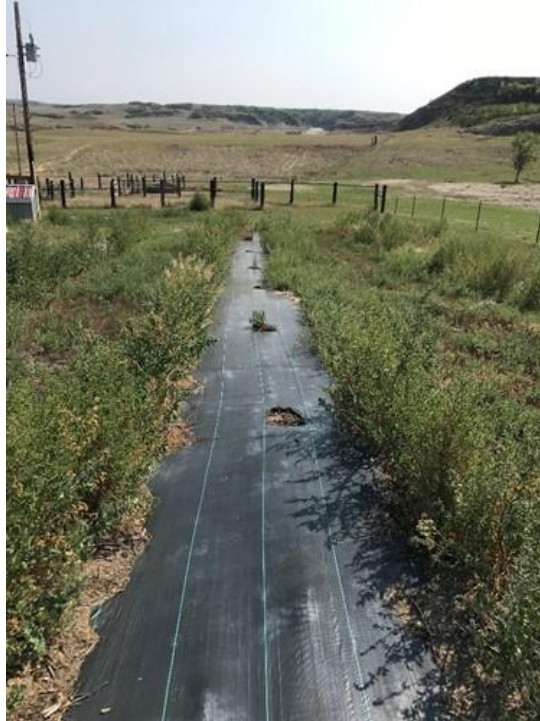
Photo 1 – View facing south

Weeds are encroaching all rows.

Row 1 - Green Ash (*Fraxinus pennsylvanica*). Total of 16 seedlings planted. All have died.

Row 2 – Ponderosa Pine (*Pinus ponderosa*). Total of 13 seedlings planted. All have died

Row 3 – Lilac (*Syringa vulgaris*). Total of 18 seedling planted. All have died
