Andeavor NGL Pipeline Project As-Built Inspection Report PU-18-72

Prepared for:
**North Dakota
Public Service Commission**

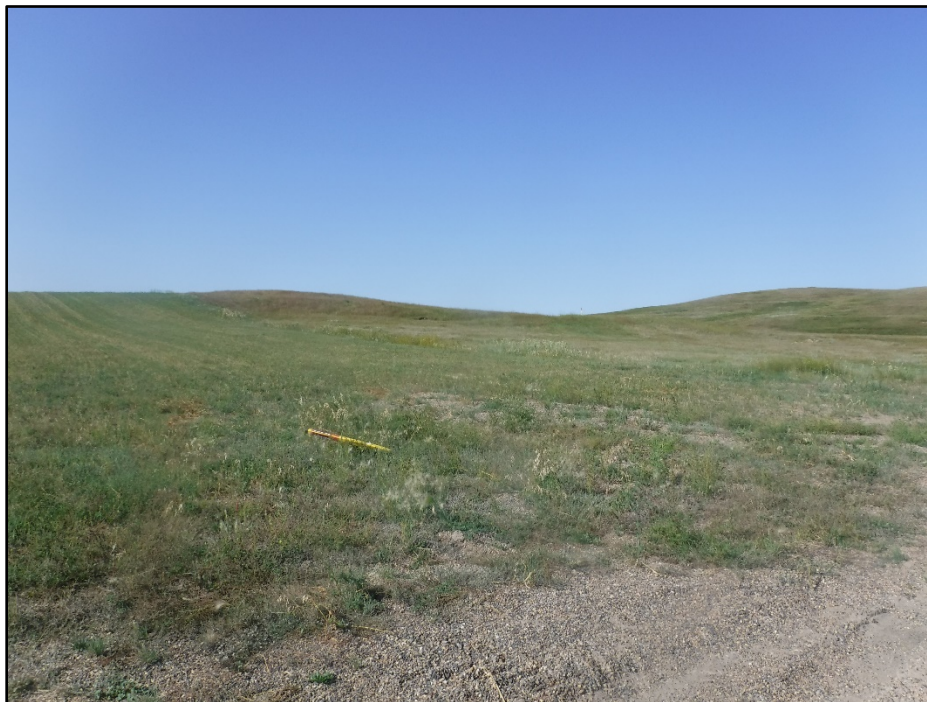
Photo 20. (Observation Point 11) Direction: Southwest. The northernmost point of the South Segment of the pipeline. View of the temporary workspace in hayland where the bore for the Andeavor pressure station exited. Vegetative growth in the ROW of this section was about 80% cover and soil was replaced to existing topography.

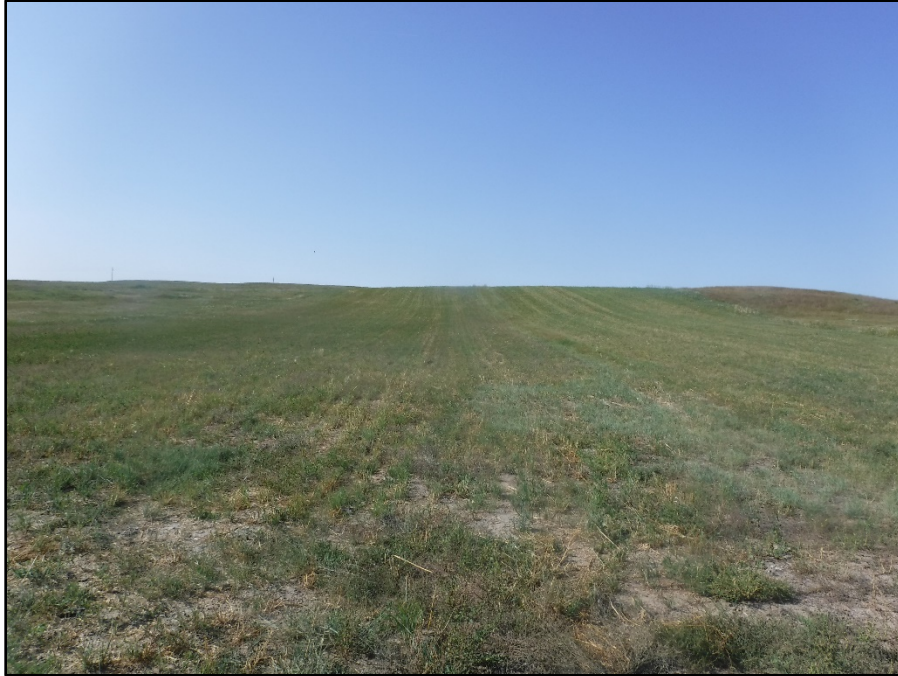
Photo 21. (Observation Point 11) Direction: South. Additional view of ROW shown in Photo 20. Vegetation cover was at approximately 70%, with 30% bare ground. Dominant species included smooth brome and alfalfa. Some annual weed species were present inside the ROW corridor.

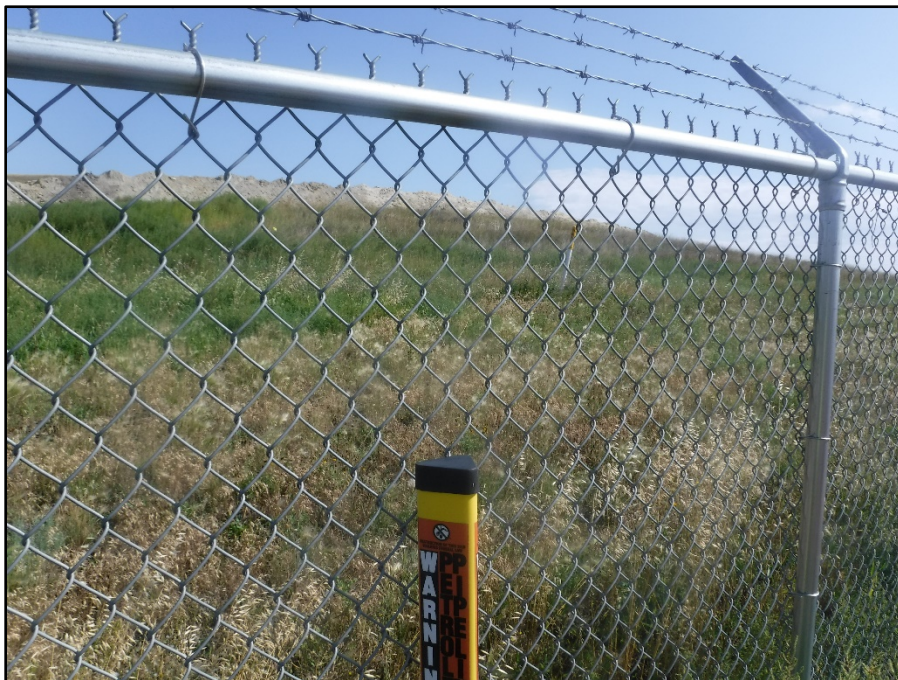
Photo 22. (Observation Point 12) Direction: Northeast. View of pipeline ROW from the Oasis Wild Basin natural gas processing plant at the southern-most point of the North Segment. Vegetation growth was 90%, though the co-native, weedy grass foxtail barley (*Hordeum jubatum*) was the dominant species. Soil was replaced to match topography. Note the chain link fence for public safety.

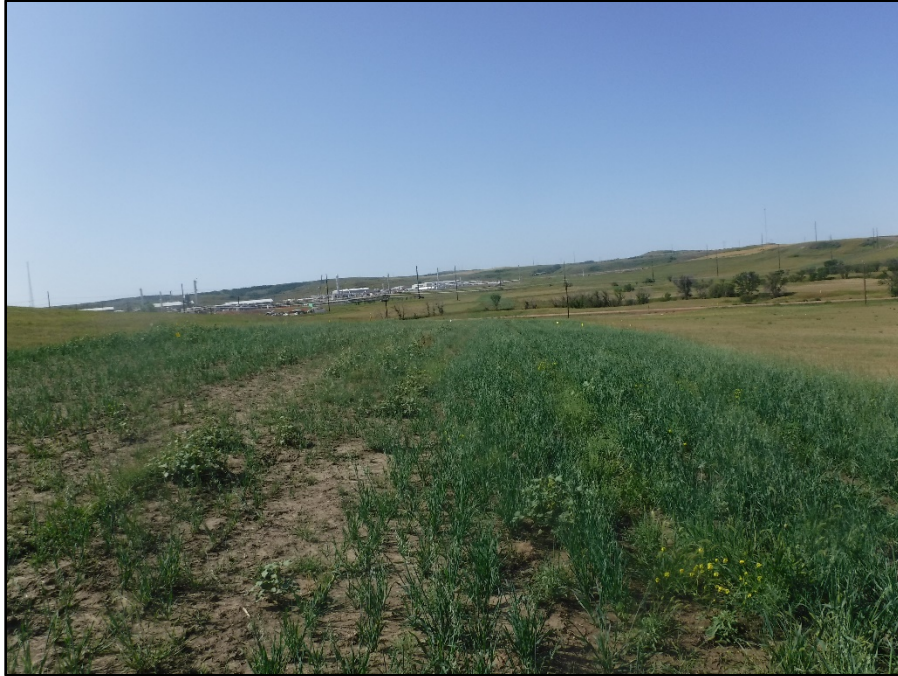
Photo 23. (Observation Point 13) Direction: Southwest. View of Pipeline ROW through rangeland on the North Segment. Vegetative growth was approximately 50-60% ground cover with minimal annual weeds. Dominant species included smooth brome, crested wheat grass, and oats.

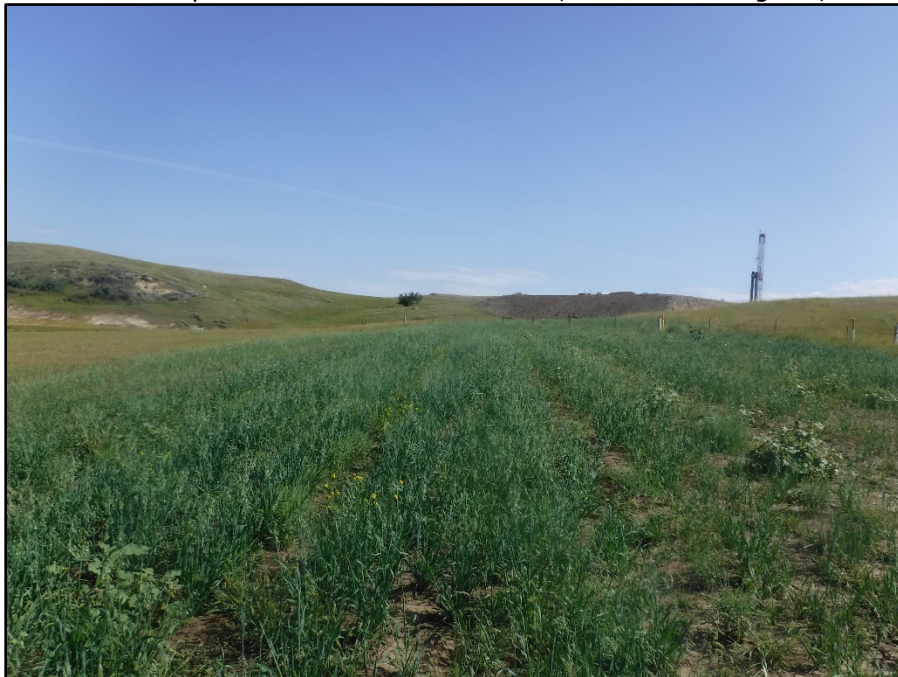
Photo 24. (Observation Point 13) Direction: Northeast. View of Pipeline ROW through rangeland on the North Segment. Vegetative growth was approximately 60% ground cover. Dominant species included smooth brome, crested wheat grass, and oats. Soil was replaced to match existing topography.

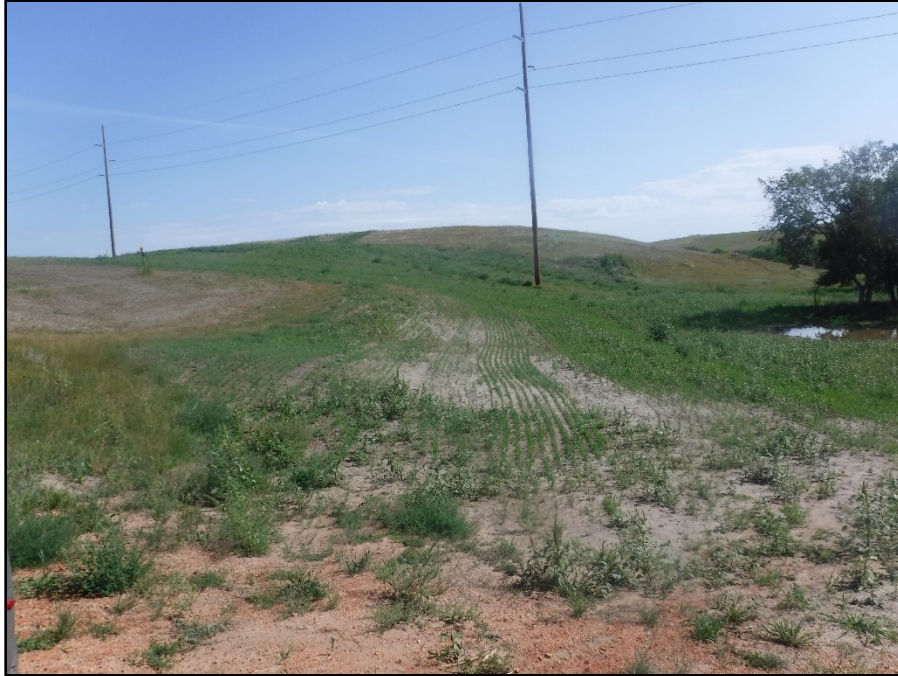
Photo 25. (Observation Point 14) Direction: Northeast. View of pipeline ROW along a slope on the Northern Segment. Vegetative growth was limited in this area, growing to about 40% cover with 60% bare ground. These conditions could make this hillslope susceptible to erosion. Note the woody draw on the right hand of the photo.

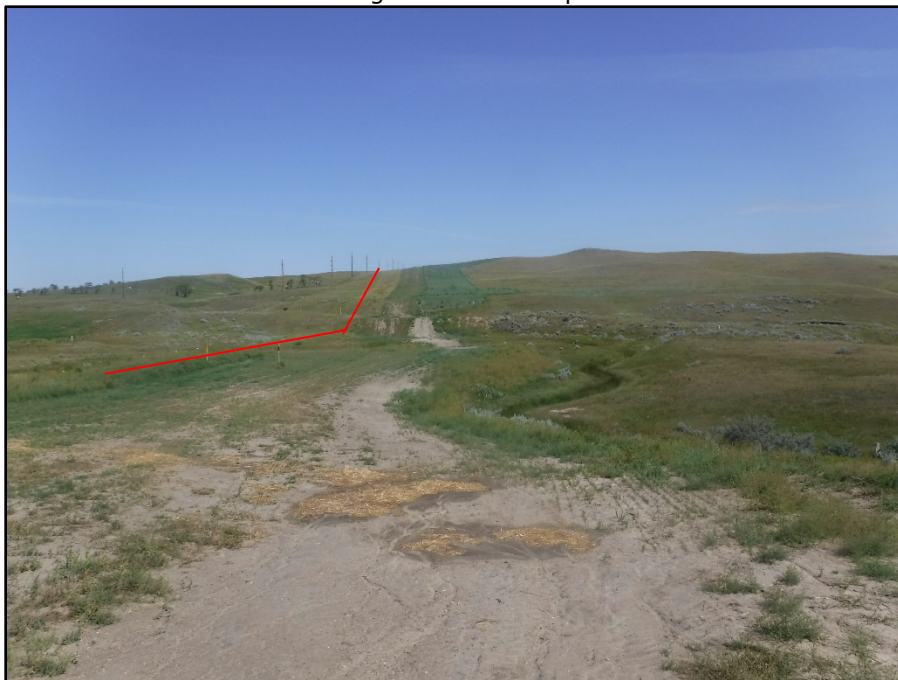
Photo 26. (Observation Point 15) Direction: North. Three adjacent pipeline corridors run north and south, crossing Sevenmile Creek and an intermittent stream tributary to Sevenmile Creek. According to Mr. Begley, Andeavor horizontally drilled underneath the streams in this area. Vegetation growth within the Andeavor ROW has been somewhat successful (Andeavor ROW depicted by red line), with 60-80% cover. Andeavor may need to conduct additional remediation measures if it contributed to the bare soil in this area. Only minor erosion had occurred during the time of the inspection.

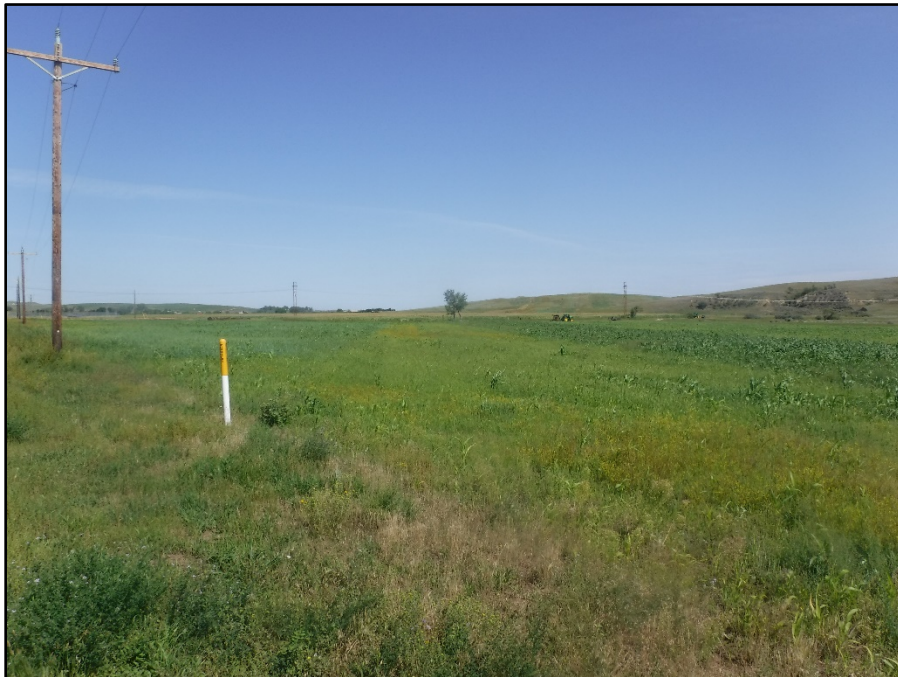
Photo 28. (Observation Point 16) Direction: Northwest. View of Pipeline ROW through cropland. The ROW was seeded with grasses. A difference in color was noted between vegetation in the ROW and vegetation outside, but regrowth is generally the same throughout the field. Note the pipeline marker in the foreground.

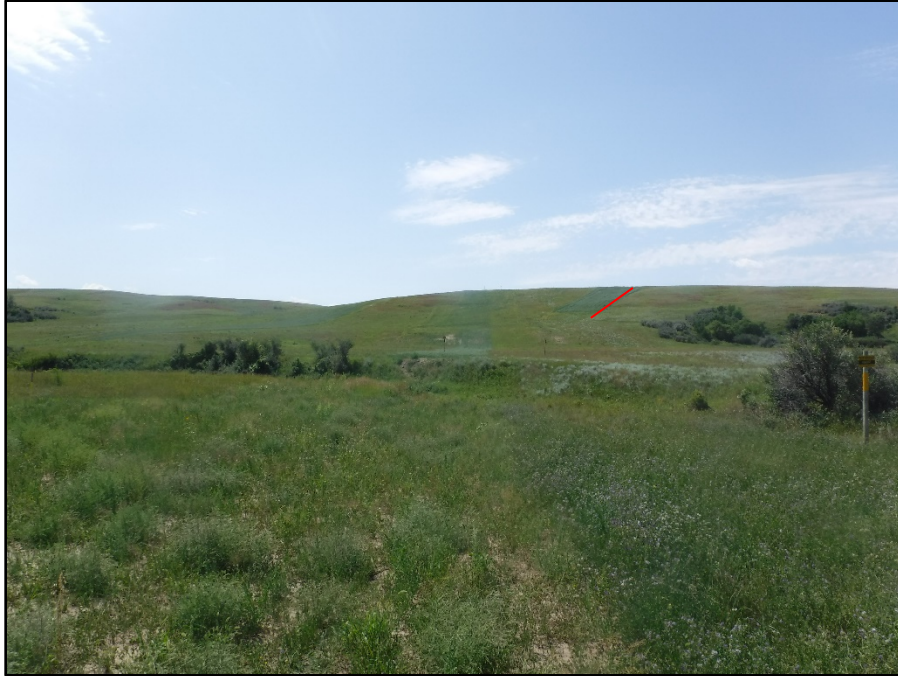
Photo 29. (Observation Point 17) Direction: South. View of a temporary workspace along the North Segment where Andeavor horizontally drilled under Northfork Creek. Vegetative regrowth was successful in the ROW. Disturbance along the stream bank was caused by wood mats Andeavor laid across the stream bank for transportation of heavy construction equipment. Note the red line depicting the Andeavor ROW continuing to the southwest, up the slope on the other side of the channel.

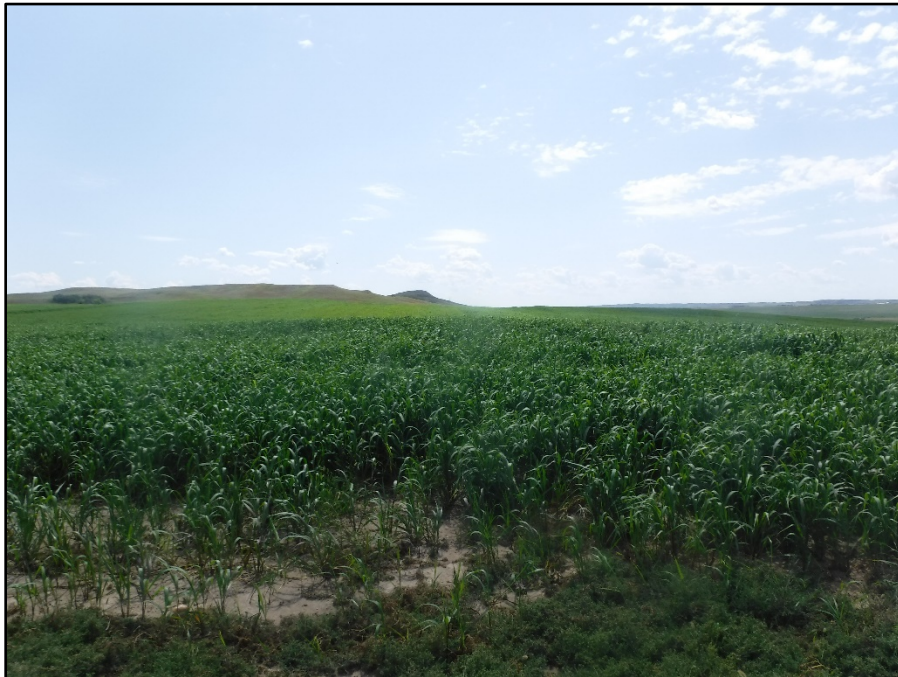
Photo 30. (Observation Point 18) Direction: South. View of pipeline ROW through a corn field.
