Public Service Commission

June 13, 2019

The North Dakota Public Service Commission (Commission) has reviewed your filing, dated May 15, 2019, regarding your land located in the NW $\frac{1}{4}$ of Section 34, T146N, R88W.

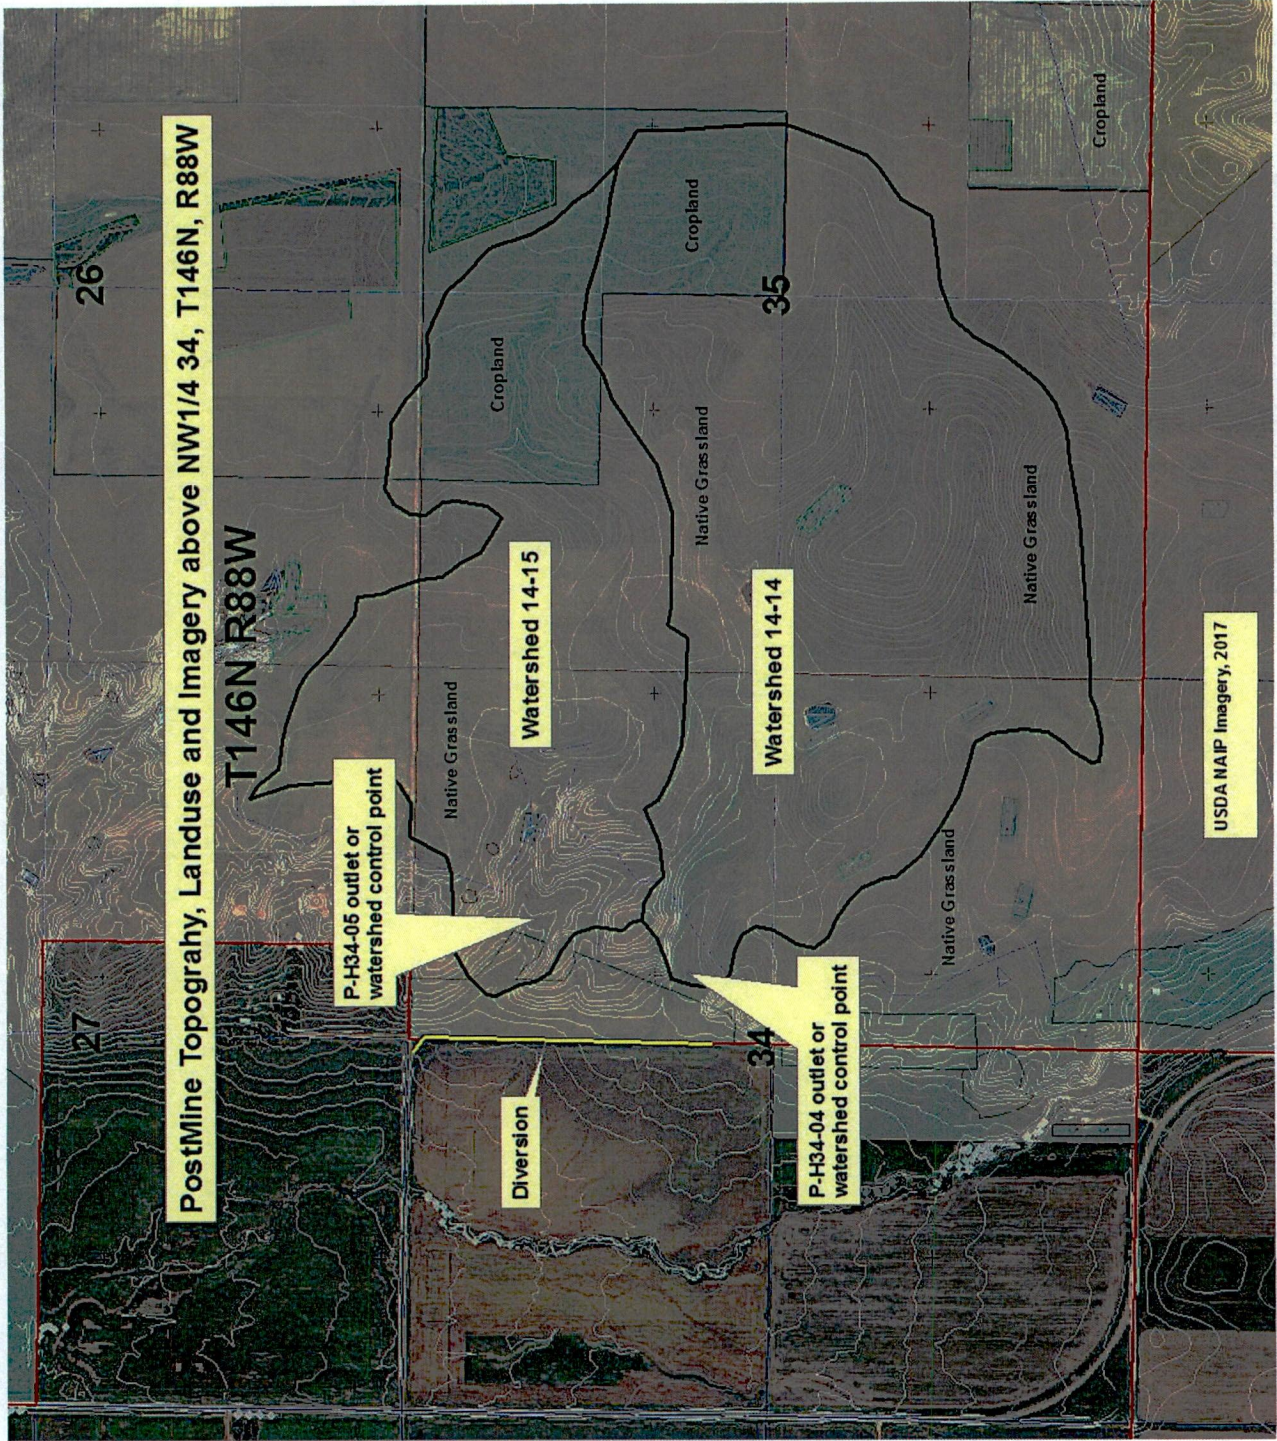
PostMine Topography, Landuse and Imagery above NW1/4 34, T146N, R88W

Our analysis shows that even though the total combined watershed size increased after reclamation, the expected total flow rates and volumes are less than the premine condition. This is due to a number of reasons but is primarily due to the reclaimed or postmine watersheds being less steep than the premine watersheds. The premine average slope of watershed 14-15 was 12.7% and the postmine average slope is 4.4%. In addition, the shallow and claypan soils that were common in the premine watershed were replaced with deeper, loamy soils with higher infiltration rates. In addition, there is less cropland and more native grassland in the reclaimed watershed than in the premine watershed. The perennial native grassland vegetation generally has a lower runoff potential than cropland.

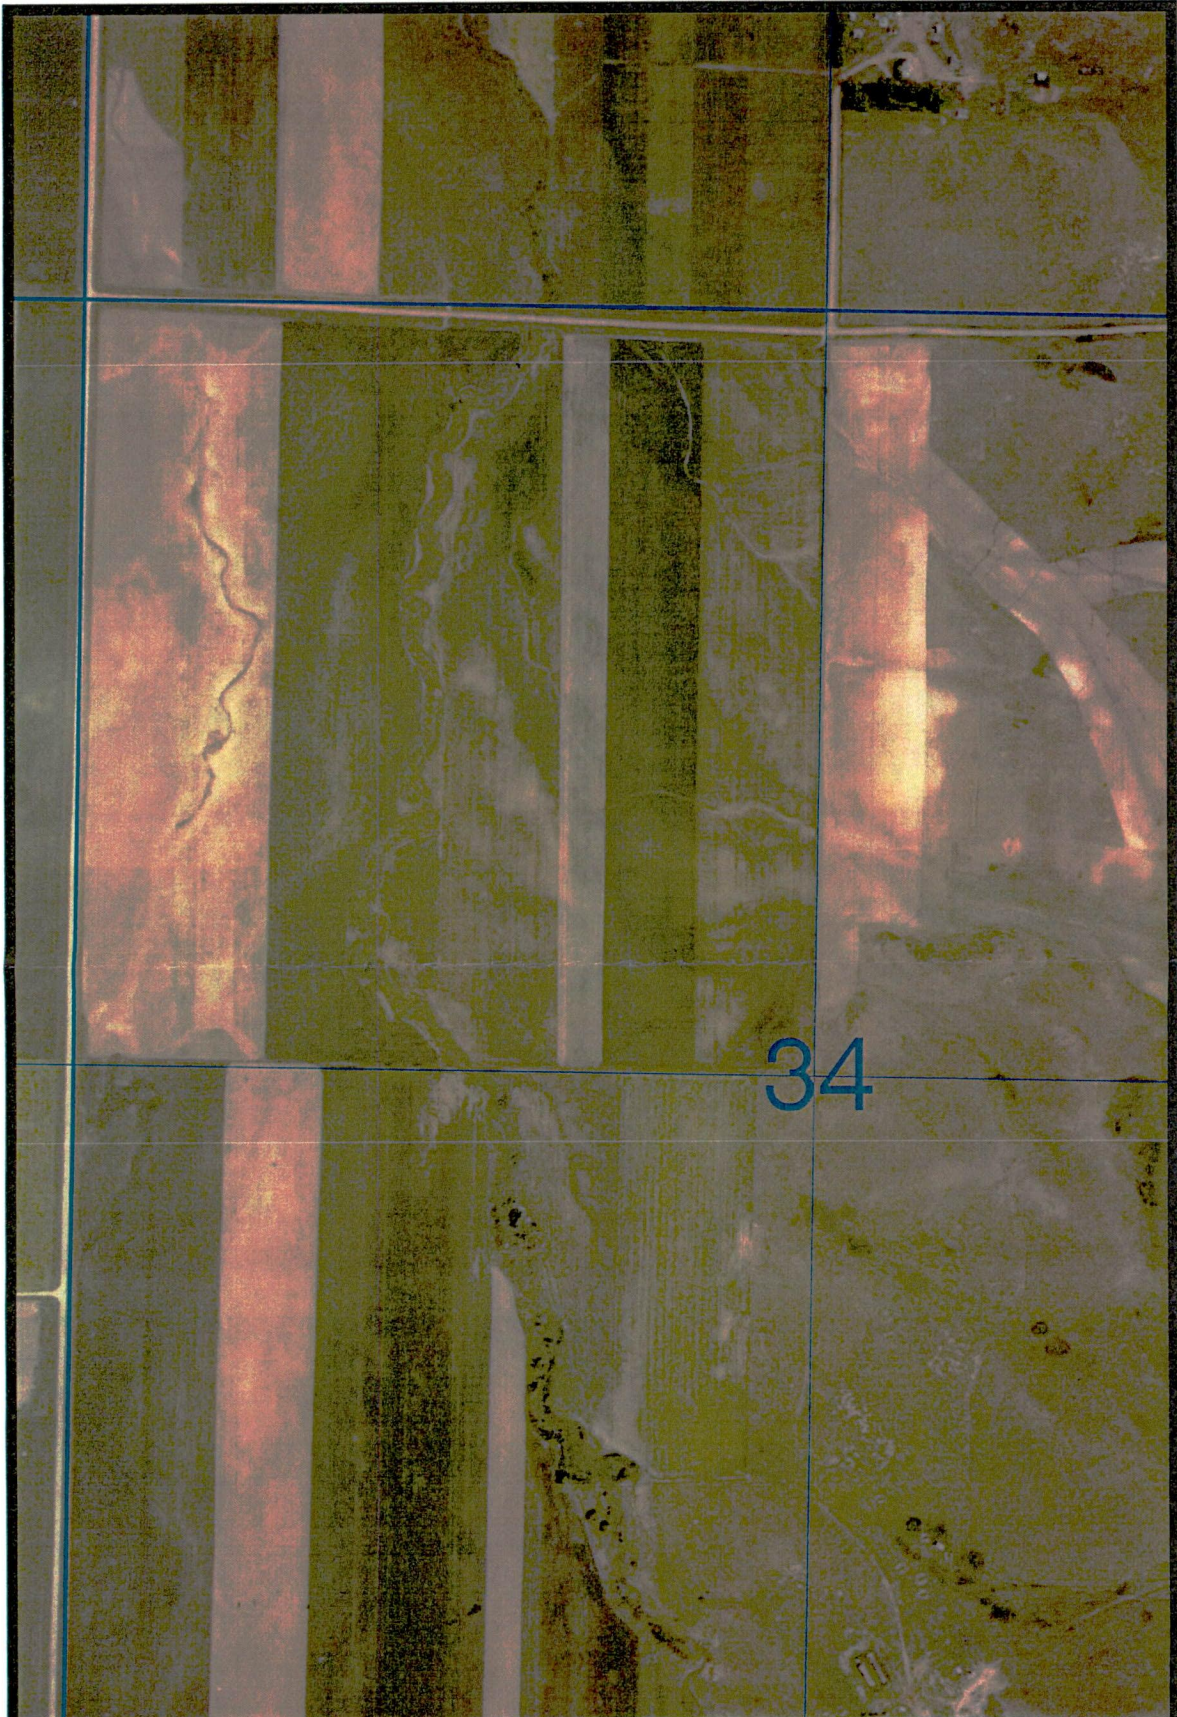
COTEAU <small>THE COTEAU MINING COMPANY</small>	FREEDOM MINE BEULAH, ND 58523
	FIGURE 1 AERIAL PHOTO 1977
SCALE: 1"=400' PROJECT:	PAPER SIZE 11"x17" REVISION:

There is evidence that there has been a long-term erosion problem in the NW¼ of Section 34. Historical aerial photographs provide evidence of erosion prior to mining and reclamation. Google Earth contains aerial photos dating back to 1995, prior to any mining having taken place in the watersheds above your property. The 1995 aerial photo shows the same erosion and

It should be noted that flows during mining and following mining are less than the flows which occurred pre-mining. It should also be noted that erosion and flooding occurred in the subject field long before mining, as can be shown by viewing aerial photos, including Figures 1 and 2, dating back several decades prior to Coteau entering the area.

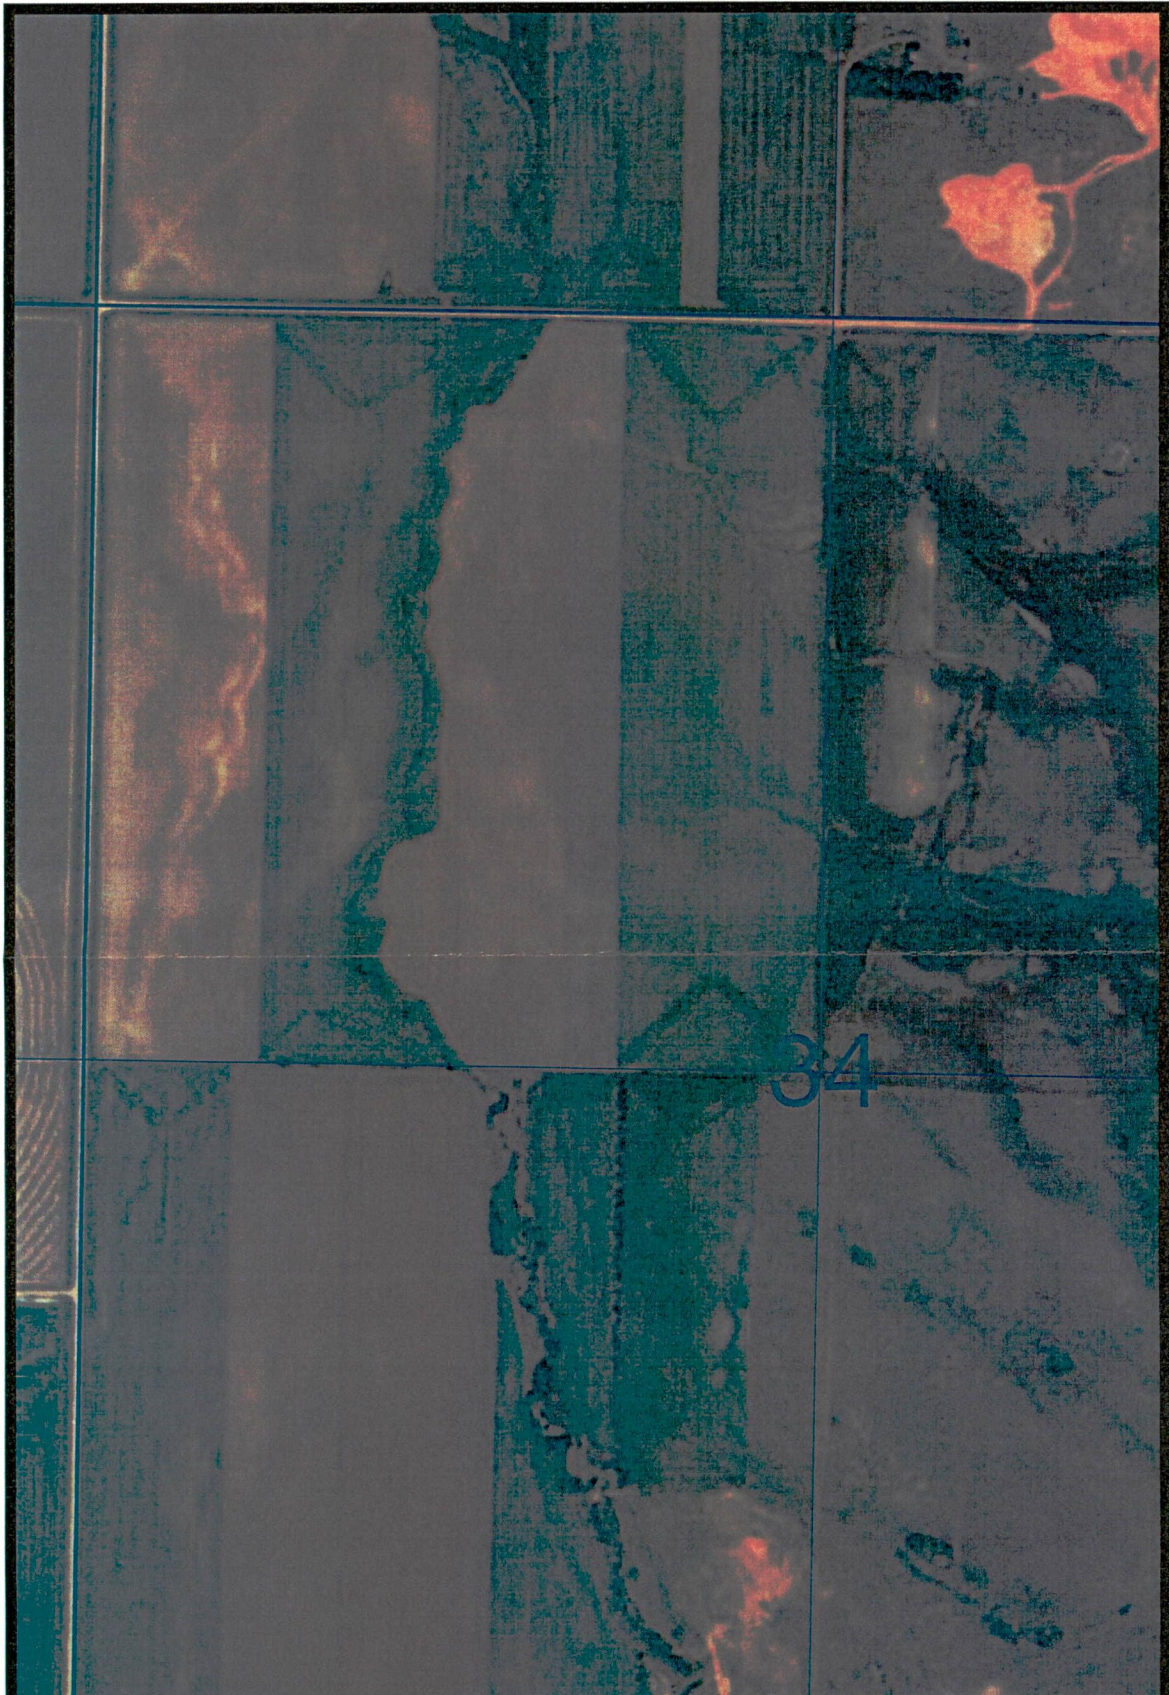
FIGURE 2
 AERIAL PHOTO
 JULY 2, 1996

drainage patterns as pointed out on Page 9 of 17 of the PSC and OSMRE Complaint: Eisenbeis Farmland. In addition, Attachment No. 4 includes aerial photos from 1977 and 1996 that show similar erosion and drainage patterns. We believe the field-engineered diversion was constructed as an attempt to minimize runoff and reduce erosion well before the adjacent area was permitted, mined, and reclaimed. As previously pointed out, runoff from the upstream areas was routed around your property during mining and reclamation activities via pipe discharges to natural drainage at the north end of property. Runoff from upstream areas continues to be routed around property via the reconstructed diversion.

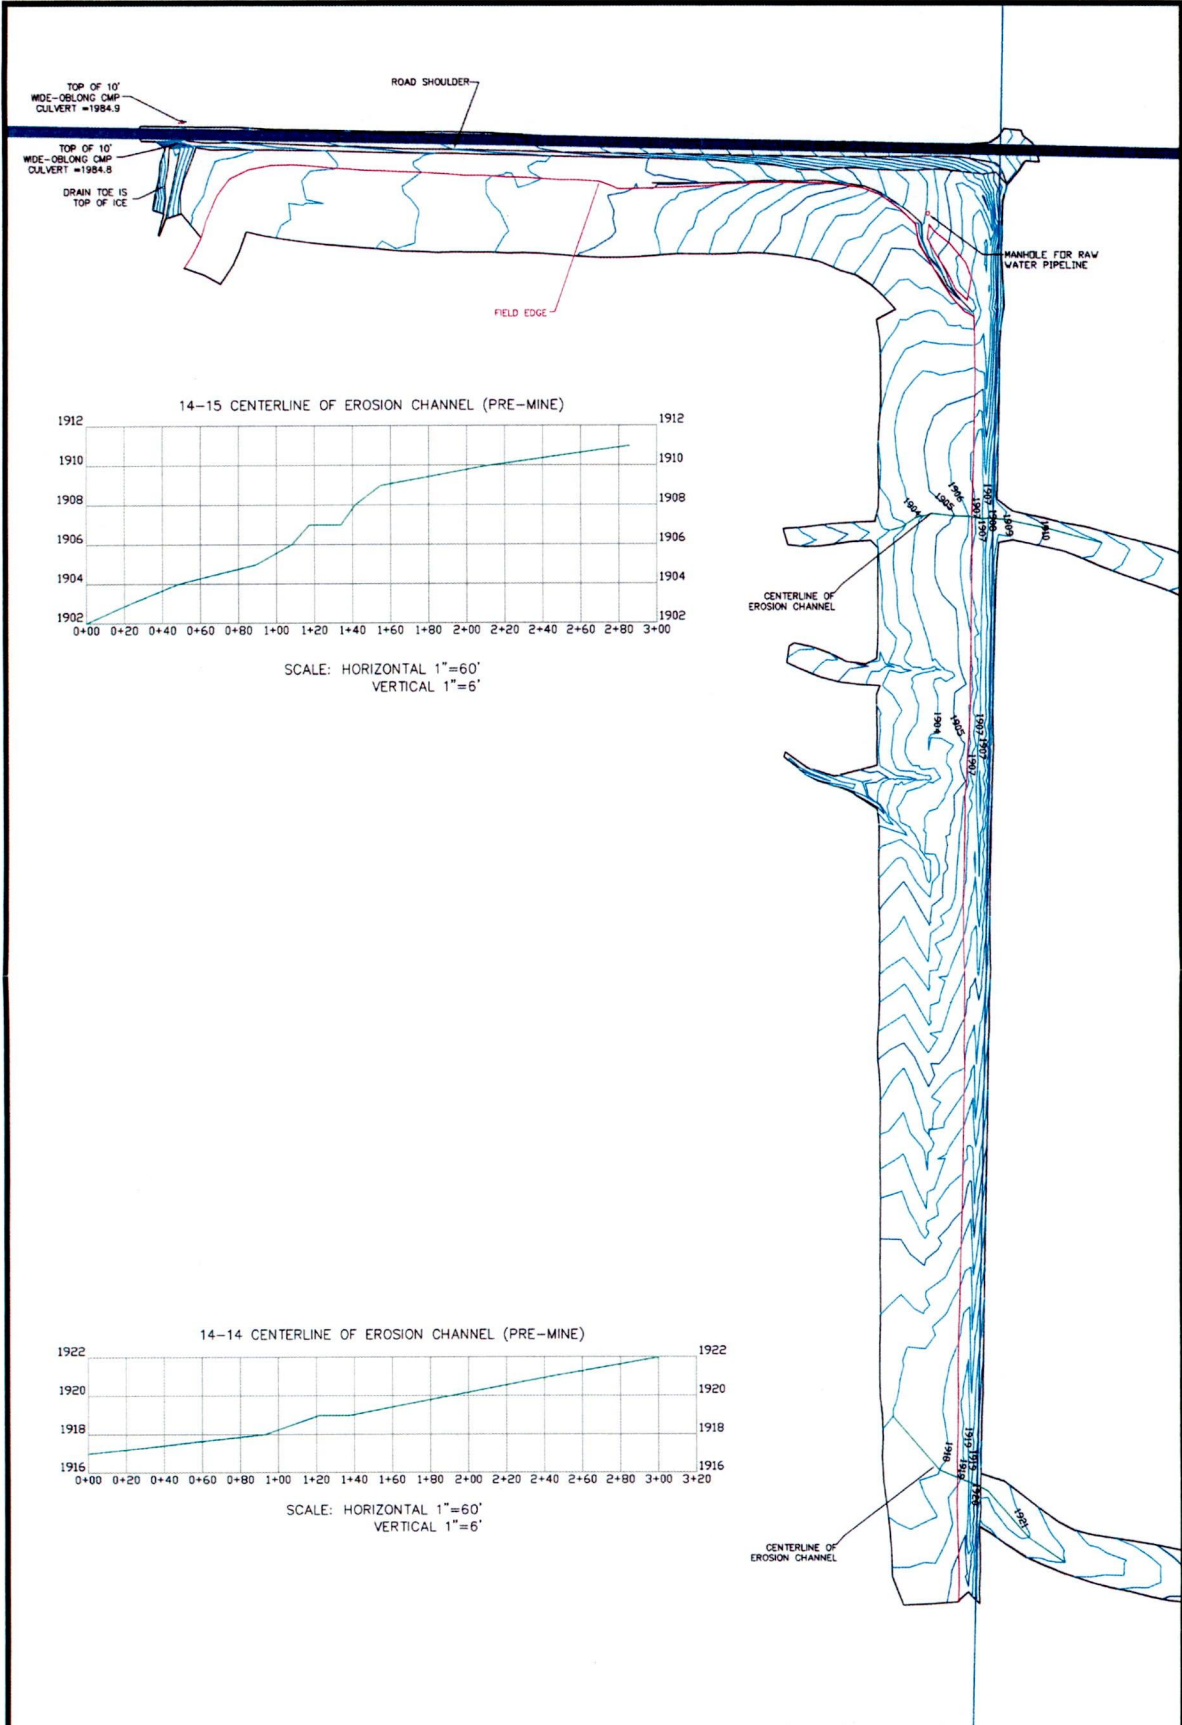
The producer approached Coteau in both 2010 and 2011 about aiding in repairing erosion in the field while the sediment ponds were in place and functioning. Additionally, Figure 3 is the original ground topography survey prior to reconstruction of the diversion. As can be seen in the drawing, there are several areas that show erosion west or below the diversion. Figure 3 includes two cross-sections of the existing diversion, one at the entrance of watershed 14-14 and one at the entrance of watershed 14-15. Both cross-sections indicate that runoff would flow across the diversion to the west uninterrupted. This survey was collected on November 29, 2011, after installation of the sedimentation ponds, but prior to the reconstruction of the diversion or removal of any sedimentation ponds.
