RE: Request

The PSC Commissioner Meeting, 12 Jun 2019, Questions not allowed.  
15-May-2022

# PSC Formal Complaint Decision Letter - Appendix A

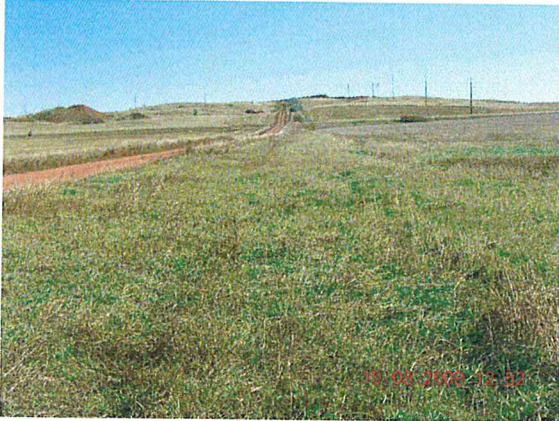
Road ditch on 8 Oct 2008

- 4) Why did the PSC not question the contents of that NAC letter? The PSC photos dated 8 Oct 2008, prove the ditches were not filled with sediment.
- 5) Why did the PSC not question the missing statements about the mining sedimentation pond water overflowing onto the Esther Eisenbeis farmland?

The diversion ditch was not in poor condition. It was not filled with sediment. This can be verified by the PSC photo dated 8 Oct 2008.

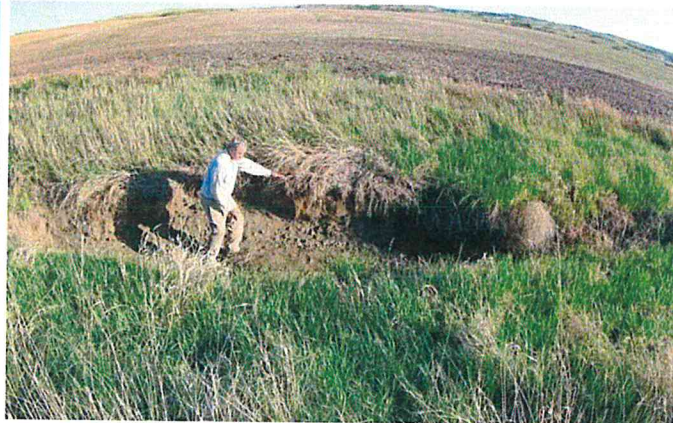
Road ditch on 3 Jun 2021

- 8) Will NAC be held accountable for a dishonest letter that was used to make a PSC final decision?
- 9) Why does the PSC not question NAC why NAC deepen the road ditch if it is not mining related? Did NAC deepen the road ditch to penalize the Eisenbeis family because they did not allow NAC to discharge more pond water from the south mine into the farmland creek?

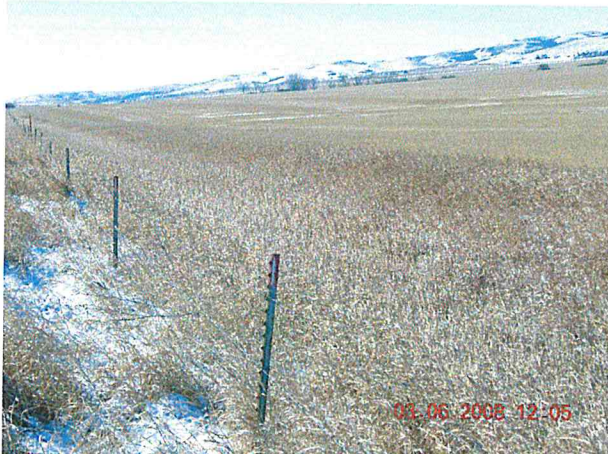
Diversion ditch on 8 Oct 2008

The diversion was in poor condition. It was silted in areas and blown out in others. There were also small trees or shrubs growing in the diversion channel. There was little to no elevation difference between the field and diversion bottom and between the field, ditch bottom, and the road top. The ditch had filled in with sediment over the years and when water did flow in this area, it mostly flattened out over a broad area and flooded into the adjoining field.

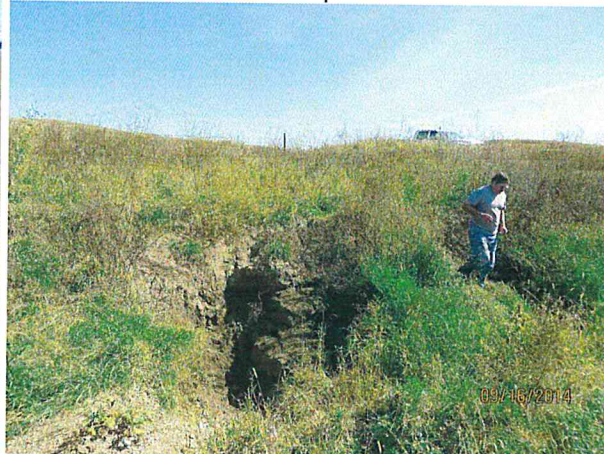
Diversion ditch on 16 Sep 2014

We are aware that the rebuilt diversion overflowed twice, both times in 2014. One overflow event took place on the south end of the reconstructed diversion and was likely due to snow blocking the diversion channel making it non-functional during a snowmelt event. The other overflow event took place in August 2014 following a significant rainfall event in excess of the design standard that caused sediment pond P-H34-05 to overflow. The watershed 14-15 outlet into the reconstructed diversion washed out causing the diversion to overtop. The pond overflow was not considered a violation since adequate storage was provided in sediment pond P-34-05 to contain a 10-year/24-hour event. We are aware that the erosion associated with these events was repaired by Coteau.

1) This contradicts the PSC photos and reports. The diversion overflowed in 2011, 2014, and 2017. See FCC photos on pages 8 and 9 and in the PSC Inspection Report dated 26 Apr 2018 (Appendix C at Beulah.FoxPing.com).

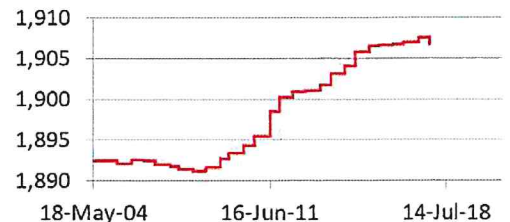
Water Table MP03-P01B (elevation in feet)

For proof, look at the increase in water table elevation increases a half mile south of the farmland (the opposite direction of Lake Sakakawea) beginning in 2011.
