Public Service Commission

State of North Dakota

June 13, 2019

The North Dakota Public Service Commission (Commission) has reviewed your filing, dated May 15, 2019, regarding your land located in the NW $\frac{1}{4}$ of Section 34, T146N, R88W.

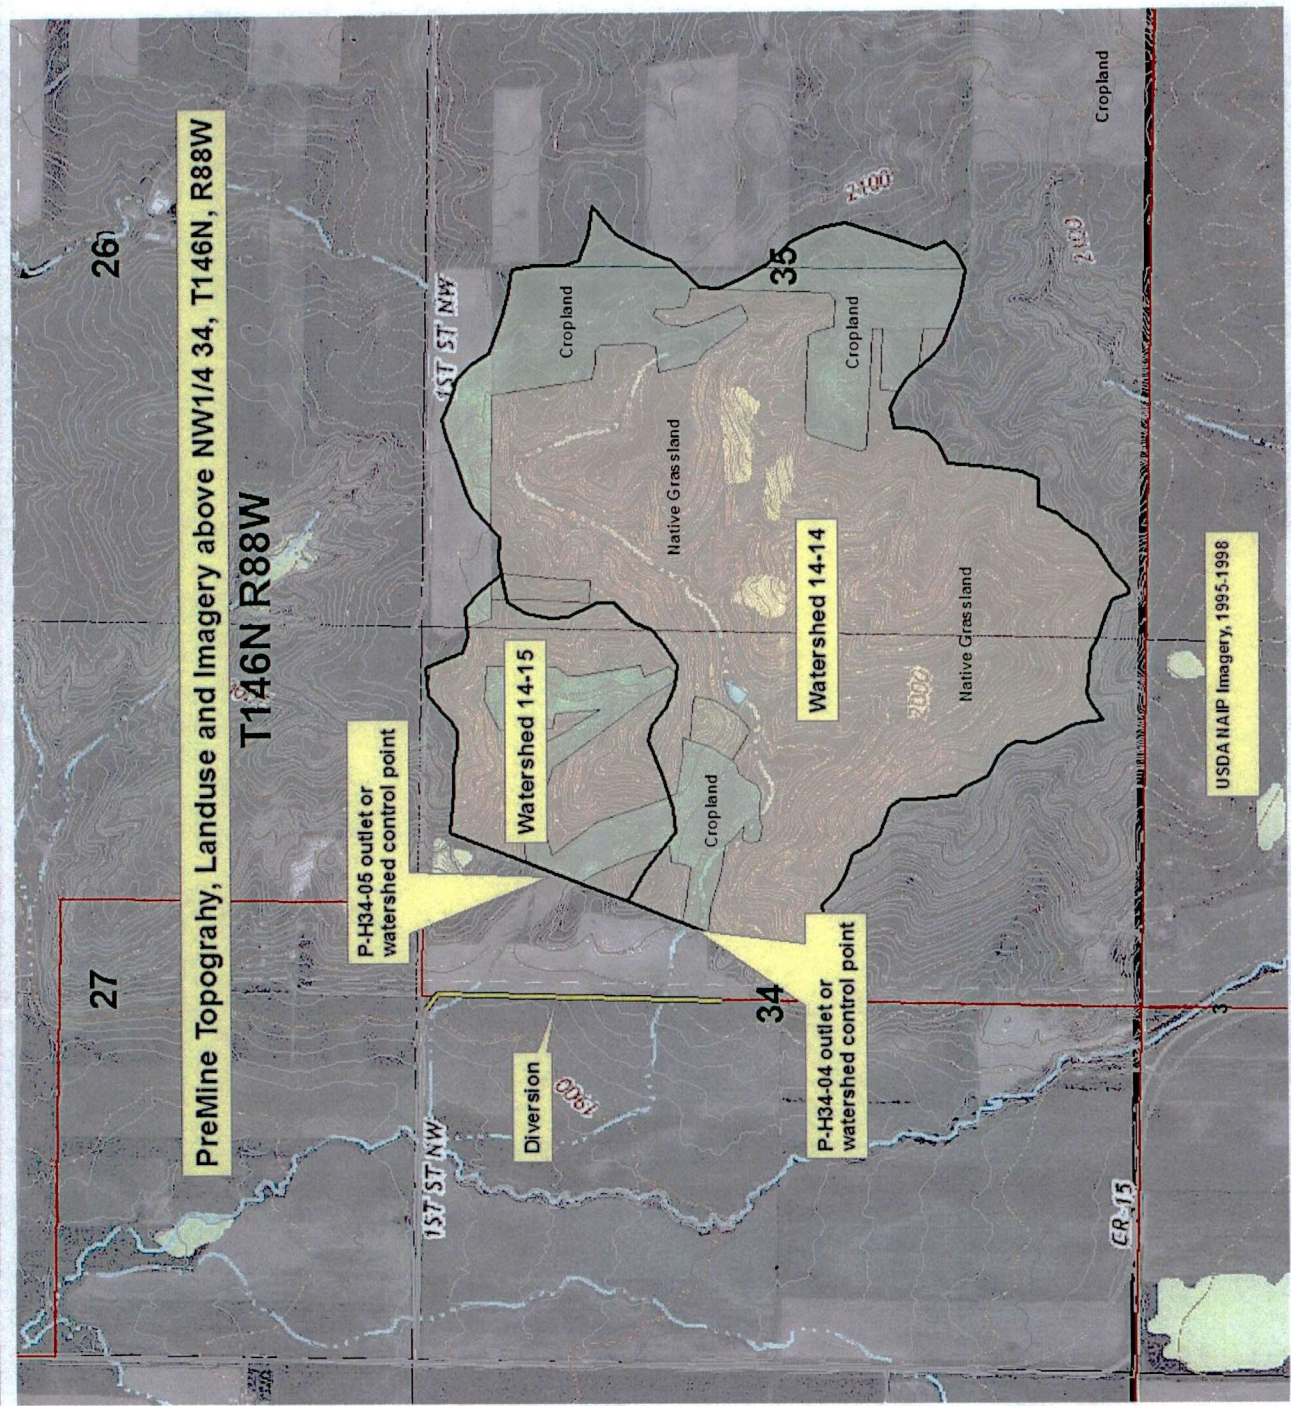
PreMine Topography, Landuse and Imagery above NW1/4 34, T146N, R88W

There is evidence that there has been a long-term erosion problem in the NW¼ of Section 34. Historical aerial photographs provide evidence of erosion prior to mining and reclamation. Google Earth contains aerial photos dating back to 1995, prior to any mining having taken place in the watersheds above your property. The 1995 aerial photo shows the same erosion and

drainage patterns as pointed out on Page 9 of 17 of the PSC and OSMRE Complaint: Eisenbeis Farmland. In addition, Attachment No. 4 includes aerial photos from 1977 and 1996 that show similar erosion and drainage patterns. We believe the field-engineered diversion was constructed as an attempt to minimize runoff and reduce erosion well before the adjacent area was permitted, mined, and reclaimed. As previously pointed out, runoff from the upstream areas was routed around your property during mining and reclamation activities via pipe discharges to natural drainage at the north end of property. Runoff from upstream areas continues to be routed around property via the reconstructed diversion.

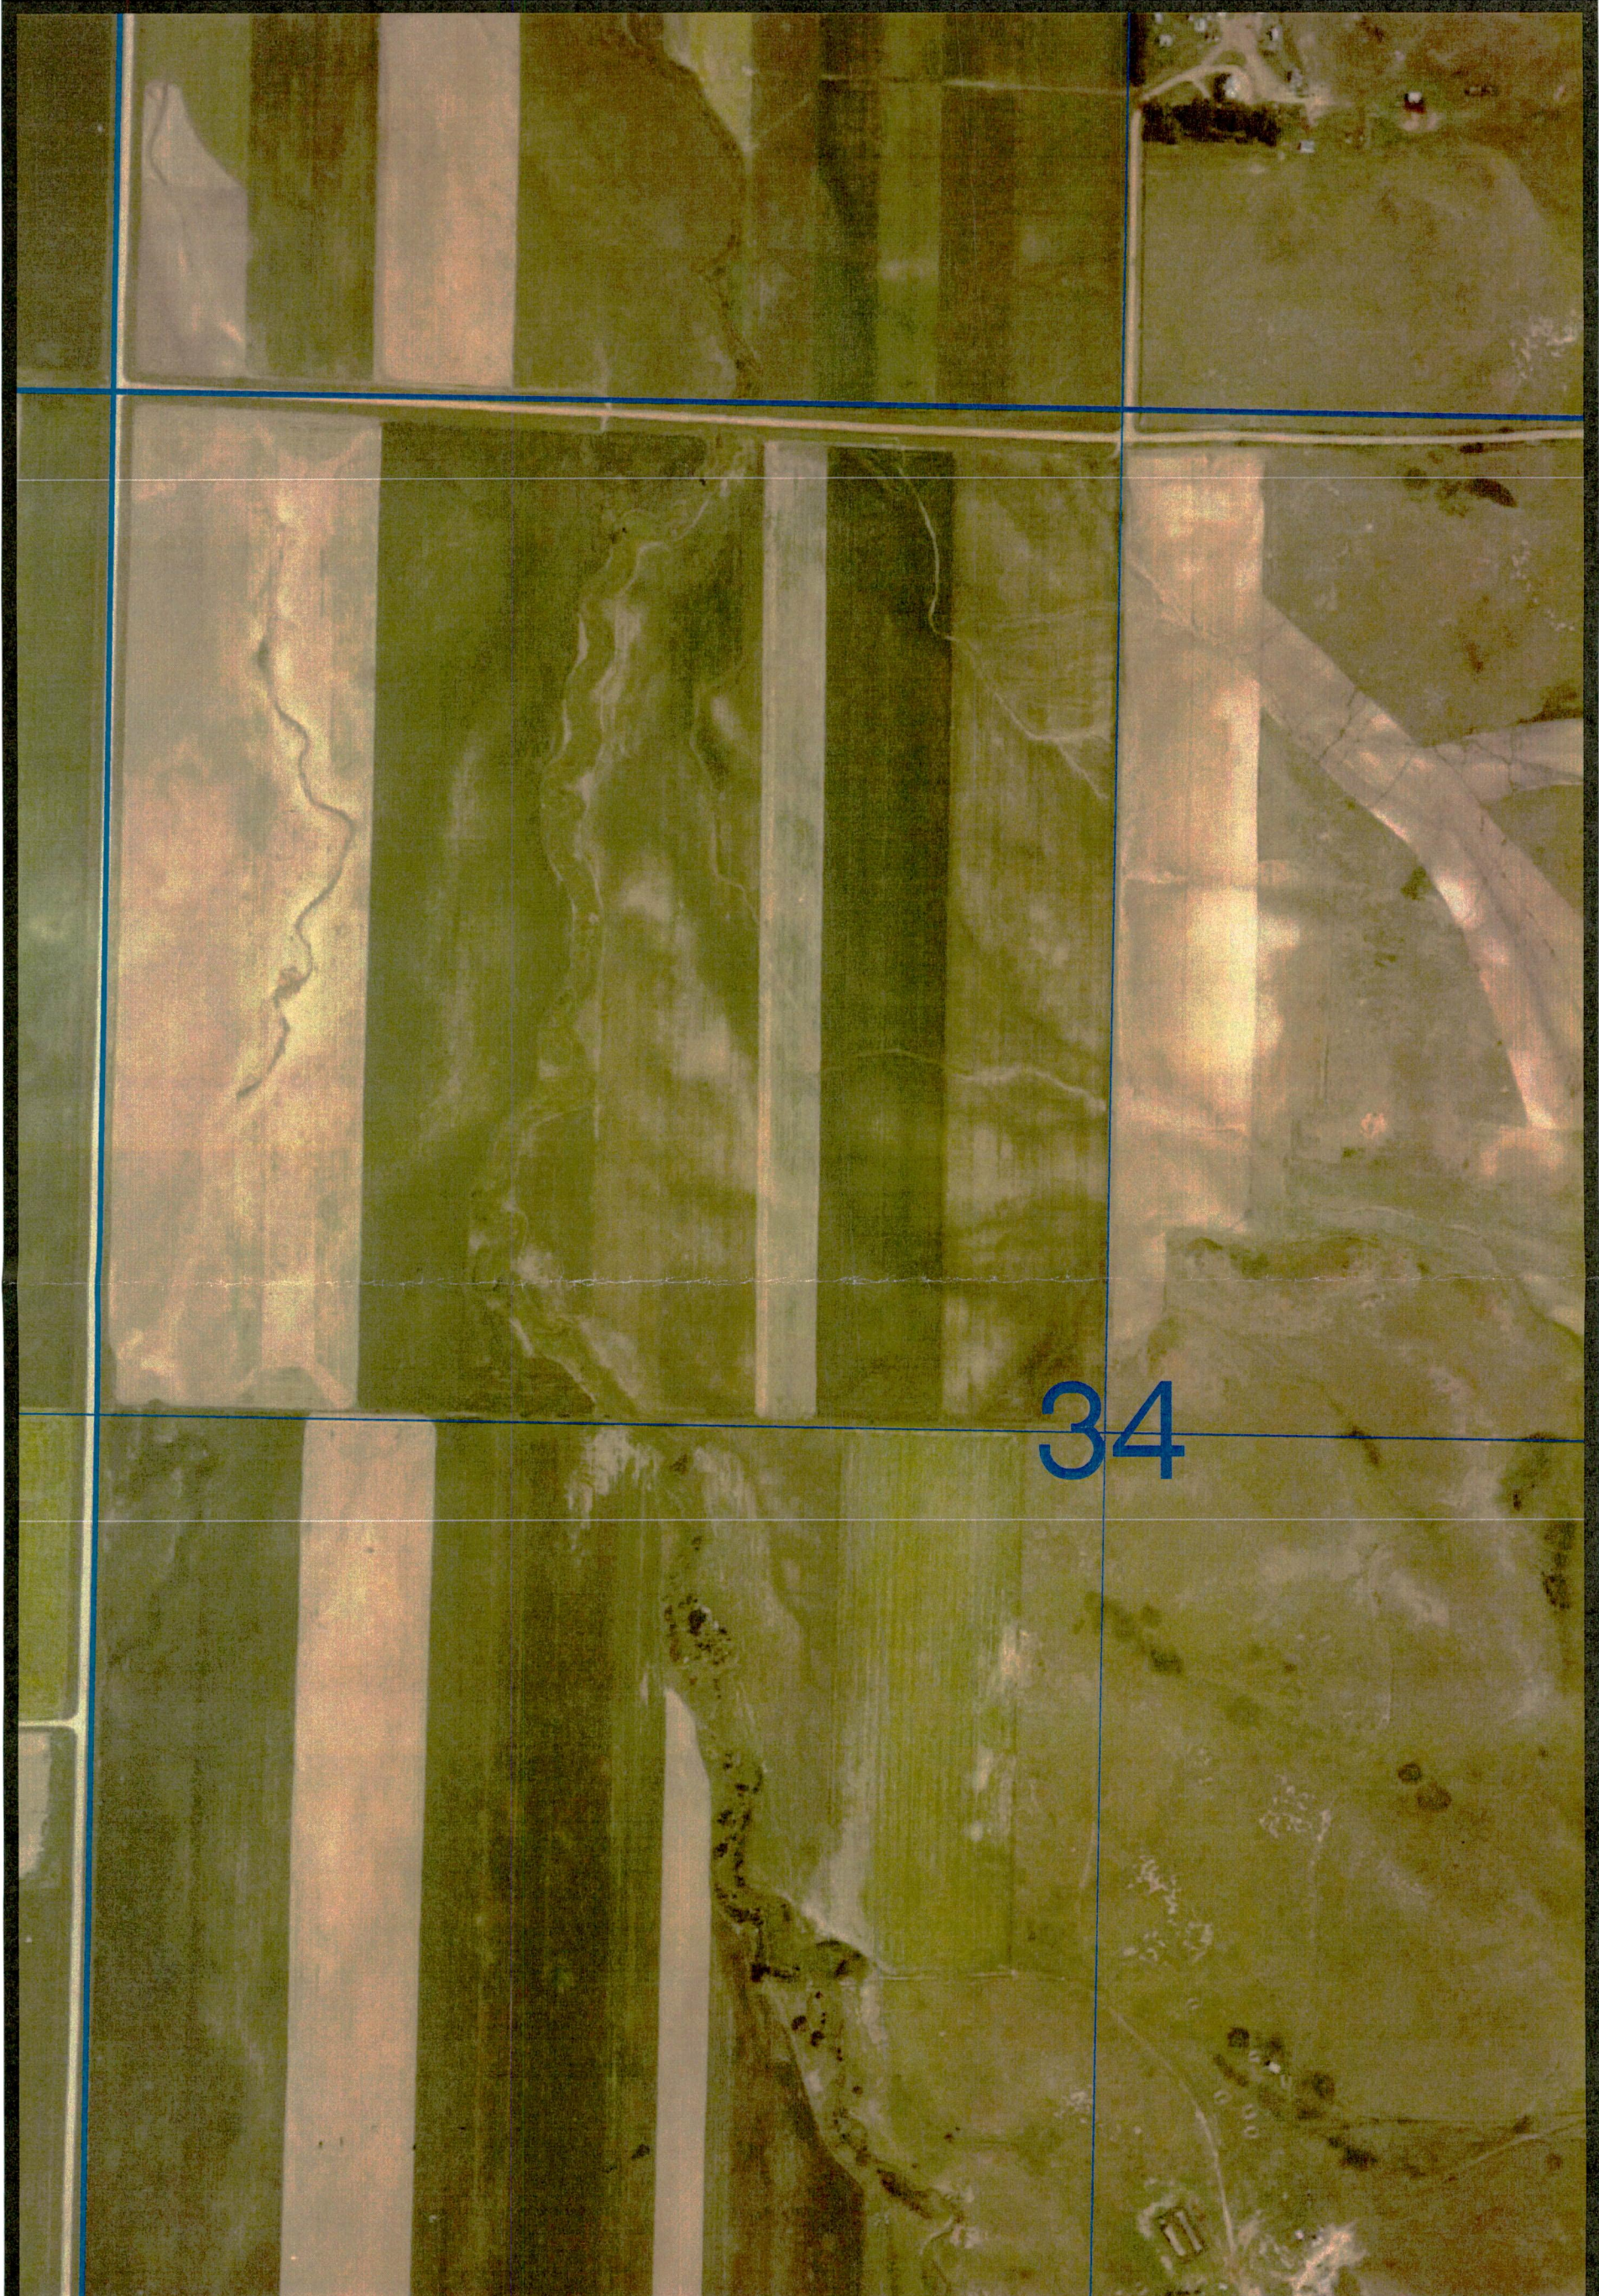
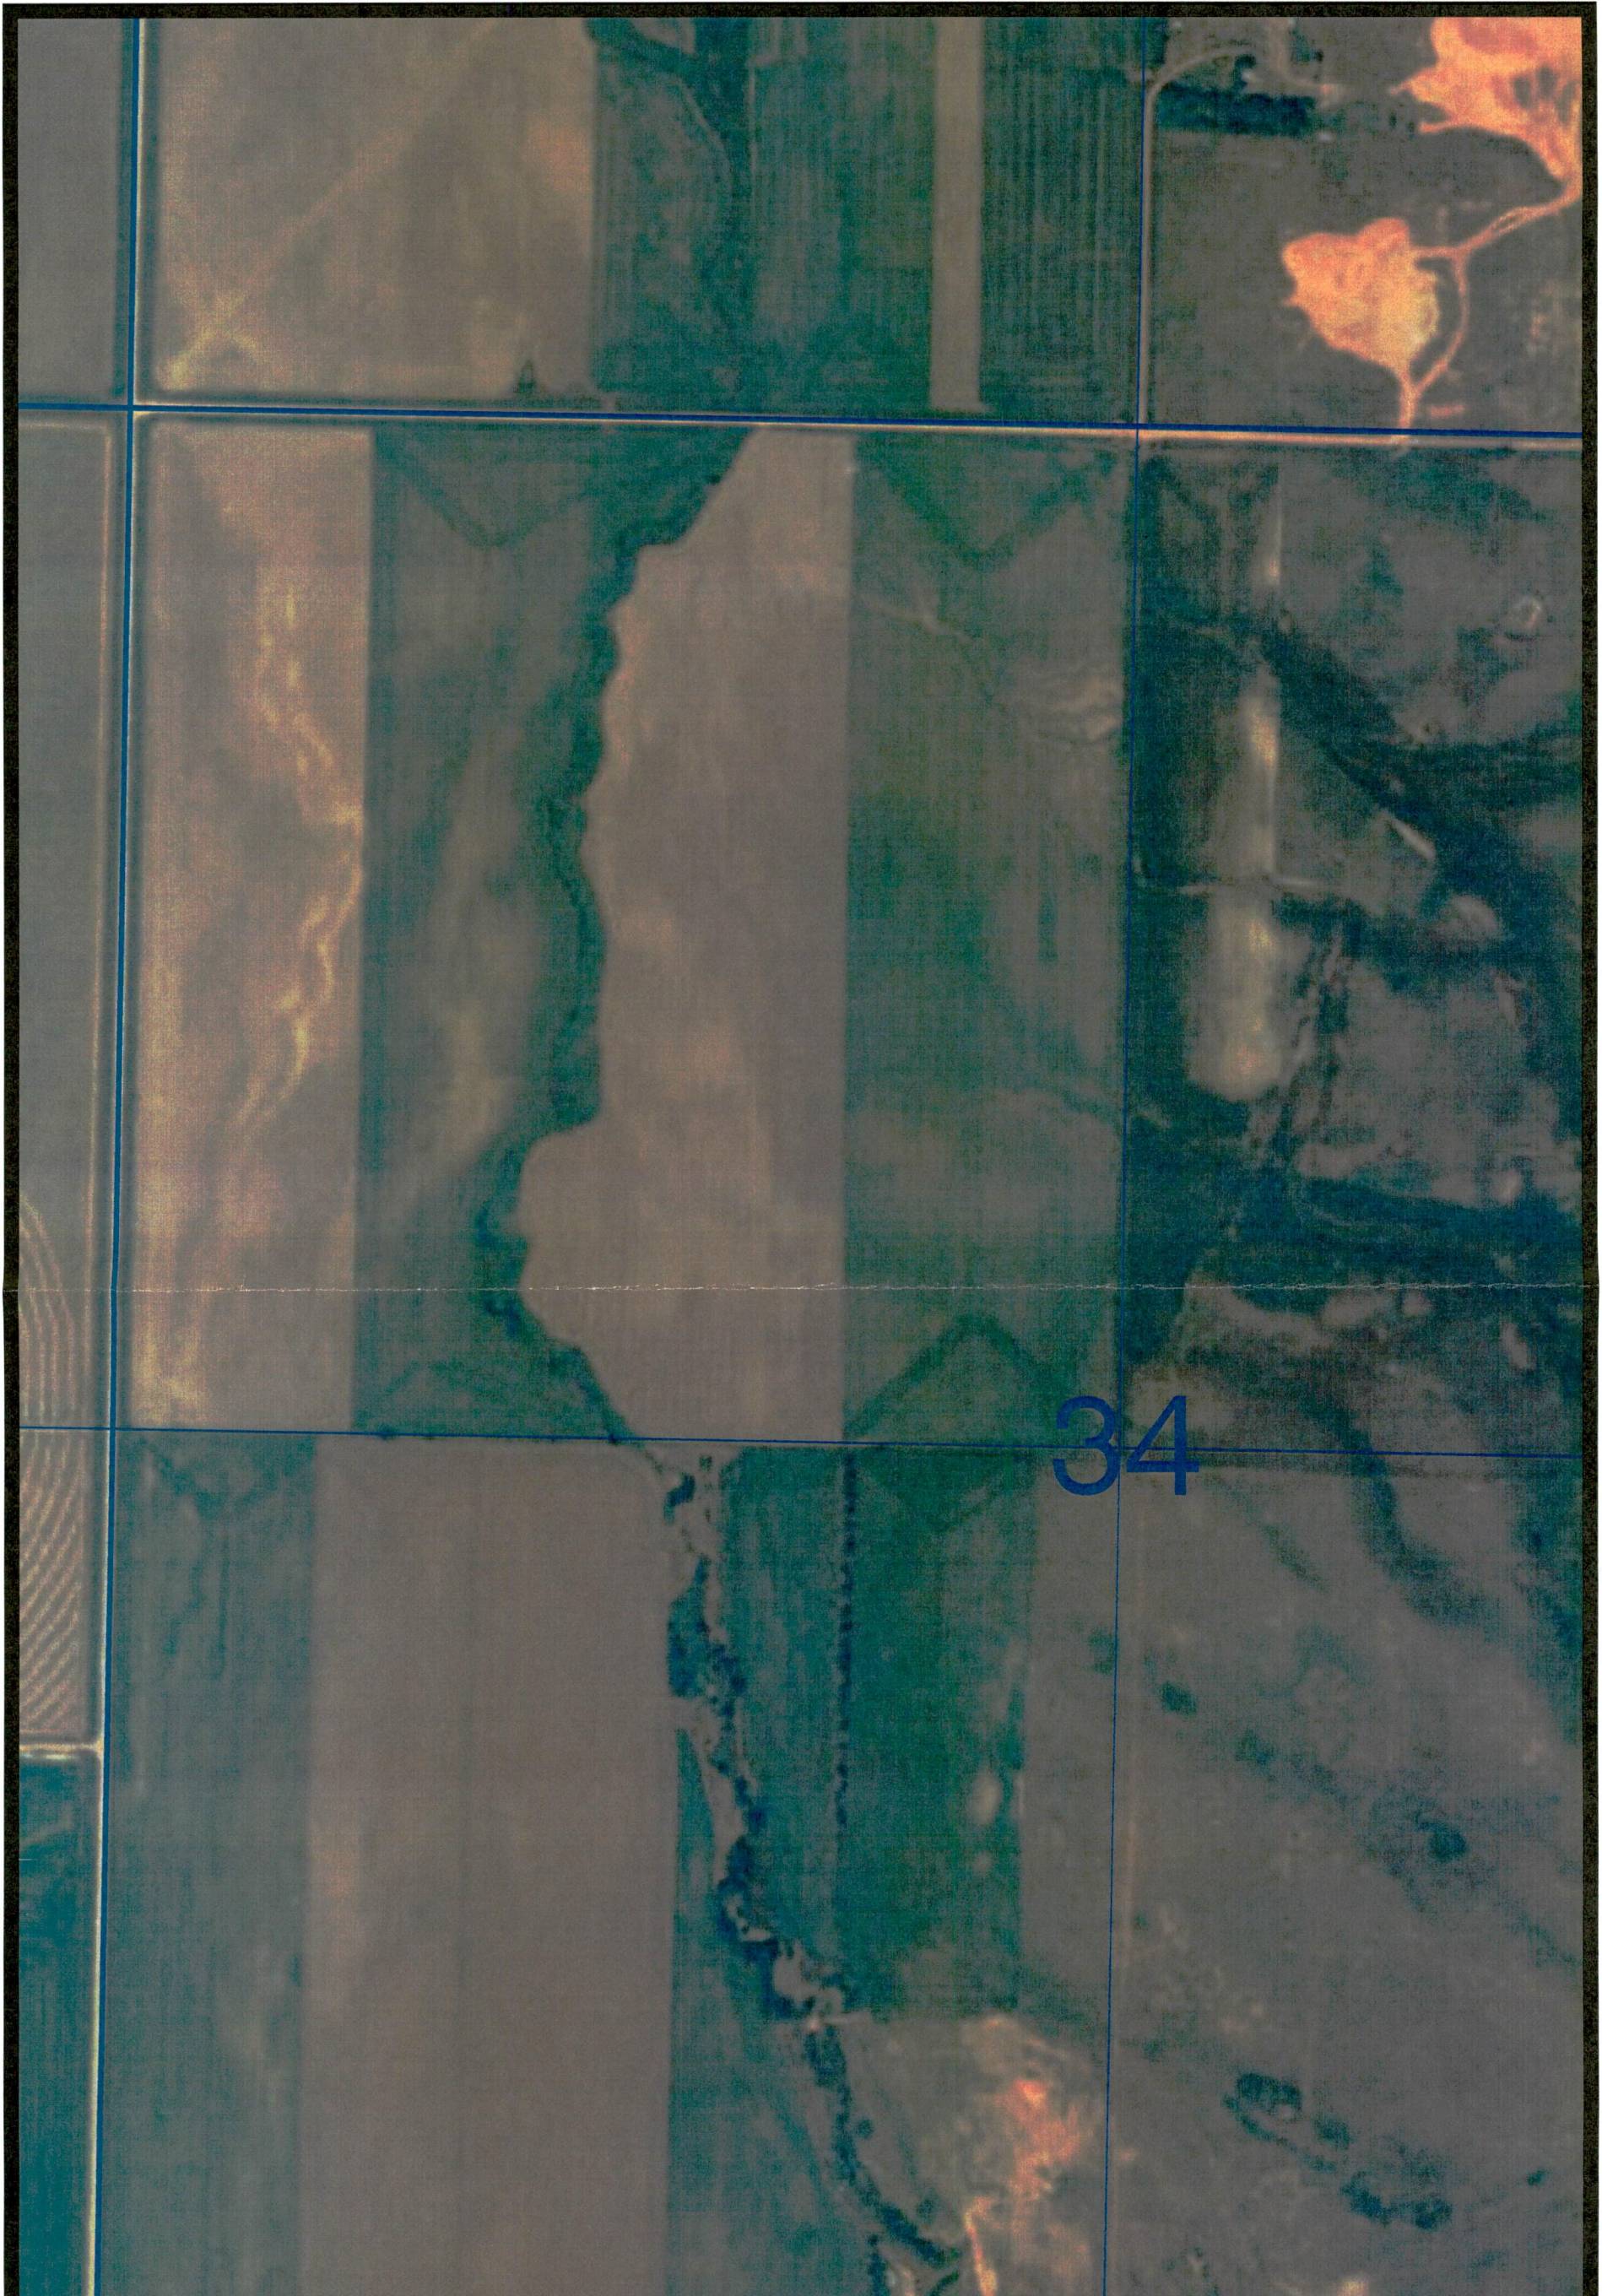
It should be noted that flows during mining and following mining are less than the flows which occurred pre-mining. It should also be noted that erosion and flooding occurred in the subject field long before mining, as can be shown by viewing aerial photos, including Figures 1 and 2, dating back several decades prior to Coteau entering the area.

The producer approached Coteau in both 2010 and 2011 about aiding in repairing erosion in the field while the sediment ponds were in place and functioning. Additionally, Figure 3 is the original ground topography survey prior to reconstruction of the diversion. As can be seen in the drawing, there are several areas that show erosion west or below the diversion. Figure 3 includes two cross-sections of the existing diversion, one at the entrance of watershed 14-14 and one at the entrance of watershed 14-15. Both cross-sections indicate that runoff would flow across the diversion to the west uninterrupted. This survey was collected on November 29, 2011, after installation of the sedimentation ponds, but prior to the reconstruction of the diversion or removal of any sedimentation ponds.
