PU-25-84
Hiland Crude, LLC
Hiland Express Spine Pipeline
Topsoil Inspection Report

File No. 193807520

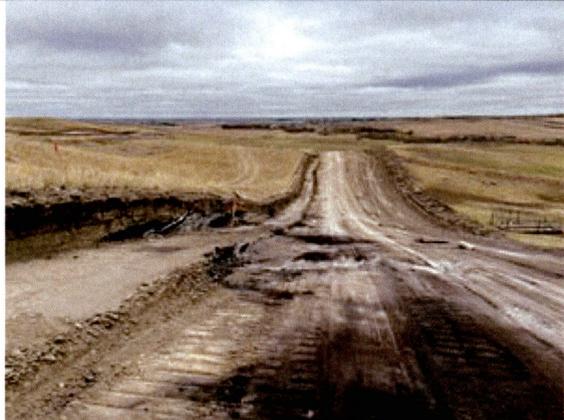
<p>Observation Point: 13 Date Taken: October 15, 2025 1:49 PM Direction Photo is Taken: North</p> <p>Photo Description: Area of excess topsoil depth, stripped well past the required 12". Use of biorolls observed in photo to mitigate erosion from steep slope/dropoff.</p> <p>Latitude: 47.71329825291326 Longitude: -103.29081561671842</p>
---	---

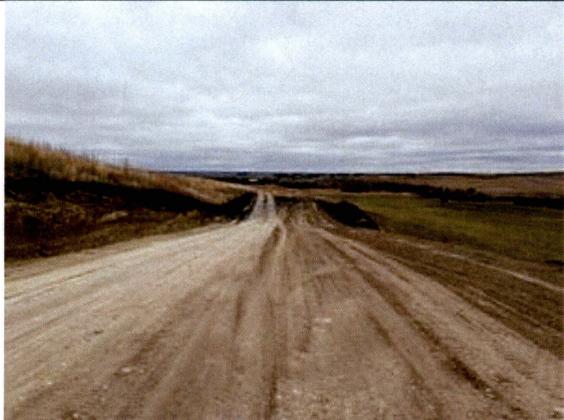
<p>Observation Point: 14 Date Taken: October 15, 2025 1:52 PM Direction Photo is Taken: North</p> <p>Photo Description: Topsoil stripped to full depth and proper segregation observed. Pipeline not yet installed in this area.</p> <p>Latitude: 47.71565041084372 Longitude: -103.29291175671906</p>
--	---

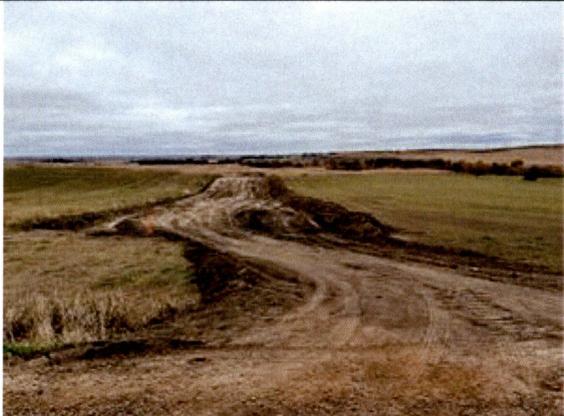
<p>Observation Point: 15 Date Taken: October 15, 2025 1:56 PM Direction Photo is Taken: North</p> <p>Photo Description: Topsoil stripped and segregated adequately.</p> <p>Latitude: 47.71791703658616 Longitude: -103.29281368429623</p>
---	--
