Architectural and Viewshed Report

An Architectural Survey and Viewshed Report for the Minnesota Power Longspur Wind Project Morton and Mercer Counties, North Dakota

PREPARED BY

Merjent, Inc.
1 Main Street SE, Suite 300
Minneapolis, Minnesota 55414

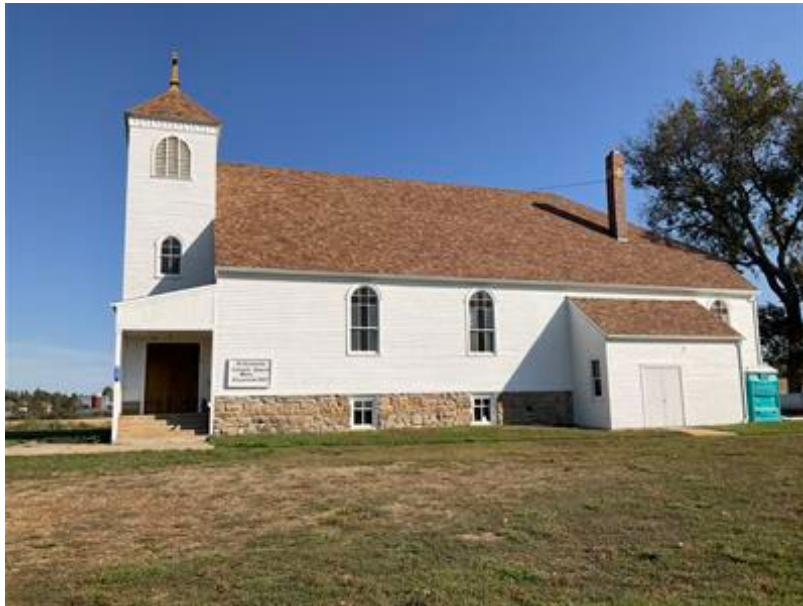
The church (see Photo 1 below) was constructed in 1937 after a 1905 wood-frame church was destroyed by fire. The current church is wood frame, with a stone foundation. The church is front gabled, with the façade facing west. The door opening is located in the southwest corner of the façade. The steeple juts from the front on the southern end of the façade. There are six window openings on the façade; two on the first level are two over two double hung windows; the remaining windows are six-light arched windows. Except for the steeple, the church is rectangular in shape. The north elevation has four arched, stained-glass windows. The south elevation has 2 arched, stained-glass windows on the west end. A lean to shed or storage addition is located on the east end of the southern façade. The church appears to be little altered from its 1937 construction (see Photo 1 below).

Photo 1: St. Clements Church. South elevation

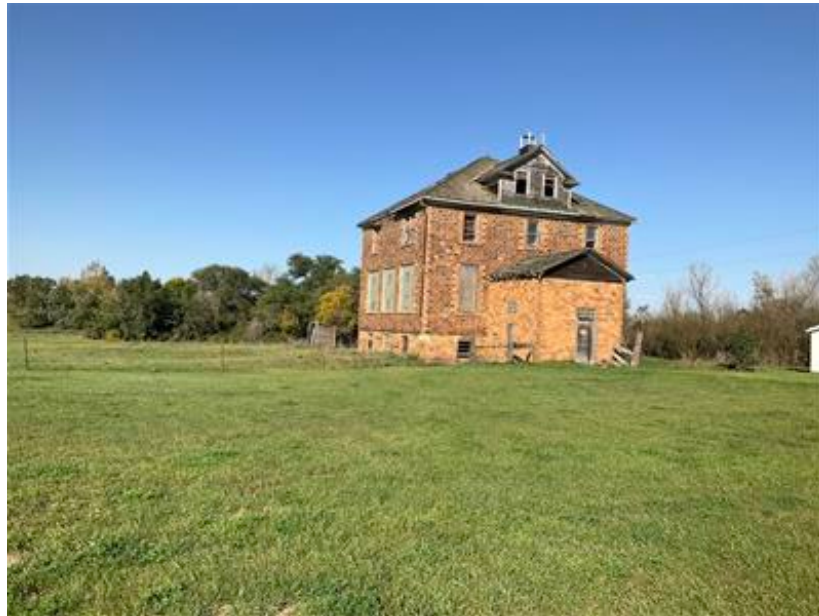
The property also contains a brick, two-story schoolhouse (see Photo 2). The schoolhouse appears to date to the early 20th century, and most likely was built around the same time as the 1905 wood frame church that was later destroyed by fire. The schoolhouse is brick with a stone foundation. It has a pyramid shaped roof with a gabled dormer on the east façade. A brick entry way juts from the façade and was most likely added at a later date. The entry had a front gabled roof. There are multiple window openings on each side of the schoolhouse, most are covered by

plywood or boarded-over. The schoolhouse is in fair condition but does show signs of deterioration.

Photo 2: East facade and south elevation of the St. Clements school

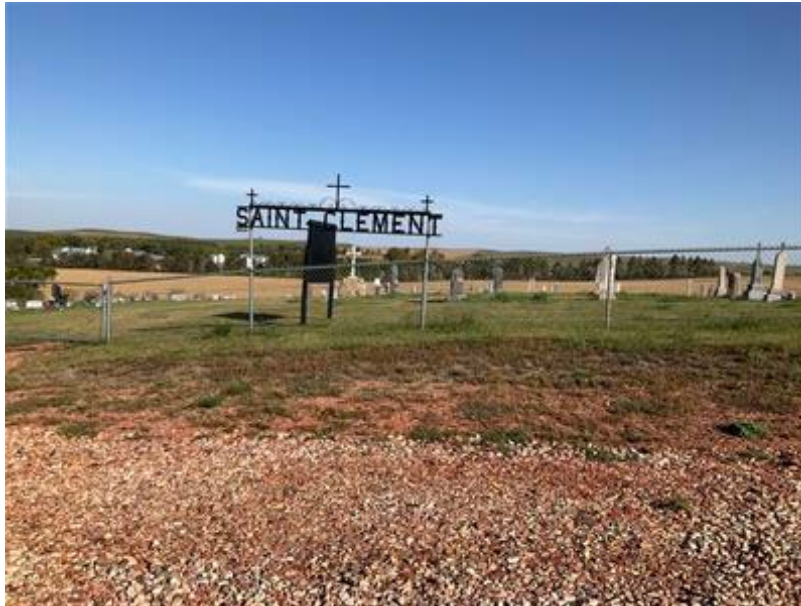
Also known historically as St. Clement's Church, the property contains the church building and a historic age schoolhouse (see Photos 1-3 and Figure 2 in Appendix A). An associated cemetery (see Photo 3 below) is located across the road and just to the east of the church property. Based on available resources, the property was recommended as meeting all the requirements of eligibility by the SHPO at an unknown date.

Photo 3: St. Clements Cemetery, view to the north

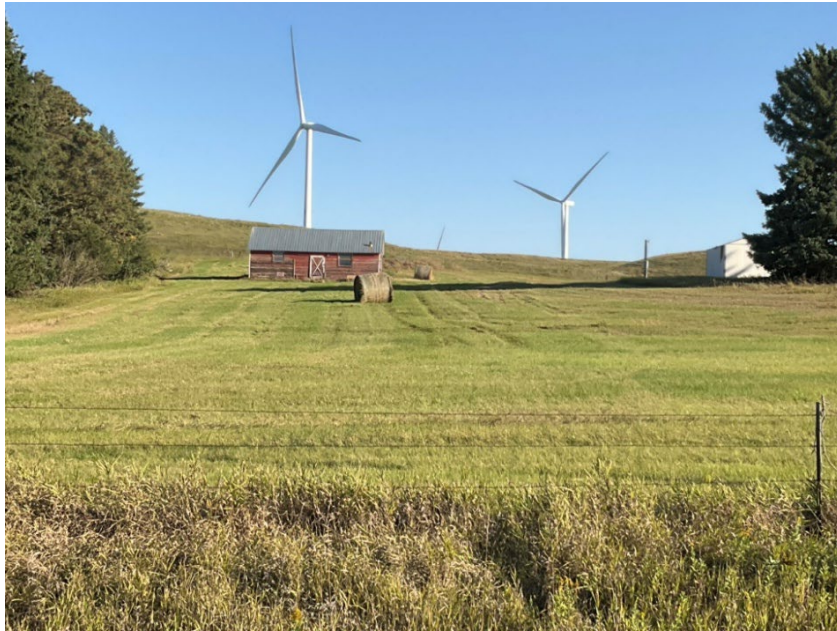
32MOX831 (MER-433) is the remnants of a farmstead and contains two structures (see Photo 4 below and Figure 2 in Appendix A). The first structure is a small, rectangular, utilitarian agricultural outbuilding. The structure is wood frame, with horizontal wood siding. The roof is low pitched and side gable. The facade faces south with three openings: two small windows on the east and west ends, with a centrally placed doorway. building is visible to the southeast of Feature 1. Based on view from the ROW and aerial imagery, it is unclear if the building is historic or modern. Views from the ROW of other elevations were not able to be viewed or assessed.

The structure is a rectangular, wooden storage building with a gable roof. It appears to be original, in fair condition with some dilapidation. Integrity of materials and workmanship for the structure remains intact. Other aspects of integrity, especially feeling and setting may be altered as this site was most likely part of a homestead and other buildings associated with the property are no longer extant. However, the resource is recommended as not eligible for listing on the NDSHSR under Criteria 2 and 4, because it does not appear to have significant association with an important historic building style or development, nor does it exhibit any character-defining or architectural features worthy of note. A more intensive survey would be required to determine if the site as any historic associations to events that have made significant contributions to broad patterns in American history (Criteria 1 NDSHSR), or to people significant in our past (Criteria 1 NDSHSR), so at this time the resource remains unevaluated.

Photo 4: Overview of outbuilding looking west, 32MOX831 (MER-433)

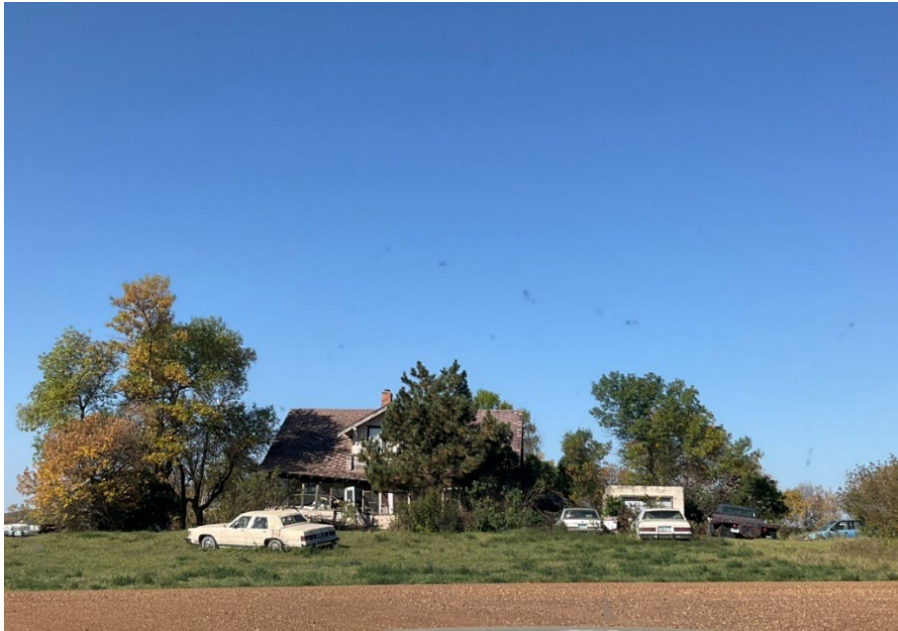
32MOX832 (MER-444) is the remnants of a farmstead (see Photo 5 below and Figure 2 in Appendix A). One building remains on the property (Feature 1), a wooden vernacular Craftsman bungalow. The house is rectangular and side-gabled with a steeply pitched roof and a front-gabled dormer. The house is wood frame with wide overhanging eaves. Only the façade of the house was partially visible, the rest of the view was blocked by mature tree growth, vegetation, and a collection of cars. The house is in relatively poor condition as the enclosed porch and portions of the roof appear to be sagging. A garage and outbuilding are located to the north and northwest of Feature 1. It is unclear of the buildings are historic due to mature tree cover and shadows in aerial imagery.

The resource is recommended as not eligible for listing on the NDSHSR under Criteria 2 and 4, because it does not appear to have significant association with an important historic building style or development, nor does it exhibit any character-defining or architectural features worthy of note. A more intensive survey would be required to determine if the site has any historic associations to events that have made significant contributions to broad patterns in American history (Criteria 1 NDSHSR), or to people significant in our past (Criteria 1 NDSHSR), so the resource currently remains unevaluated.

Photo 5: Site overview looking west, 32MOX832 (MER-444)

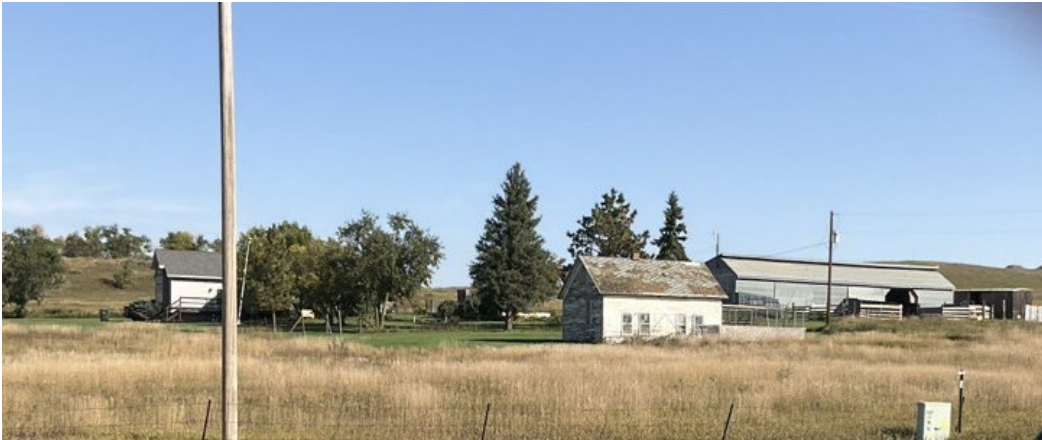
The structures do not appear to be altered significantly and are in fair condition. However, the resource is recommended as not eligible for listing on the NDSHSR under Criteria 2 and 4, because it does not appear to have significant association with an important historic building style or development, nor does it exhibit any character-defining or architectural features worthy of note.

A more intensive survey would be required to determine if the site has any historic associations to events that have made significant contributions to broad patterns in American history (Criteria 1 NDSHSR), or to people significant in our past (Criteria 1 NDSHSR), so the resource remains unevaluated.

Photo 6: Site overview looking north, 32MOX833 (MER-446)

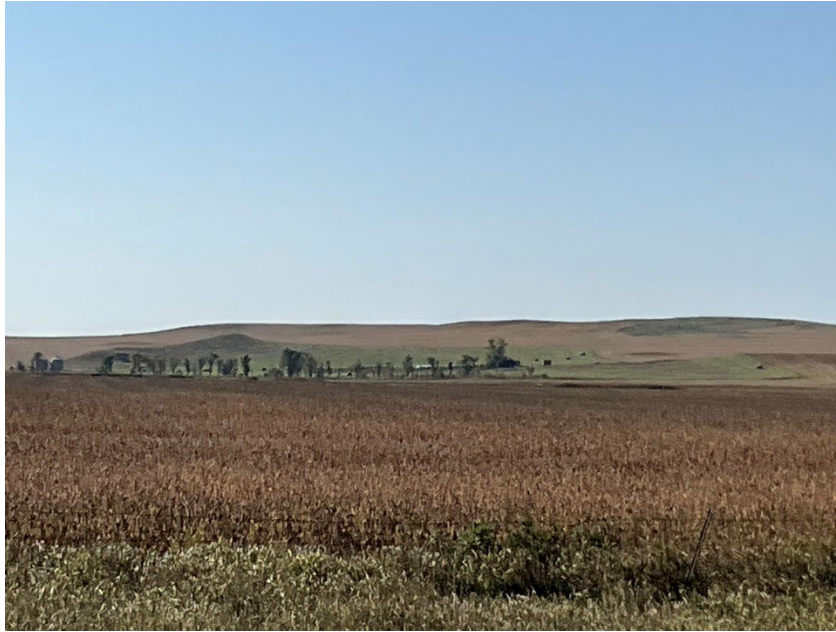
visible at a distance from the ROW, no recommendation of eligibility for the NDSHSR could be made.

Photo 7: View south toward 32MOX834 (MER-448)

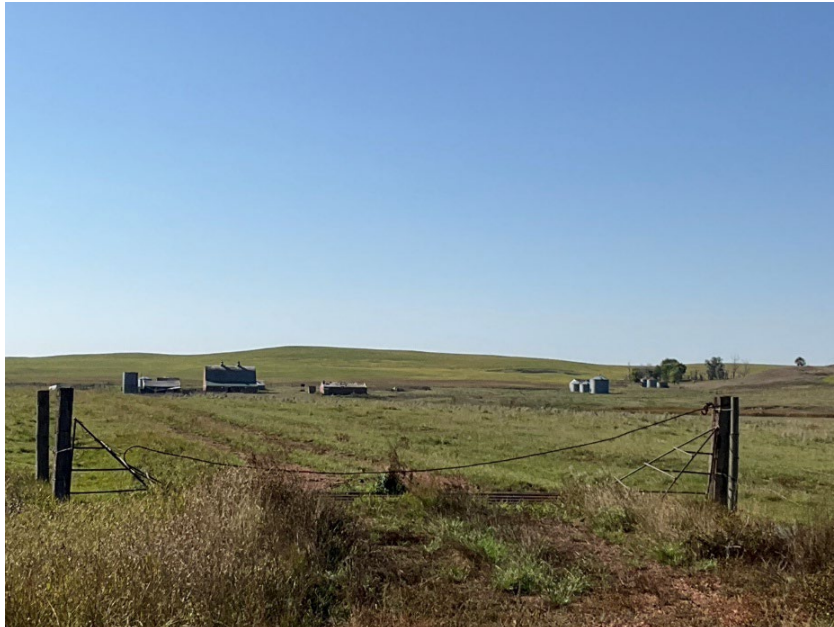
A more intensive survey and research are needed to ascertain the accurate number of buildings, their age and any historic significance, associations, and integrity. With the property only partially visible at a distance from the ROW, no recommendation of eligibility for NDSHSR could be made.

Photo 8: View southwest toward 32MOX835 (MER-449)

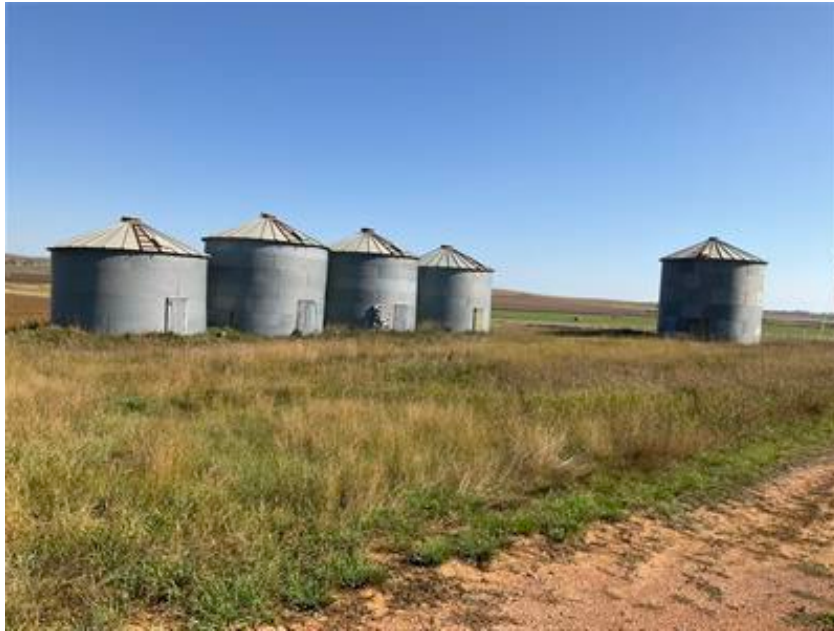
The resource is recommended as not eligible for listing on the NDSHSR under Criteria 2 and 4, because it does not appear to have significant association with an important historic building style or development, nor does it exhibit any character-defining or architectural features worthy of note. A more intensive survey would be required to determine if the site as any historic associations to events that have made significant contributions to broad patterns in American history (Criteria 1 NDSHSR), or to people significant in our past (Criteria 1 NDSHSR), so the resource remains unevaluated.

Photo 9: Site overview looking northeast, 32MOX836 (MER-450)

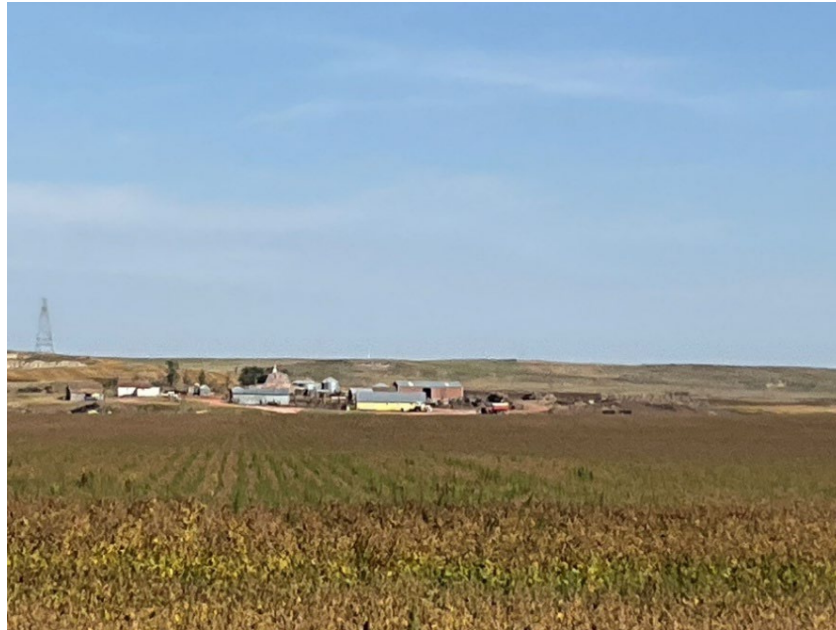
wooden, square shed west of the barn (Feature 10) and northeast of the house (Feature 1). Feature 12 is a small, rectangular, wooden, shed immediately north of, and adjacent to, the repair/workshop (Feature 2) that first appears in aerial imagery in 2010.

A more intensive survey and research is needed to ascertain the accurate number of buildings, their age, and any historic significance, associations, and integrity. With the property only partially visible at a distance from the ROW, no recommendation of eligibility for the NDSHSR could be made.

Photo 10: View north toward 32MOX836 (MER-453)

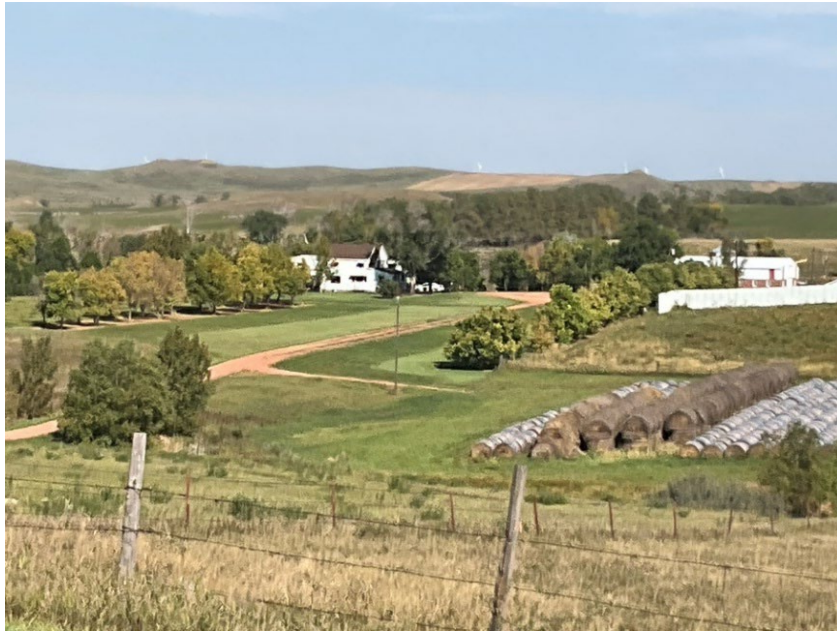
The farmstead is at a distance from the public ROW, and few distinguishing features or characteristics could be ascertained. A more intensive survey and research are needed to ascertain the accurate number of buildings, their age and any historic significance, associations, and integrity. With the property only partially visible at a distance from the ROW, no recommendation of eligibility for the NDSHSR could be made.

Photo 11: View northwest toward 32MOX838 (MER-457)

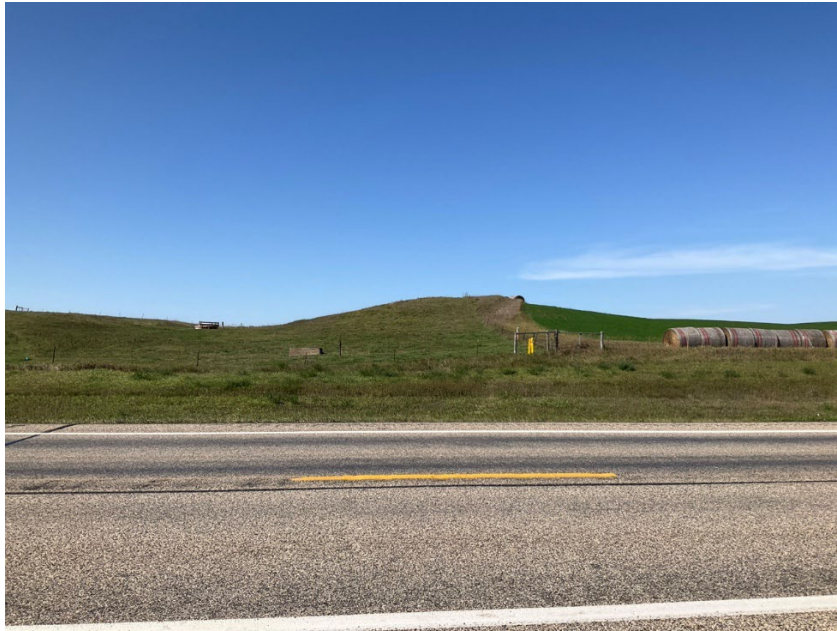
A more intensive survey and research are needed to ascertain the accurate number of buildings, their age and any historic significance, associations, and integrity. With the property only partially visible at a distance from the ROW, no recommendation of eligibility for the NDSHSR could be made.

Photo 12: View west toward 32MOX839 (MER-459)

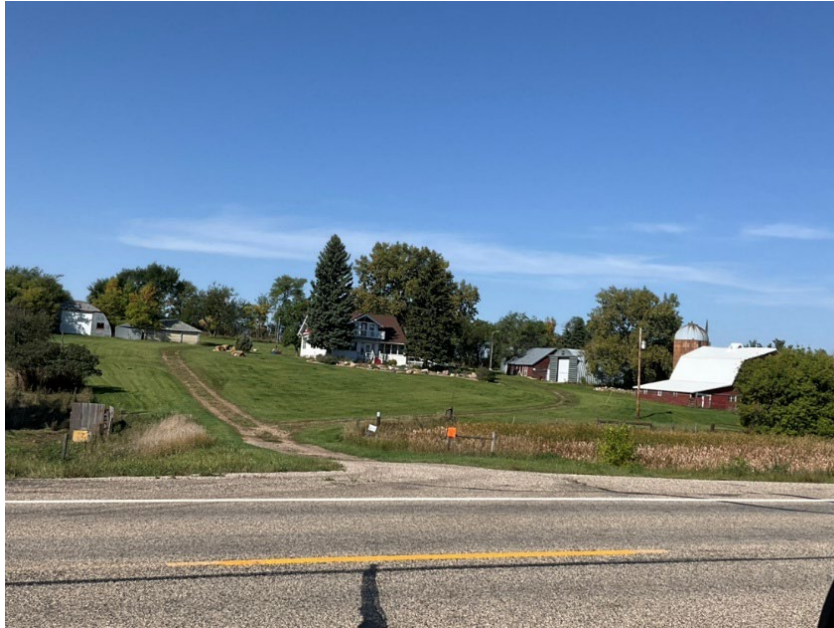
The house dates approximately to the 1920s or 1930s and is a vernacular wooden Craftsmen bungalow. The house is side gabled with a front gabled dormer on the façade. The porch is enclosed with window openings running across the façade; a centrally placed doorway between them. The house sits on a stone or brick foundation. The window openings appear to be original. Few other details could be ascertained because of distance and mature tree growth.

The structures do not appear to be altered significantly and are in fair condition. However, the historic-aged resource is recommended as not eligible for listing on the NDSHSR under Criteria 2 and 4, because it does not appear to have significant association with an important historic building style or development, nor does it exhibit any character-defining or architectural features worthy of note. A more intensive survey would be required to determine if the site has any historic associations to events that have made significant contributions to broad patterns in American history (Criteria 1 NDSHSR), or to people significant in our past (Criteria 1 NDSHSR), so the resource remains unevaluated.

Photo 13: Overview looking west, 32MOX840 (MER-460)

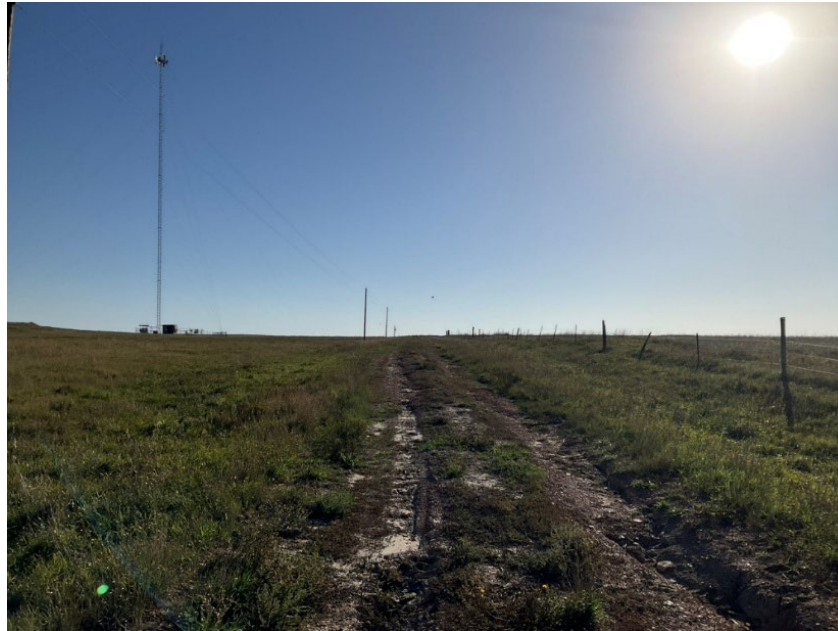
The farmstead can only be viewed from aerial imagery and is not visible from the public ROW. A more intensive survey and research are needed to ascertain the accurate number of buildings, their age and any historic significance, associations, and integrity. With the property not visible from the ROW, no recommendation of eligibility for the NDSHSR could be made.

Photo 14: View east toward 32MOX841 (MER-462)

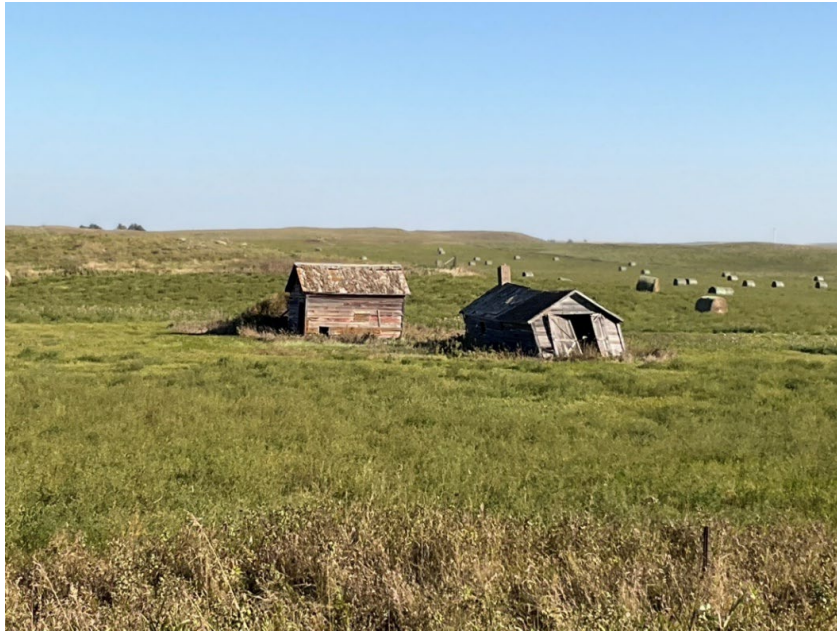
32ME2404 (Field number MER-468) updates the remnants of a small residential property with two structures (see Photo 15 below and Figure 2 in Appendix A). The first structure is a small, wood frame cabin that dates to the earliest years of the 20th Century. The structure is rectangular in shape, with a side gabled roof. The structure is clad in horizontal wood siding. No openings could be seen from the ROW. The structure is in fair condition.

The second structure is a small, wood-framed shed, possible granary, that appears to be of a style that typically dates to the early 20th Century. The structure is rectangular in shape, with a front gabled roof, with a large centrally placed opening with double wooden doors. There is a centrally placed chimney at the north end of the structure. The structure is clad in wood siding and asphalt shingle roof. The center of the garage is collapsing, and the structure is in poor condition.

The structures do not appear to be altered significantly and are in fair condition. However, the property is recommended as not eligible for listing on the NDSHSR under Criteria 2 and 4, because it does not appear to have significant association with an important historic building style or development, nor does it exhibit any character-defining or architectural features worthy of note. A more intensive survey would be required to determine if the site has any historic associations to events that have made significant contributions to broad patterns in American history (Criteria 1 NDSHSR), or to people significant in our past (Criteria 1 NDSHSR).

Photo 15: Overview looking northwest, 32ME2404 (MER-468)

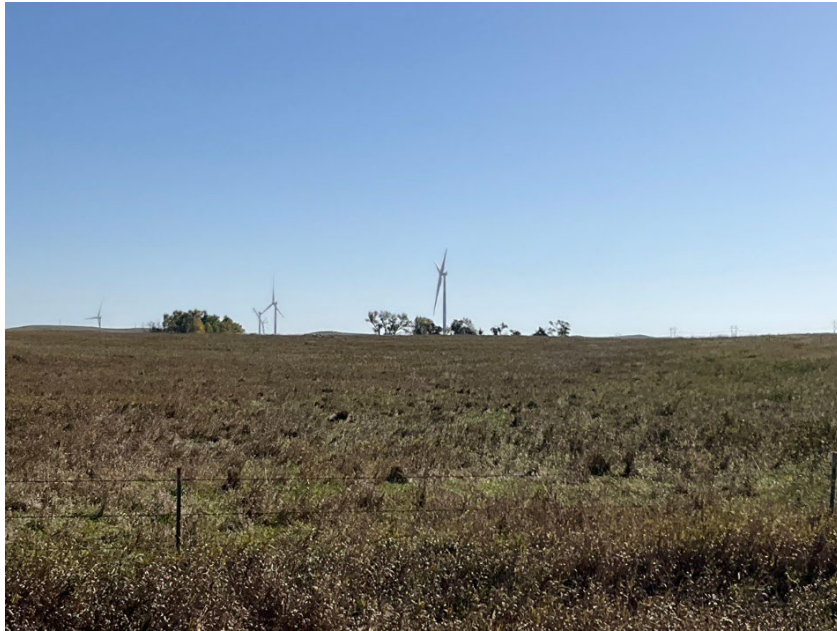
Feature 1 is a Gambrel-roofed animal shelter or barn with a metal building attached to the west side. Based on aerial imagery, it appears that the original farmhouse was located northeast of this building and has been demolished. Feature 2 also appears to be an animal shelter. It is wooden and rectangular with a gable roof and was added between 1960 and 1975. Feature 3 is somewhat larger than Feature 2 and is also wooden, rectangular, and has a gable roof. It was added between 1975 and 1990. They appear to be in very poor condition.

A more intensive survey and research is needed to ascertain the accurate number of buildings, their age and any historic significance, associations, and integrity. With the property not visible from the ROW, no recommendation of eligibility for the NDSHSR could be made.

Photo 16: View northeast toward 32OLX559 (MER-478) and the Project area

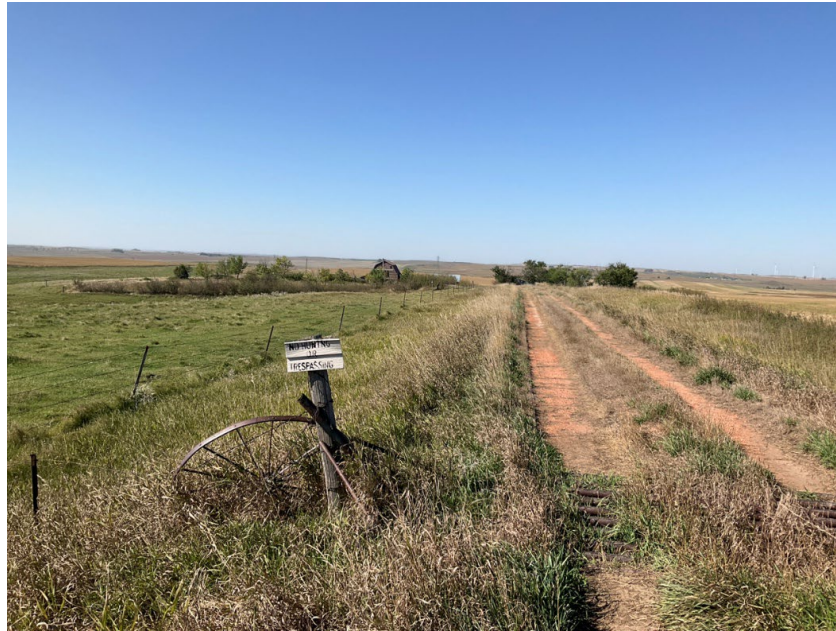
MER-489 is a farmstead with several structures (see Photo 17 below and Figure 2 in Appendix A). The structures could not be viewed from the public ROW. The structures can be viewed from aerial imagery, where it appears the farmstead includes a Gambrel-style barn and multiple outbuildings. A more intensive survey and research are needed to ascertain the accurate number of buildings, their age and any historic significance, associations, and integrity. With the resource not visible from the ROW, no recommendation of eligibility for the NDSHSR could be made. This property is being more thoroughly described in a forthcoming Class III addendum report.

Photo 17: View west toward 32MO1740 (MER-489) and the Project Area

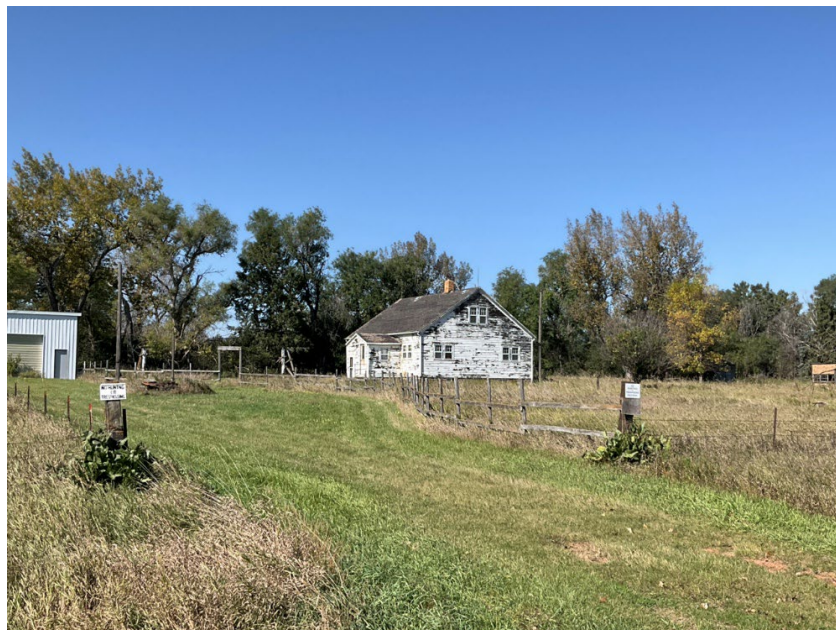
32MOX842 (MER-494) is a farmstead with several buildings of varying ages, sizes and condition. The property includes a house, barns, workshops, and grain bins for a total of approximately 8 features.

While the structures could be viewed from the ROW, they were at a distance, and many details and features of the structures could not be ascertained. The structures do not appear to be altered significantly and are in fair condition. However, the resource is recommended as not eligible for listing on the NDSHSR under Criteria 2 and 4, because it does not appear to have significant association with an important historic building style or development, nor does it exhibit any character-defining or architectural features worthy of note. A more intensive survey would be required to determine if the site as any historic associations to events that have made significant contributions to broad patterns in American history (Criteria 1 NDSHSR), or to people significant in our past (Criteria 1 NDSHSR), so the resource remains unevaluated.

Photo 18: 32MOX842 (MER-494), view facing west toward the house

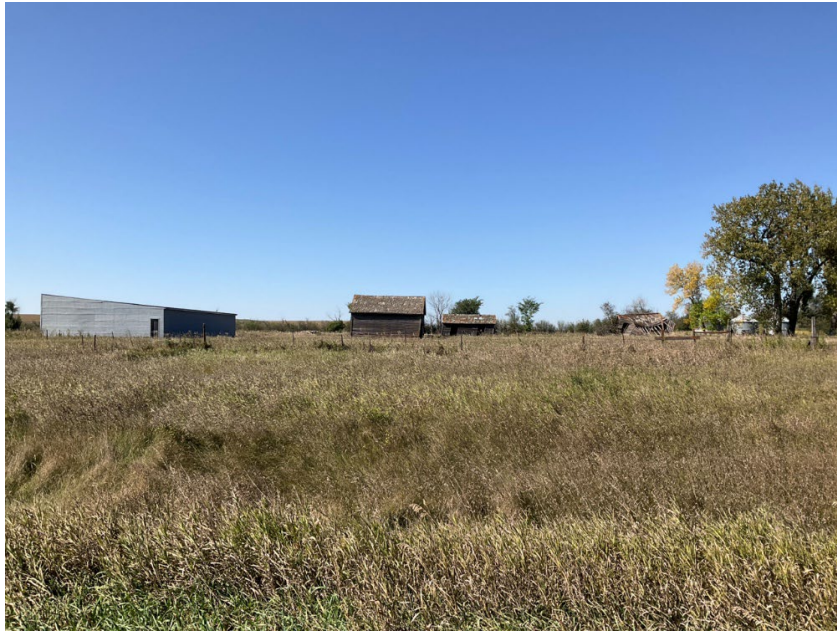
South of those structures were two wood framed agricultural buildings (see Photo 19 below). The first is a rectangular, wooden, utilitarian agricultural structure. The likely use was as a chicken coop. The structure faces east and has two openings on the facade. The structure has a side-gabled roof and horizontal wooden siding. The condition is poor, but no other details could be ascertained because of distance from the ROW. The other is a small utilitarian, wooden barn. The barn has a steeply pitched gabled roof and horizontal wooden siding. The barn is in poor condition and is slanting slightly to the north. Because of the distance from the ROW, no other details could be ascertained.

Photo 19: 32MOX842 (MER-494), view facing west toward several agricultural structures

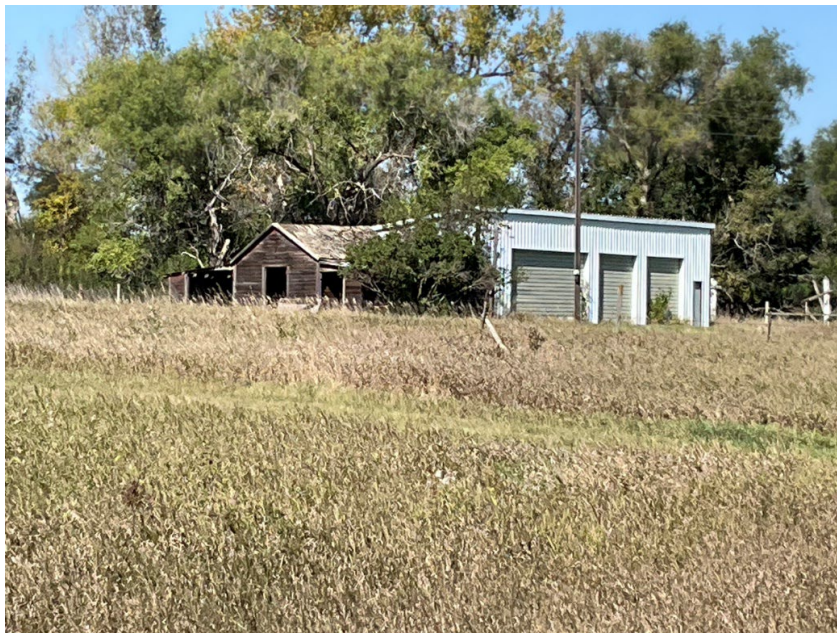
Immediately south of the metal shed is a utilitarian wooden shed or residential structure with a gabled roof and a south facing facade. The structure is clad in horizontal wooden siding. There are multiple openings on the south facade, but vegetation and distance from the ROW prevented a full view of the facade. The structure is in poor condition and on the verge of collapse.

very slanted. The rest of the structure has collapsed. Because of the distance from the ROW and the condition of the structure, no other details could be ascertained.

Photo 20: 32MOX842 (MER-494), view facing northwest

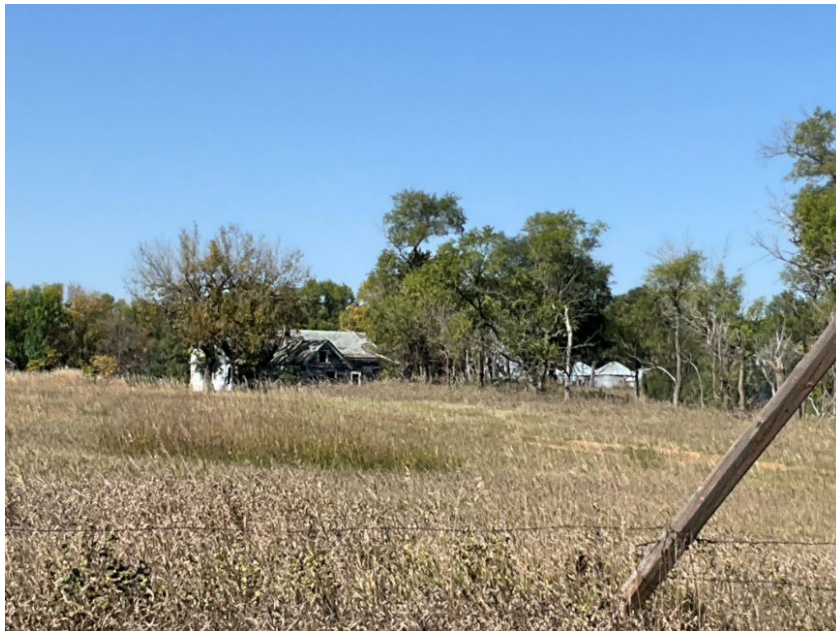
Feature 5 is a wood frame shed in the south center portion of the site. Feature 6 is a wood frame shed in the western portion of the site. The structures could only be viewed from aerial imagery. View of the structures from the ROW was blocked by vegetation and mature trees. A more intensive survey and research is needed to ascertain the accurate number of buildings, their age and any historic significance, associations, and integrity. With much of the property not visible from the ROW, no recommendation of eligibility for the NDSHSR could be made.

Photo 21: Overview looking northwest, 32MOX843 (MER-495)

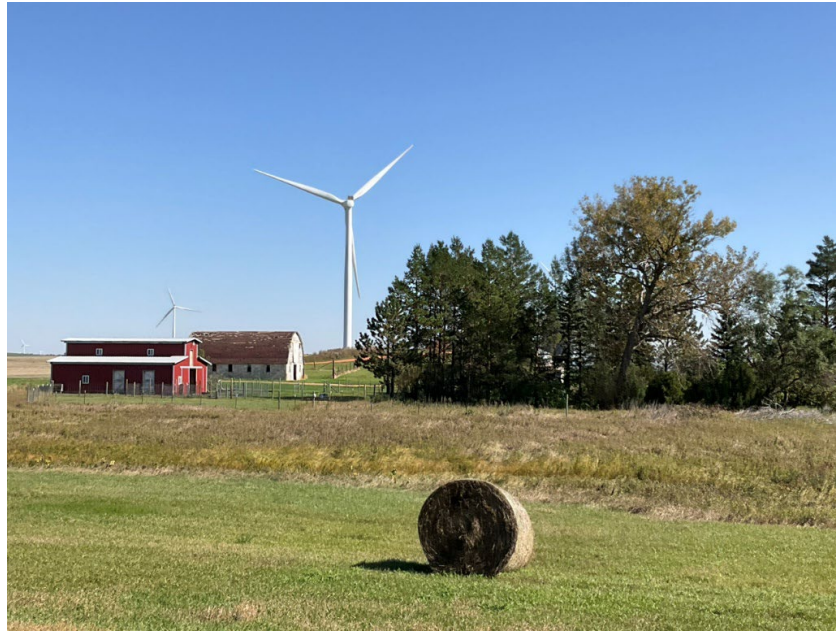
Several grain bins of various sizes and ages, as well as the house and other agricultural outbuildings, were not visible from the ROW. A more intensive survey and research is needed to ascertain the accurate number of buildings, their age and any historic significance, associations, and integrity. With much of the property not visible from the ROW, no recommendation of eligibility for the NDSHSR could be made.

Photo 22: Overview looking southeast, 32MOX844 (MER-500)

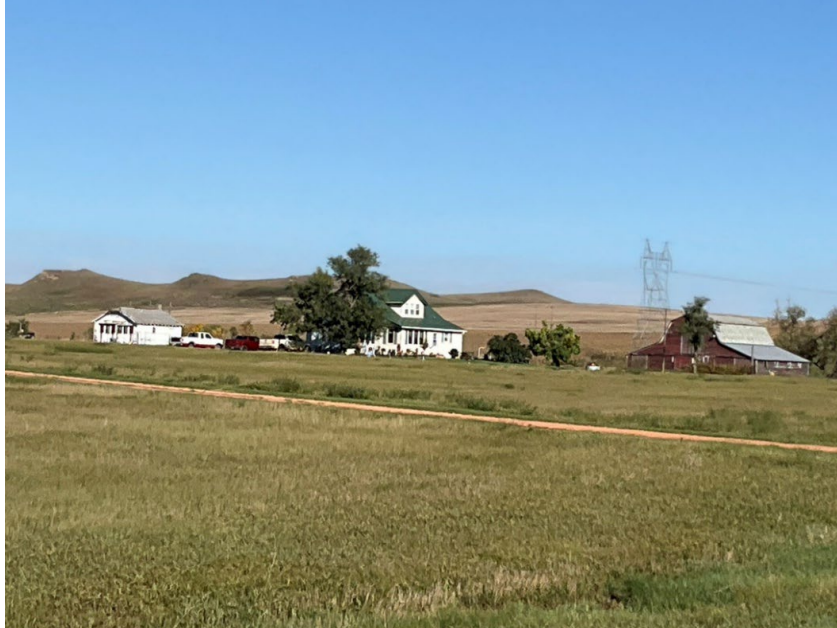
Several grain bins of various sizes (Features 2, 7, 8, and 9) were also observed. Feature 2 reflects the grain bin at the far south, Feature 7 identifies the grain bin second from the south in the line, Feature 8 identifies the grain bin third from the south in the line, and Feature 9 identifies the grain bin at the north end of the line.

A more intensive survey and research are needed to ascertain any historic significance, associations, and integrity. With the property only visible at a distance from the ROW, no recommendation of eligibility for the NDSHSR could be made.

Photo 23: 32MOX845 (MER-509), view northwest of the barn, house and garage

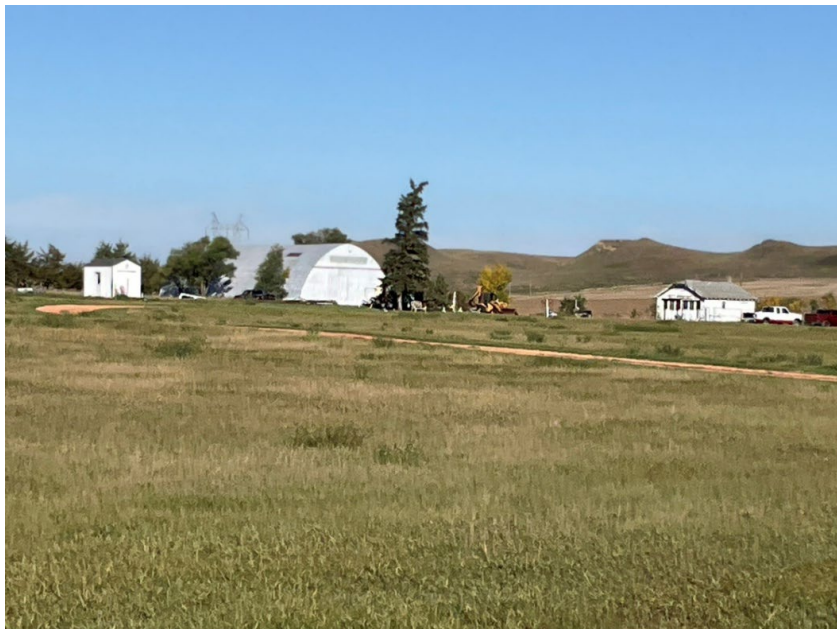
Photo 24: 32MOX845 (MER-509), view northwest of Quonset workshop and garage

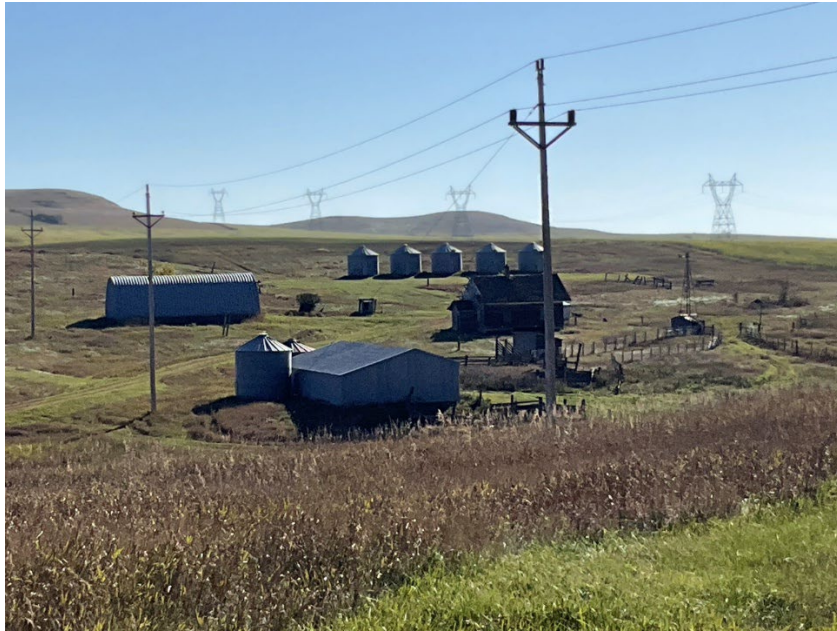
The early 20th Century Craftsman garage (Feature 5) is wooden and a gable offset roof. The facade faces south. The facade has a large bi-fold garage door that appears to be original. A small window opening is on the south end of the east facade. The structure does appear original but is in a dilapidated condition. The structure could only be viewed at a distance from the ROW and not all characteristics could be ascertained.

A more intensive survey and research is needed to ascertain any historic significance, associations, and integrity. With the property only visible at a distance from the ROW, no recommendation of eligibility for the NDSHSR or NDSHSR could be made.

Photo 25: Overview looking southeast, 32MOX846 (MER-511)

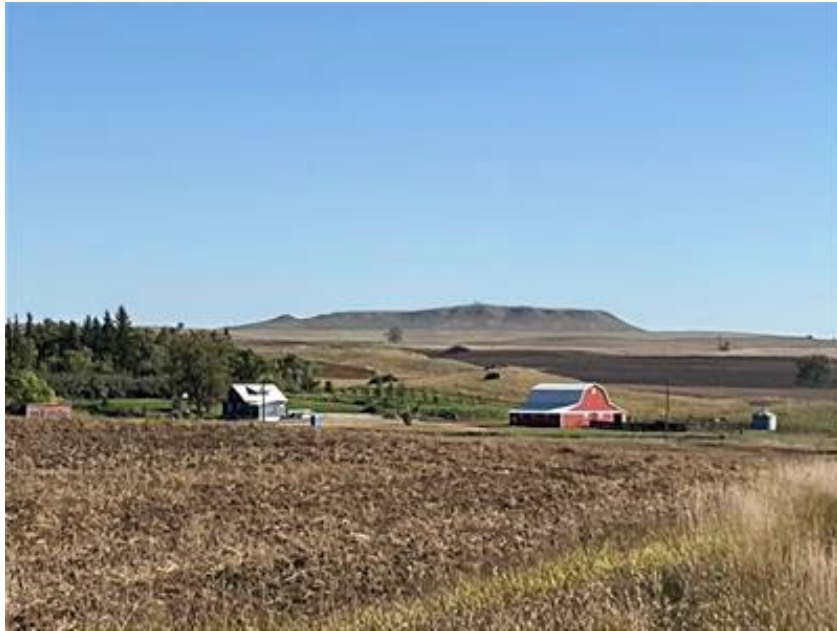
A more intensive survey and research is needed to ascertain any historic significance, associations, and integrity. With the property only visible at a distance from the ROW, no recommendation of eligibility for the NDSHSR could be made.

Photo 26: Overview looking northeast, 32MOX847 (MER-513)
