# **Structural Monitoring at a Pressurized Grout Remote Backfilling AMLR Project at Beulah, North Dakota**

**William E. Dodd**

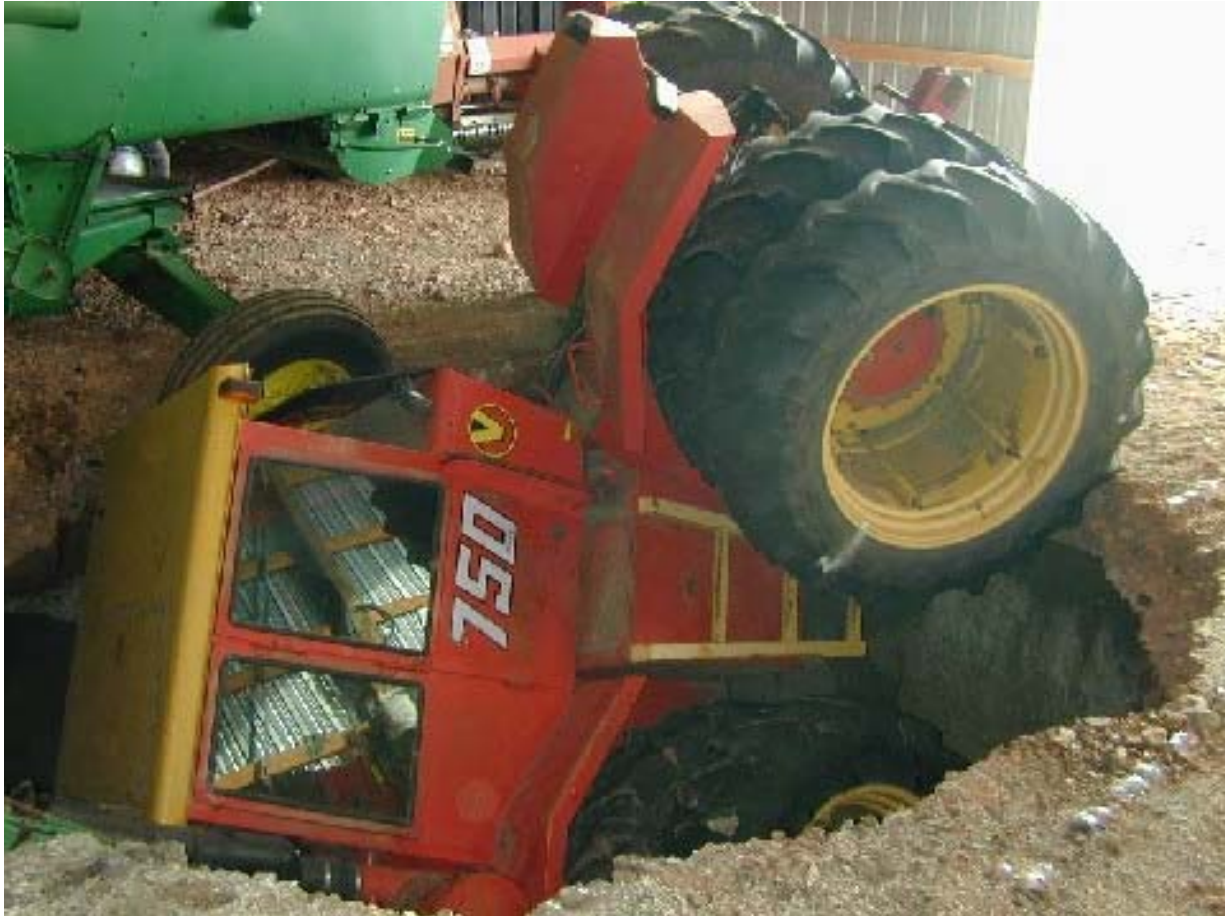
**Figure 1:** Underground mine subsidence “swallowed” this tractor in a machine shed north of Beulah, ND.
