2021-2022 Sinkhole Filling and Maintenance Project Summary

Project Scope: Filling dangerous sinkholes caused by the collapse of underground mines and extinguishing coal fires on abandoned mine lands.

2021-2022 Sinkholes Filled
State of North Dakota
Public Service Commission
Abandoned Mine Lands Division

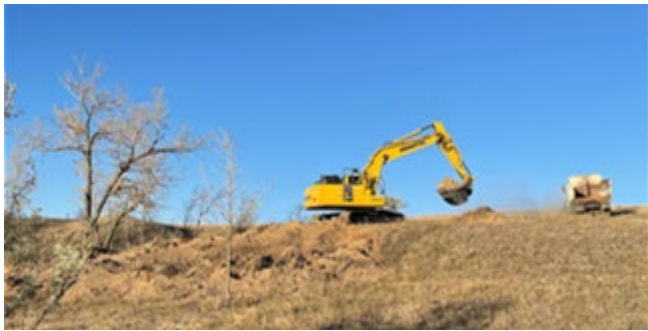
Between 2021 and 2022, the North Dakota Public Service Commission (ND PSC) Abandoned Mine Lands (AML) Division filled approximately 223 sinkholes in nine different locations in the western half of North Dakota. Coal refuse fires near Velva and New Leipzig were also extinguished and reclaimed under these contracts.

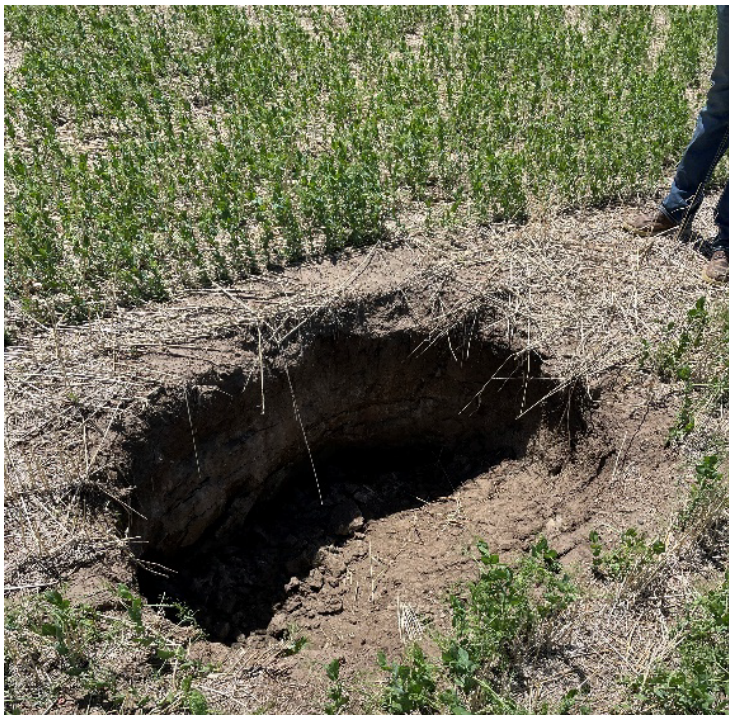
These sites included North Dakota Game and Fish property as well as private land. The picture below is on pastureland just north of Beulah. The excavator is positioned on top of a knoll used as a borrow area, which provides the fill material. A truck delivers the fill material to the sinkholes.

Then the excavator compacts the fill material in lifts in the sinkhole. When sinkhole filling is done, the borrow area is also reclaimed. Thirty-five sinkholes were filled at the Beulah sites.

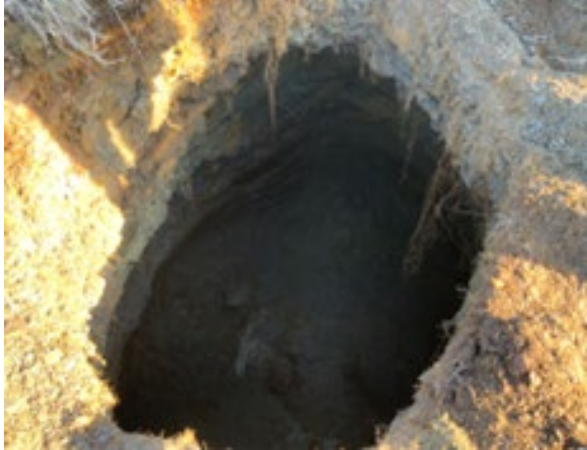
Hanks

In June 2021, AML staff met with the renter about hazardous sinkholes in a field which made planting and harvesting difficult. A total of eight sinkholes were in the field. Another five sinkholes were filled in a nearby pasture. One sinkhole in the pasture measured 10 feet in diameter with an average depth of about 12 feet.

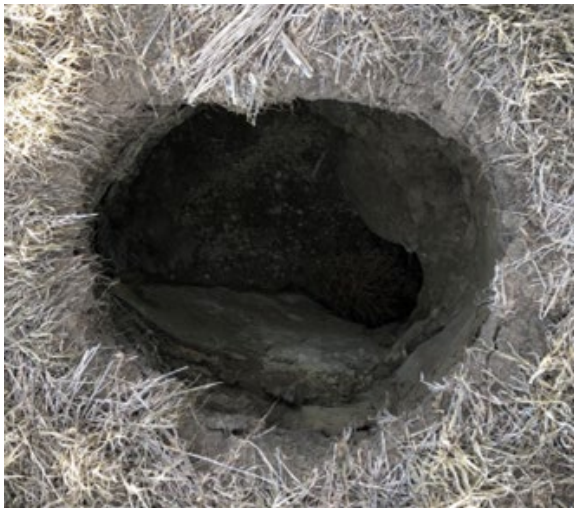
The Haynes site is approximately 9 miles east of Hettinger. The Ihle Coal Mine was both an underground and surface mine. The surface mine was reclaimed by the AML Division in 1996. The AML Division also extinguished a coal refuse fire in 2011. During a recent site investigation, a landowner pointed out a sinkhole that had recently opened to approximately 20 feet in diameter and 25 feet deep with straight sides.

While working to fill a different sinkhole, the surface collapsed under the contractor's truck tire to reveal the sinkhole in the photo.

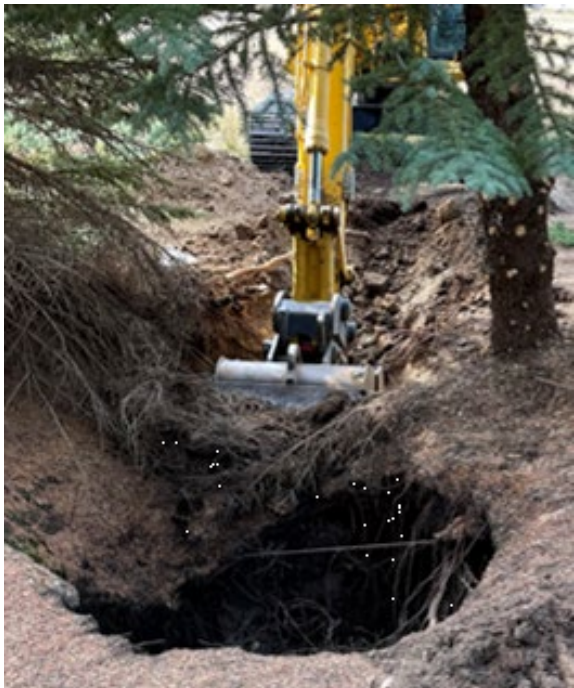
New Salem

A sinkhole does not need to be large to cause damage to farm equipment or cause an injury. The sinkhole pictured in the photo was in a farmer's field and presented a hazard to the farmer and his equipment. Six sinkholes were filled in or adjacent to cropland.

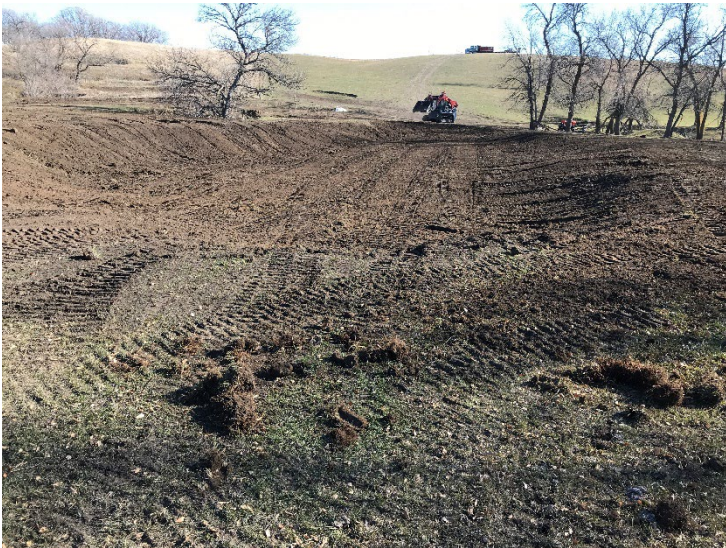
Scranton, North Dakota was aptly named after the coal mining town of Scranton, Pennsylvania. A sinkhole had opened on the Scranton Equity Exchange bypass road. The Scranton Equity Exchange filled the sinkhole, but the collapse continued. The AML Division filled this sinkhole and two additional holes in the road ditch. The Scranton Equity Exchange can be seen in the background.

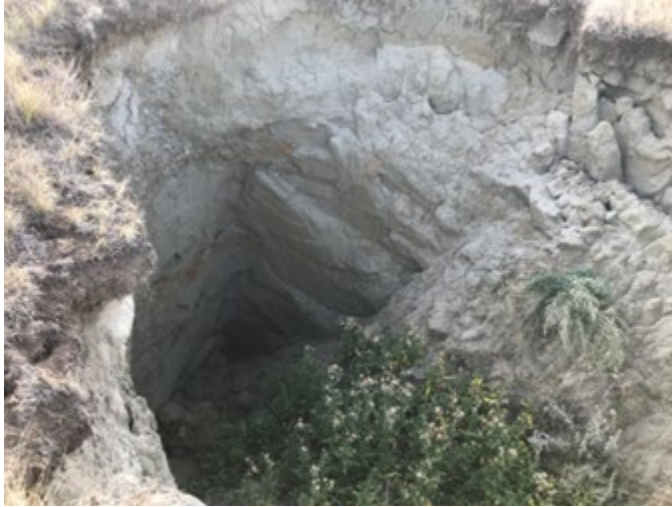
In December 2020 the AML Division received a report of a sinkhole in a pasture east of Williston. Staff then contacted other landowners around Williston where sinkholes have been filled previously. The AML Division filled 7 sinkholes on three properties near Williston. One of the sinkholes was located about 30 feet from a gas pipeline.

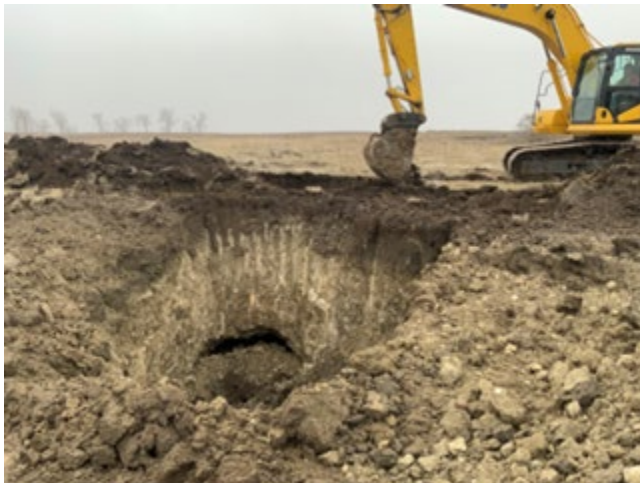
Wilton was once the site of one of the largest underground lignite coal mines in the world. Several drilling and grouting projects have been conducted in the area to protect roads and farmsteads, but sinkholes will continue to be a problem. The sinkhole shown was less than 4 feet in diameter at the surface, but excavation revealed a significantly larger hole. Forty-two sinkholes were filled near Wilton in 2021.

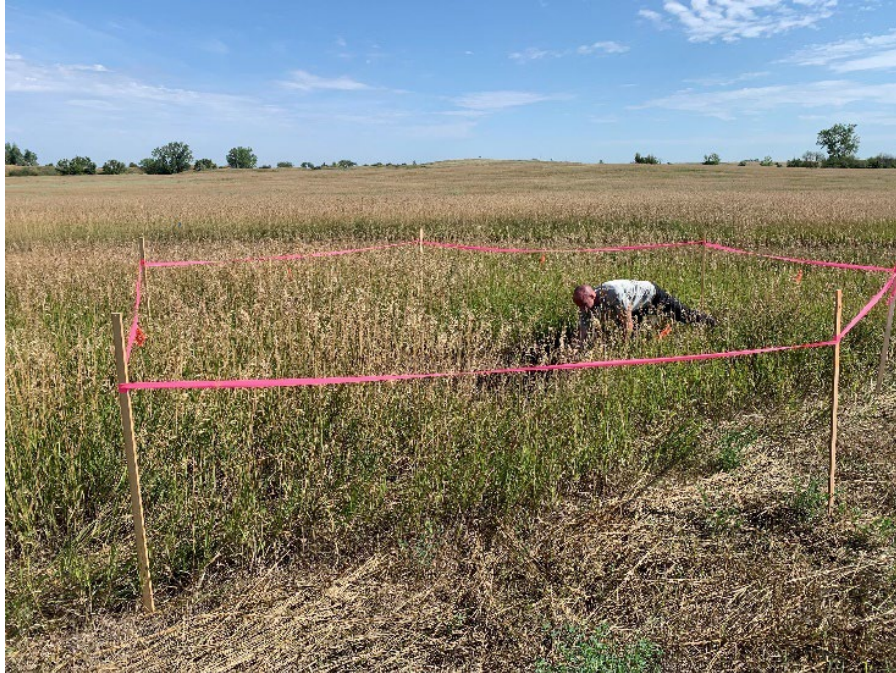
Velva Coal Refuse Fire

In the summer of 2017, the AML Division was notified of a coal refuse fire near the abandoned DePue Mine south of Velva. The local fire department attempted to extinguish the fire with water. This slowed but did not extinguish the fire. With the nearest home nearly two miles away, it posed little threat to the surrounding area as it smoldered and slowly burned between two water-filled pits. The AML Division monitored the fire by visiting the site periodically. In 2021 a drought significantly dried the two ponds, and the fire began advancing toward a stand of trees. It became necessary to extinguish the fire to avoid a potential wildfire. As excavation began, the contractor uncovered a shallow coal seam.

The water table was also shallow, so a moat was created around the burning refuse pile. The burning material was then excavated and stockpiled in the center of the moat. Spoil material from a nearby abandoned surface mine was hauled in, and the refuse pile was capped to prevent the fire from spreading to the coal seam. The AML Division will continue to monitor the site.

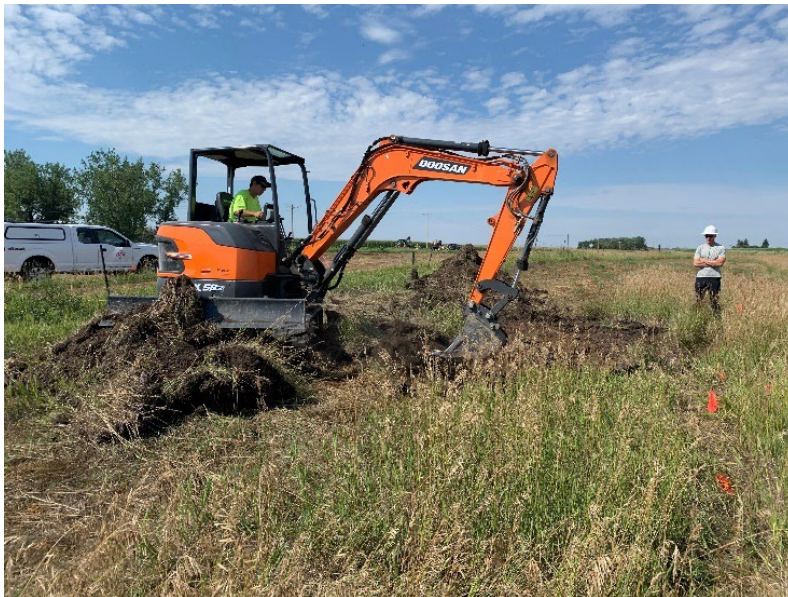
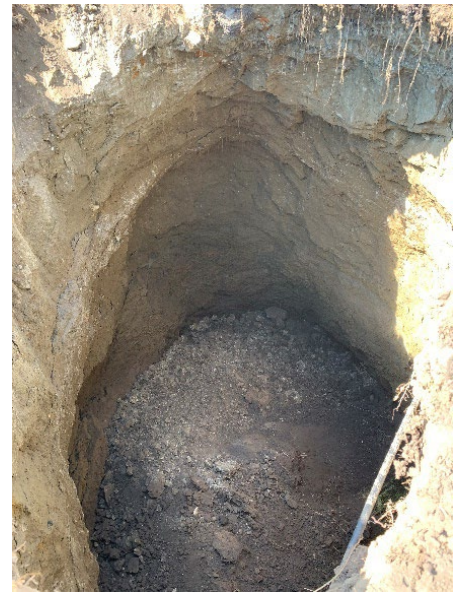
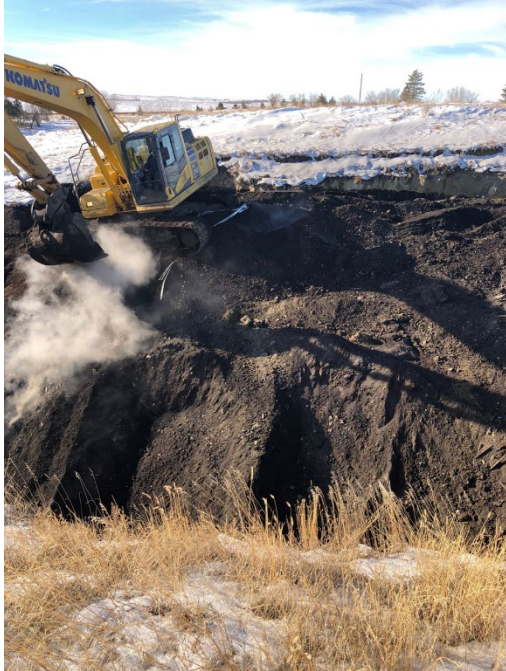
Wilton Emergency

In July 2022, the AML Division was notified of a sinkhole with an exposed fiber optic line and within 75 feet of ND Highway 36. The bell-shaped sinkhole was approximately 12 feet in diameter and 15 feet deep. The AML Division worked with the telecommunications company to ensure the protection of the fiber optic line while

reclaiming the sinkhole. The hole was filled with about 77 cubic yards of soil. Eight additional hazardous sinkholes in the area were filled. Work was completed on August 19, 2022.
