2022 Exploratory Drilling AML Project

Contractor: Earth Energy & Water Systems, Inc.

Contract Number: AM-863-22

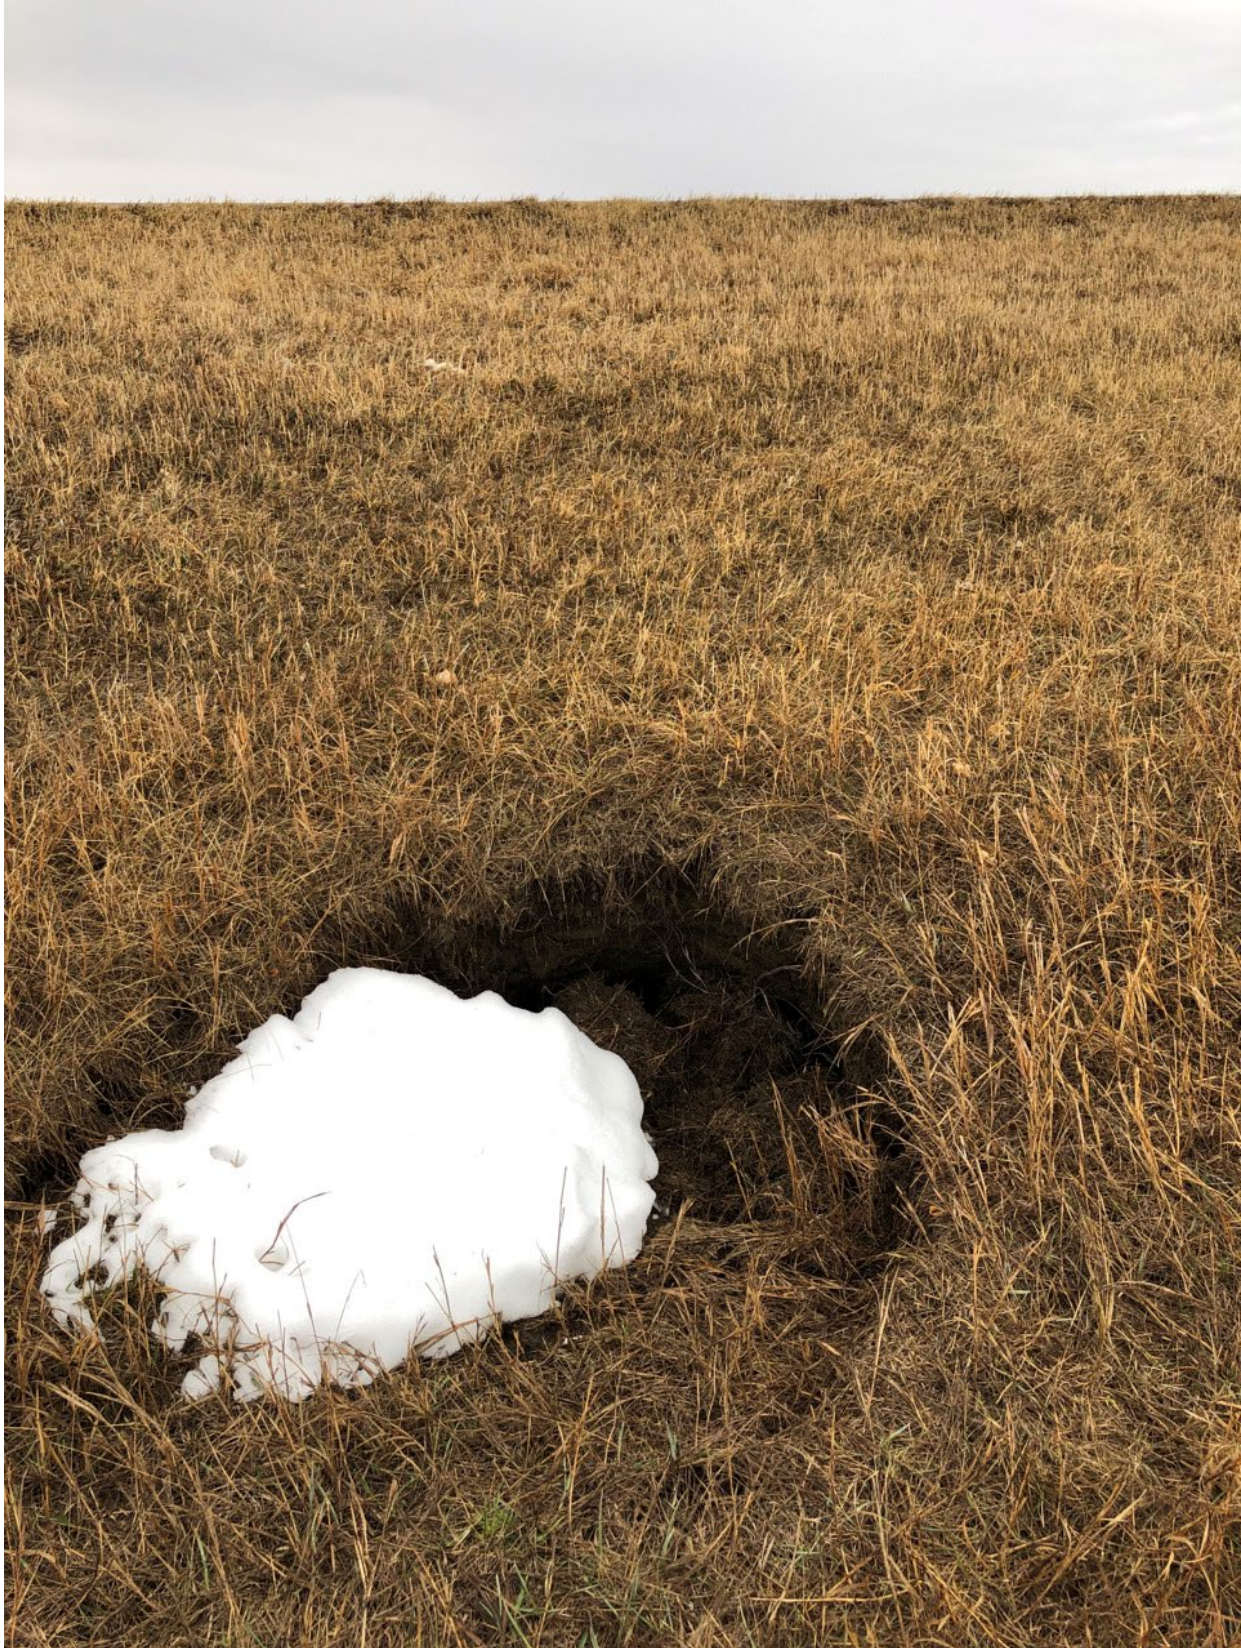
Figure 1: A sinkhole in the ditch of Lehigh Road that formed in the spring of 2022. Drilling near this sinkhole located additional underground mine voids.

In 2003 drilling and grouting halted as there was a concern of phenols in the groundwater generated from industrial wastewater. Mine maps indicated important infrastructure was most likely undermined and hazardous sinkholes continued to form (**Figure 1**). The AML Division worked with the ND Department of Environmental Quality (NDDEQ) to test monitoring wells. No contamination was found allowing drilling and further monitoring to resume.

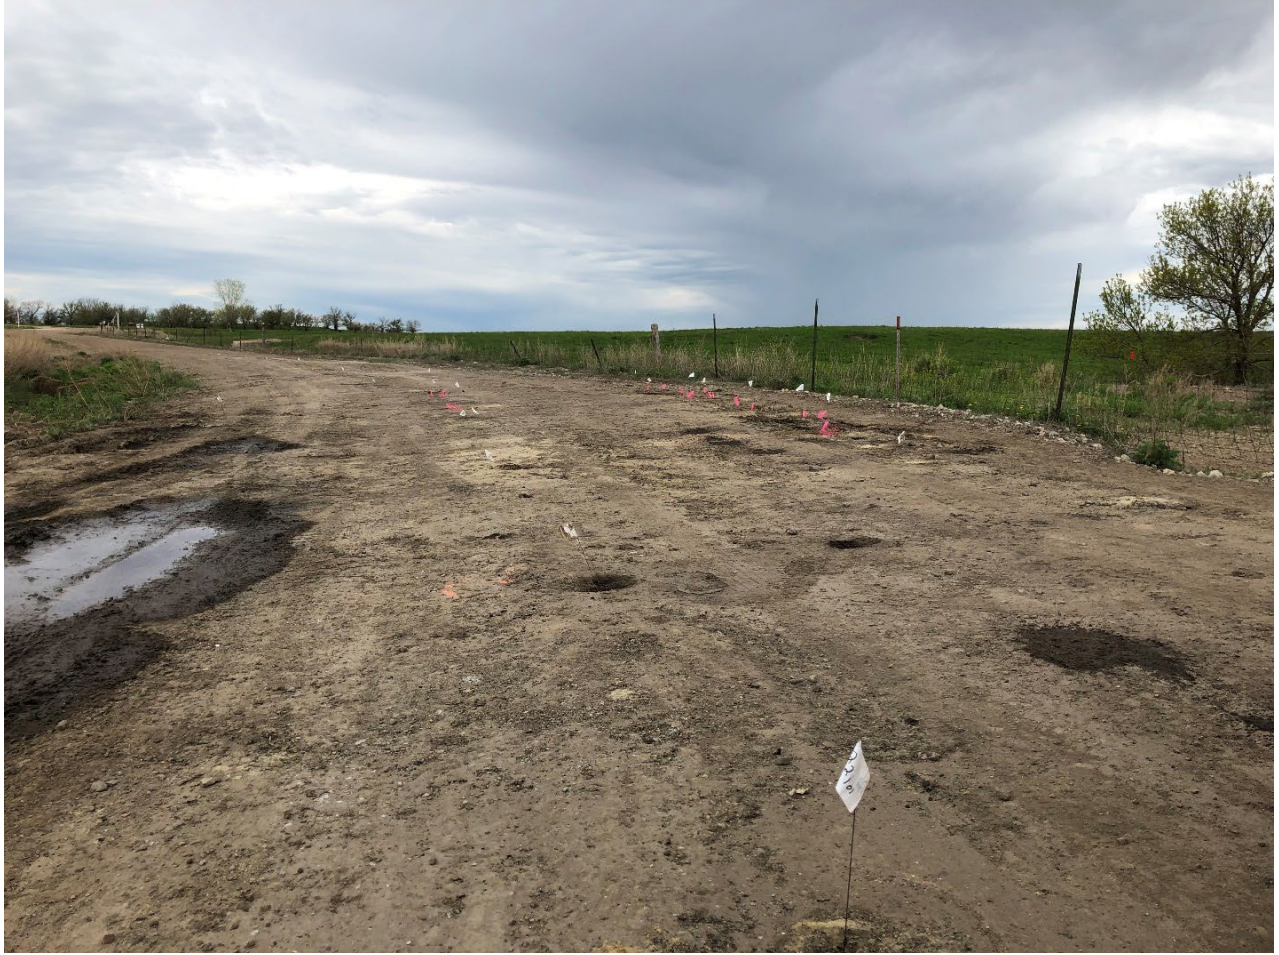
Figure 2: The white pin flags indicate drillhole locations. The pink whiskers indicate a drillhole encountered a mine void. Voids are cased with schedule 40 PVC pipe. This area is a driveway to an industrial business off Lehigh Road.

The 2022 Exploratory Drilling Project continued drilling where it paused in 2003. Drilling was needed to confirm the extent of the mines. Grout has been pumped under the shoulders of both Lehigh Road and Lehigh Drive during previous drilling and grouting projects. Confirmation drilling in the 2022 Exploratory Drilling Project confirmed that grout had filled many mine voids along said roads. Drilling also helped identify several abandoned underground mine workings in new locations (**Figure 2**). Additional drilling and grouting reclamation work is planned for this site.

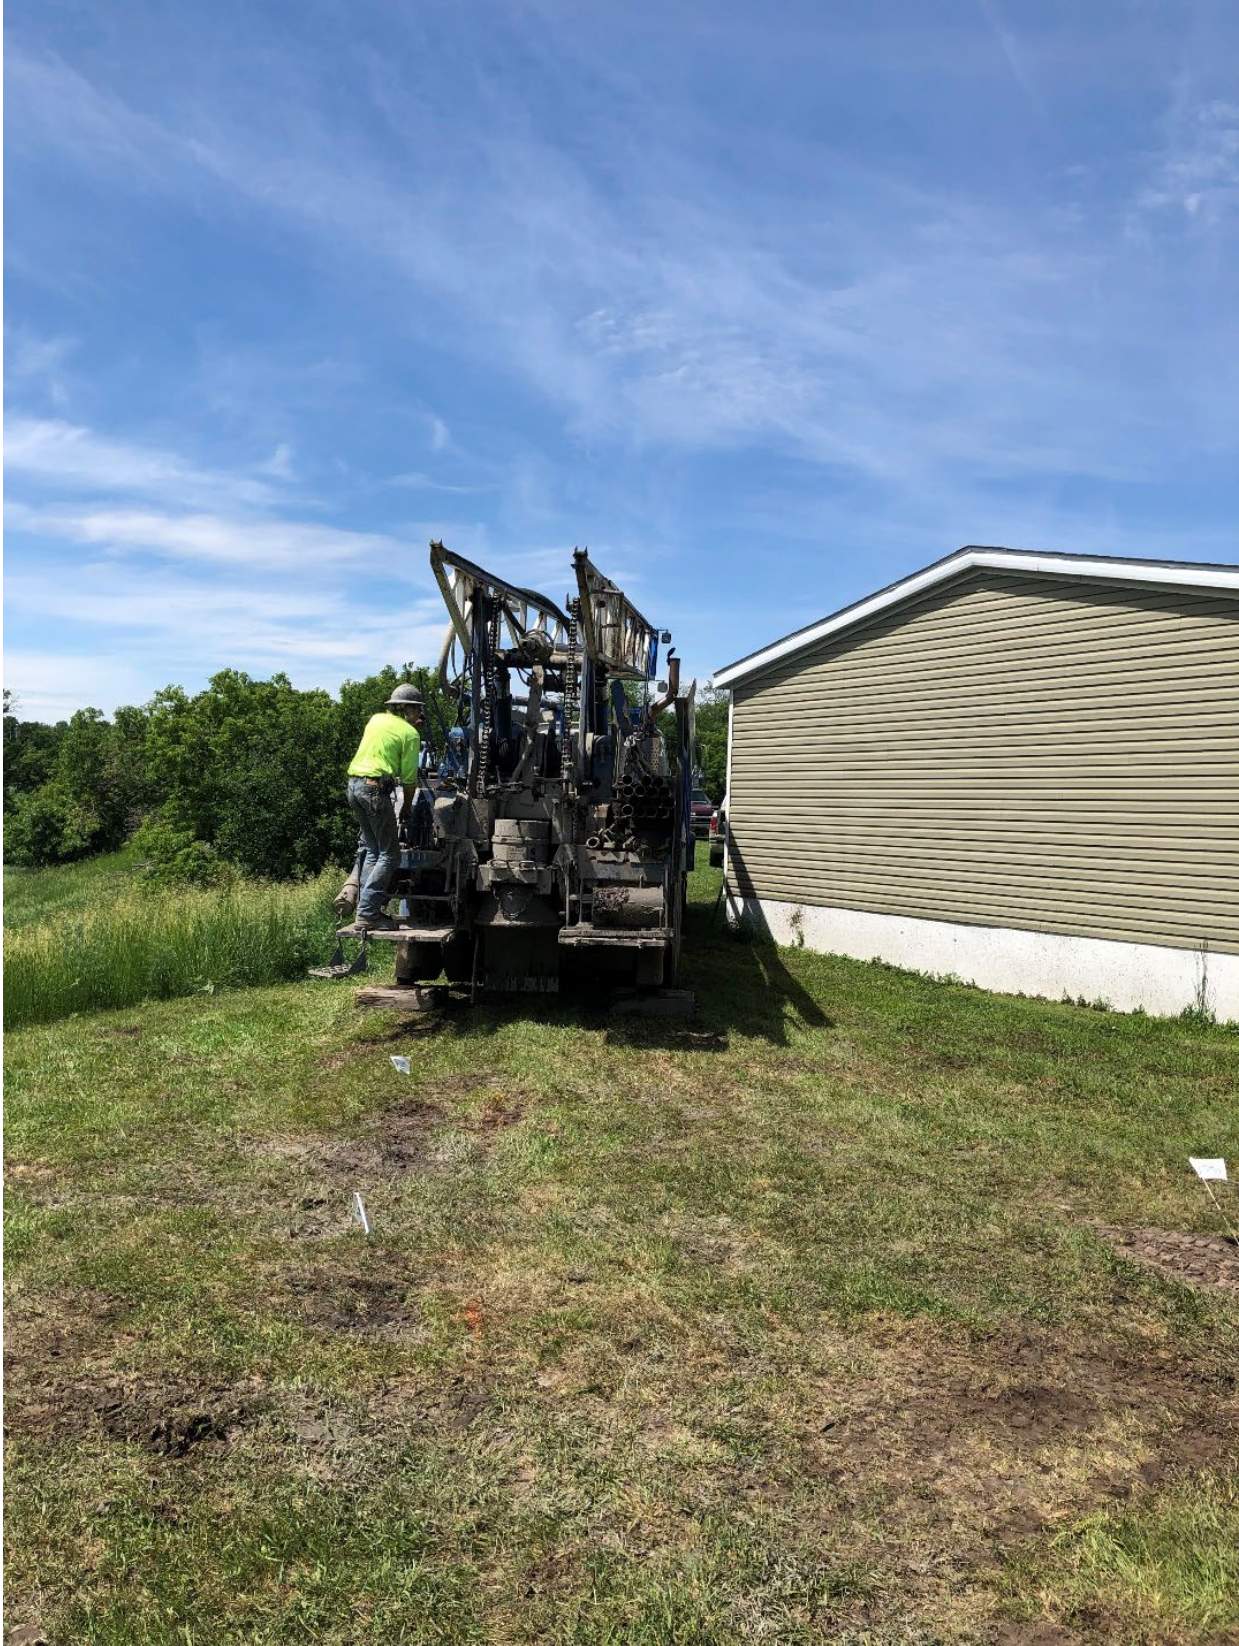
Figure 3: Drilling around a rural residence southwest of Velva.

AML staff received a call in September 2021 from a concerned landowner. The home is near multiple abandoned underground and surface lignite coal mines. AML staff visited the site and found some depressions that looked like formerly filled sinkholes. Additionally, there was a large, barricaded steel and concrete structure near the house that looked like it could be blocking a possible mine entrance. Drilling revealed poor-quality coal and no mine workings (**Figure 3**). No additional work is planned at this location.

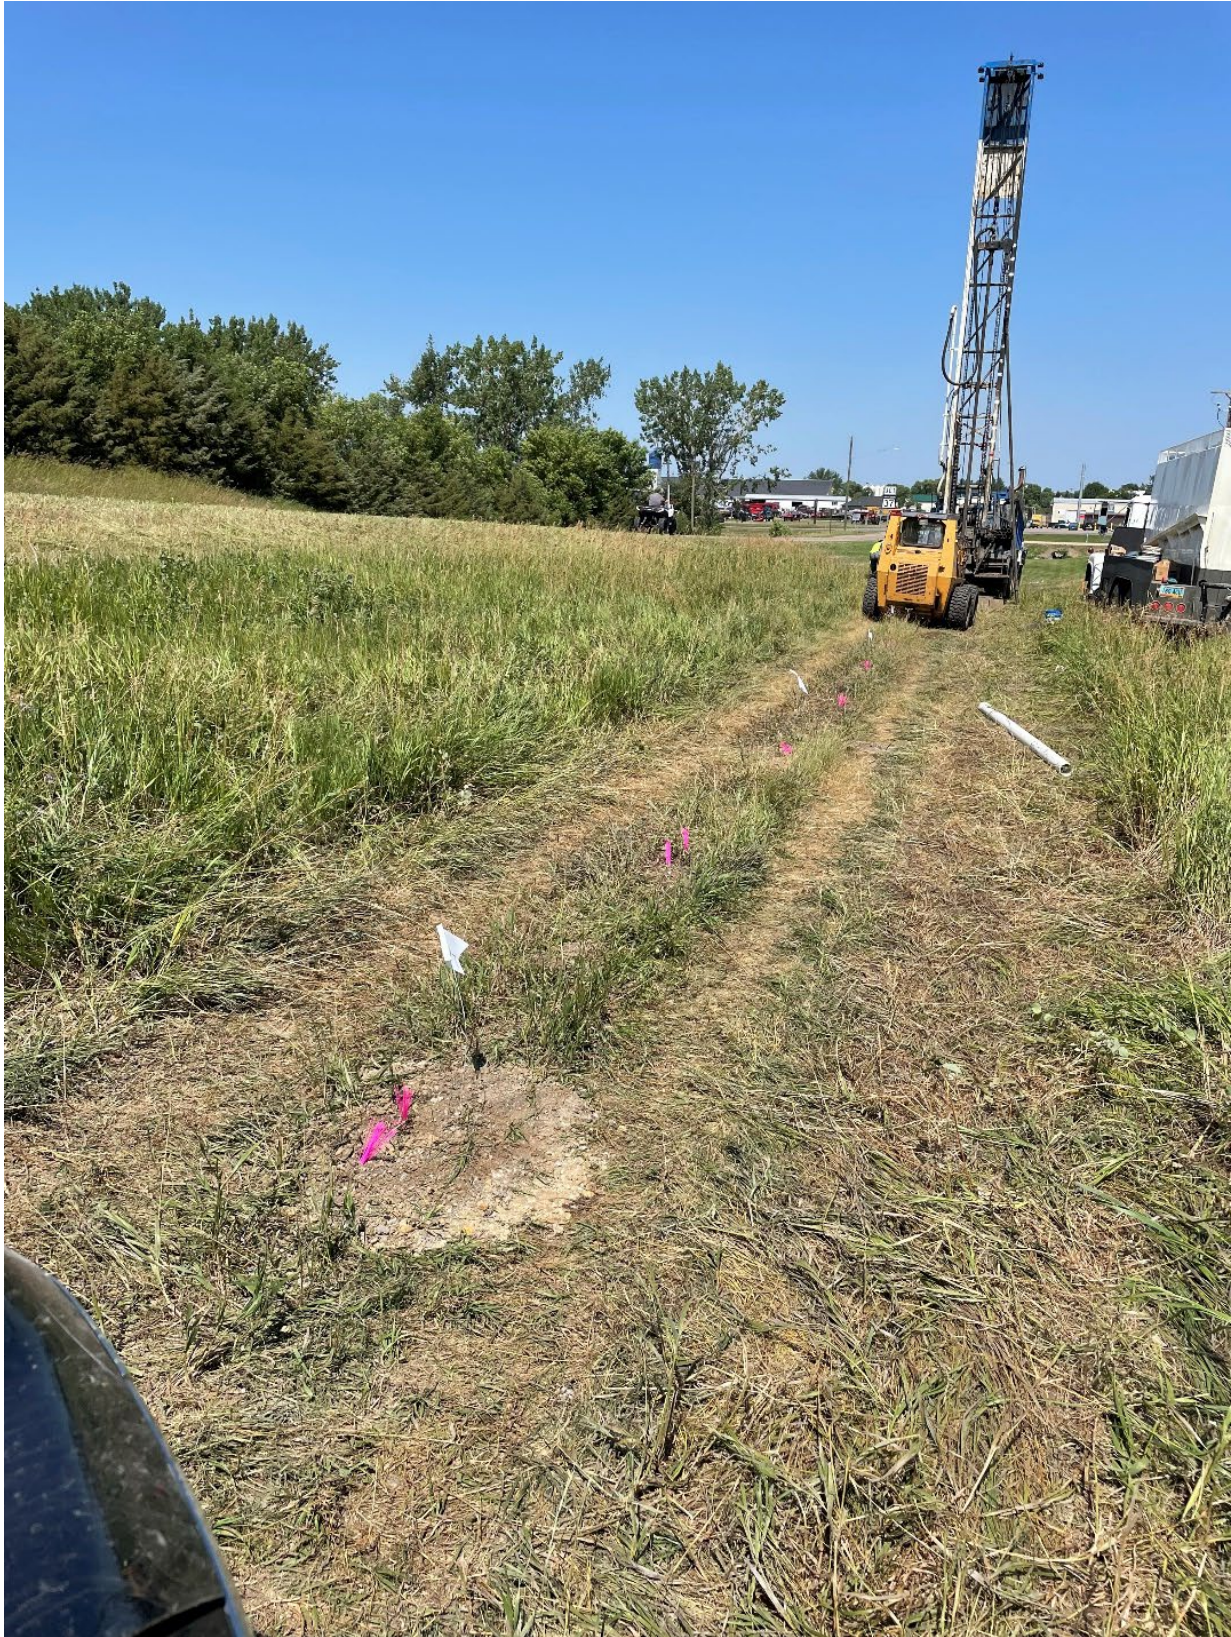
Figure 4: The drill rig is facing north in the east ditch of McLean County Highway 15. Buildings in Garrison can be seen in the background.

abandoned underground mines. The 2022 exploratory drilling in Garrison was done prior to the 2022 Garrison Phase 5 AML Drilling and Grouting Project. The 2022 drilling showed the extent of the abandoned underground mines in this area is larger than anticipated (**Figure 4**).

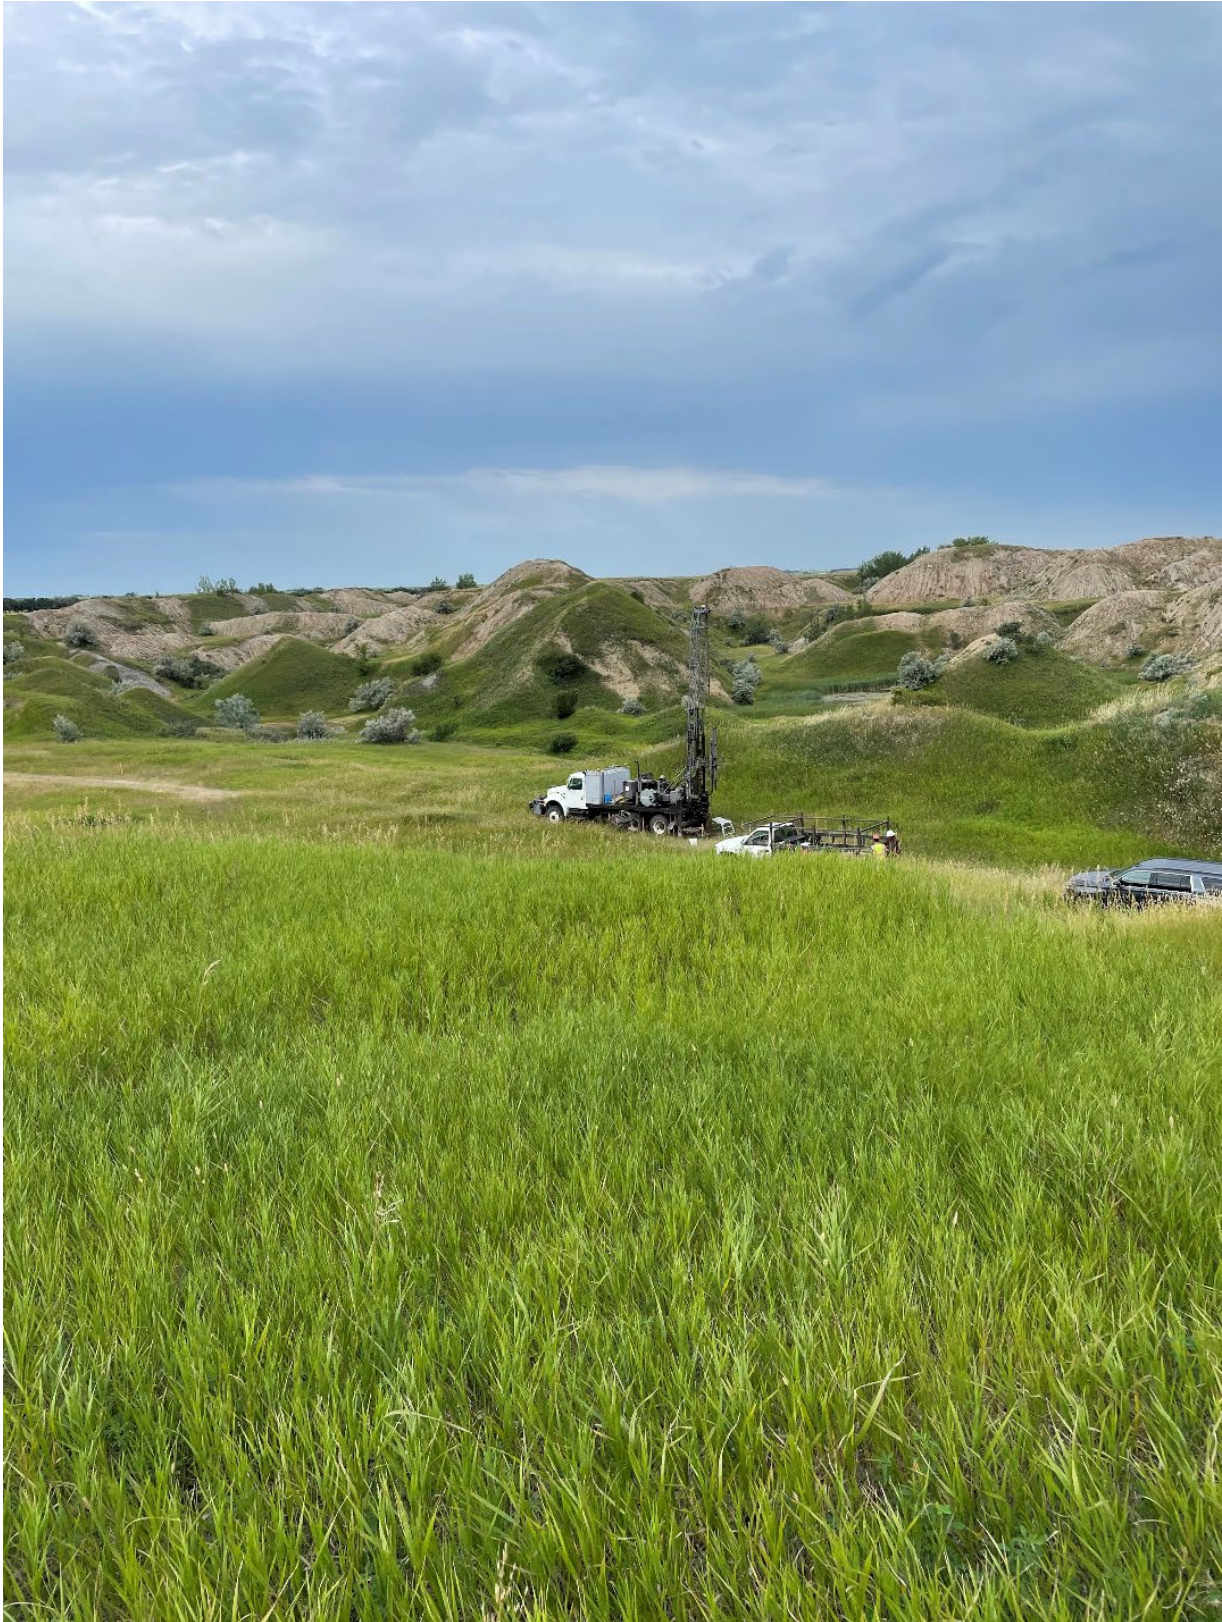
Figure 5: The Noonan site has both abandoned underground and surface coal mines. The hills behind the drill rig are spoil piles from historic surface mines.

In 2020 the AML Division conducted a foamed sand injection project at an abandoned underground mine on North Dakota Game and Fish land near the town of Noonan (**Figure 5**). The 2022 project intended to do additional testing on foamed sand material using the standard penetration testing and split barrel sampling. Results indicated that the foamed sand was able to penetrate small mine workings. No future work is planned at this site.

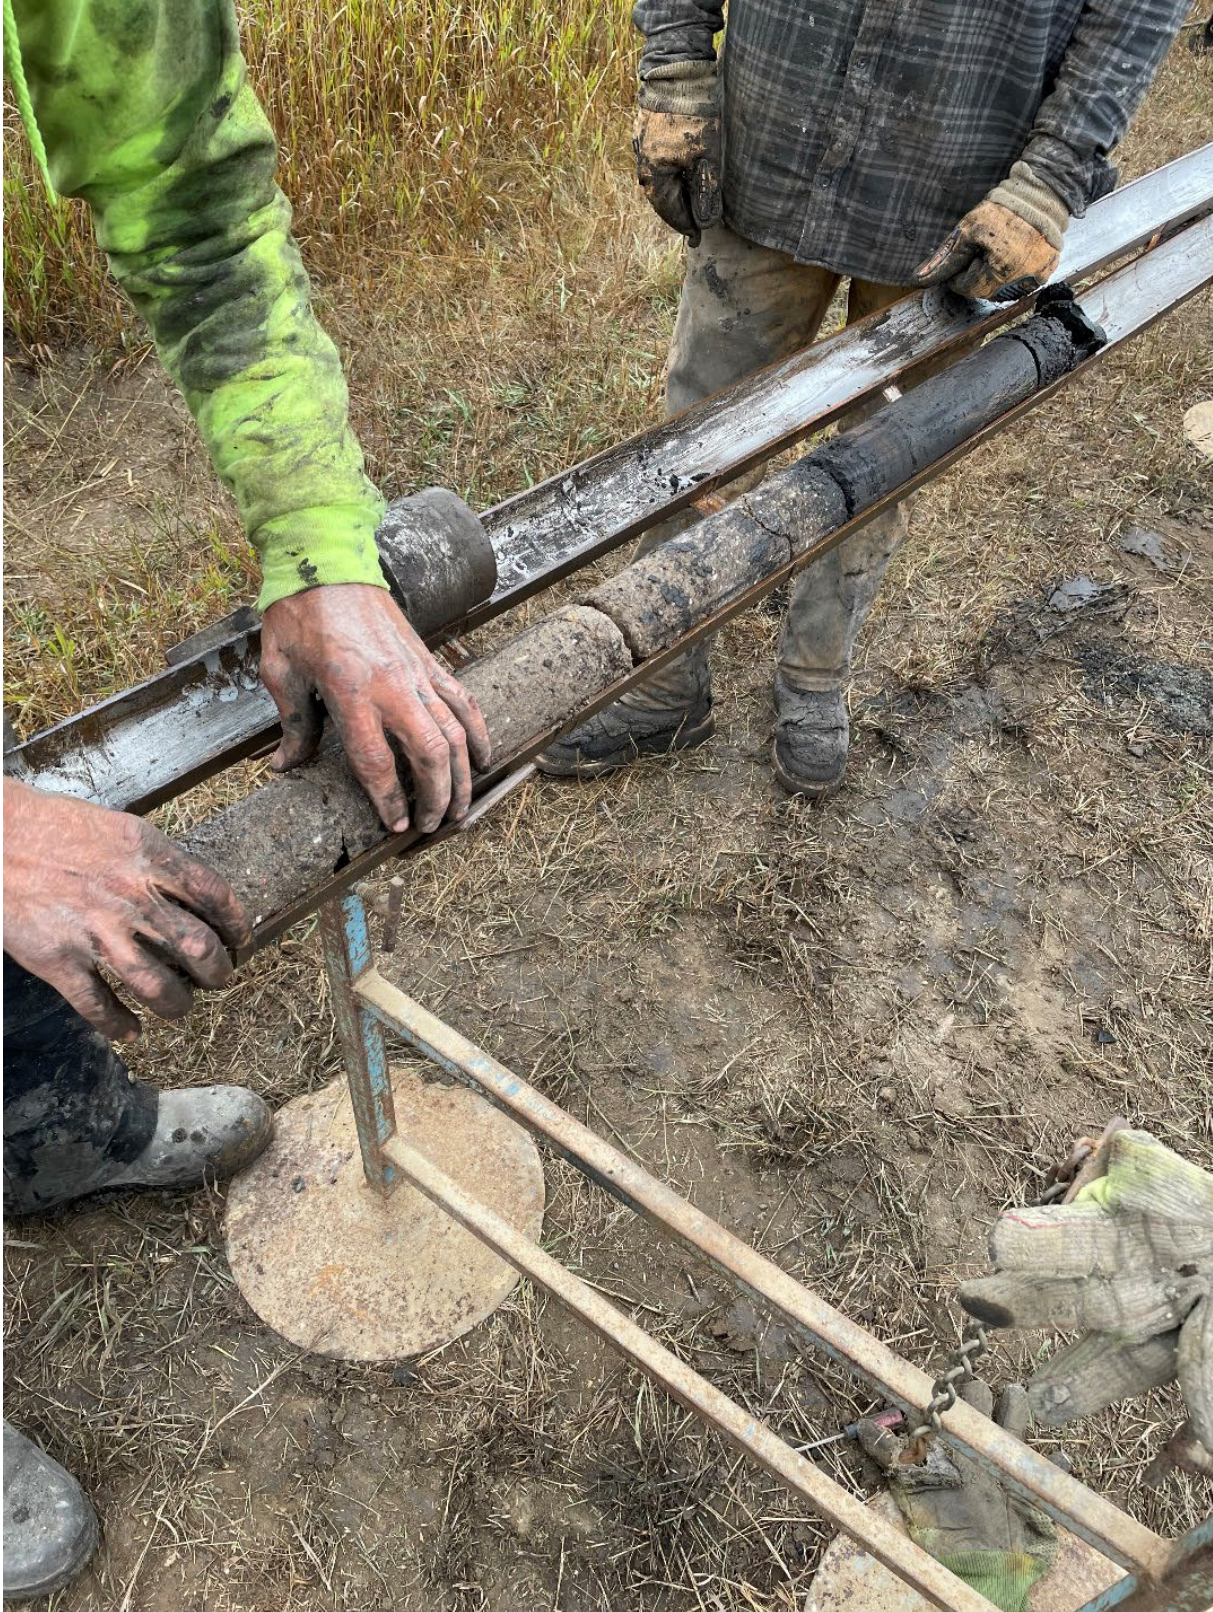
Figure 6: The drillers are opening the core barrel revealing solid grout and coal.

Fifty feet of coring was conducted at the Beulah site. Two core samples were collected in the north ditch of Highway 200 where grouting took place in 2021. Both cores found solid grout (**Figure 6**). The remaining core samples were taken in the driveway of the rural residence. Those cores also showed solid grout.
