## 2022 Morton County Phase 3 Project Summary

**Contract Number:** AM-866-22

**Location:** The site is located approximately six miles northwest of New Salem in Morton County.

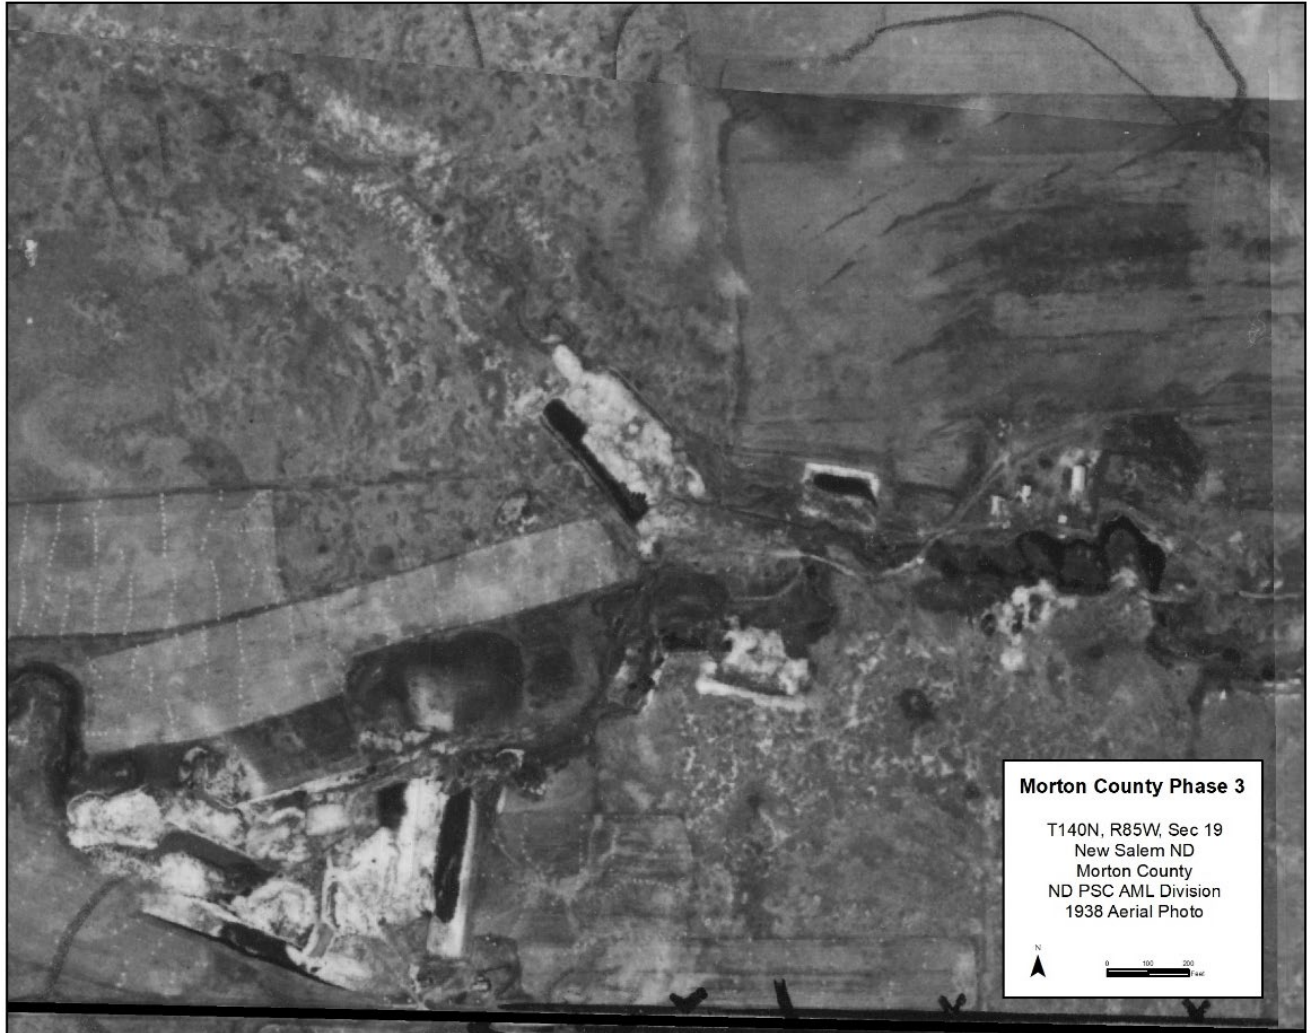
**Figure 1:** A 1938 aerial photo shows initial mining activity at the Youngtown Mine.

Historic records documented in the *1983 Centennial History of New Salem* indicate the mine operated from the 1900s until the early 1950s. A small surface mine is visible in a 1938 aerial photo (**Figure 1**). Mining had been completed by 1957, which is evident by comparing current aerial imagery to the 1957 aerial imagery (**Figure 2**). In 1990 the AML Division conducted a small reclamation project to reclaim the most dangerous highwalls at this site. The entire area could not be addressed due to limited funding.

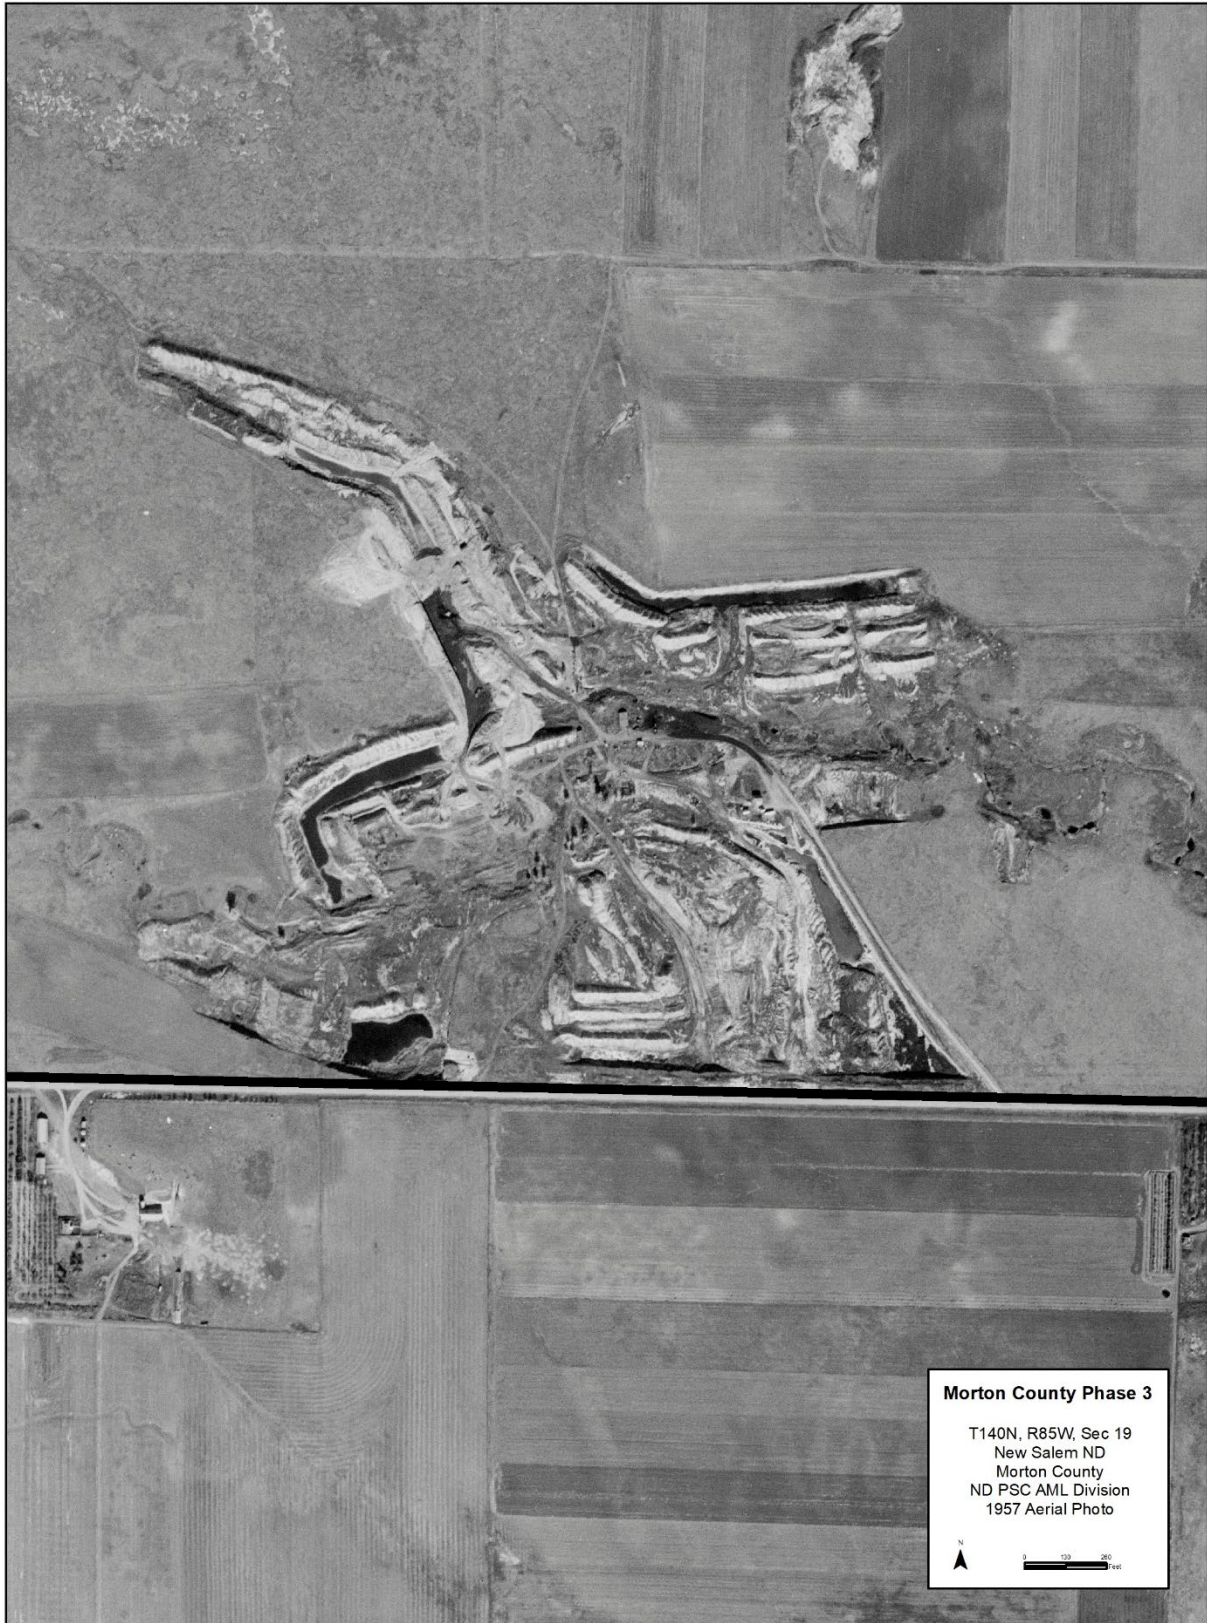
**Figure 2:** A 1957 Photo shows mining completed at Youngtown Mine.

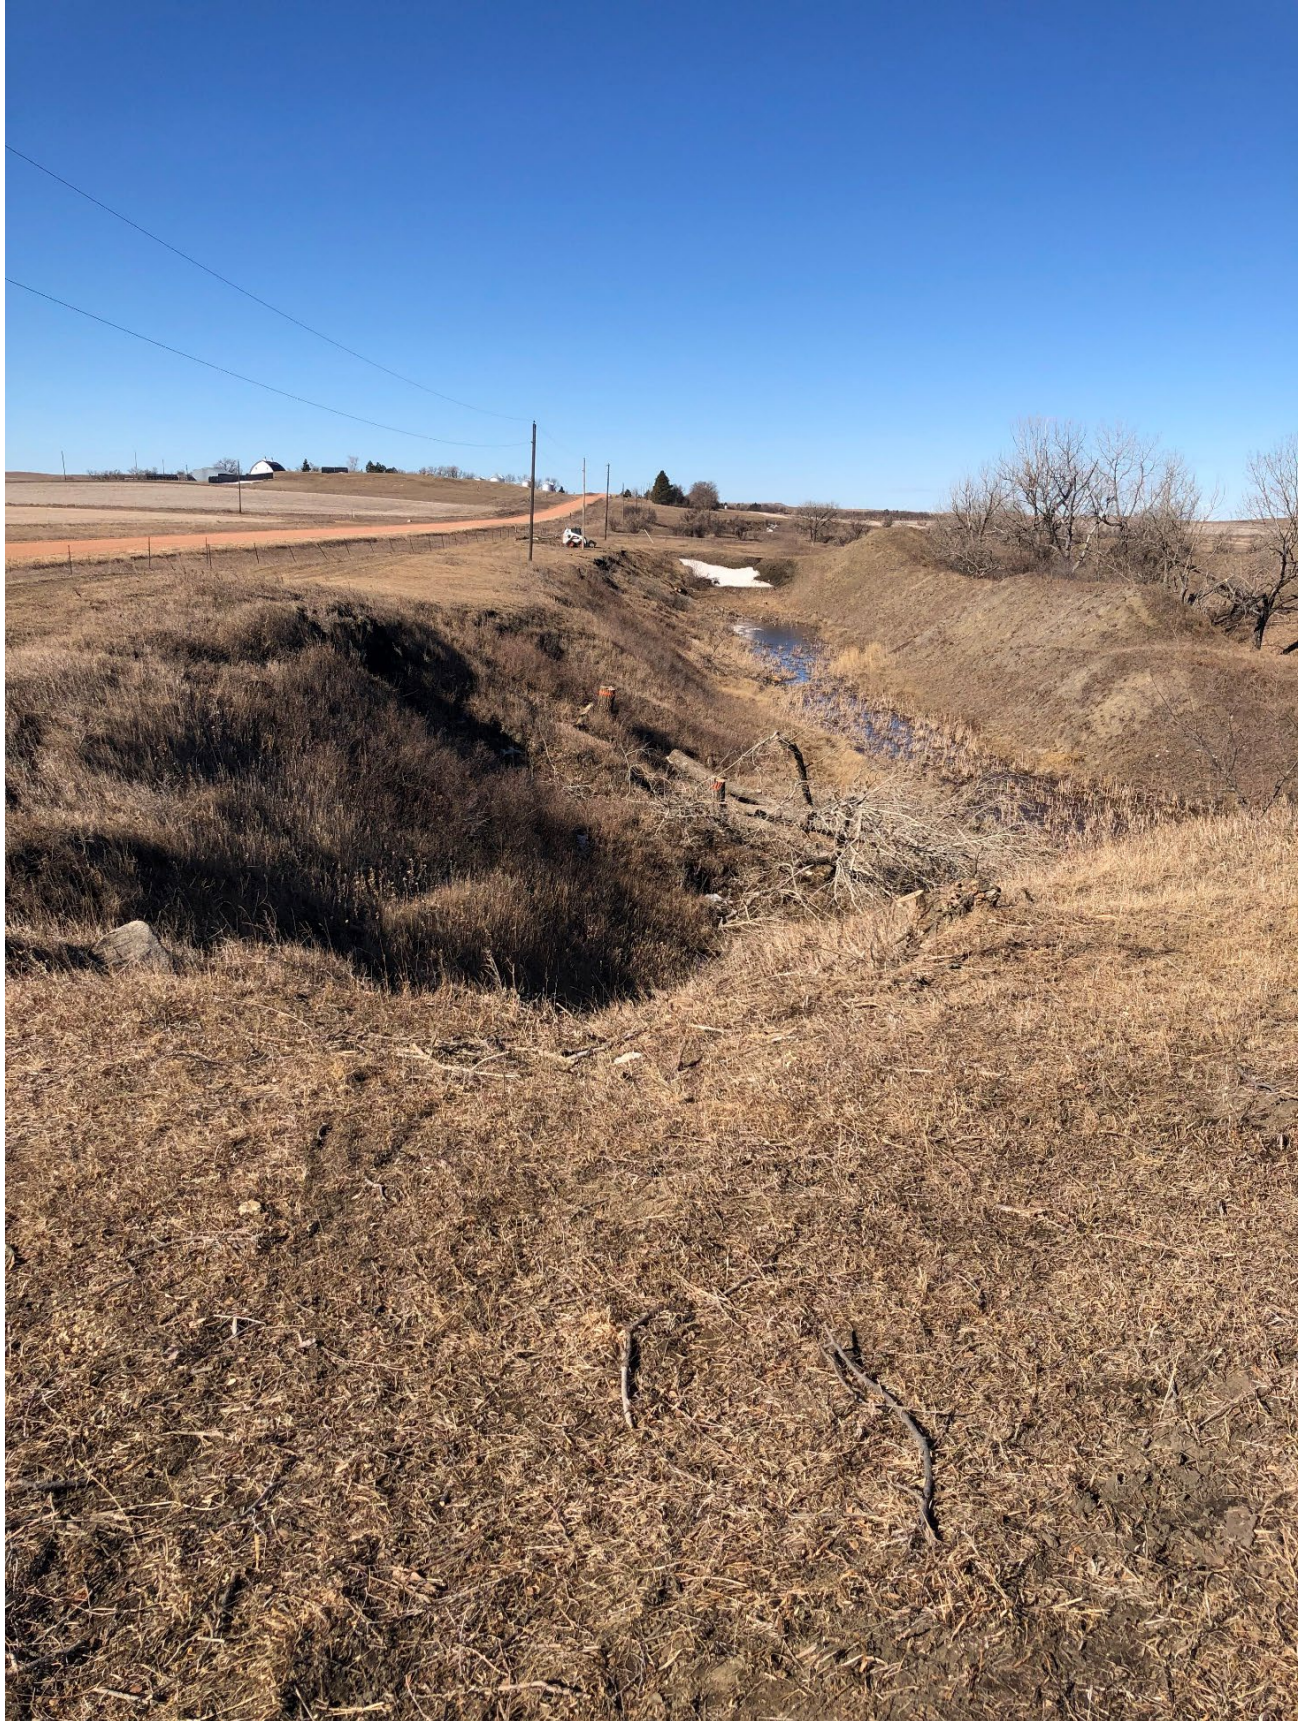
**Figure 3:** *Trees felled along the East Youngtown highwall.*

The Youngtown Mine contained numerous large trees that would have inhibited dirt-moving operations. Tree removal in AML projects is conducted during winter months to limit the potential impact to raptors and the threatened Northern Long-Eared Bat. On February 28, 2022, the Commission executed Contract AM-862-22 with Advanced Tree Service, Inc. Tree removal began on March 15, 2022, and all trees were felled and removed by March 29, 2022. (**Figures 3 and 4**).

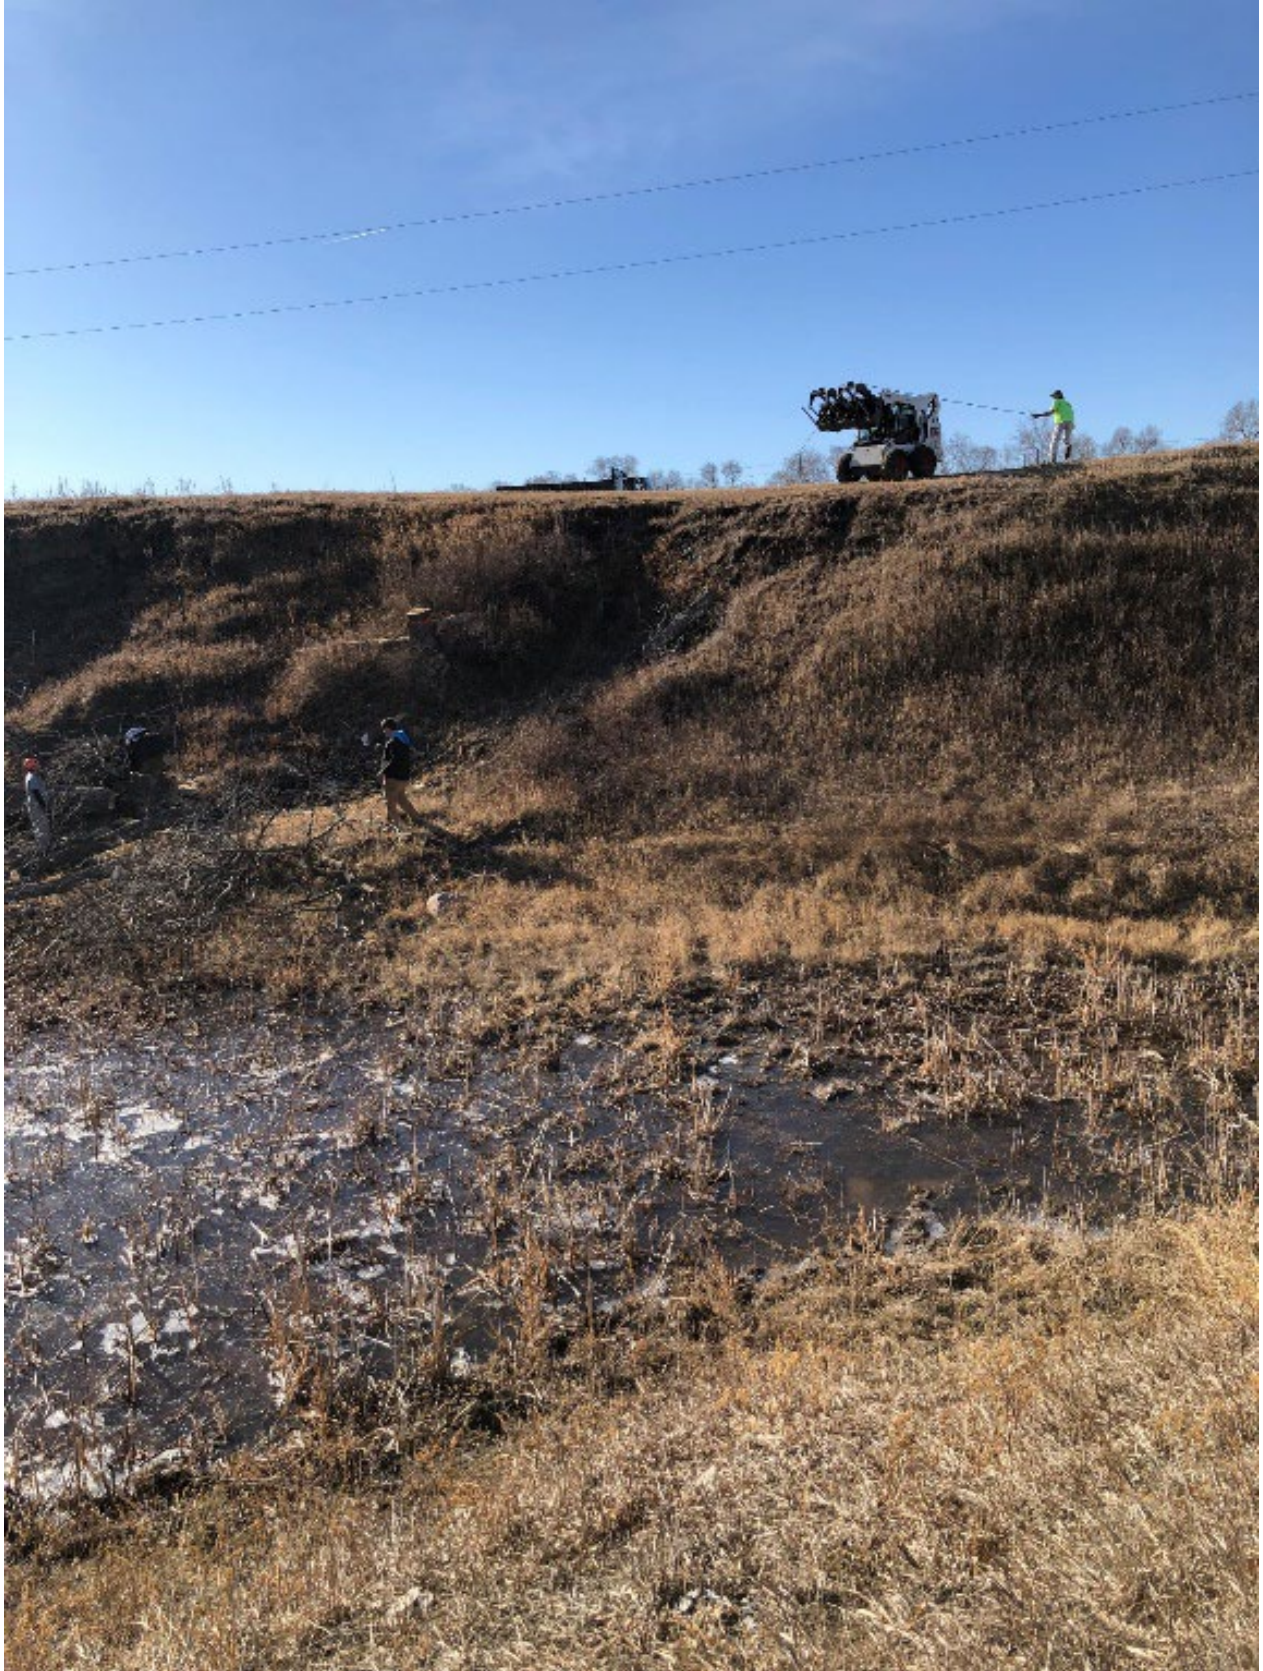
**Figure 4:** Tree removal operations in the East Youngtown's pit.

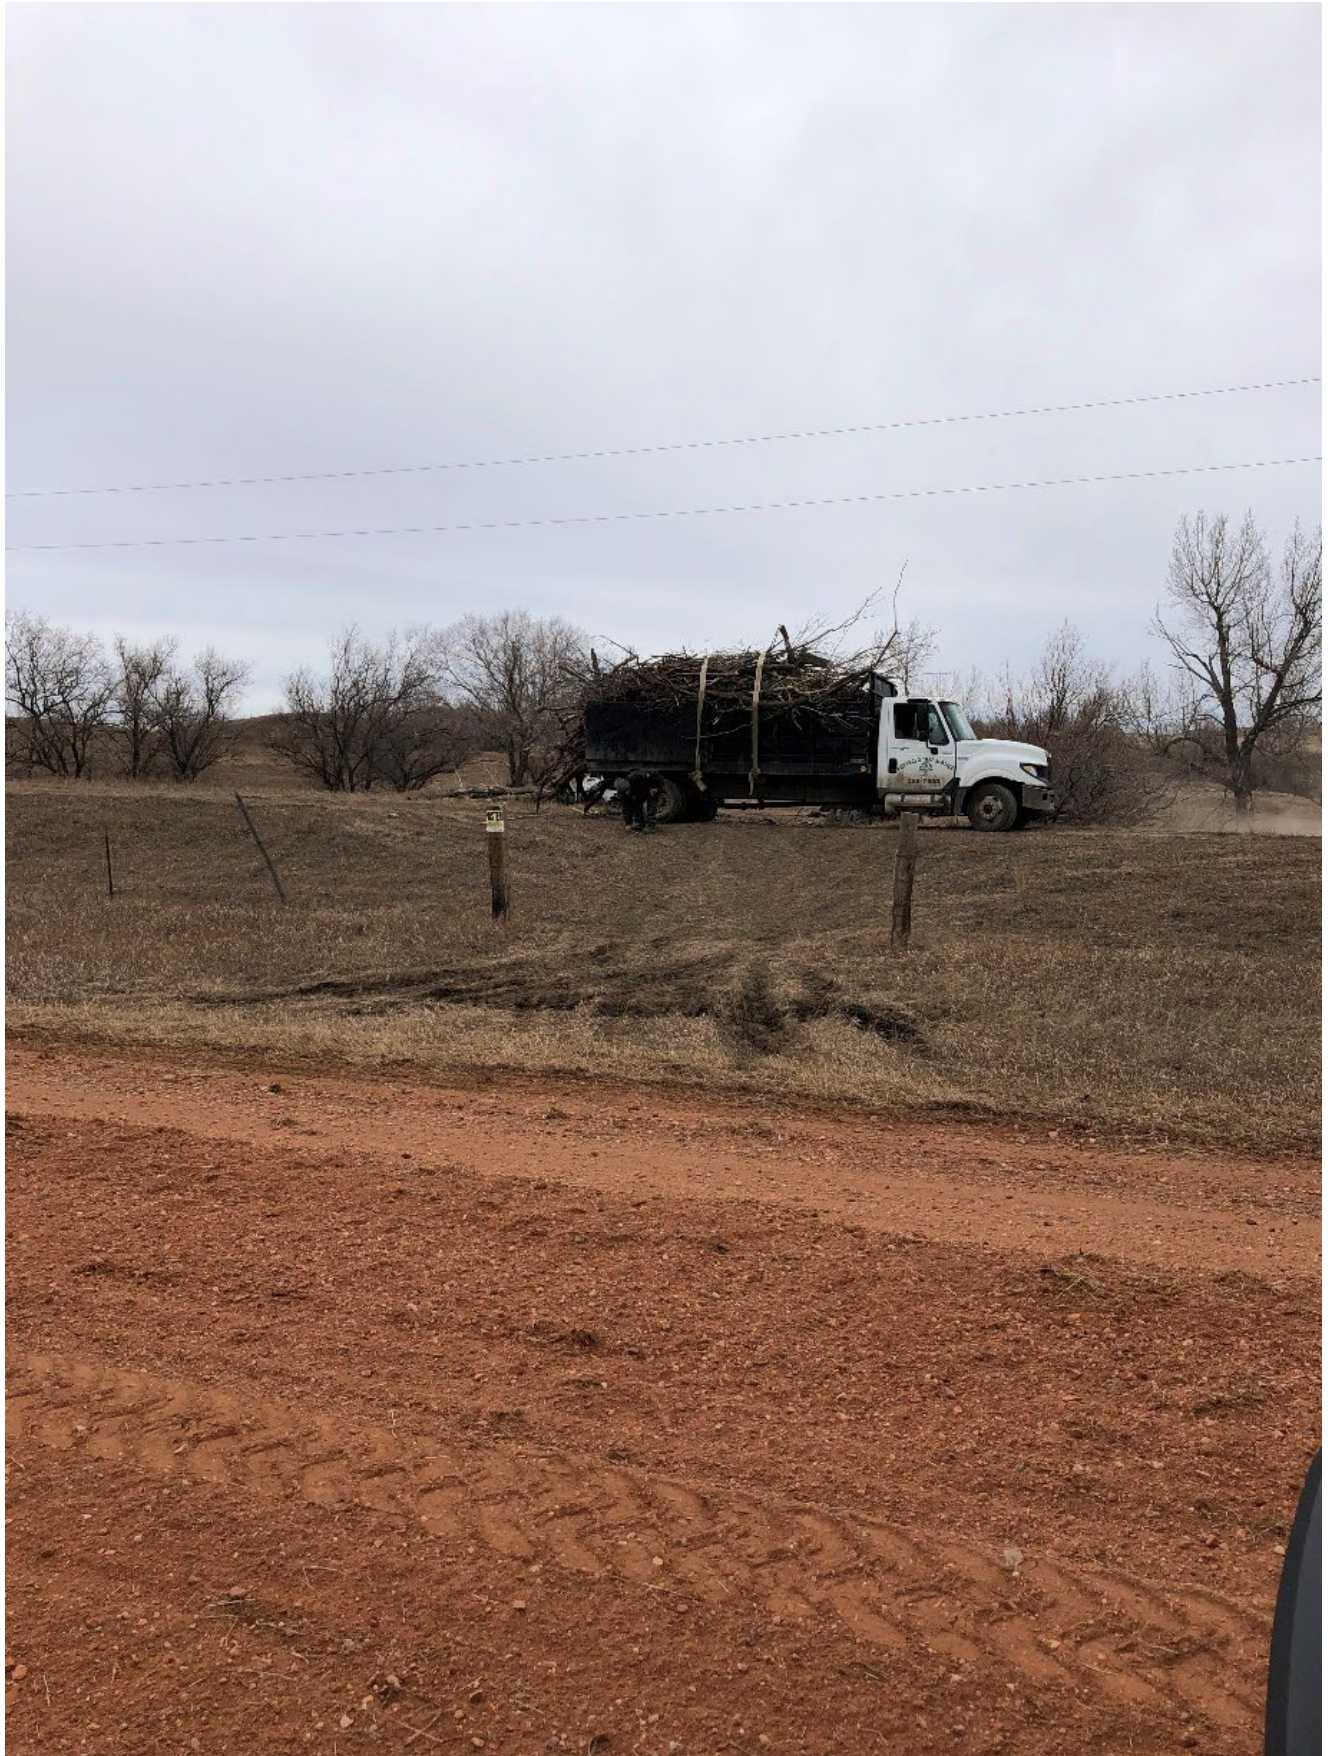
**Figure 5:** All trees were strapped before being hauled to the landfill.

A total of 68 trees were removed from the site with 55 of the trees having trunks greater than eight inches in diameter. All trees were hauled off-site (**Figure 5**) and disposed of in the New Salem landfill. The total cost of the tree removal contract was \$41,750.

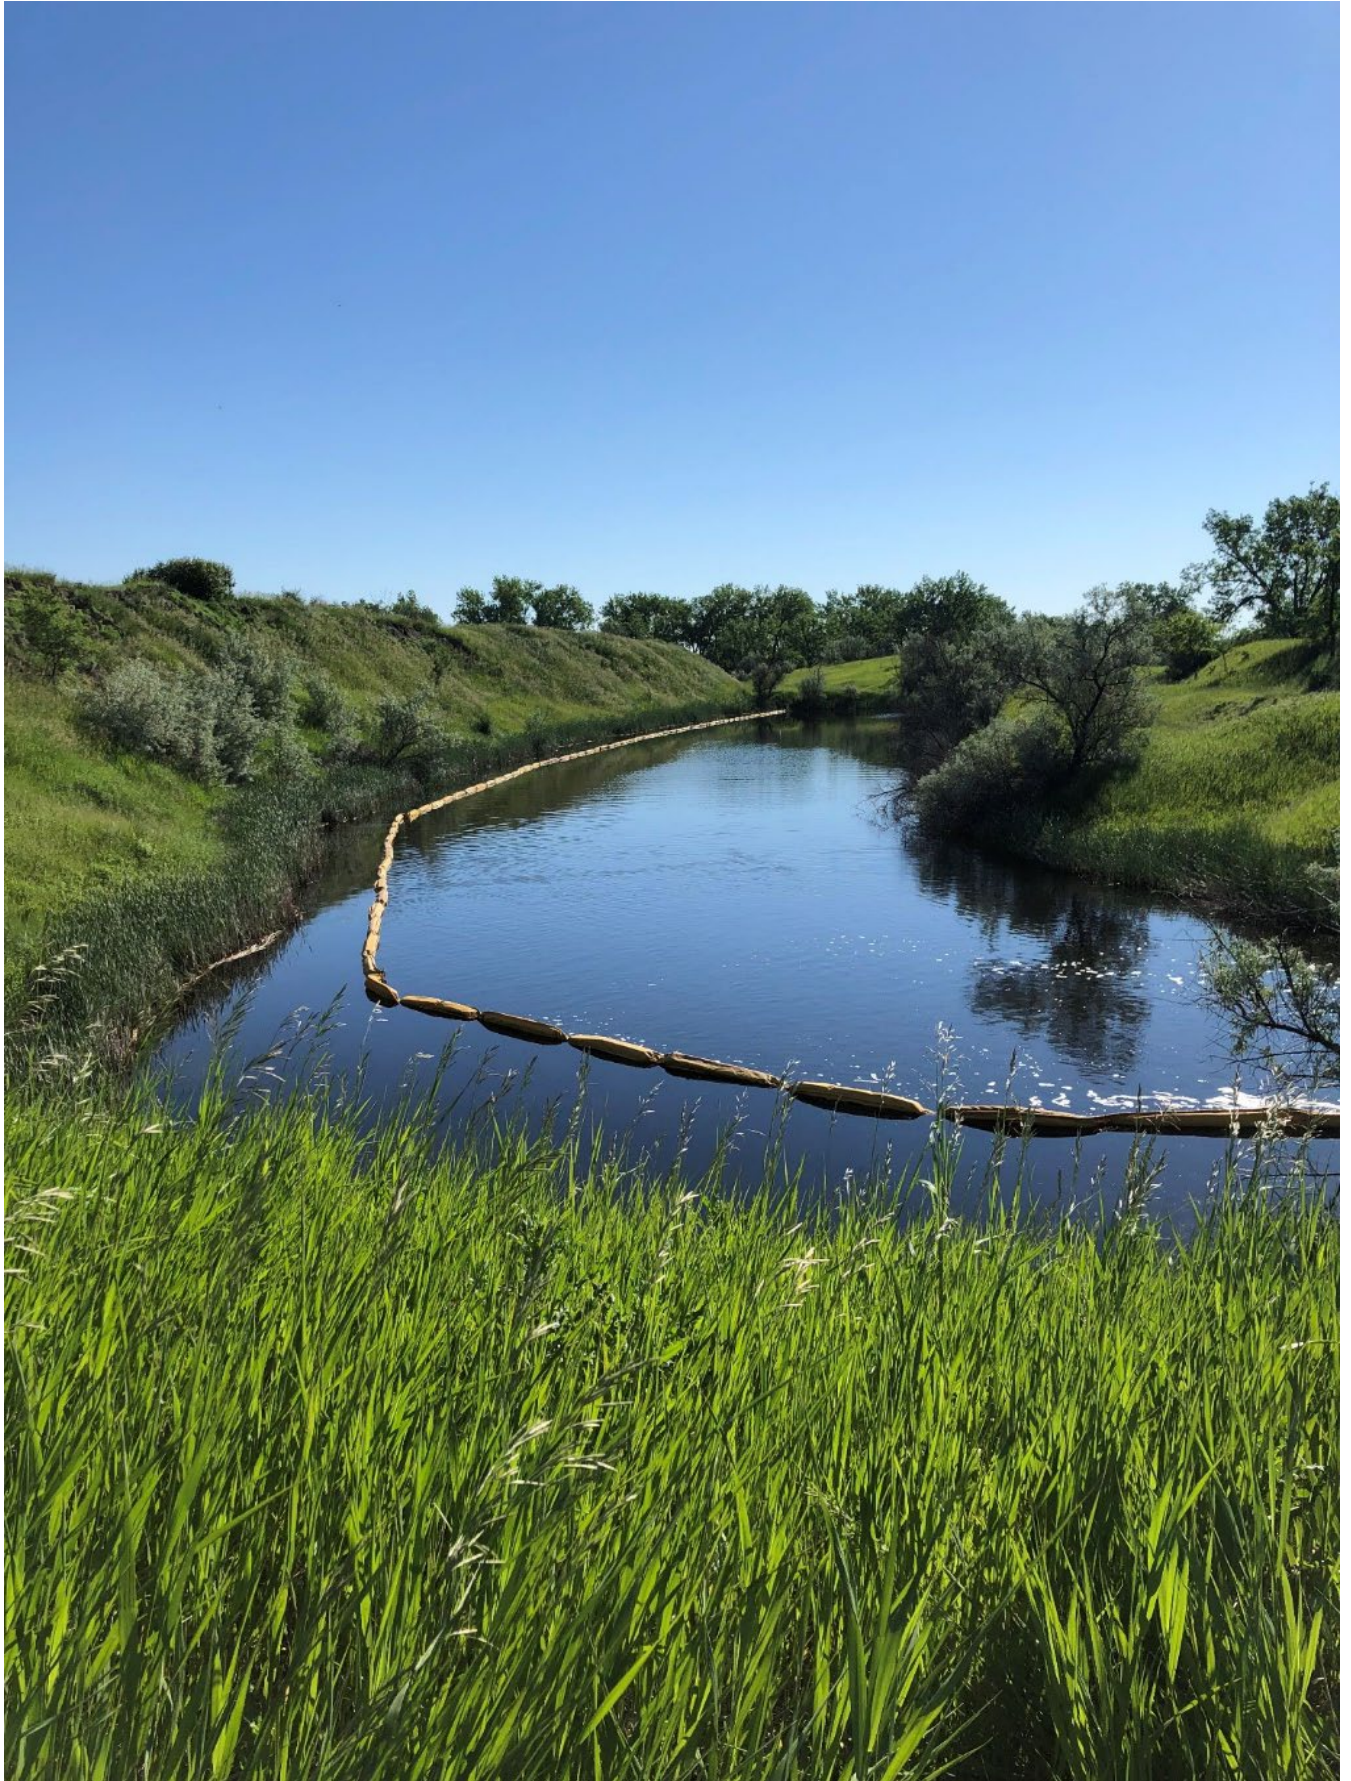
**Figure 6:** A turbidity curtain was installed in the pit pond along the north highwall.

Construction started in late June with the installation of the floating turbidity curtain to protect the pond that developed in the final pit (**Figure 6**). A total of 1,225 feet of silt fencing was installed to control sediment. A safety barrier mesh was also used to protect the landowner's pet cemetery.

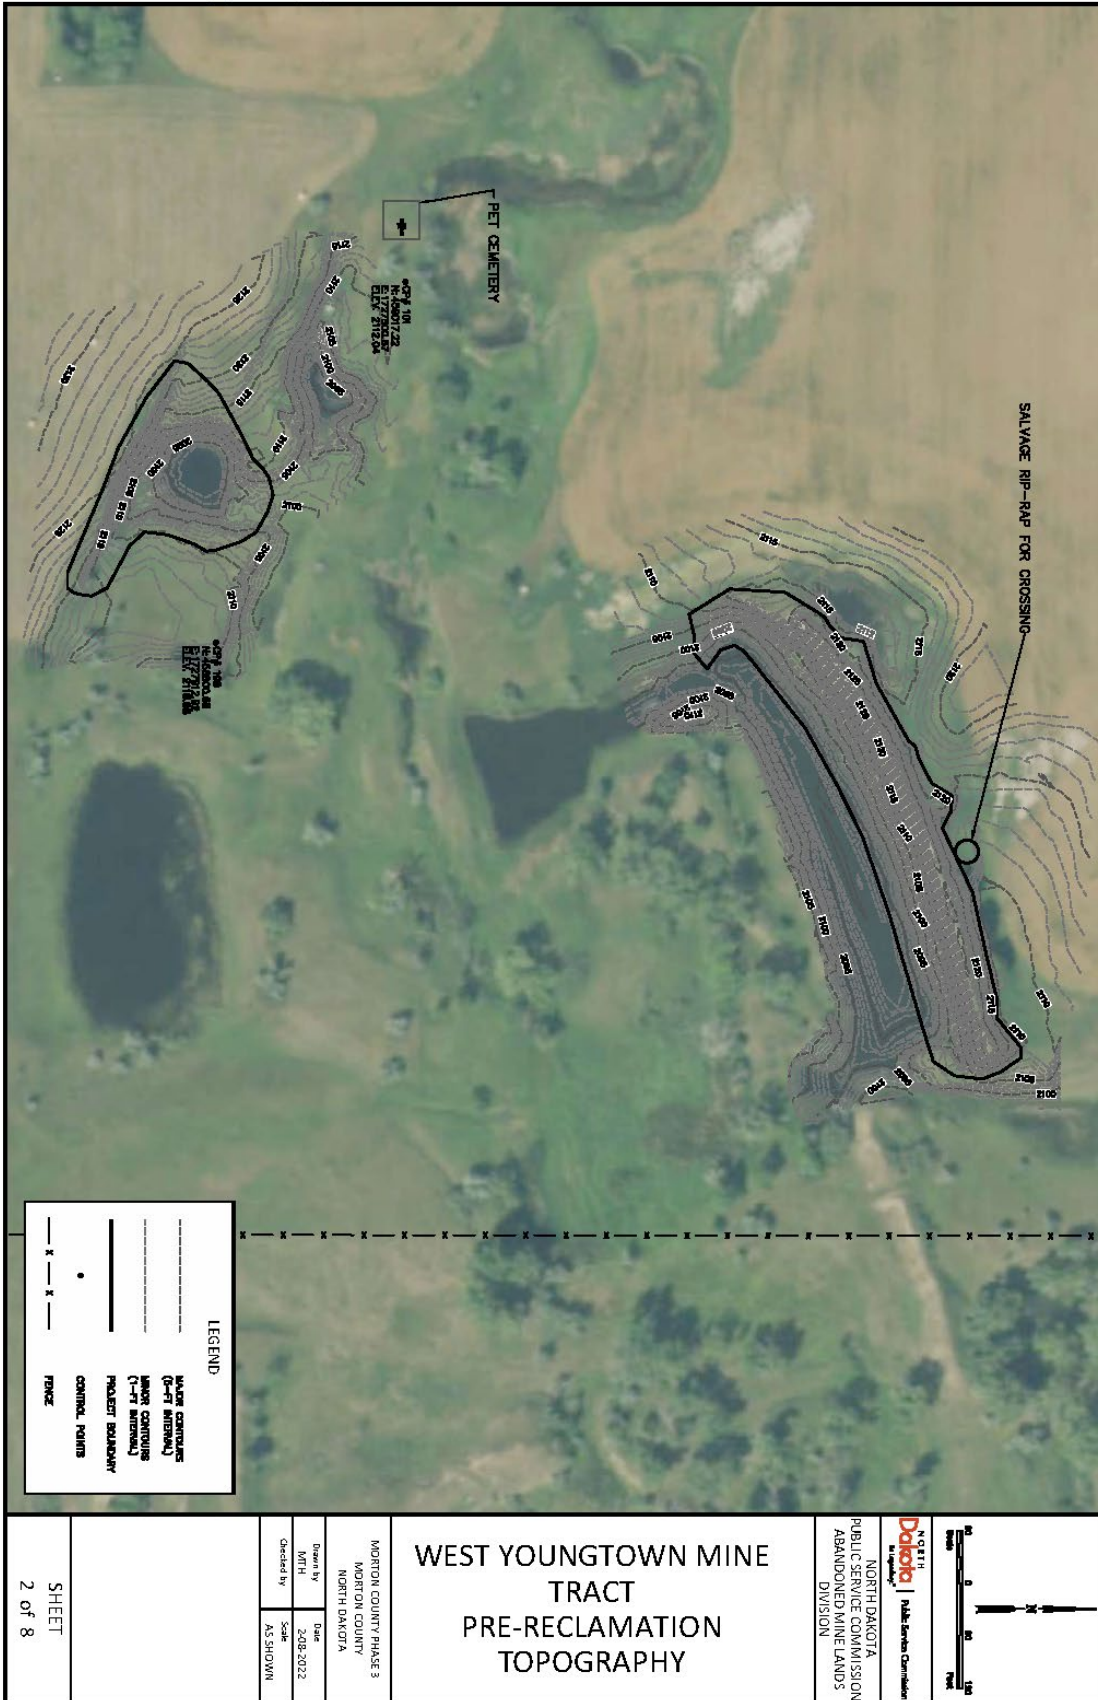
Figure 7: Map showing the West Youngtown Tract's topography prior to reclamation.

A map shows the pre-reclamation topography along with the north borrow site, south fill site, and pet cemetery (**Figure 7**). The original plan was to complete the reclamation of this site first and then move to the East Youngtown Site. However, there were delays in the delivery of gravel and the site received five inches of rain between July 2 and July 9. In late July the proposed haul road area was still saturated from the recent rains. The project manager and contractor decided that topsoil would be used to bridge the saturated section of the haul road. The topsoil stockpile bridge was completed by July 26 (**Figure 8**). Additionally, a gravel road was constructed (**Figure 9**) and it tied into the topsoil bridge. It was used to haul spoil from the north highwall to the two southern pits (**Figure 10**). Moving spoil from the north borrow area went as planned with dozers leveling the scraper dumps and they also pushed spoil material up to the highwall.

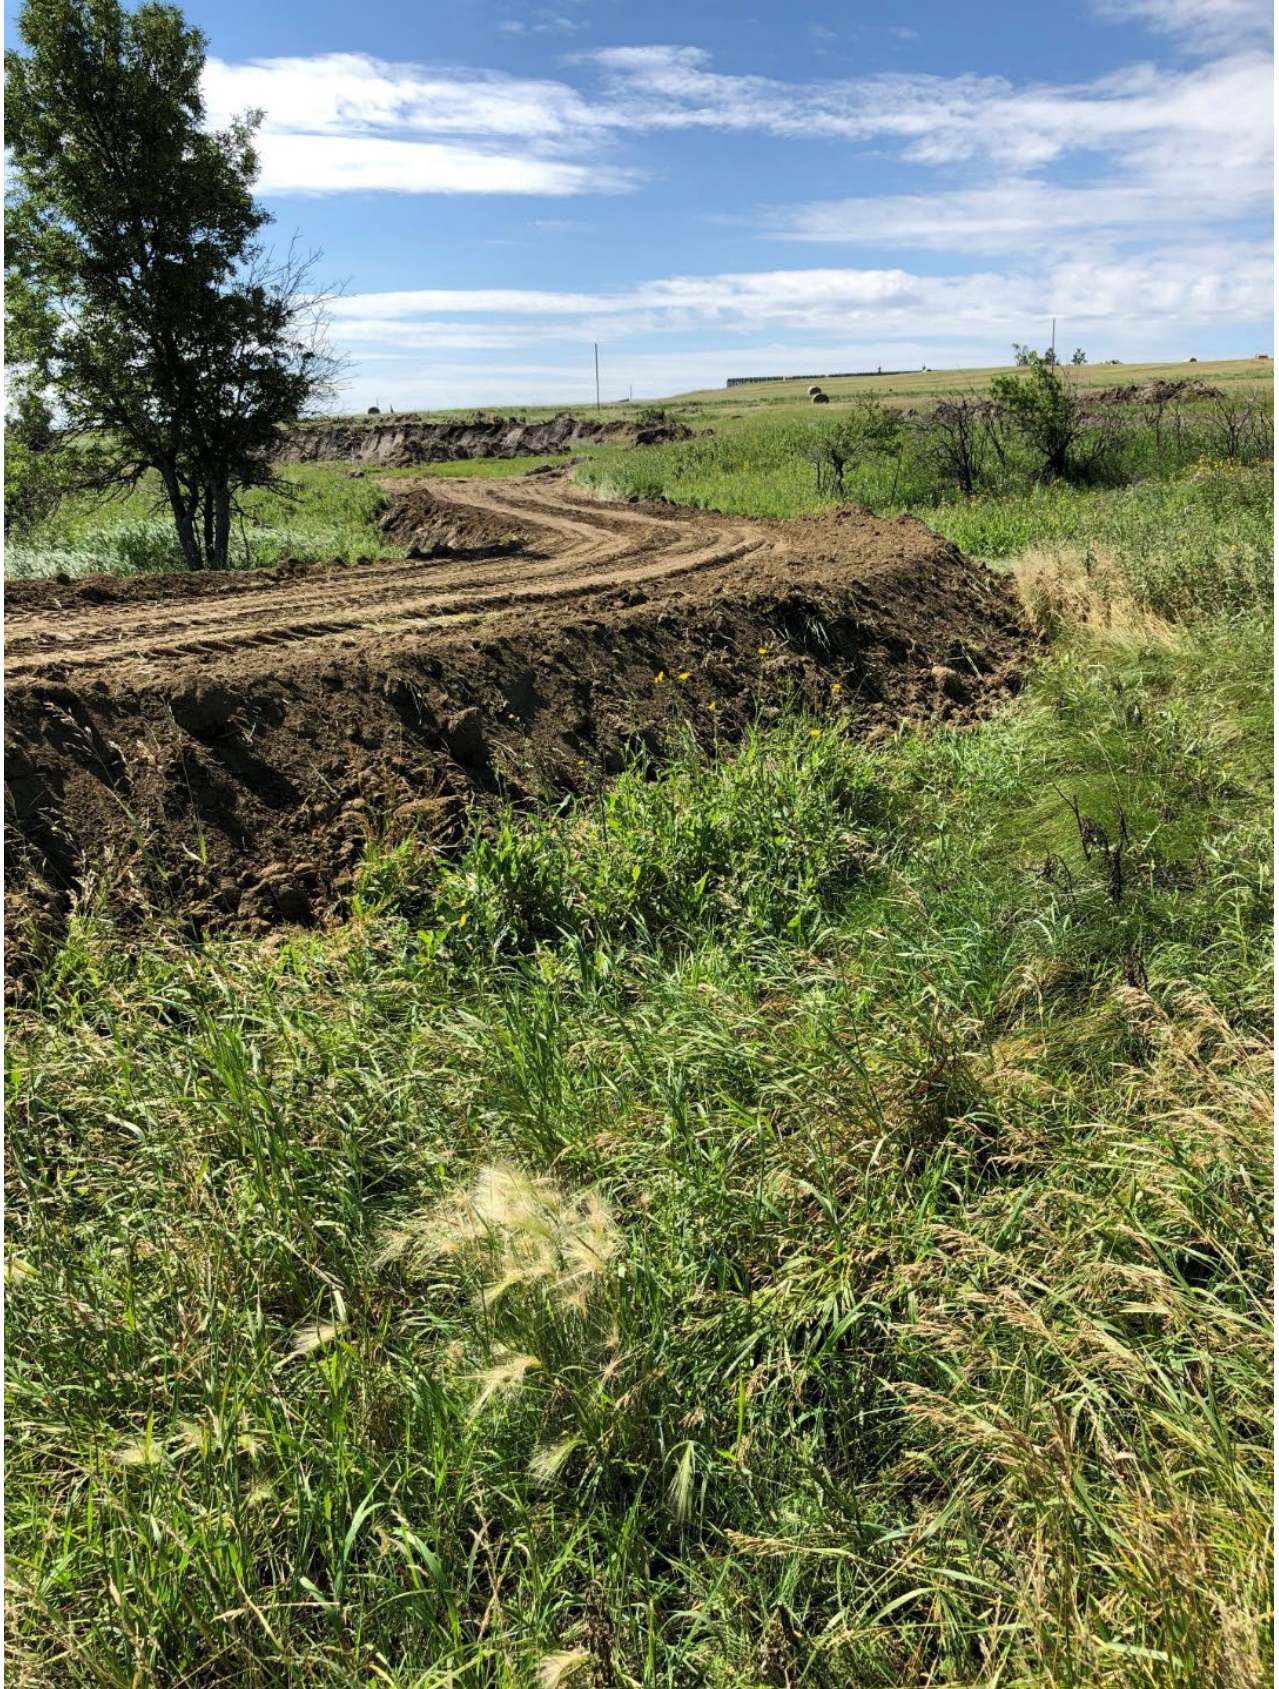
**Figure 8:** A temporary topsoil bridge was constructed in a saturated portion of the mine.

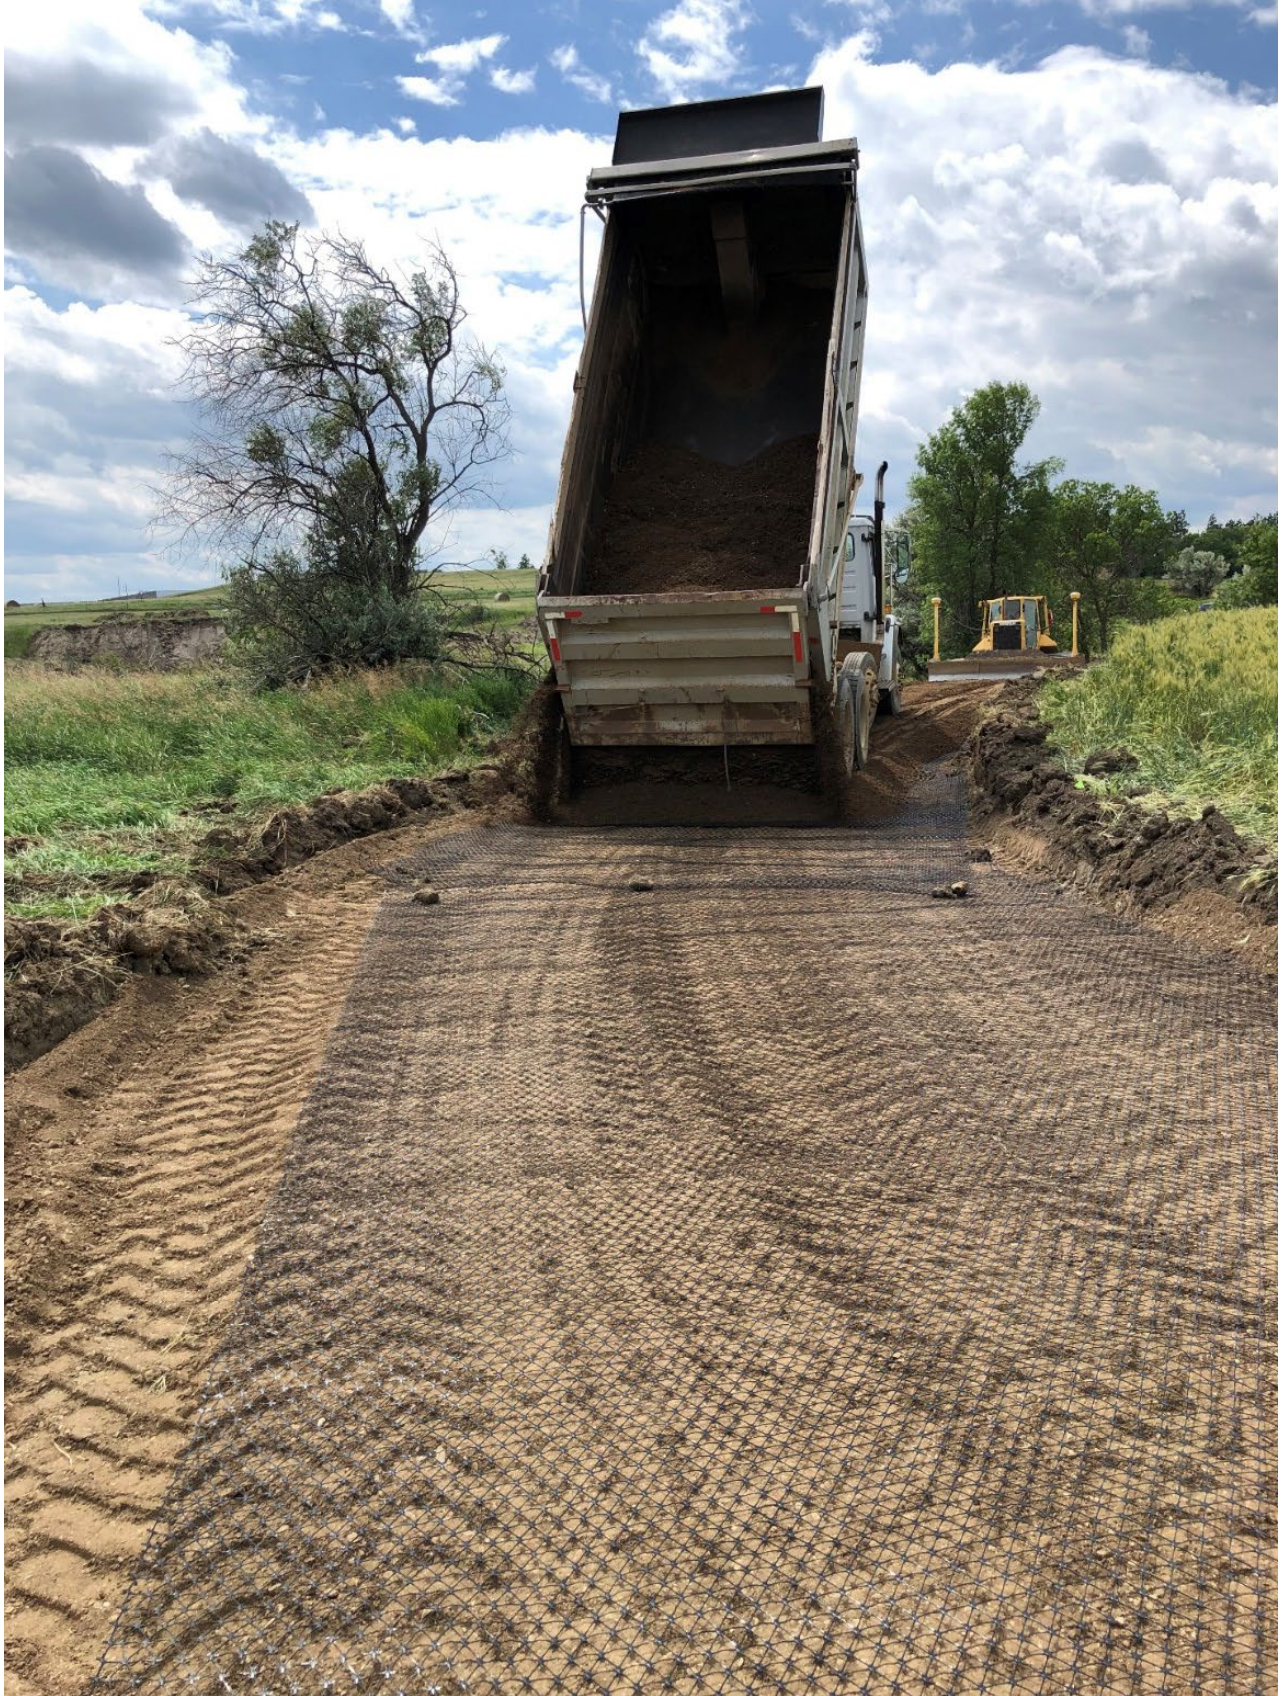
**Figure 9:** Constructing the temporary haul road/topsoil bridge in the West Youngtown Tract.

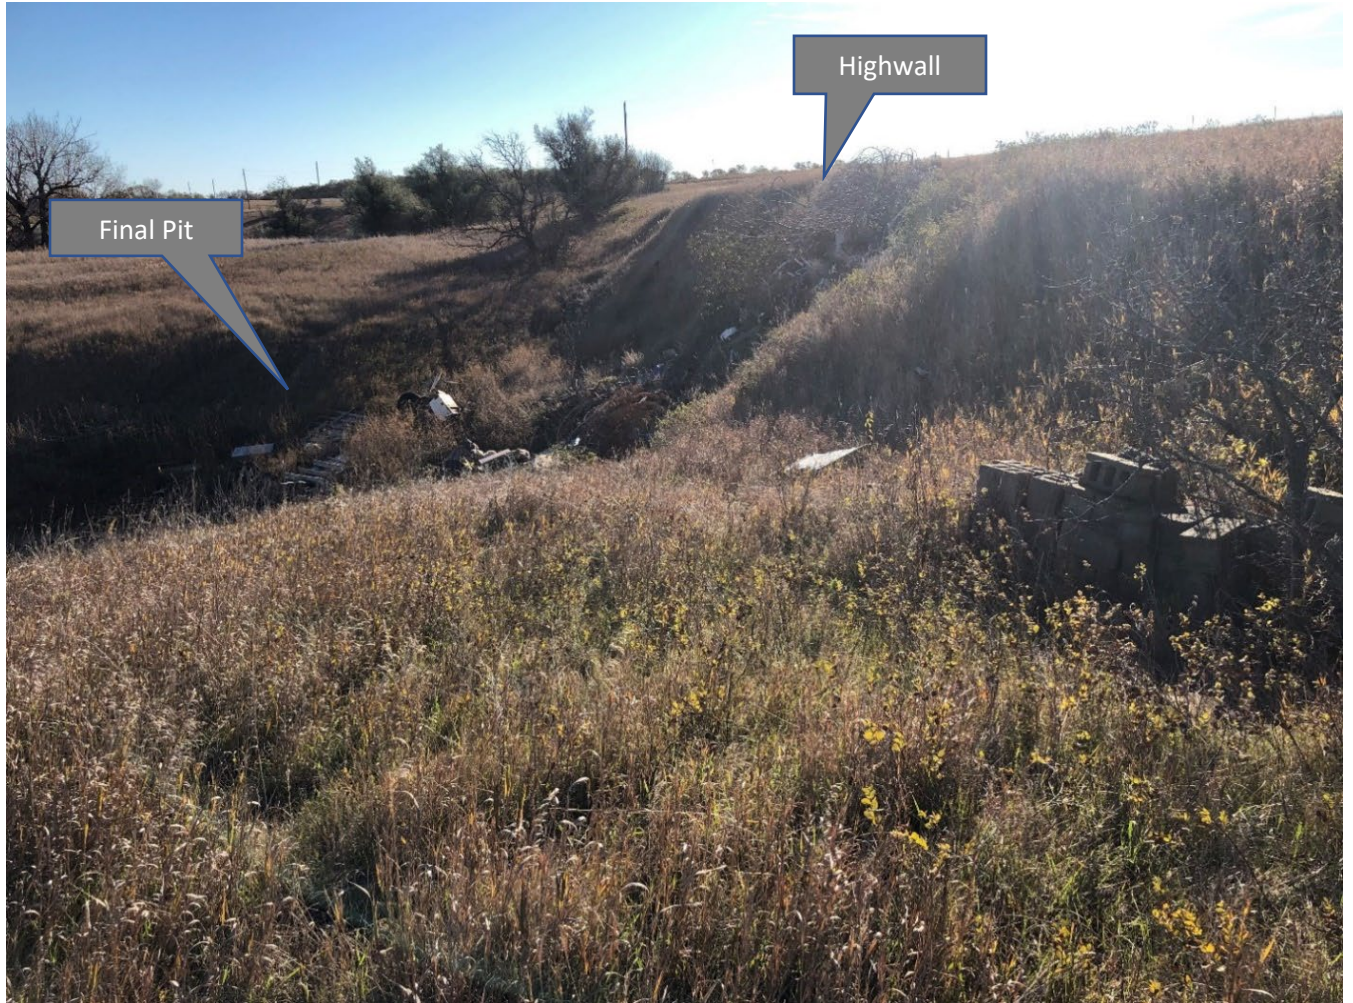
**Figure 10:** *The West Youngtown Tract's southeast highwall and final pit before reclamation.*
