## 2022 Morton County Phase 3 Project Summary

**Contract Number:** AM-866-22

**Location:** The site is located approximately six miles northwest of New Salem in Morton County.

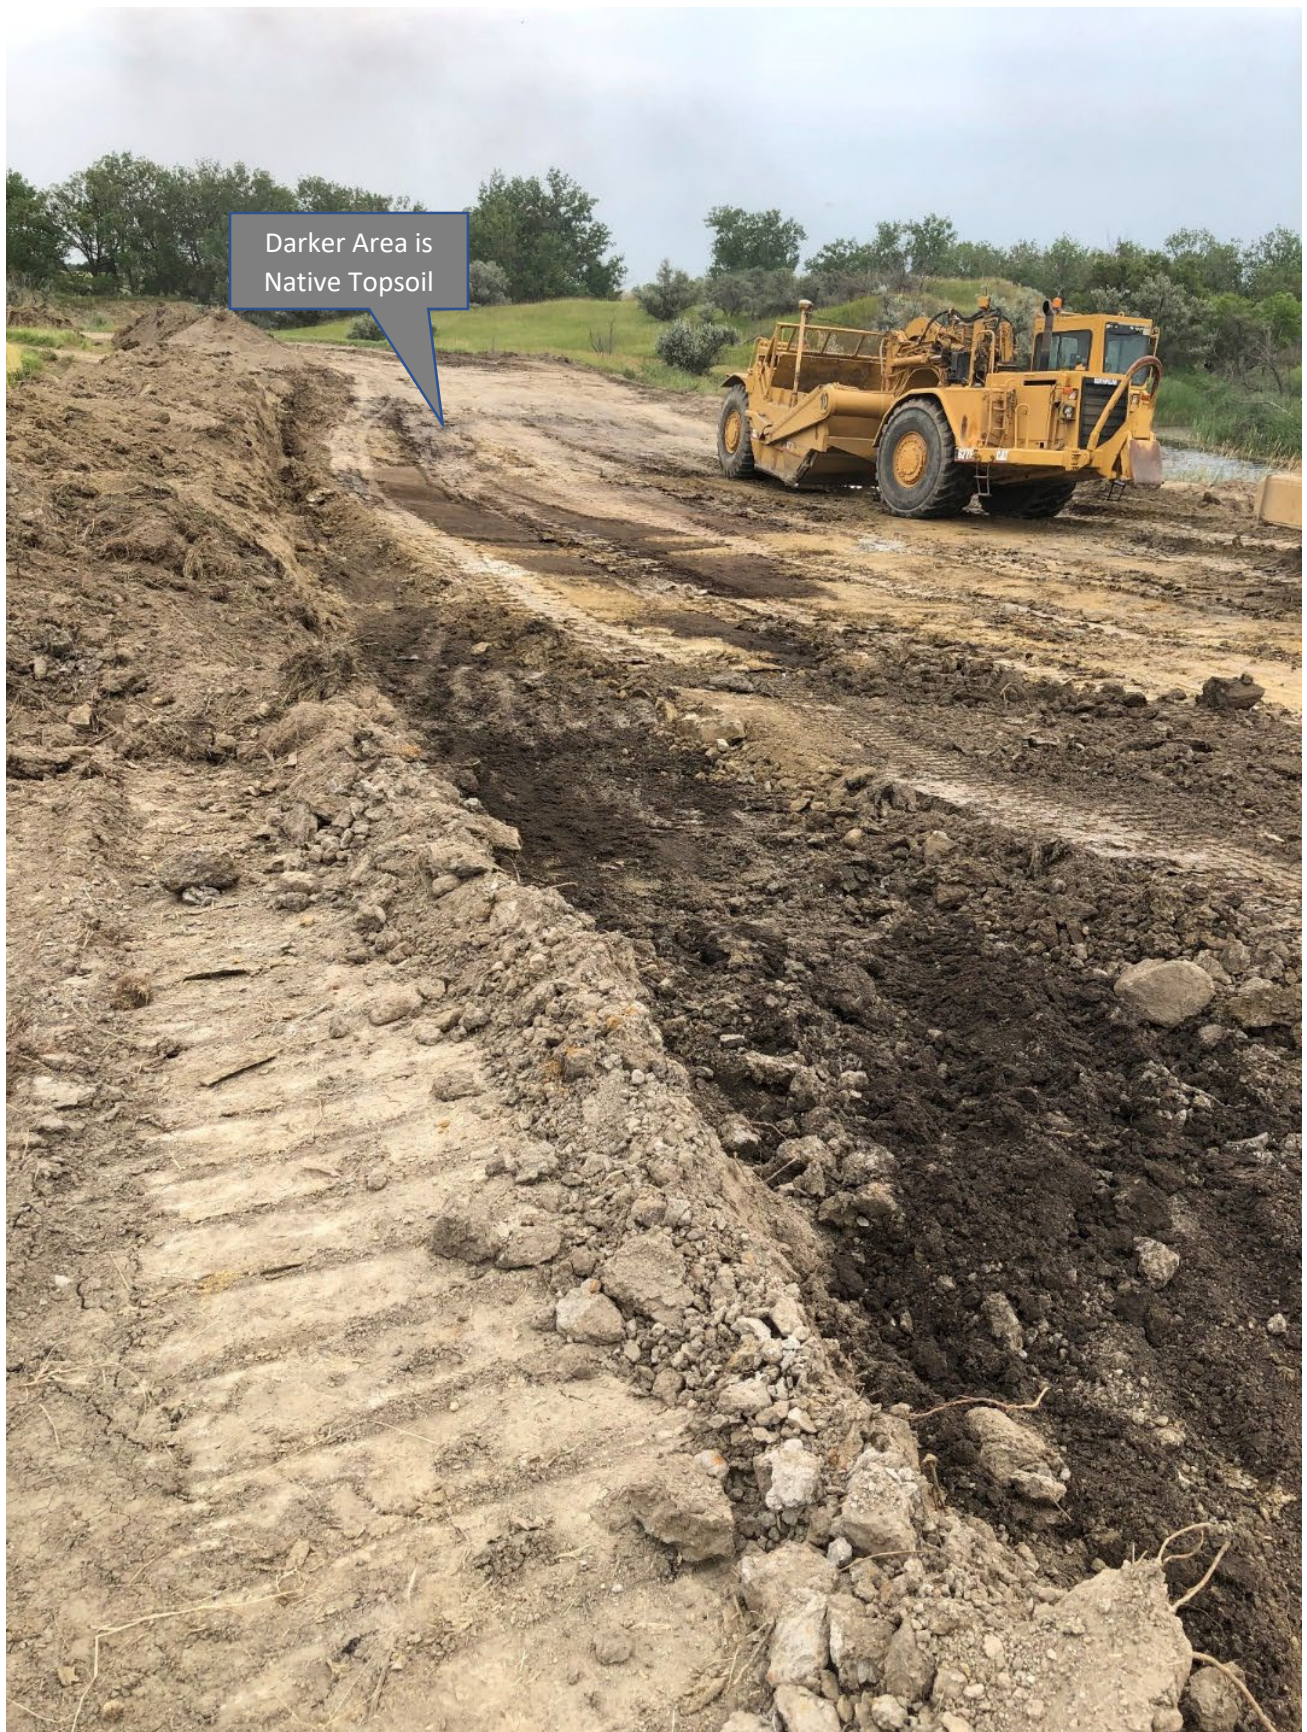
**Figure 11:** Original topsoil was exposed and salvaged along the north highwall in the West Youngtown Tract.

After excavating approximately 15 feet of spoil on the north highwall native topsoil was uncovered and salvaged (**Figure 11**). On August 2, all excavation and backfilling activities were complete and the topsoil used to bridge the saturated area was removed and respread on the site (**Figure 12**). Additional manure was hauled to the West Youngtown Site and incorporated into the topsoil. On August 5, all earthwork was completed (**Figure 13**).

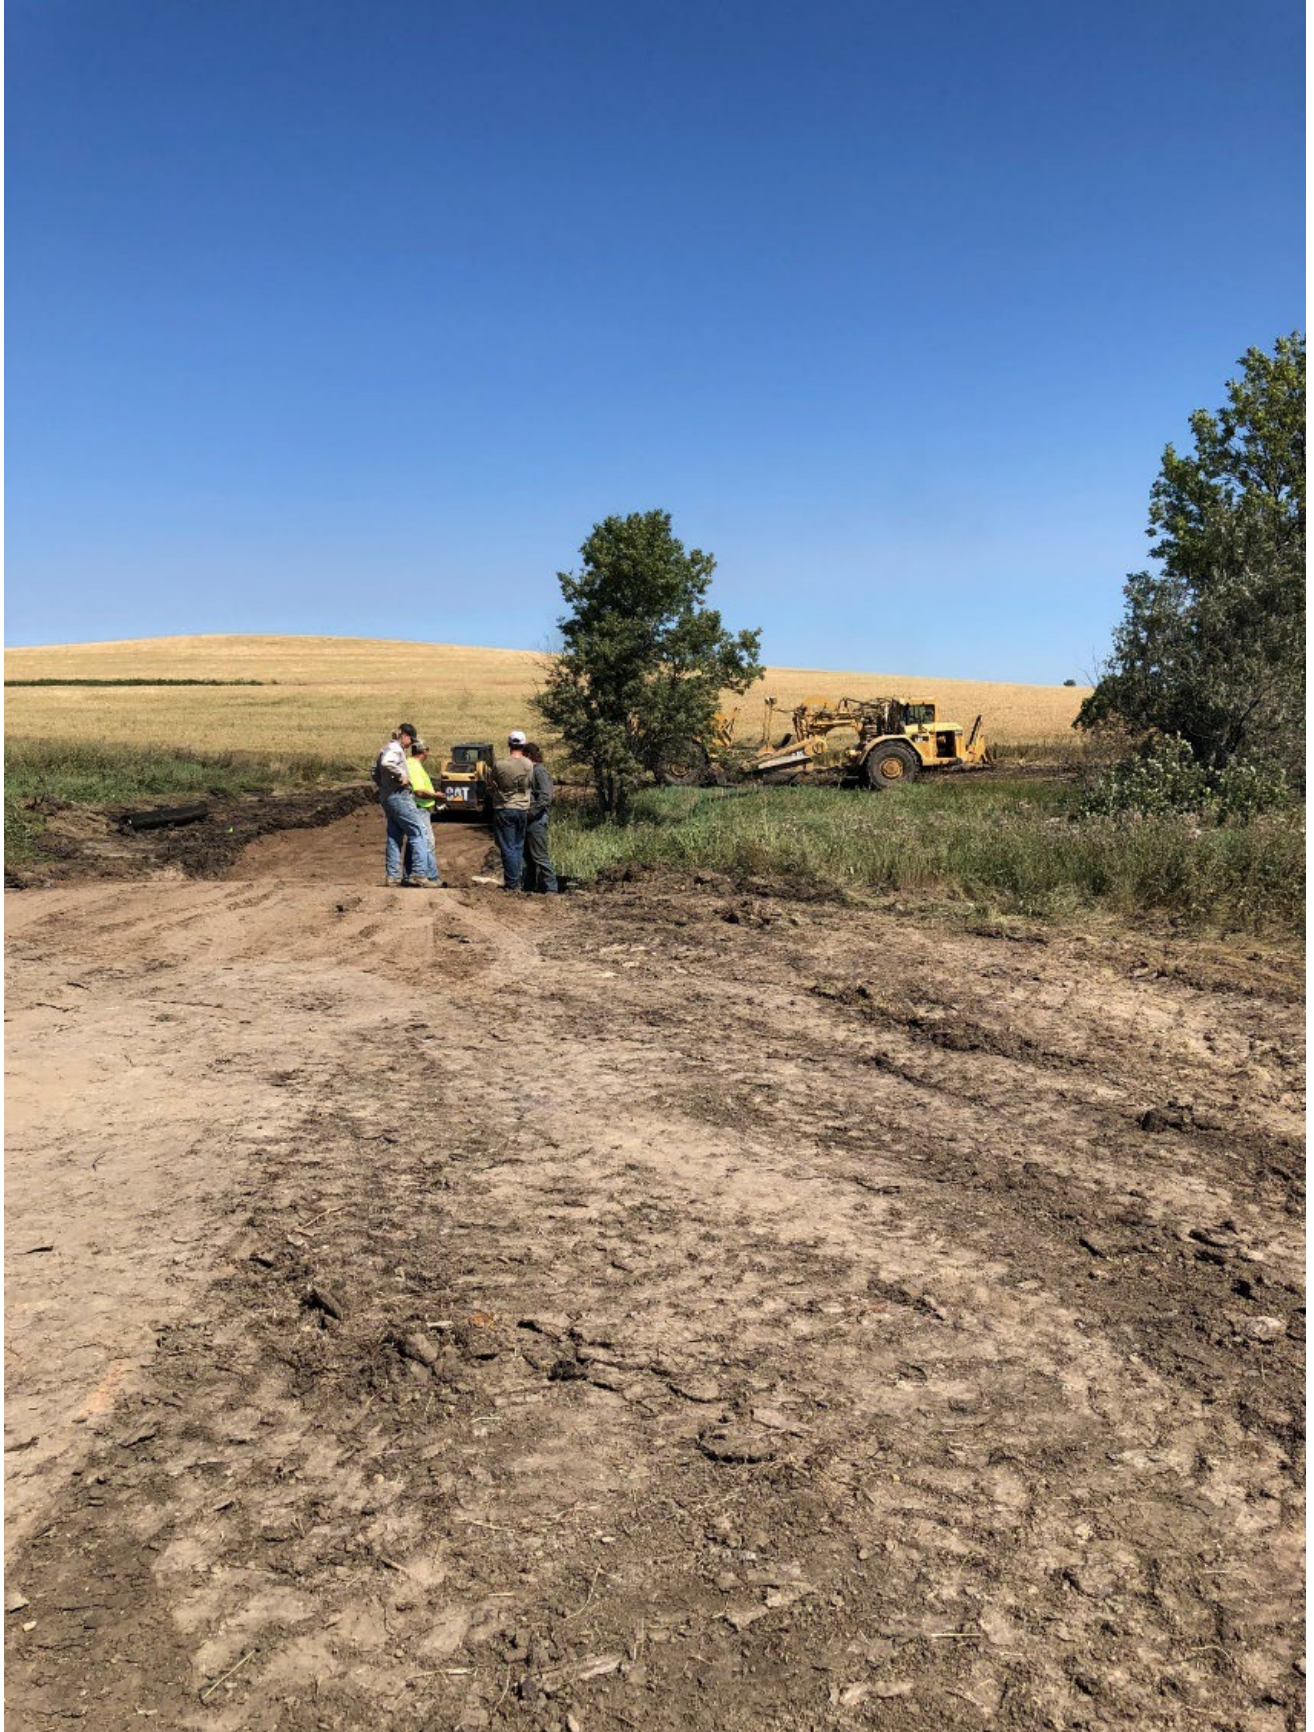
**Figure 12:** The contractor is using a scraper to haul topsoil in the West Youngtown Tract.

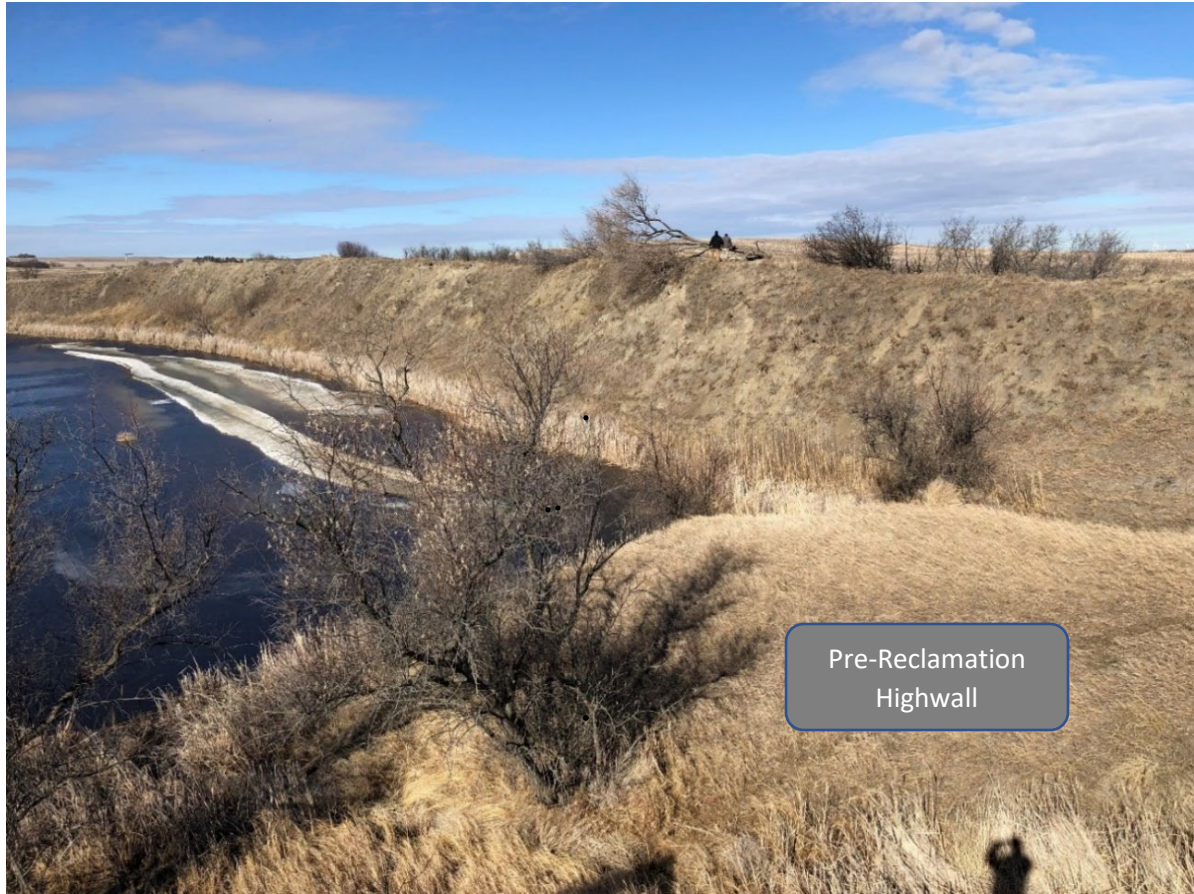
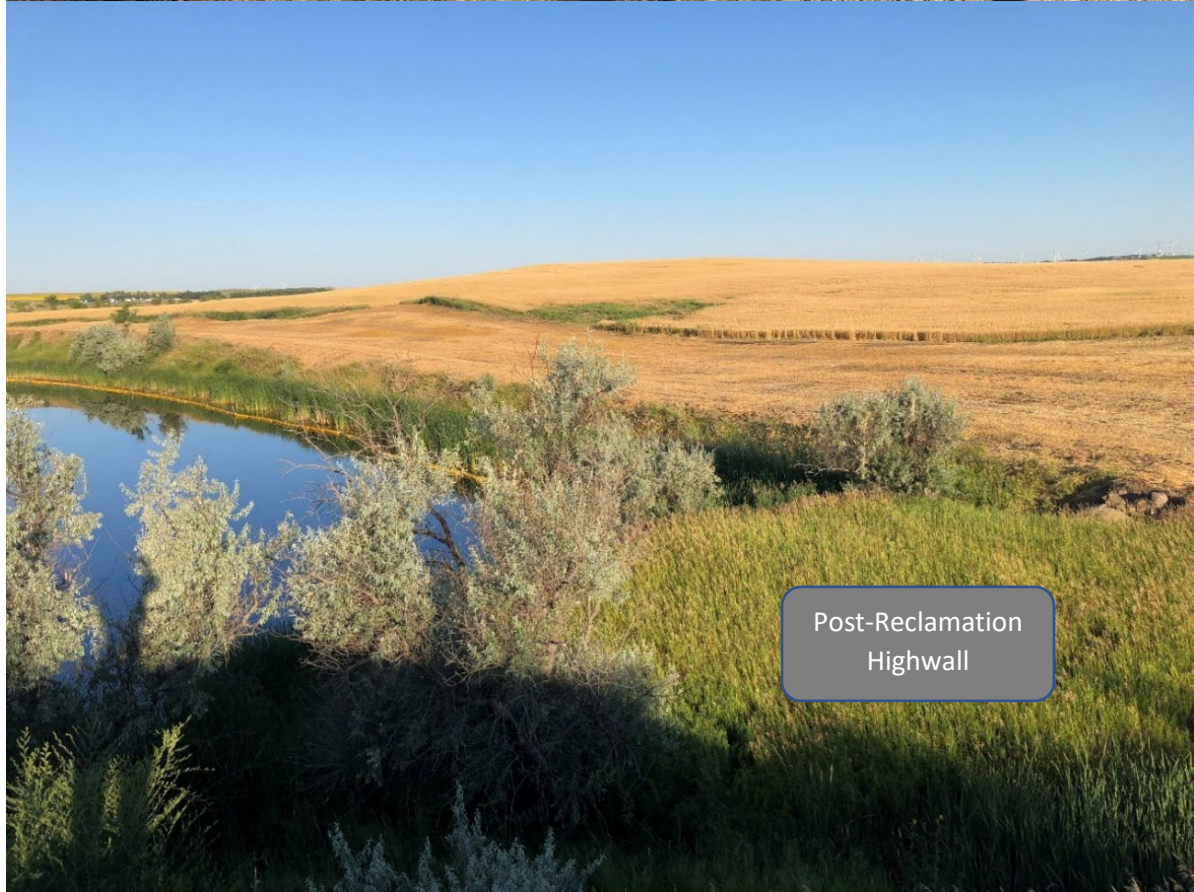
Pre-Reclamation  
Highwall

Post-Reclamation  
Highwall

**Figure 13:** Before and after reclamation of the north highwall in the West Youngtown Tract.

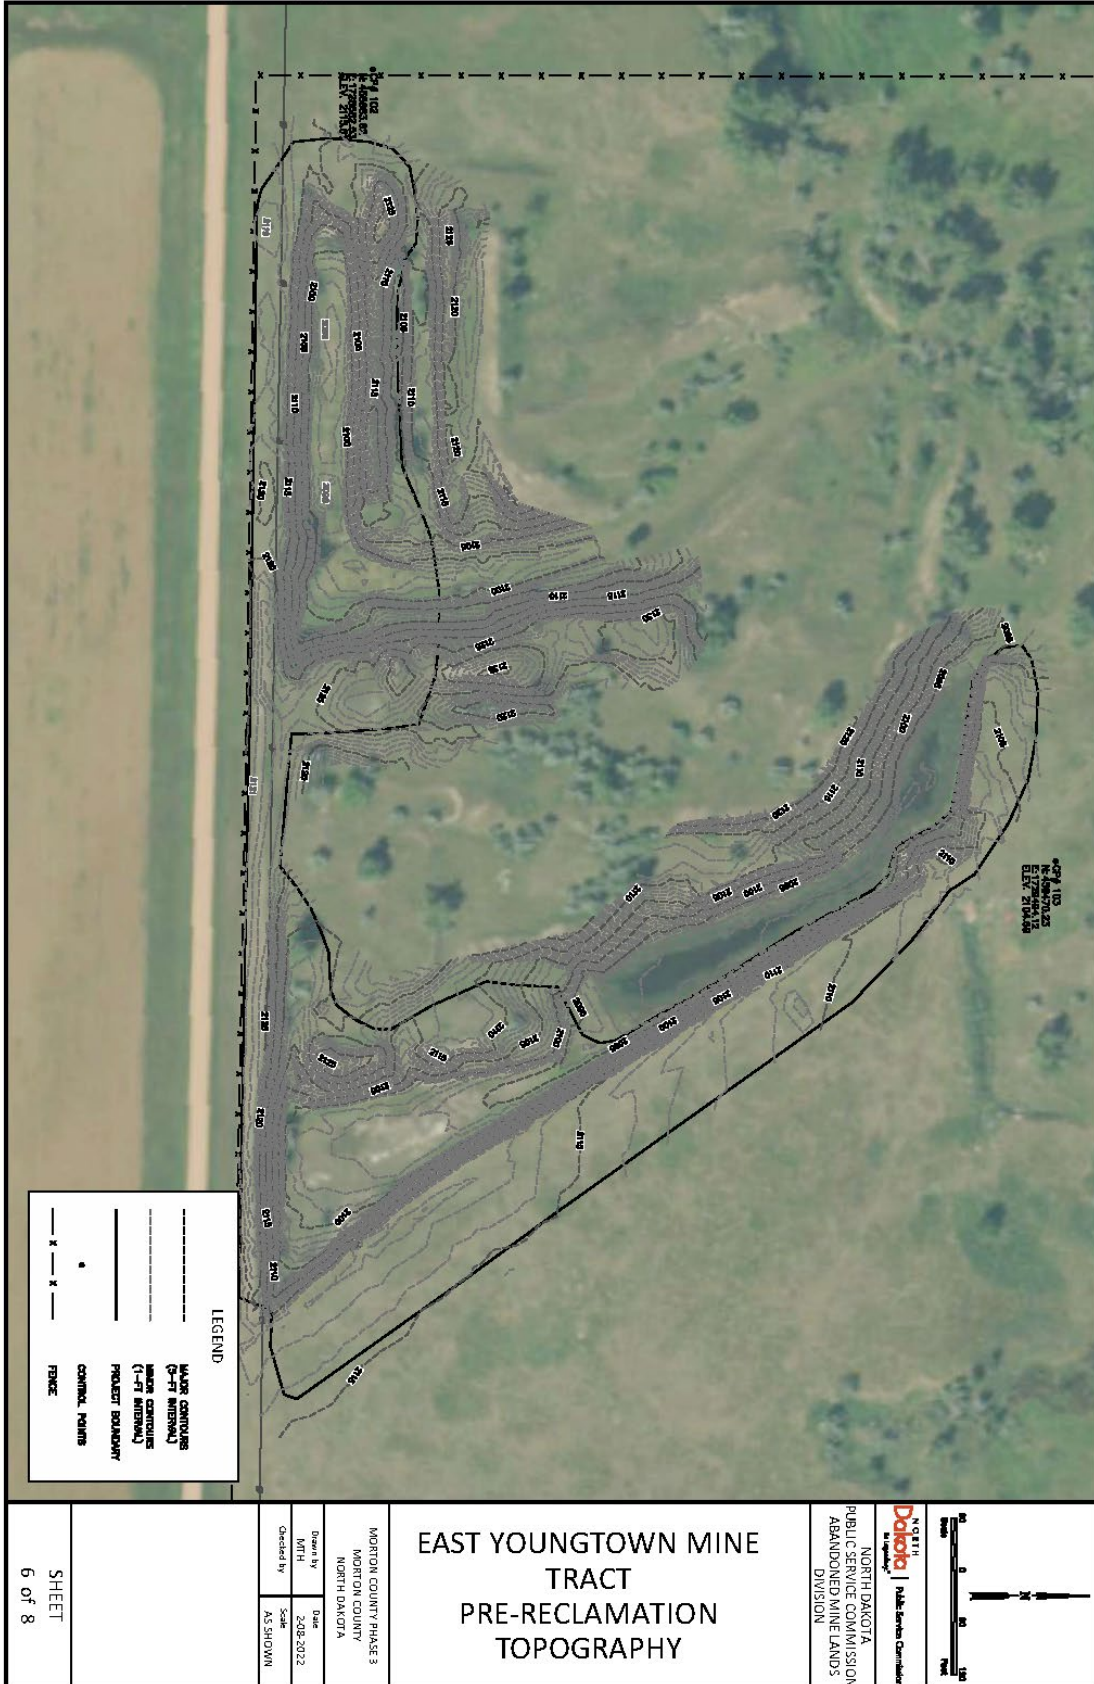
Figure 14: Map showing the East Youngtown Tract’s topography prior to reclamation.

The map (**Figure 14**) shows the pre-reclamation topography at the East Youngtown Tract. Construction started at the East Youngtown Tract with the installation of a temporary fence used to keep cattle out of the project area and still allow grazing of the undisturbed portion of the site. The fence was completed on July 8. By July 13, 2,366 feet of silt fence had been installed to reduce sediment leaving the construction site. On July 14, construction began with stripping topsoil.

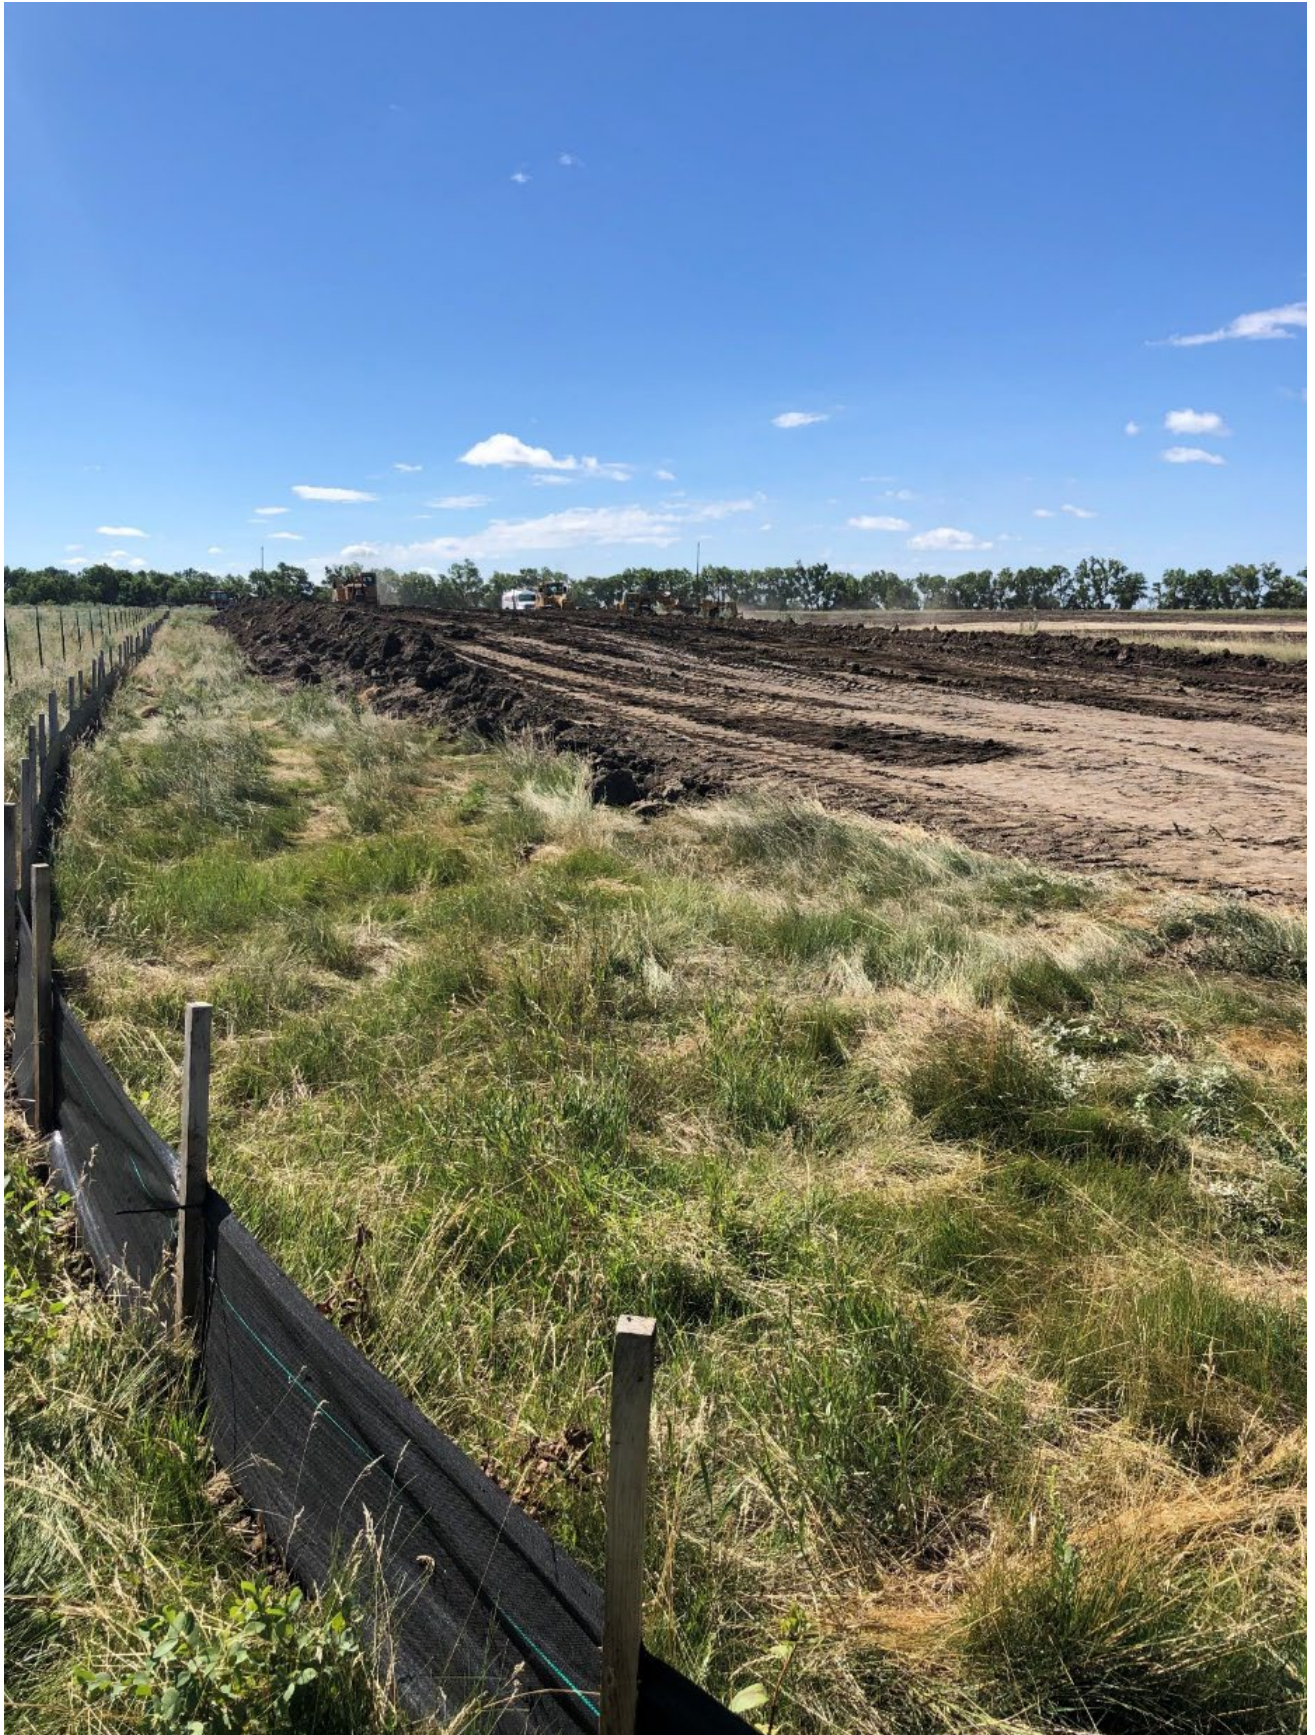
**Figure 15:** Topsoil stockpile and silt fence in the East Youngtown Tract.

Once the topsoil was removed and stockpiled (**Figure 15**), the backfilling and backsloping of the highwall commenced. During the excavation process, a layer of buried native topsoil was discovered and salvaged. The final pits next to the county road were then filled using excavated spoil. A large, unexpected rock layer was also encountered during excavation and needed to be buried on site (**Figure 16**). On July 28, all spoil had been moved and Wilson Construction started resspreading topsoil and hauling manure. On August 2, Thomas & Sons Construction began discing and seeding the resspread area (**Figure 17**). Seeding and mulching were completed by August 3, and then 1,909 feet of wattles and 960 feet of erosion control blanket were installed. Installation of a permanent fence was completed on August 5 and is used to keep livestock off the reclaimed area. At the request of the landowner, two of the silt fences were left intact to control erosion from the reseeded areas.

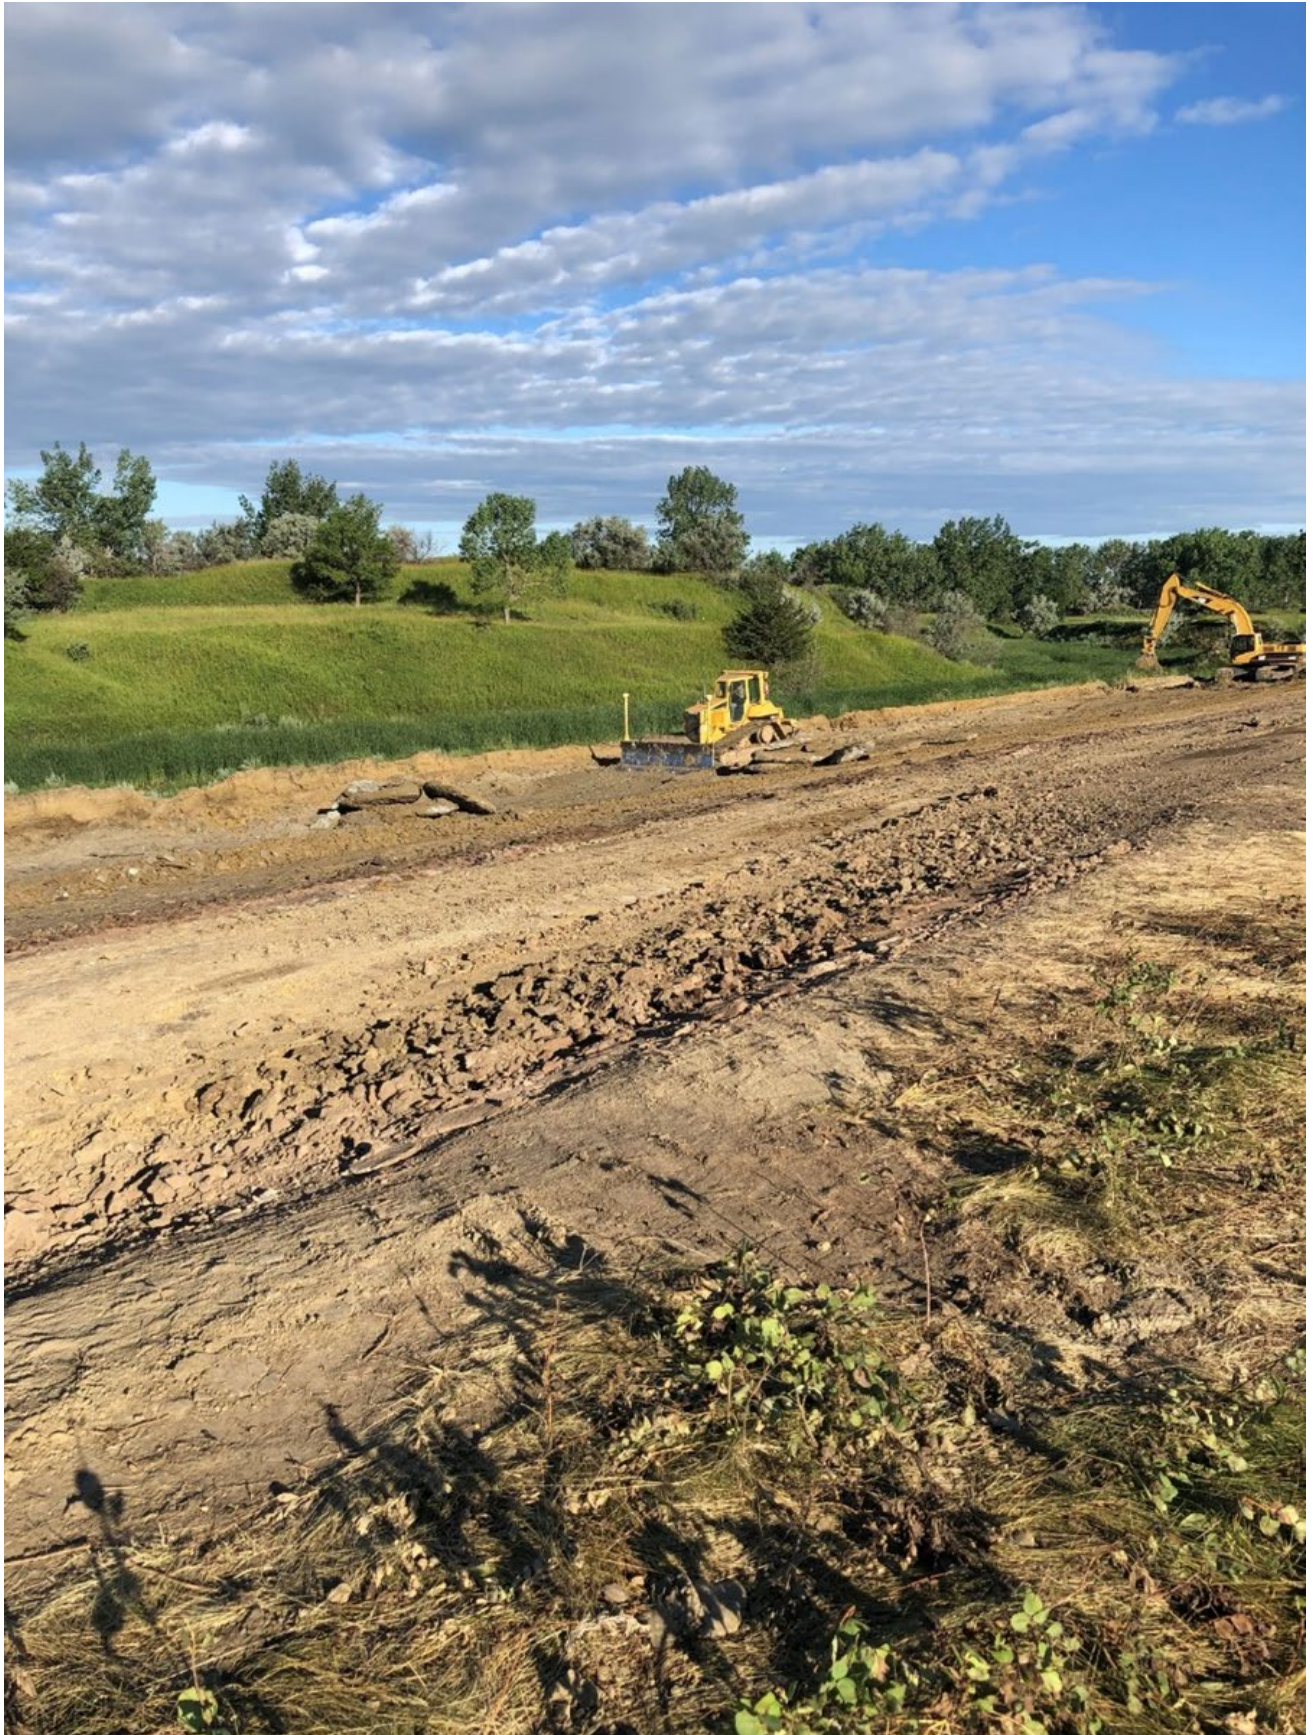
**Figure 16:** *Dozing the excavated rock ledge in the East Youngtown Tract.*

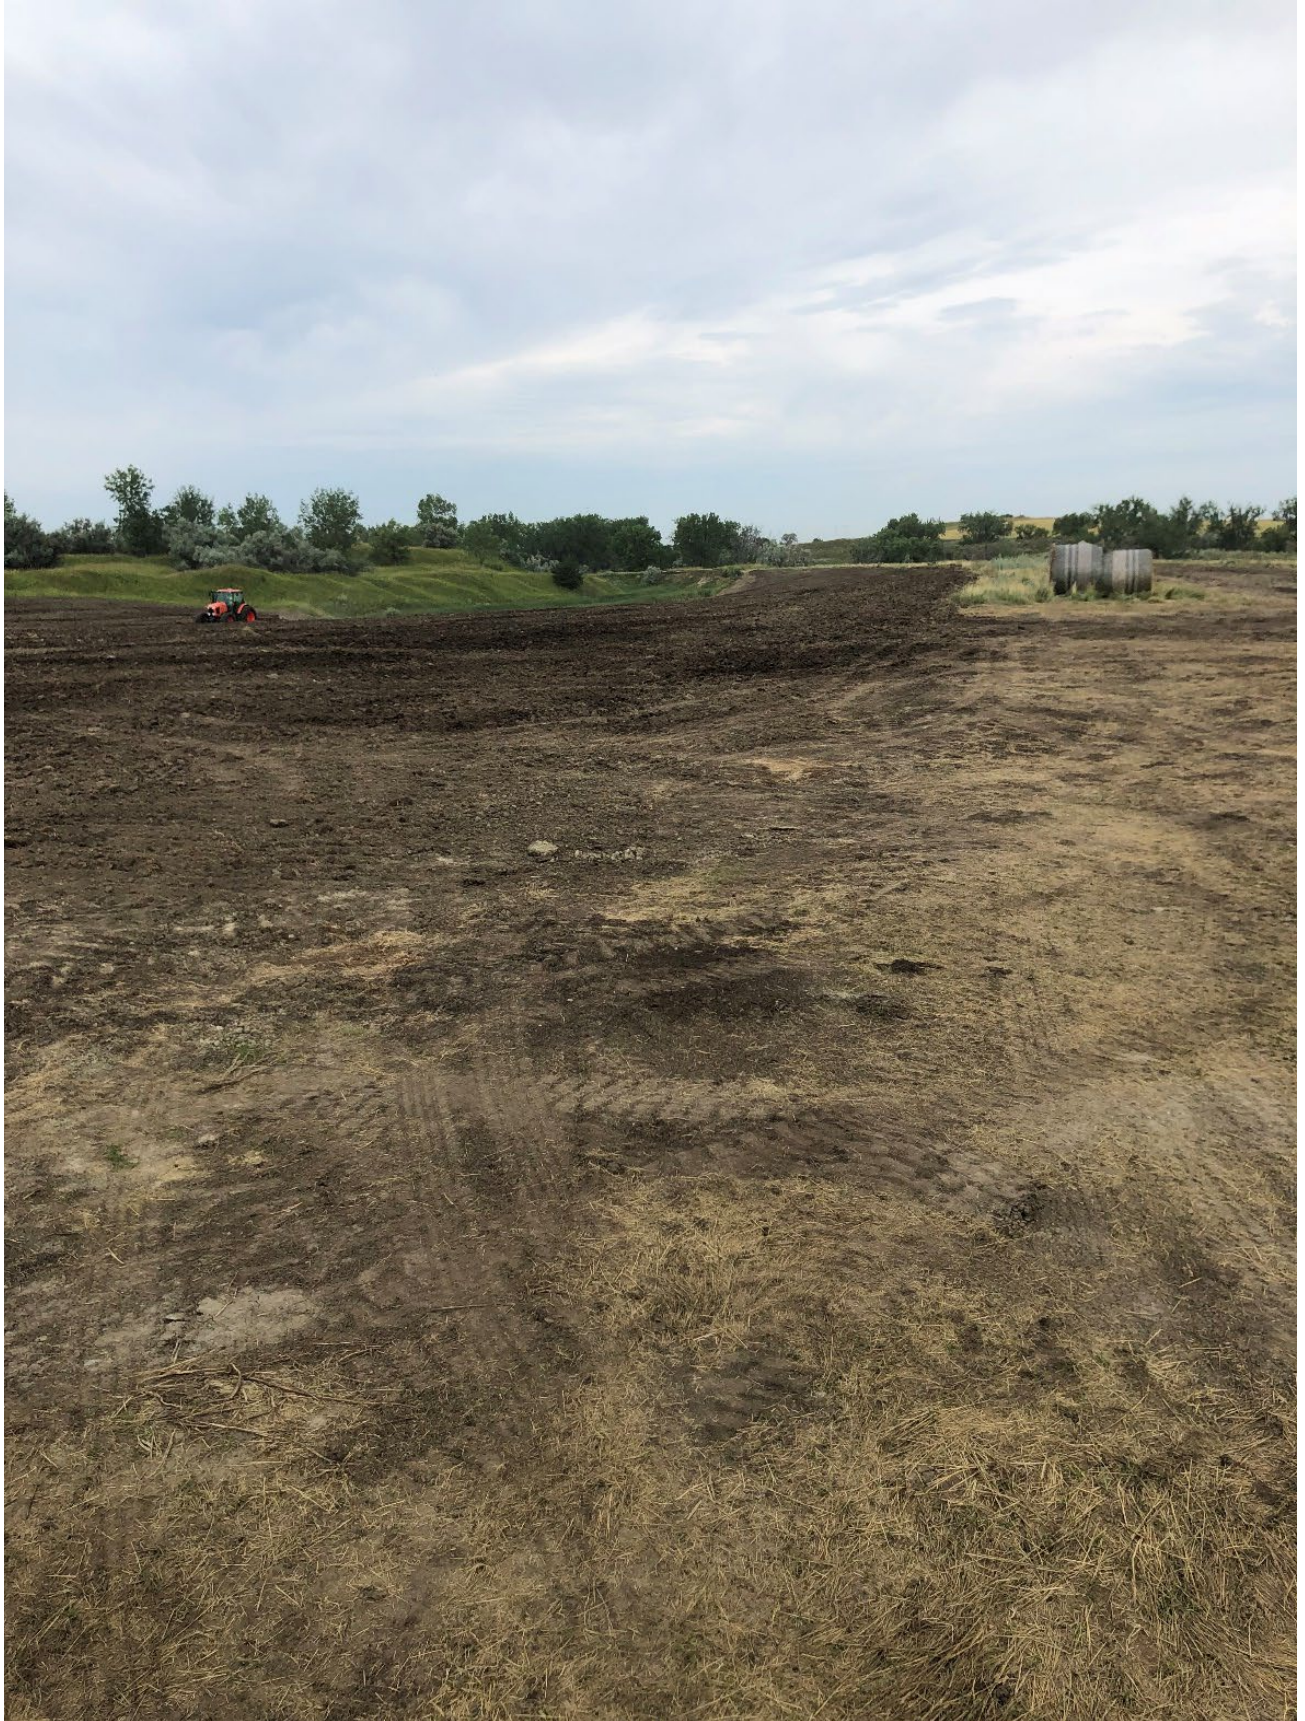
**Figure 17:** Seeding the reclaimed highwall with a native grass mix in the East Youngtown Tract.
