# Abandoned Underground Coal Mine Reclamation on The ND Prairie

The Halleck Underground Mine operated five miles north of Bowman, in southwestern North Dakota, from 1919 until 1944. Halleck provided coal to heat homes in the area. The top of the 30-40 foot thick coal seam is less than 50 feet below surface in mostly soft overburden. Several huge sinkholes have opened at this abandoned mine site.

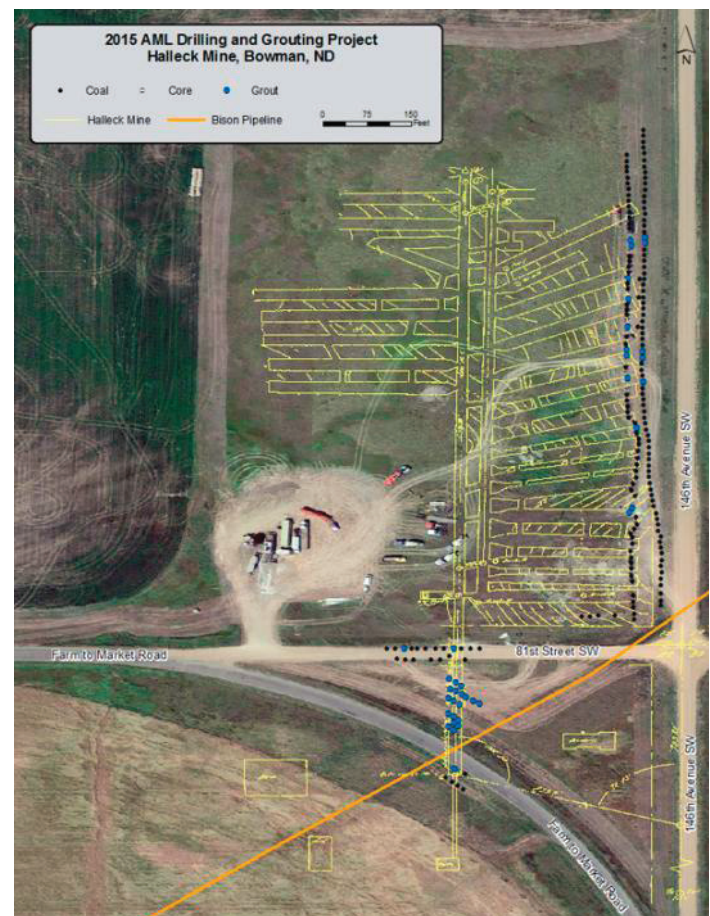
*2015 Google Earth image of the Halleck Mine site during the drilling and grouting project with mine map, drill holes and Bison pipeline overlays. The cluster of equipment in the center is an onsite batch operation. Blue dots represent void holes that were filled with grout. Toward the bottom center is where the pipeline, Farm to Market road and entry tunnel all merge.*

In consultation and meetings with the City of Bowman, Bowman County and TransCanada, the AML Division planned and conducted a 2015 drilling and grouting project to stabilize the roads and pipeline threatened by mine collapse. The Bison Pipeline was located above the entry tunnel of the Halleck Mine as it passed near the Farm to Market road. This increased the difficulty of the project. Safety was a prime concern when working around this high-pressure pipeline. TransCanada was active both in the planning and execution of this work.

Drilling near the pipeline revealed tightly packed rubble 16-24 feet below surface, which was the expected depth of the entry tunnel. This verified anecdotal reports that the entry tunnel was excavated when the Farm to Market Road was improved and paved. No drilling or grouting was conducted within the 50-foot pipeline easement. Grout injection within 75 feet of the pipeline was conducted carefully without pumping pressure and was monitored closely.

The Halleck mine entry passed directly under 81st Street (see map). We used a borehole camera to determine the tunnel was open but supporting timbers were failing. Grout was pumped into this tunnel through a hole drilled on the 81st Street until it "blew out" and broke through the ground surface in the south ditch. Using the borehole camera, we could also see the west ditch of 146th Avenue was significantly undermined with large open mine voids 60 feet or less below surface.

A total of 4500 cubic yards - about 500 truckloads - of cementitious grout were pumped into underground mine voids at the Bowman Site. We believe our goal of stabilizing these undermined public roads and areas near the Bison Pipeline were met. This successful project was a collaborative effort between the North Dakota AML Division and many interested shareholders.
