Project Summary
2014 Scranton/Bowman
Contract AM-697-14
Contract AM-698-14
Contract AM-680-13

**North Dakota Public Service Commission
2014 AML Project Summary
Scranton, North Dakota**

Project Type:	Drilling and Pressurized Backfilling with cementitious grout.
Primary Locations:	Scranton Equity Exchange Bypass Road & 133 rd Ave SW, Scranton
Project Dates:	June 16 — September 11, 2014;
Contractors:	B & C Concrete Pumping, Inc. of Williston (S&S Drilling, Williston-subcontractor) Northeast Technical Services, Inc. of Virginia, MN (Material Testing contractor) Water Supply, Inc. of Mandan (Ground Water Monitoring Contractor)
Total Project Cost:	\$753,097.35 (Drilling & Grouting) \$ 31,192.00 (Material Testing) \$ 16,262.80 (Groundwater Monitoring: 2013 & 2014)

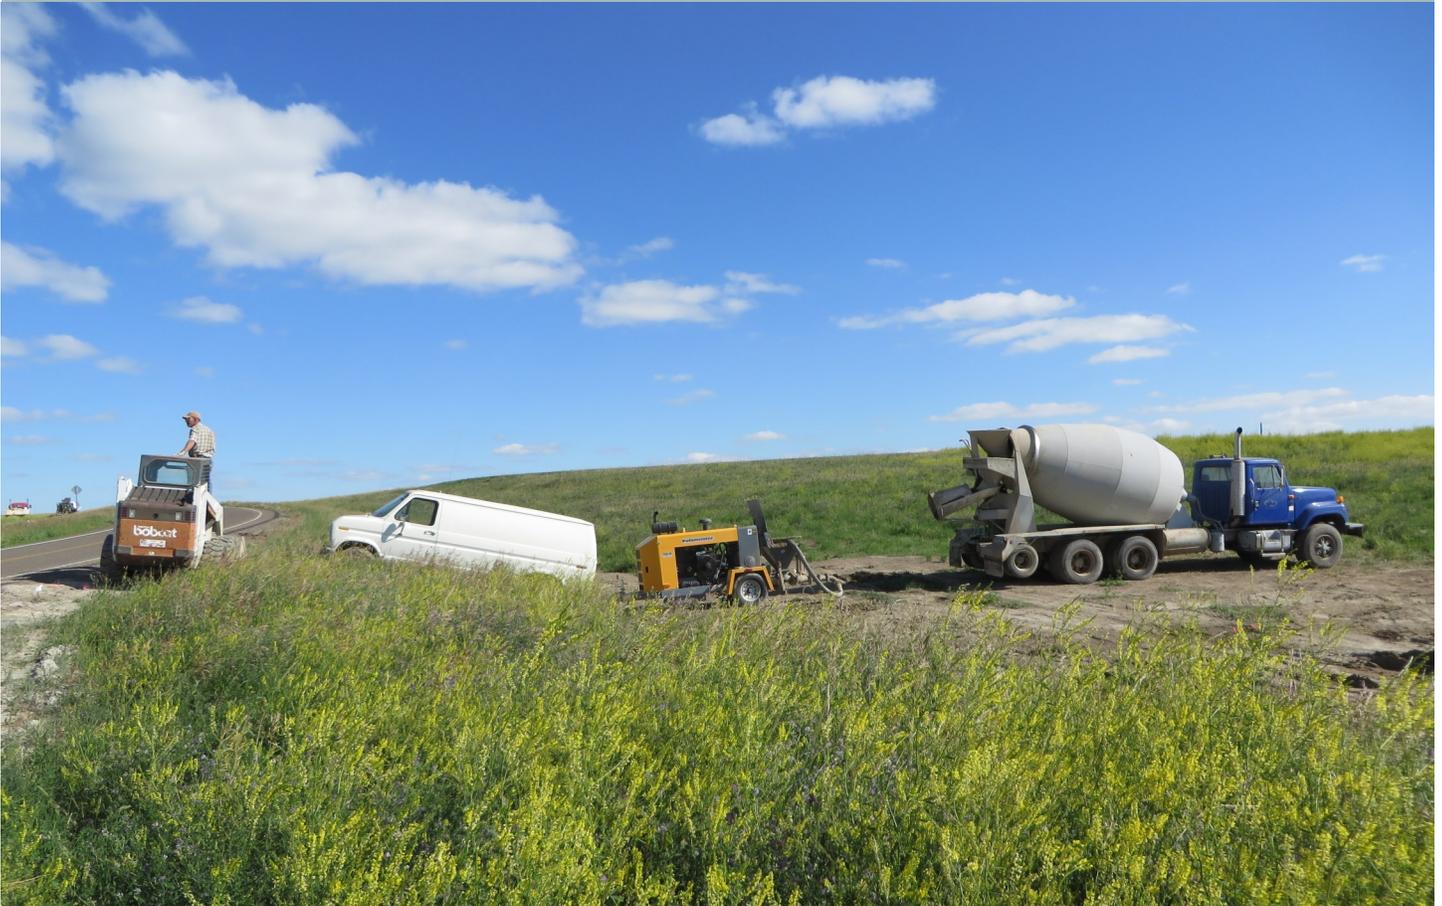
Cover Photo: Pumping grout in west ditch of 133rd Ave SW about 1/4 mile south of US Highway 12. The grout pump is a Putzmeister TKB 80 Trailer-Mounted Pump. This is the same area where numerous sinkholes have been filled in the past, including in 2014. Over 300 yards were pumped into 5 cased holes surrounding this sinkhole area.

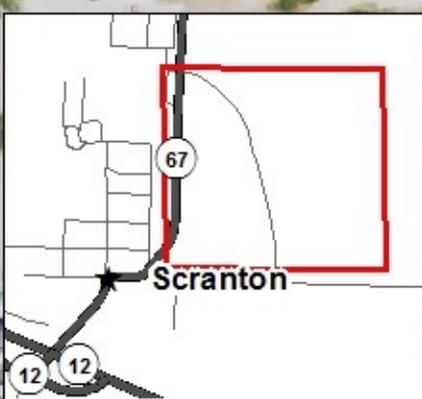
Map 1

**2014 Scranton/Bowman Phase 2
Scranton Equity Exchange
Bypass Road (SEEBR)**

● Coal	● Grout
● Filled Adjacent	● Void
	● MW Monitoring Wells

Work on Scranton/Bowman Phase 2 AML Project began on June 16, 2014 along the northeast side of the Scranton Equity Exchange bypass (Map 1). Drilling continued from the last hole drilled in 2013 on the west side of the bypass road near the municipal landfill and proceeded southward at 10 foot intervals. An additional 39 holes were drilled for a total of 380 holes along and near the Scranton Equity Exchange bypass road. Grouting proceeded southward along the east side of the bypass road and then to the newly drilled holes and finally to the voids discovered while drilling the monitoring wells. Work was completed along the bypass road on July 8, 2014 with a total of 5,025 cubic yards of grout at a cost of about \$1.3 million dollars (Map 2).

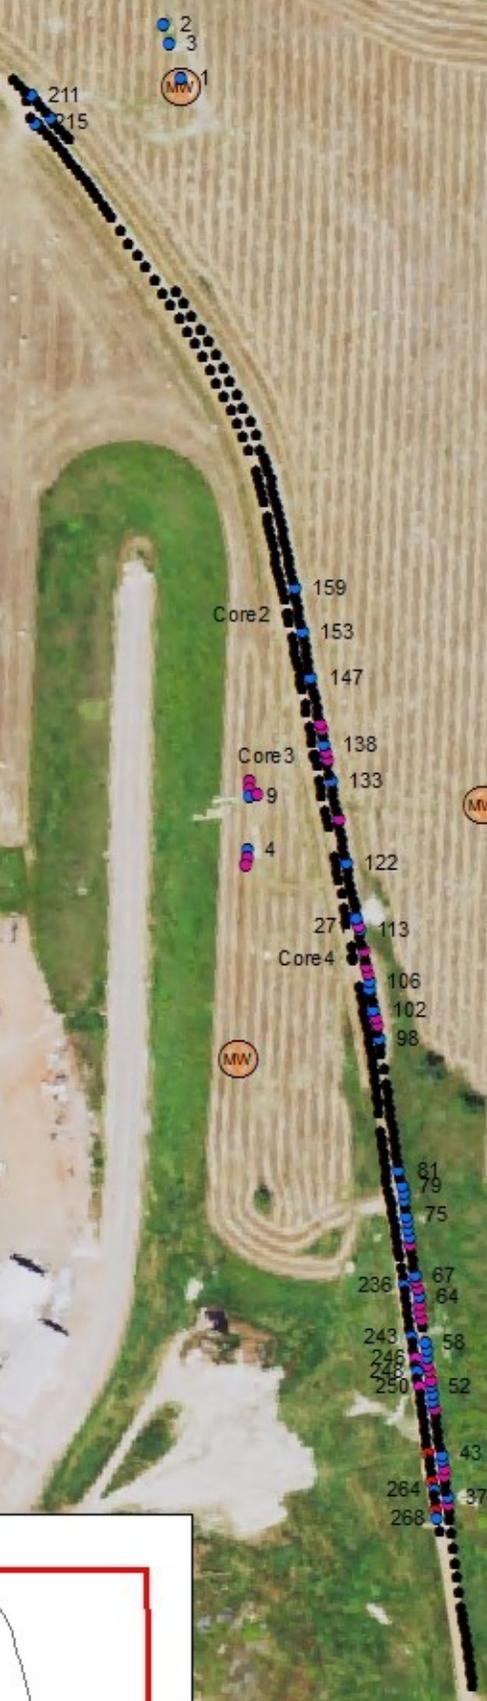
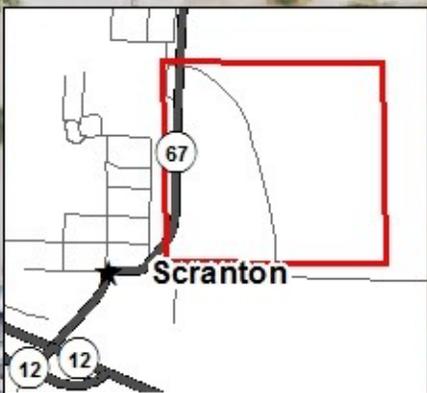
Map 2

**All Drilling and Grouting (2012-2014)
Scranton Equity Exchange
Bypass Road (SEEBR)**

● Coal	● Grout
● Filled Adjacent	● Void
	○ MW Monitoring Wells

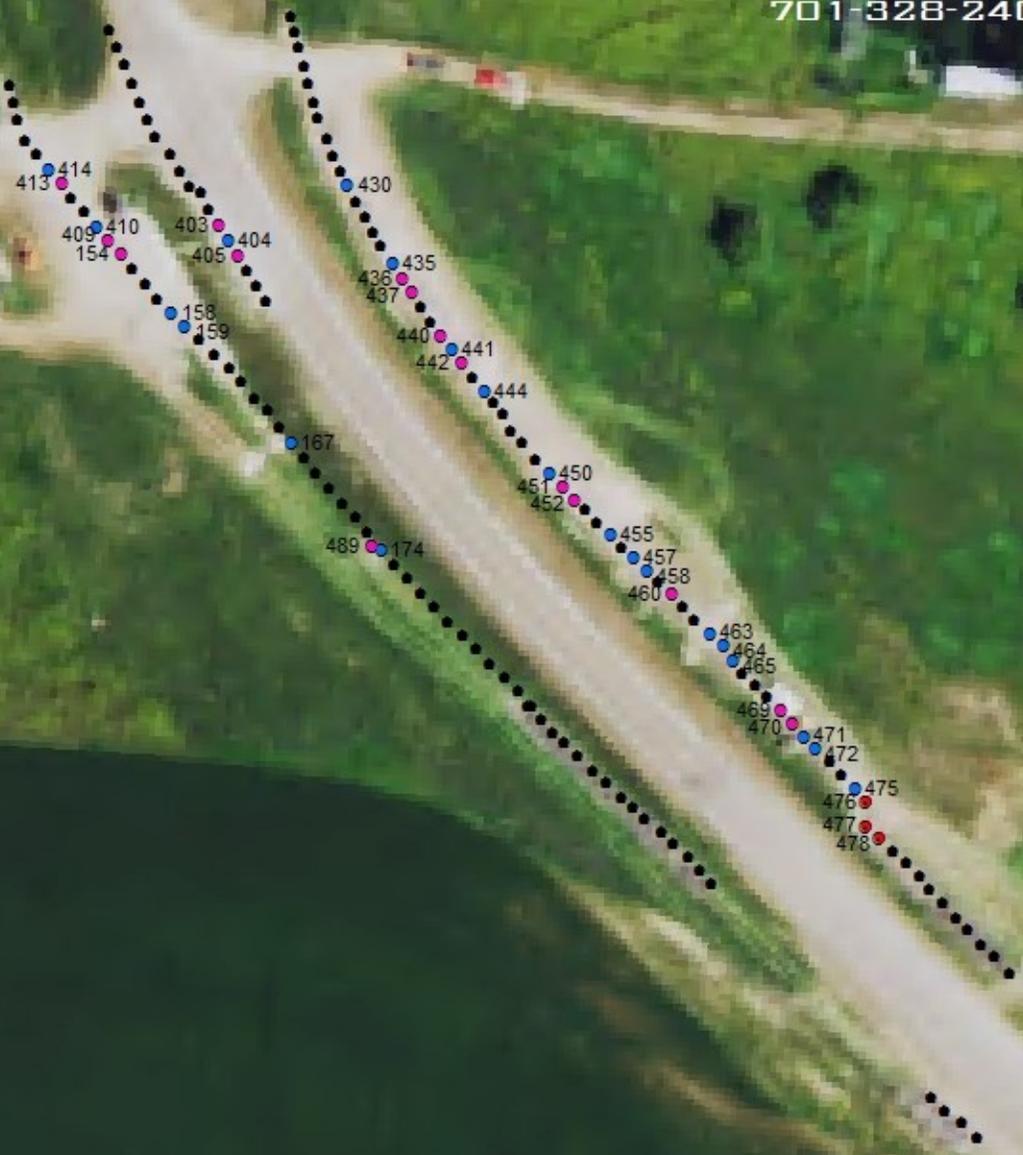
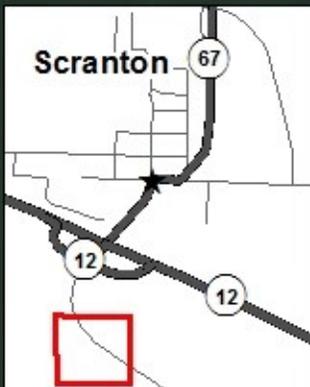
Map 3

**2014 Scranton/Bowman Phase 2
133rd Avenue SW**

● Coal	● Grout
● Filled Adjacent	● Void

The project continued with the reclamation of Andy's Mine south of Scranton (Map 3). Holes were drilled along the western side of ND Highway 67 (133rd Avenue SW) starting near the last hole drilled in 2012 and moving south until the ditch became too steep for drilling. The west ditch was also drilled from the estimated northern most point of the mine and continued southward in the ditch for 100 feet. Drilling then moved to the east side of the ditch from the northern part of the mine southward for 600 feet at 10 foot intervals. Of the 109 holes drilled 33 encountered voids or rubblized areas. This area accounted for 1,530 cubic yards of grout. Four holes remain to be pumped. It is anticipated that mine reclamation in Scranton will be completed in the 2015 construction season.

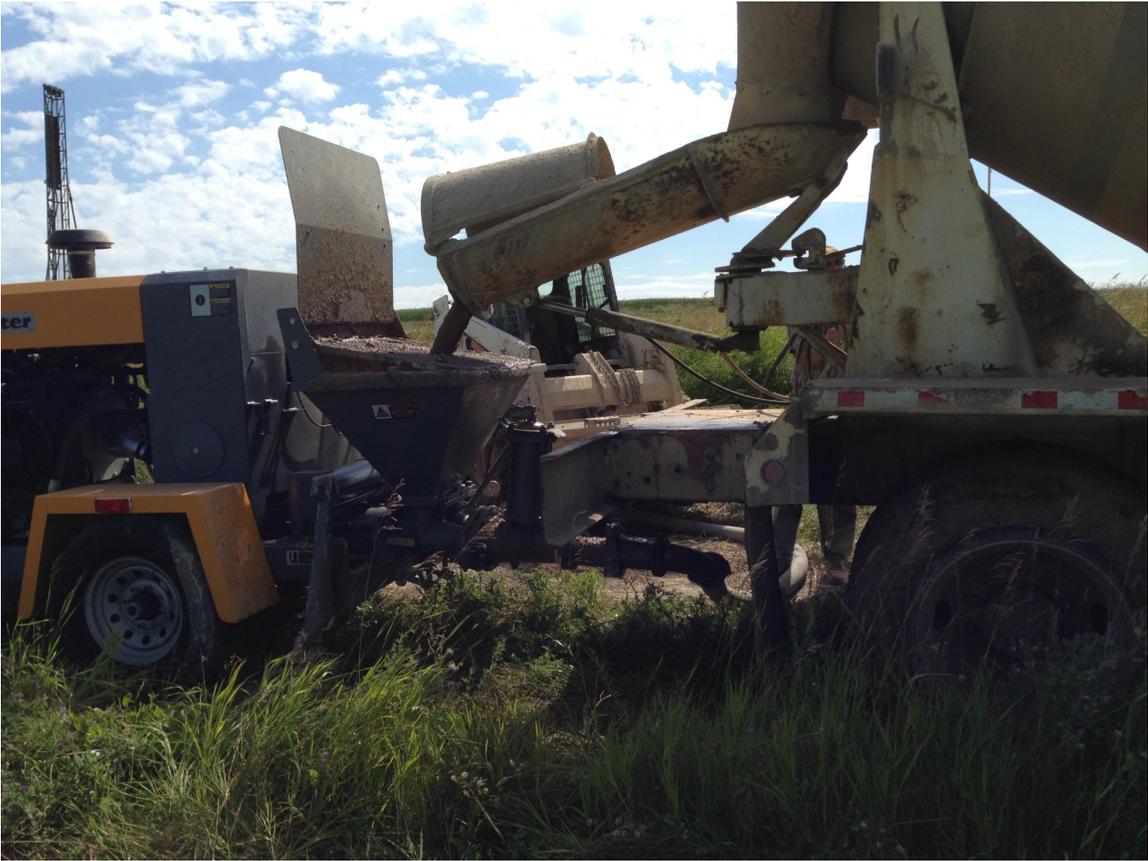
Above: Grout discharged from mixing truck into the grout pump to be pumped into underground voids.

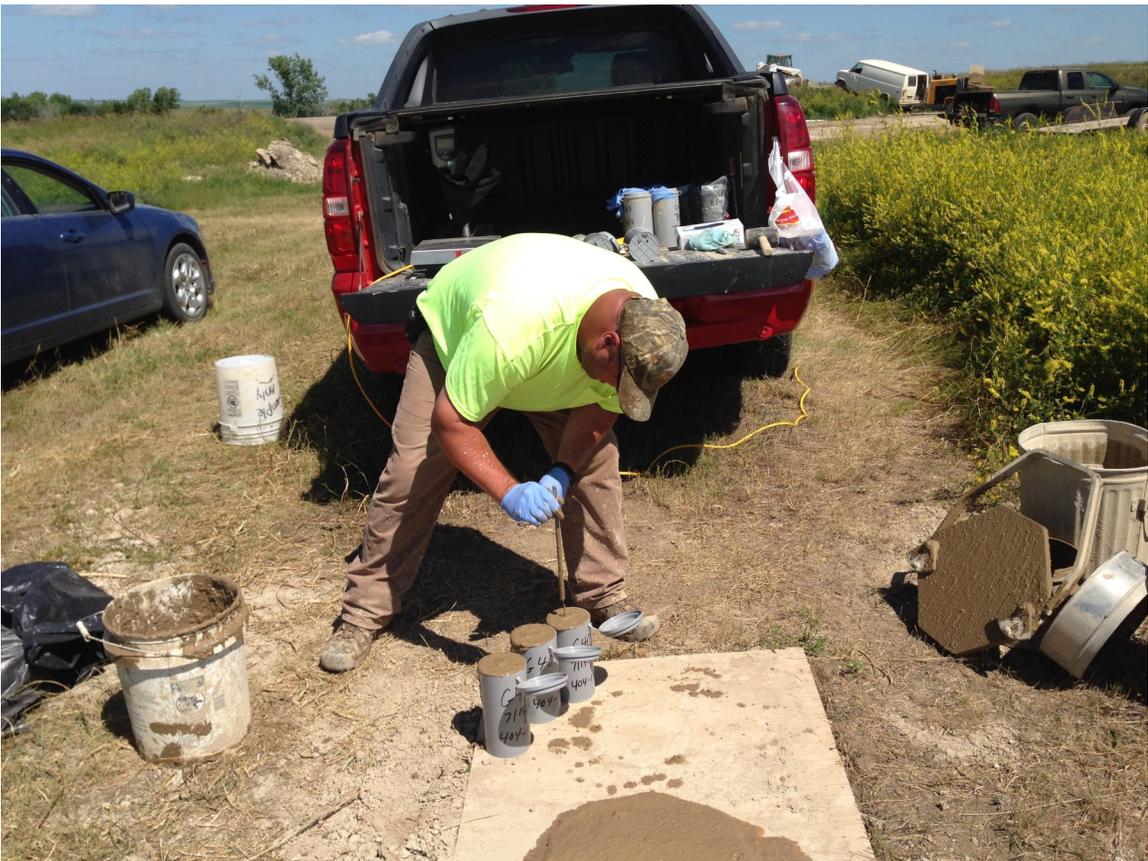
Below: Material tester, Bill Ray (Northeast Technical Services) prepared compression strength cylinders. Grout must meet a minimum 150 psi compressive strength. Grout pump can be seen in the upper right.

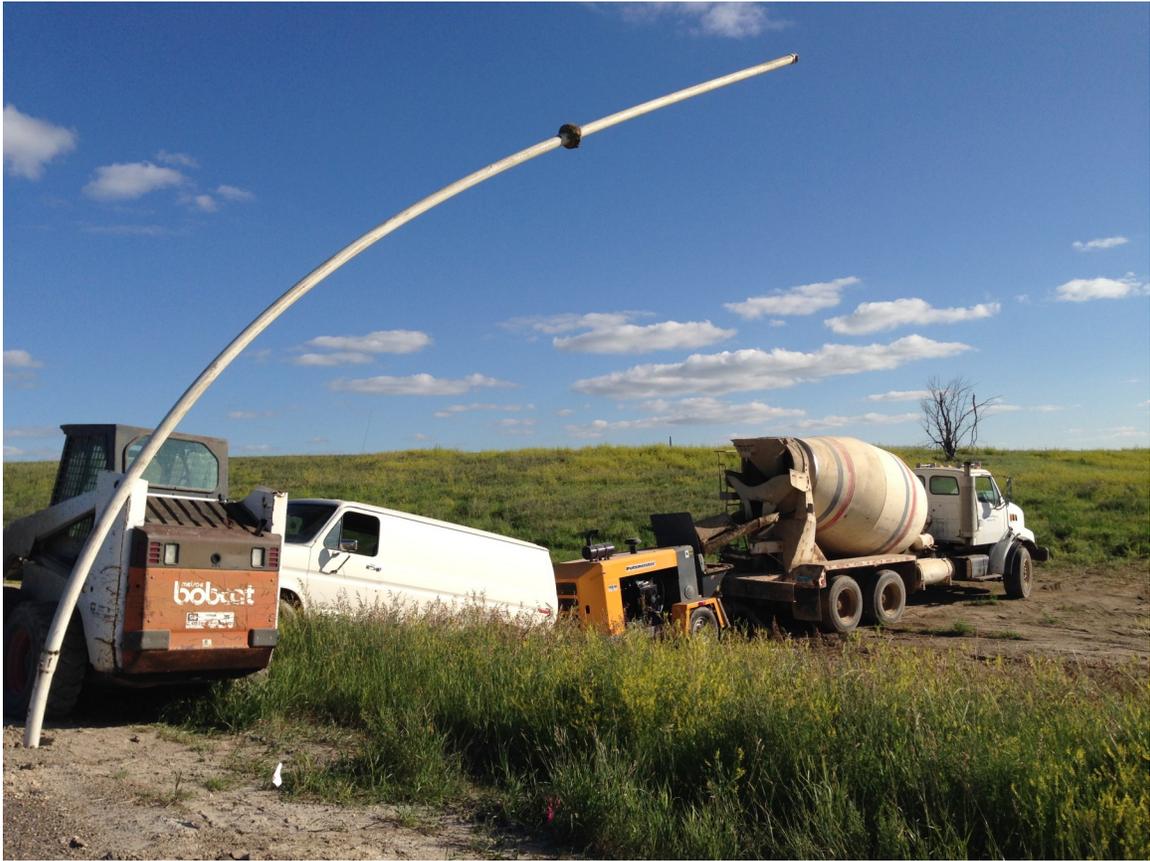
Above: 35 feet of casing on a hole near ND Highway 67 has been forced out of the ground while pumping on another hole. This indicated that the holes are connected by void space in the mine.

SOUTH SCRANTON										
403			57	63	73	52				Filled by 404-14
404			37	62	73	32	7/14	7/15	164	Blew casing of 403-14 35ft into the air. Minor crack- ing near shoulder of road between 403 and 405.
405			43	61	73	38				Filled by 404-14
409			50	70	70	45				Filled by 410-14
410	50	53	53	74	74	45	7/11	7/14	118	Refused at 120 psi
413	50	52	52	73	73	45				Filled by 414-14
414	49	52	52	60	60	44	7/8	7/10	236	
TC12-154										Filled by 410-14
TC12-158							7/14		29	Blowout in filled sinkhole near TC12-158
TC12-159							7/14		8	
TC12-167							7/16		118	Cracked in ditch near road 1/2-1" wide. 2-3 hairline cracks on road shoulder (paved portion)
TC12-174							7/25	7/26	34	Took Bore Hole Camera images prior to filling. Casing pulled due to erosion of annulus and gravity filled. Confirmation drill site for 2015

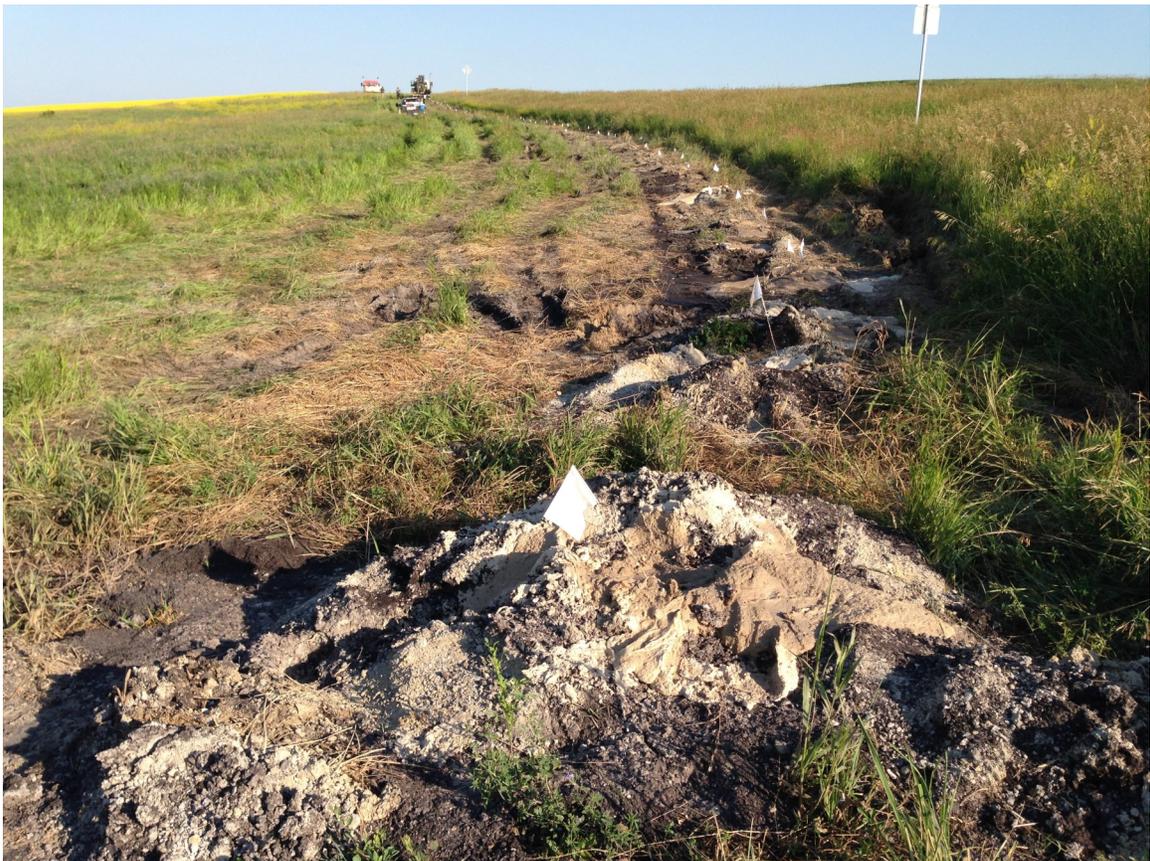
Below: The white pin flags mark holes drilled into the mine on the west side of ND Highway 67.

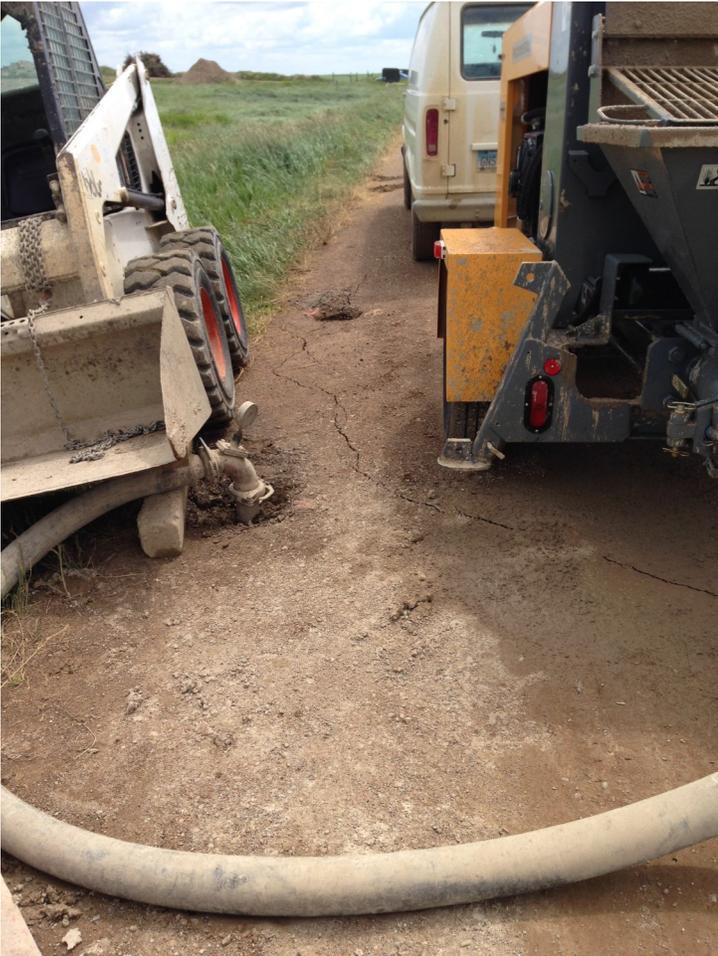
Upper left: The crack in the Scranton Equity Exchange bypass road was cased by surface lifting. As the grout was pumped into the void spaces under the road, it became so full that it eventually raised the surface of the road enough to cause it to crack. This is confirmation that the grout was pumped to where it was intended: under the road.

59-13			40	50	50	35	6/26 6/27	14	
61-13			40	60	60	35			Filled by 64-13
62-13			38	50	50	33			Filled by 64-13
63-13			30	48	50	25			Filled by 64-13
64-13			30	50	50	25	6/19 6/23	49	Road Cracked 1/2" wide running from Hole 62-13 across the road toward the SW.

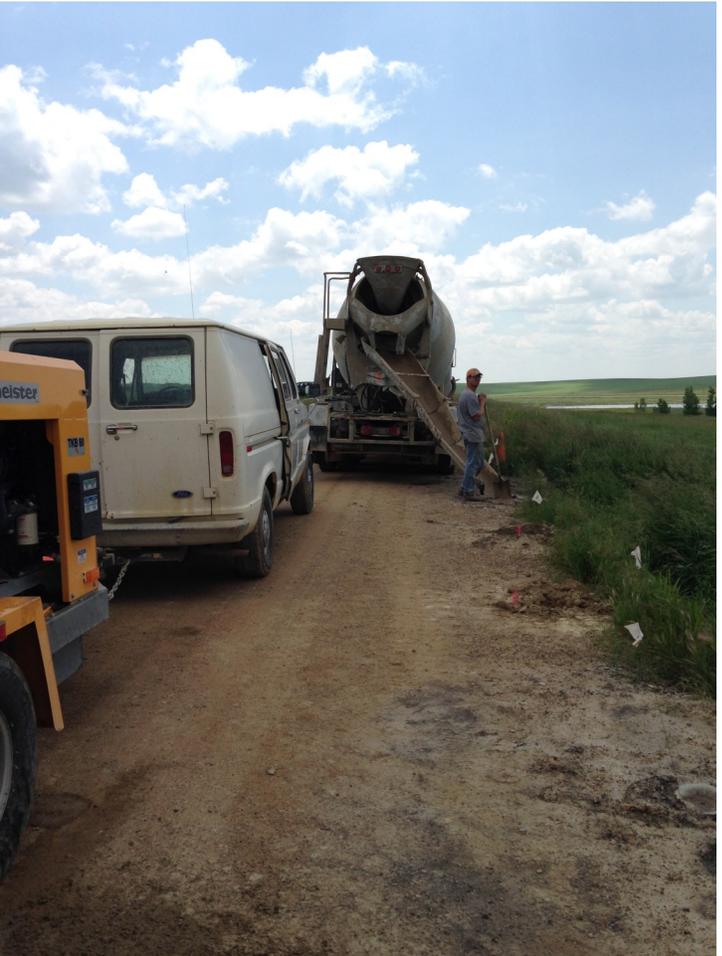
Upper Right: The grout pump is on the left and the mixer truck is being used to back fill the non-void drill holes.

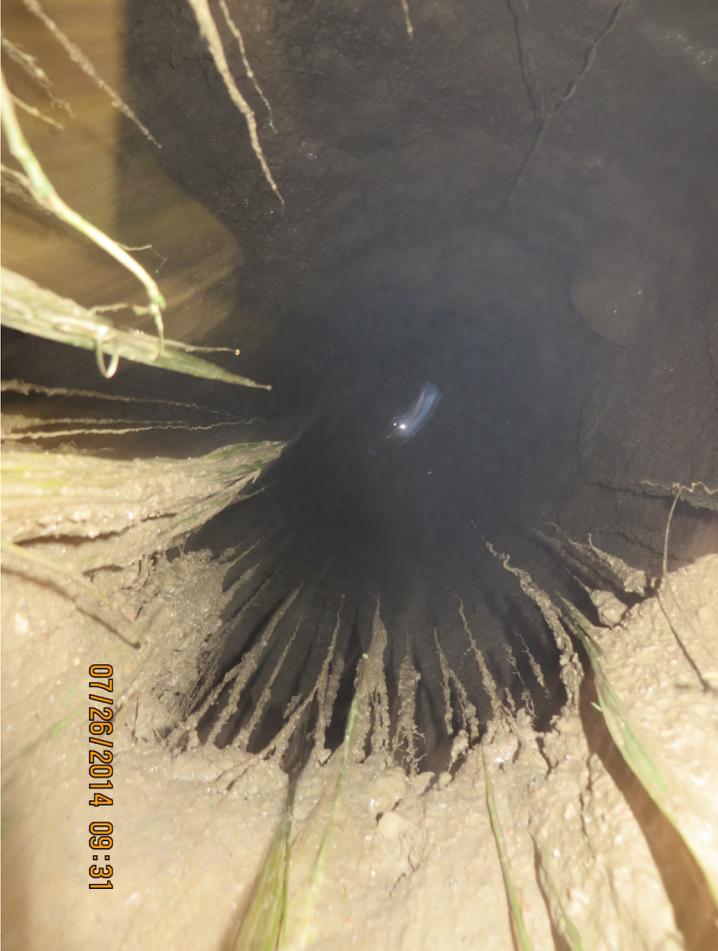
Lower Left: A shot down a drill hole. The bright spot in the center is the reflection of the camera flash of the water on top of the grout.

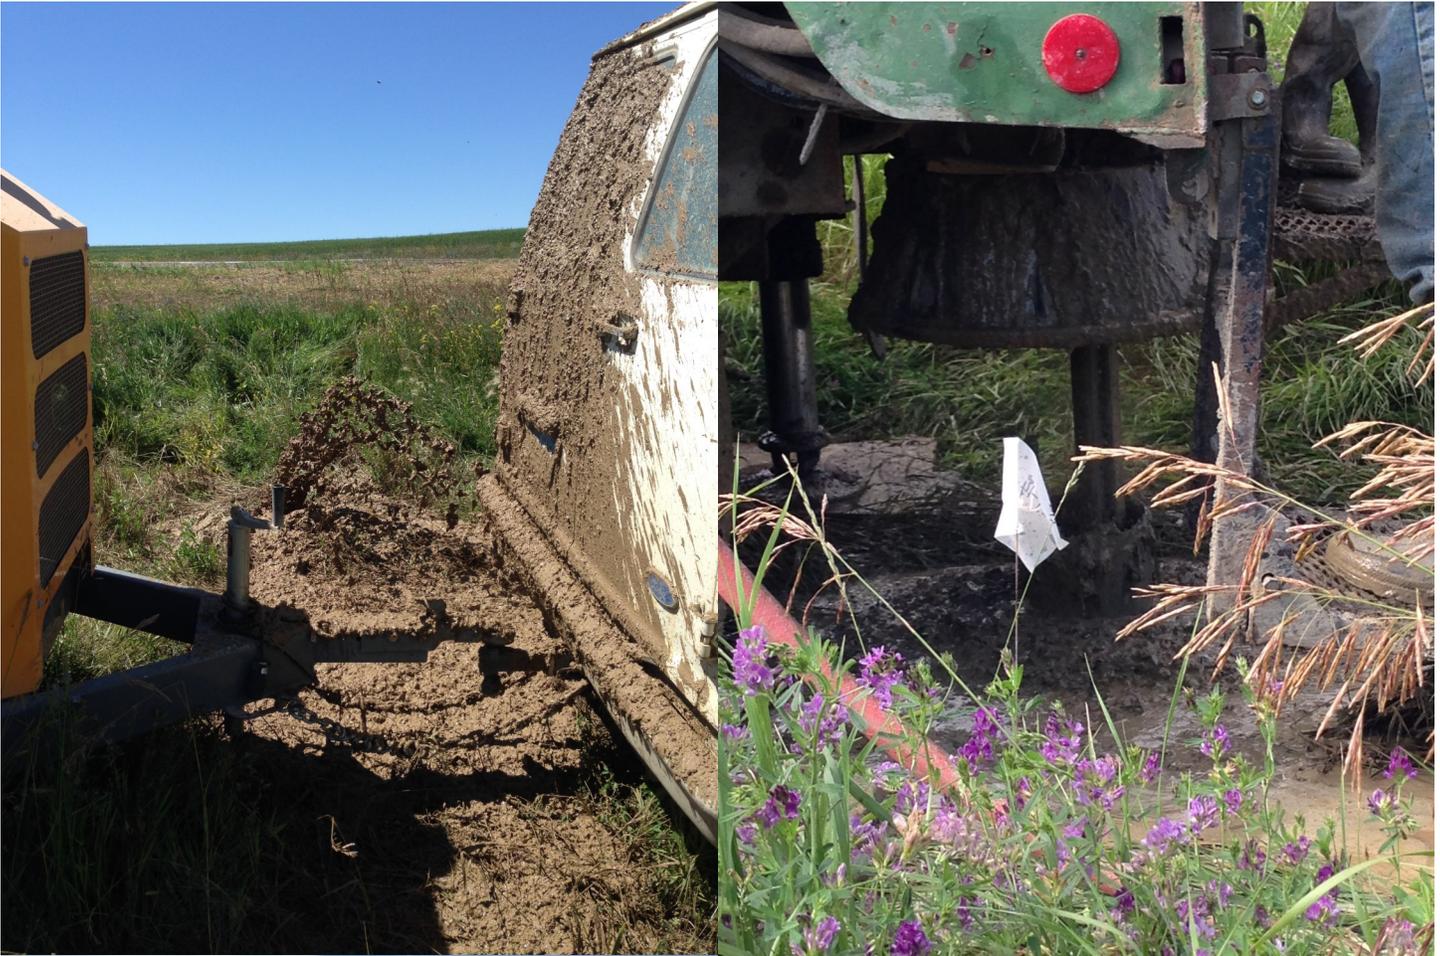
Upper left: Grout gushing from an adjacent hole indicating that the holes are connected. The hole was plugged with a post and pumping continued.
