2017 AML PROJECT SUMMARY

March 2018

Exploratory Drilling

Drilling to identify and characterize abandoned underground coal mines.

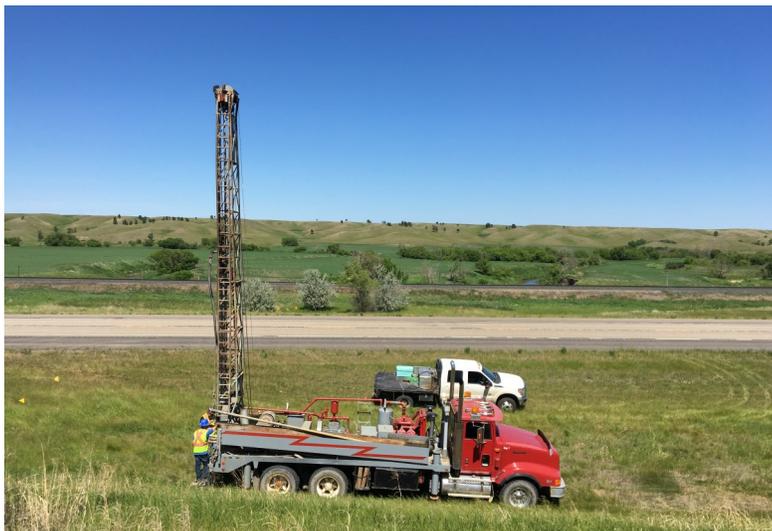
Drilling in the ditch of US Highway 52 about 2 miles south of Foxholm.

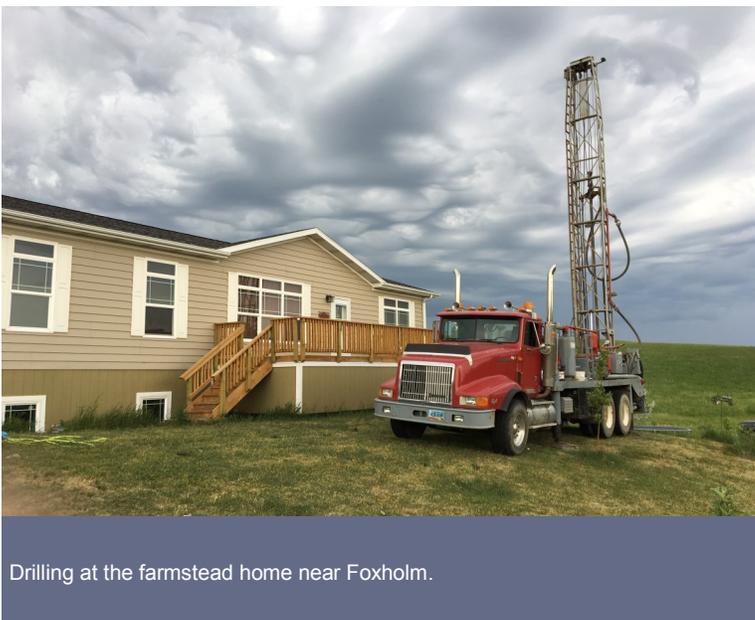
Drilling at the farmstead home near Foxholm.

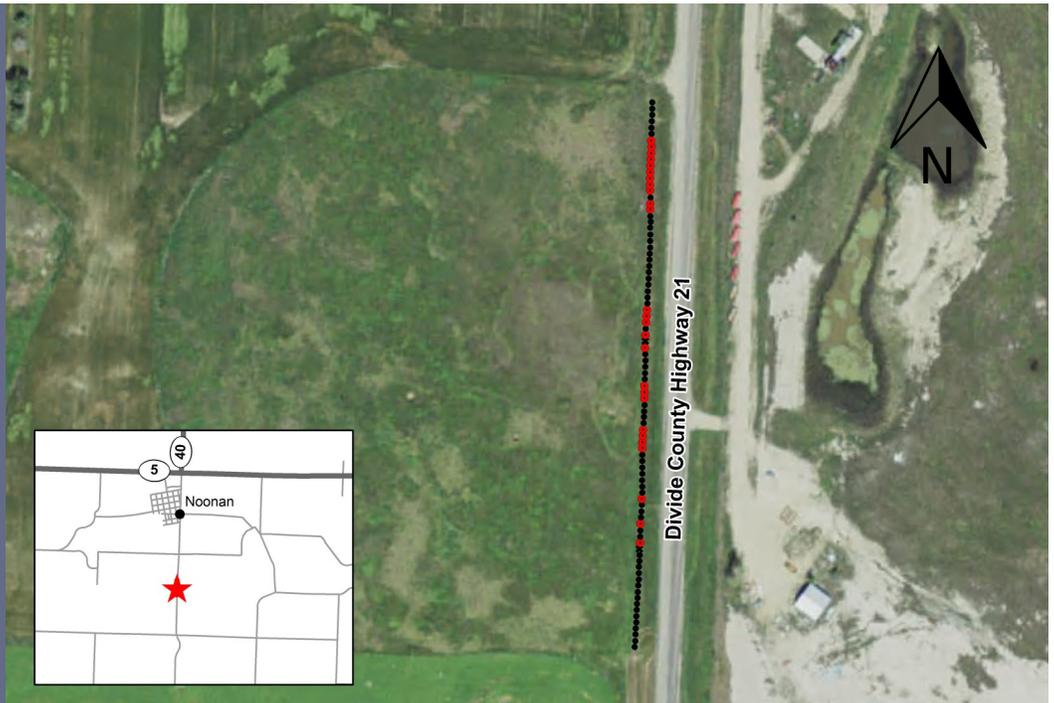
The top of the coal at the south end is 37 feet below the

Divide County Highway 21 runs north and south. Each **black dot** represents one drill hole that encountered solid coal. **Red dots** are holes that intercepted mine workings and were cased for future grouting.

surface and extends 7 feet to 44 feet below the surface (see Map). The top of the coal at the north end of the site is 27 feet below the surface and remains 7 feet thick. A total of 88 holes were drilled 10 feet apart. Twenty-six boreholes encountered heavily rubblized areas suggesting the mine roof has collapsed. These holes were cased for future reclamation work.

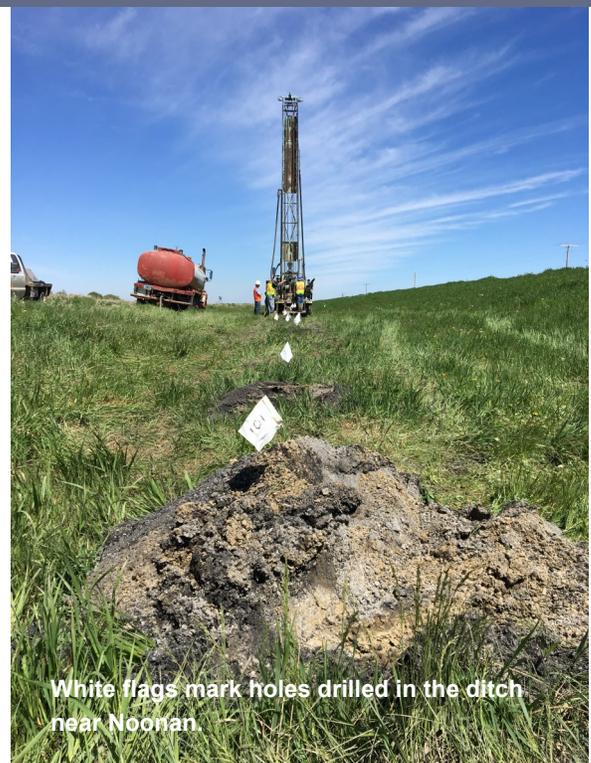
White flags mark holes drilled in the ditch near Noonan.

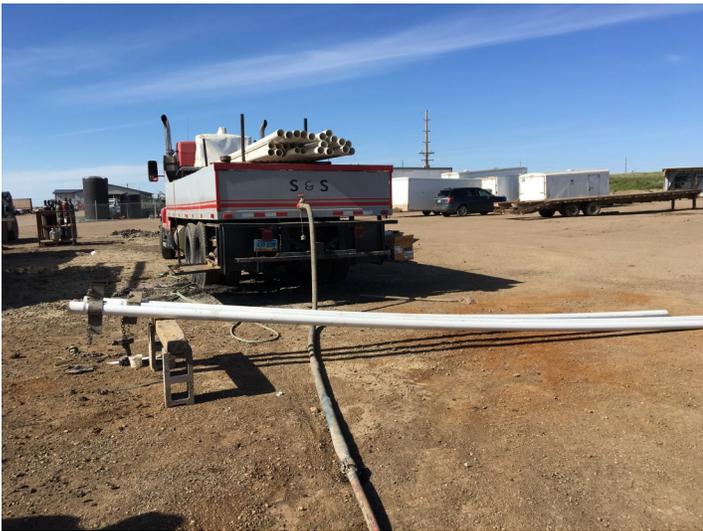
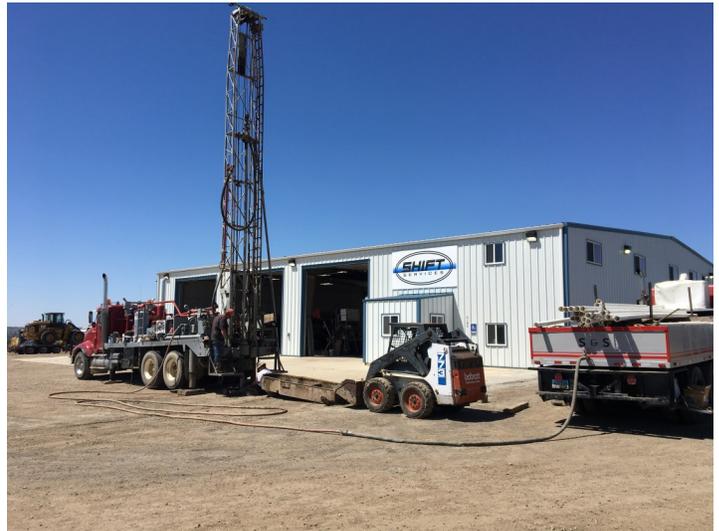
Top: Casing being prepared for installation into a “void” hole at Sunland Services. Right: Drilling at the Shift Services building.

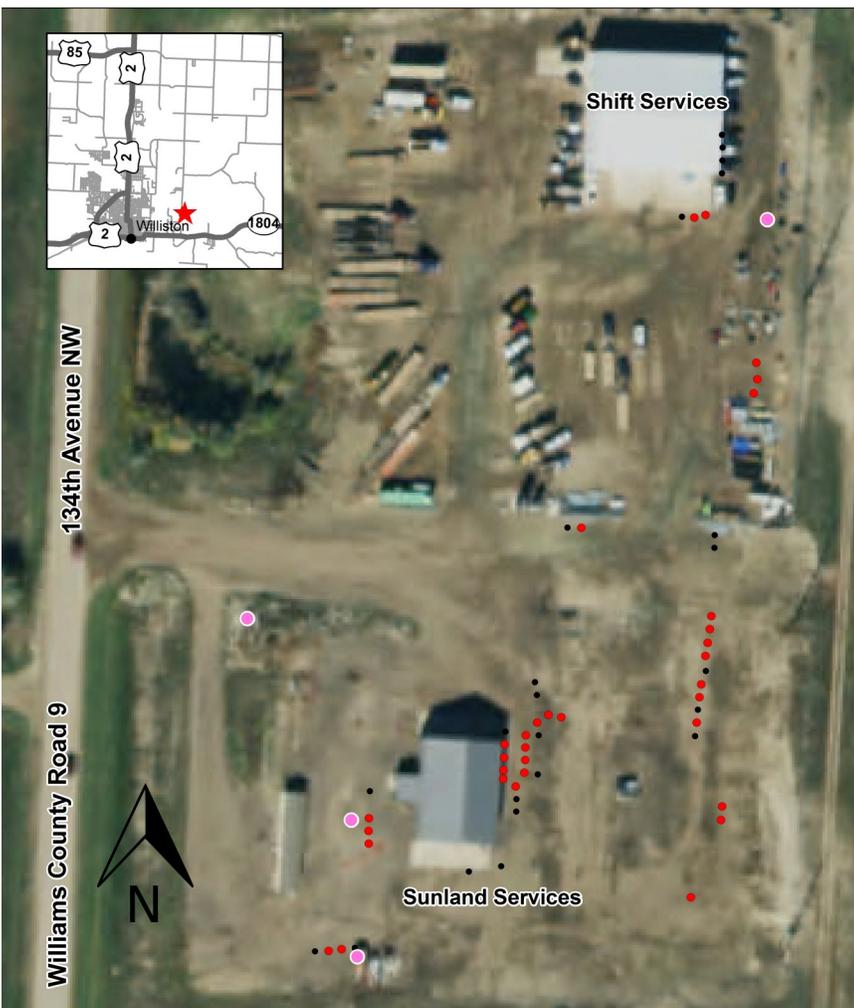
In the spring of 2017, the ND PSC AML Division was notified of a sinkhole on the Shift Services property (northern building on the Map) along Williams County Road 9. Upon investigation, another sinkhole was discovered at Sunland Services (southern buildings) as well as a potential sinkhole in the ship building. The site was immediately added to the Exploratory Drilling Project.

Of the 59 holes drilled, 33 encountered mine workings and were cased for future work (Red dots on Map). The Sunland shop building appears to be undermined. The Shift Services building may be undermined. Reclamation for this site is slated for the summer of 2018.

Williams County Road 9 runs north and south. Shift Services occupies the building to the north. The building to the south was formerly occupied by Sunland Services. Each **black dot** represents one drill hole that encountered solid coal. **Red dots** are holes that intercepted mine workings and were cased for future work. Sinkholes are represented by **pink dots**.

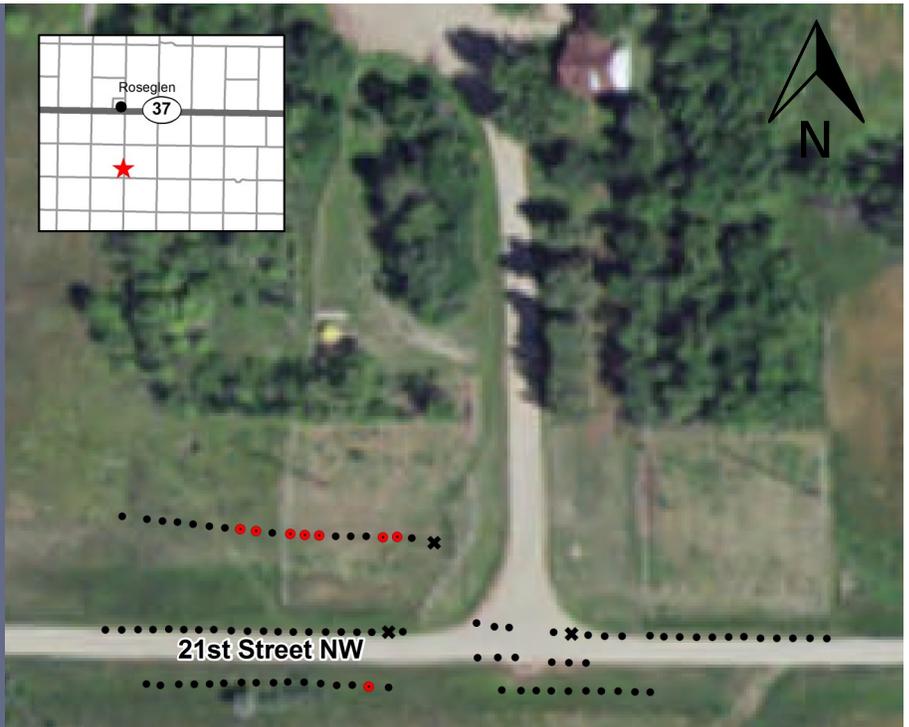
Drilling was conducted along the road and road right of way (see map above). The top of coal in this area is about 56 feet below the surface, and the seam is about 7 feet thick. Eight of the bore-

The east—west road is 21st Street NW. Each **black dot** represents one drill hole that encountered solid coal. **Red dots** are holes that intercepted mine workings and were cased for future work. A **black x** indicates a hole that was abandoned before reaching the coal.

holes encountered mine workings and were cased. At four of these holes, the mine showed evidence of collapse and migration of the collapse toward the surface. Given time, the collapse may reach the surface and produce a sinkhole.

Additional drilling will be necessary to further identify the extent and condition of the mine and how it may influence the homestead and the county road.

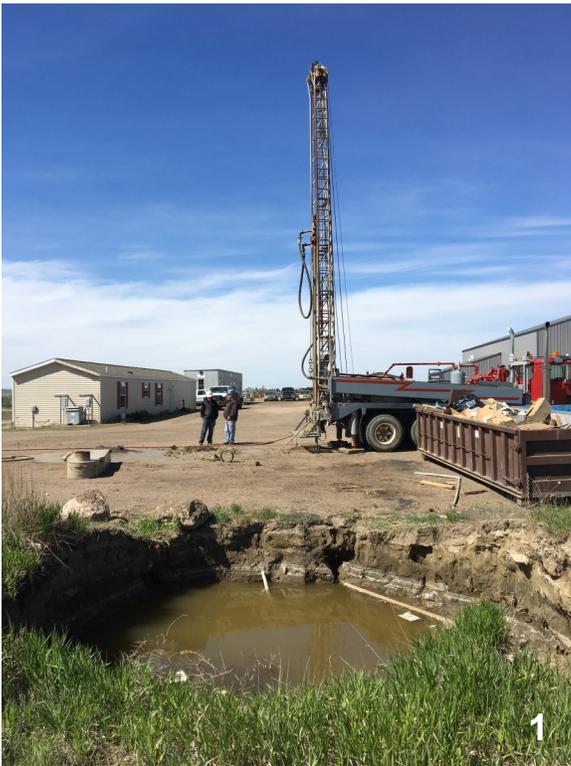
1

1. Exploratory drilling near a water filled sinkhole in Williston.
2. Using a "mud pit" while drilling with water.
3. White flags show bore hole locations at Margie Zietz's home in Burlington.
4. Angle drilling near the Shift Services Building in Williston.
5. White flags showing bore hole locations along the road shoulder and ditch near Roseglen.

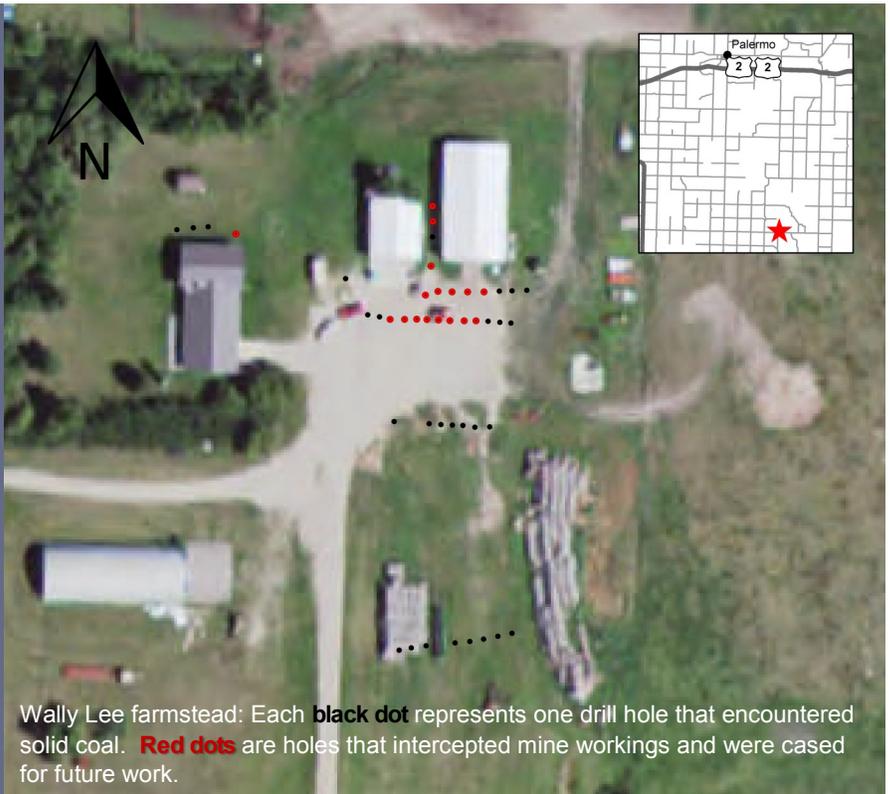
Wally Lee farmstead: Each **black dot** represents one drill hole that encountered solid coal. **Red dots** are holes that intercepted mine workings and were cased for future work.

The top of coal lies about 62 feet below the surface and the seam is 7-8 feet thick. Drilling near the shop buildings and house encountered mine workings. Of the 49 bore holes, 17 encountered rubble from collapse of the mine. About one-half of these holes showed upward migration of the collapsed area to within 35 feet of the surface. Given time, the collapsed portion may reach the surface, causing a sinkhole to form.

Since sinkhole formation is often sudden, this presents a threat to people and property at the farmstead. To reduce the threat of sinkhole formation, a drilling and grouting project is planned for this site in 2018.

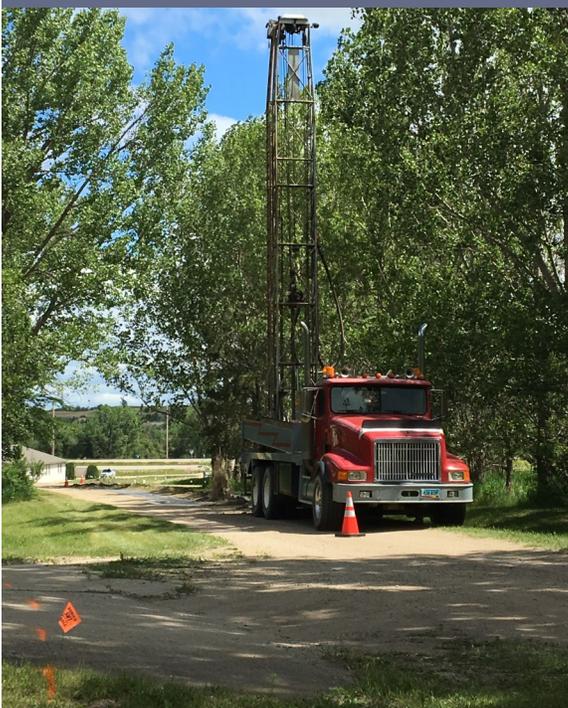
Left: Drilling on 29th Avenue NW in Burlington.

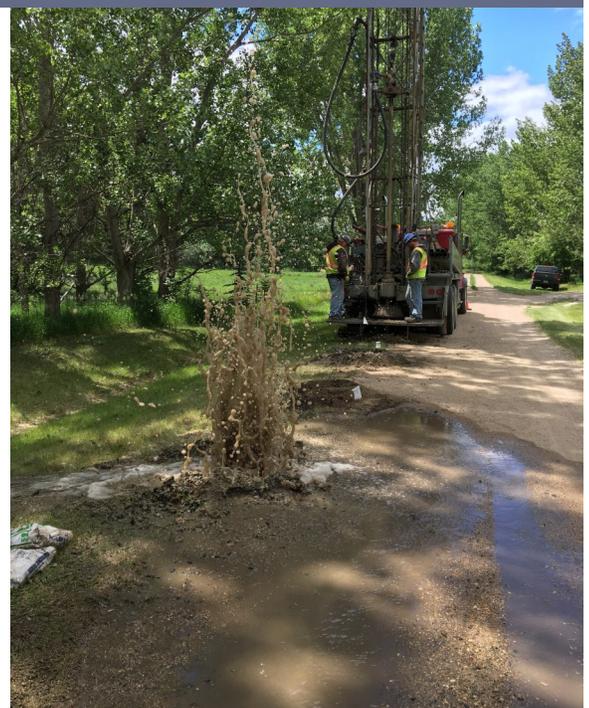
Right: Drilling on 29th Avenue NW in Burlington. Groundwater is being pushed to the surface by drilling 40 feet away. This suggests there may be an opening linking the two holes. Three holes in this area encountered mine workings and were cased for future work.

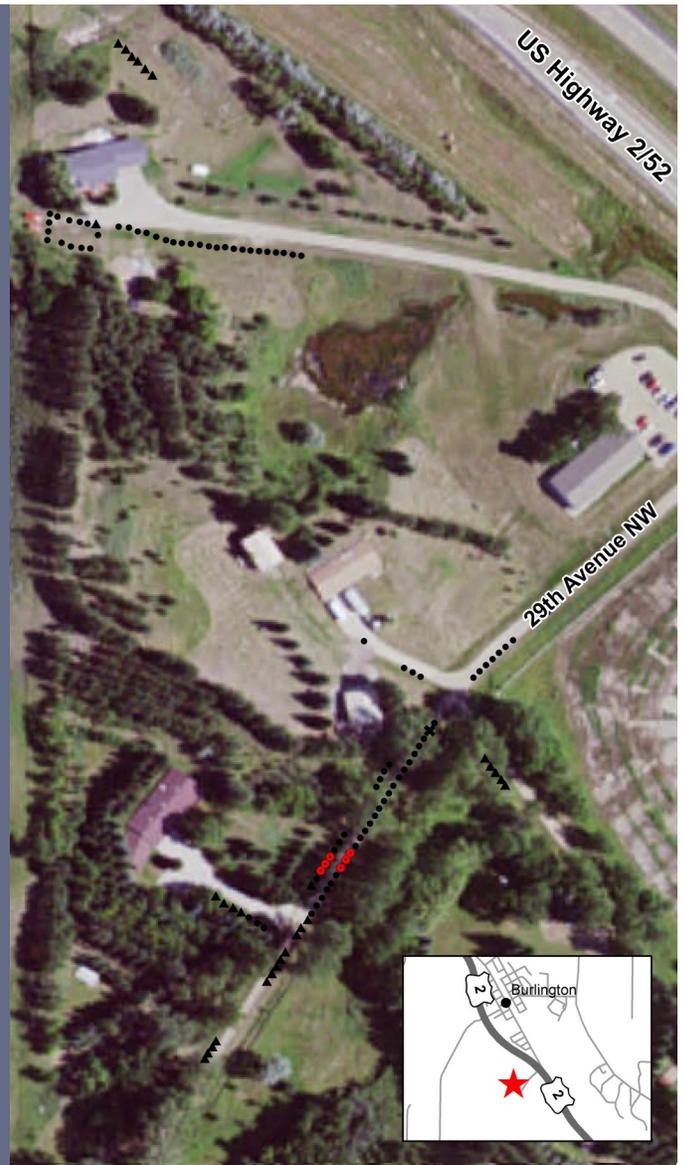
In the fall of 2016, several areas around Burlington were identified as potentially affected by abandoned underground coal mines. Sinkholes were observed within 50 to 250 feet of each home along 29th Avenue NW in Burlington. These sinkholes are likely associated with the Miller Coal Company Mine which operated between 1926-1941. No map of this mine is known to exist. Generally the coal seam is 9-10 feet thick. Along 29th Ave. NW the top of coal is between 22 and 29 feet from the surface. Of the 116 holes drilled at this site, six boreholes encountered mine workings and were cased for later work (top map). Some questions remain as to the location, extent and condition of this mine.

The second site (bottom map) is undermined by the HH Mine. A map of the mine shows workings very near both houses. Sixteen holes were drilled on 27th Avenue NW. The coal seam is about 9-10 feet thick and about 105 feet from the surface. No drill log noted mine workings and the site geology made distinguishing the condition of the mine difficult. Five holes encountered two feet of coal followed by 8 feet of sand. This is very unusual. Normally a clay layer is directly under the coal.

Top Map: 29th Avenue NW, Burlington. **Bottom Map:** 27th Avenue NW, Burlington. Each **black dot** represents one drill hole that encountered solid coal. **Red dots** are holes that intercepted mine workings and were cased for future work. Drill holes represented by **black triangles** did not encounter coal.

While drilling did provide some information on the condition of both mines and their associated geology, additional drilling will be necessary to fully understand the potential risk of the abandoned mines to homeowners.

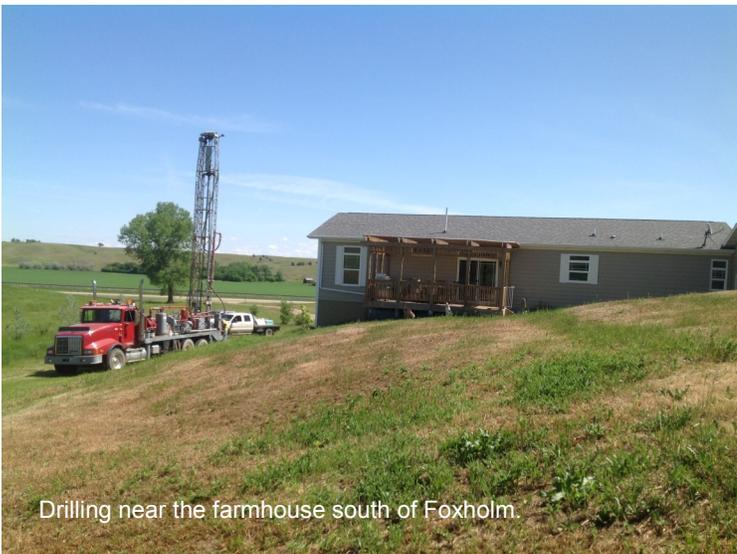
Drilling near the farmhouse south of Foxholm.

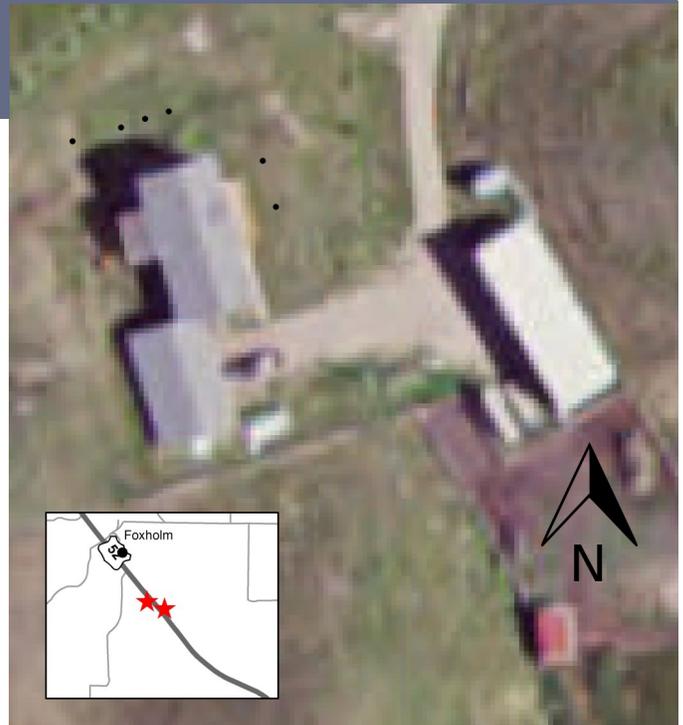
A preliminary site investigation in the fall of 2016 found evidence of historic mining including sinkholes and collapsed mine entries in the Foxholm, ND area. Exploratory drilling was conducted at 2 sites to investigate the possible impact of historic mining on the area. One site was a farmstead about 1 mile south of Foxholm (see top map). Evidence of mining at this site included a collapsed entry about 500 west of the house and a sinkhole about 200 feet east of the house. Six holes were drilled near the house. The top of 7 to 9 foot thick coal seam ranged from 47 to 52 feet below the surface. No mine workings were encountered near the home.

The second site (bottom map) was in the right of way of US Highway 52 near where a gas pipe line transects the highway. Several sinkholes can be found in the pasture near the high-

way right-of-way. Also, in the pasture near the right-of-way fence a portion of the gas pipeline appears to run under a sinkhole. Drilling was done to verify that the pipeline was not undermined in the right-of-way. The 8 foot thick coal seam in this area is very shallow, with the top of coal only 14 feet below the surface. Though drilling in the right-of-way did not encounter any mine workings, the pipeline may be undermined in the adjacent pasture.

Above: A farmstead about 1 mile south of Foxholm. **Below:** US Highway 52 runs diagonally through the map. Each **black dot** represents one drill hole where drilling encountered solid coal. No mine workings were encountered at either Foxholm sites. No additional work is planned for the Foxholm sites.

No additional work is currently planned for these sites; however, caution is always advised in areas with abandoned underground mines.

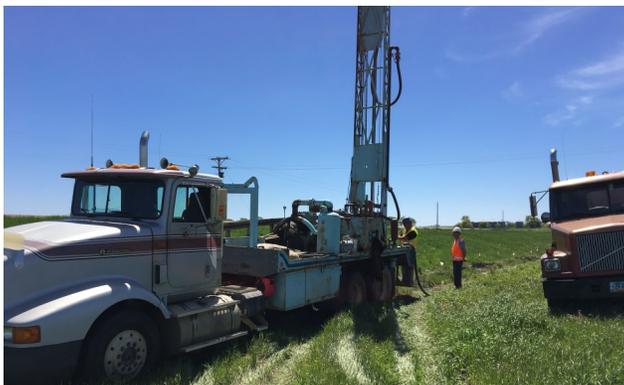
Left: Drilling in the ditch near Noonan.

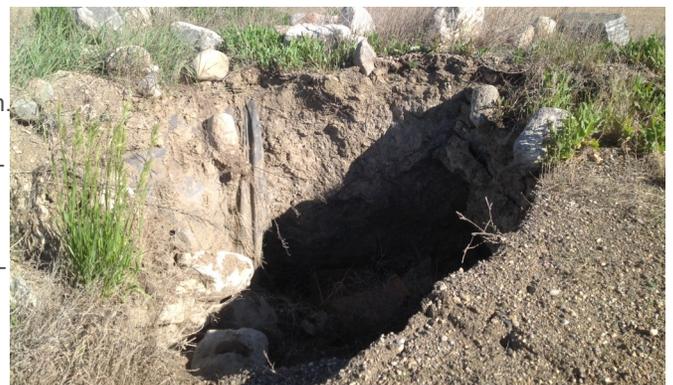
Right: A hazardous sink-hole near Sunland Services in Williston.

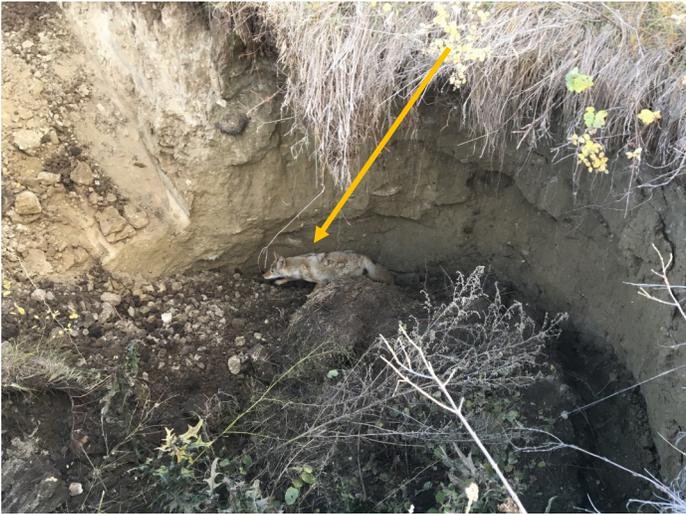
If you live or work near an abandoned underground coal mine, please use caution. The ground can give way without warning. In this photo, a coyote became trapped after falling into a sinkhole. A similar event could happen to you at an abandoned underground mine site.
