# 2019 AML PROJECT SUMMARY

## Exploratory Drilling AML Project

## Williams County Road 9 Phase 7 and Noonan AML Project

### Project Two: Abandoned Underground Mine Reclamation

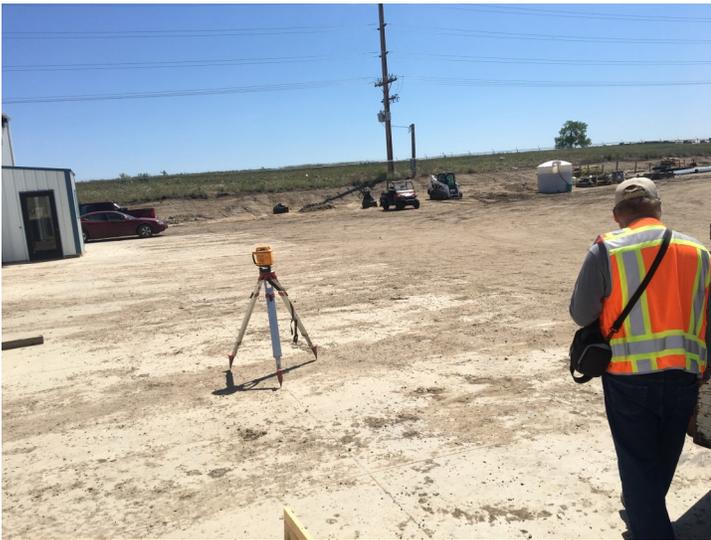
A laser level monitors ground movement near the Shirt Services building during grout pumping. Inspector, James Thornburg, is on the right.

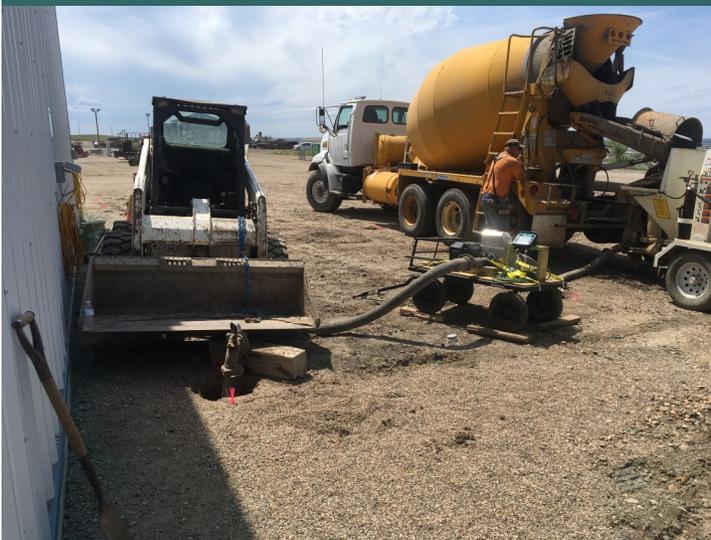
The grout runs through the meter to monitor the pressure. It then goes into the cased hole right next to a building.

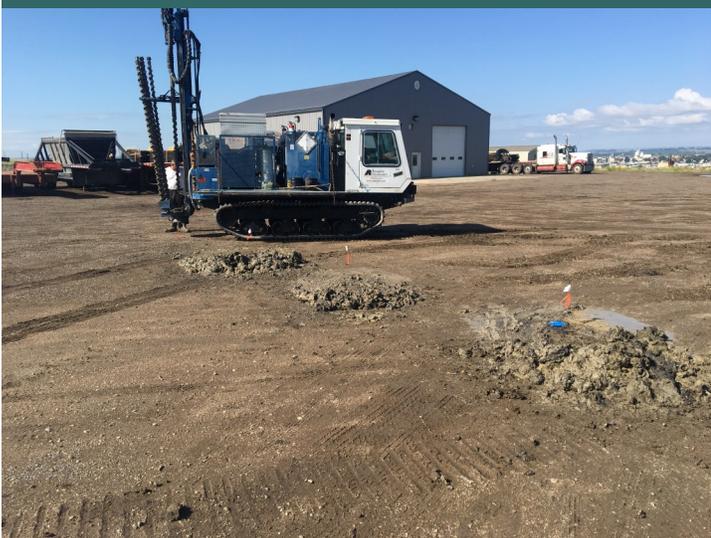
This drill rig ready to begin drilling a new hole. Piles of cuttings show the locations of recently drilled holes.

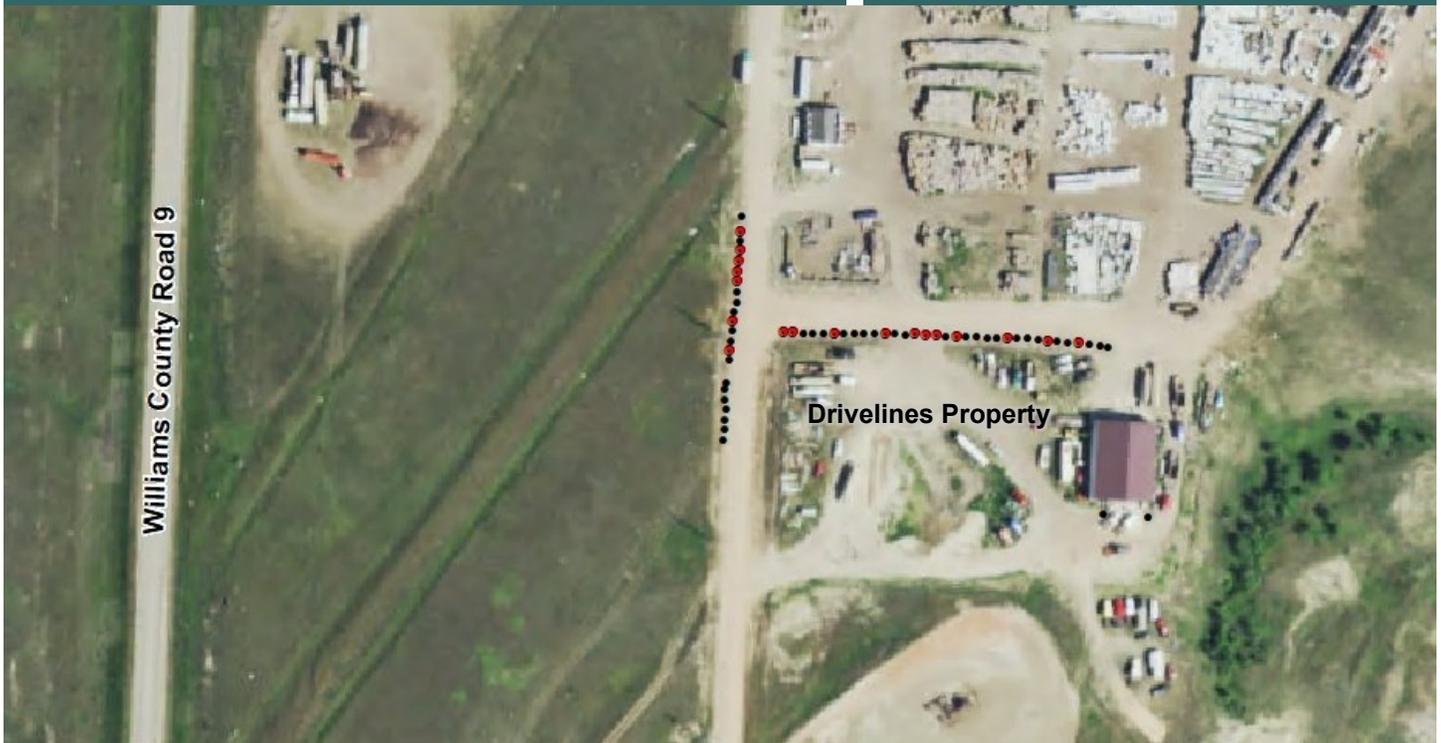
**Williams County Road 9**, also called 134<sup>th</sup> Avenue NW, runs north and south. Drilling encountered solid coal at **black dots** and no coal at **black triangles**. **Red dots** are void holes that need grout.

Drilling near the Drivelines Property is shown on the map below. One mine entrance may be to the southwest of the red-roofed building. Two holes drilled near the southern corners of the building encountered coal only. Previous drilling around the building also encountered solid coal. Drilling along the two access roads to the property did encounter the mine workings.

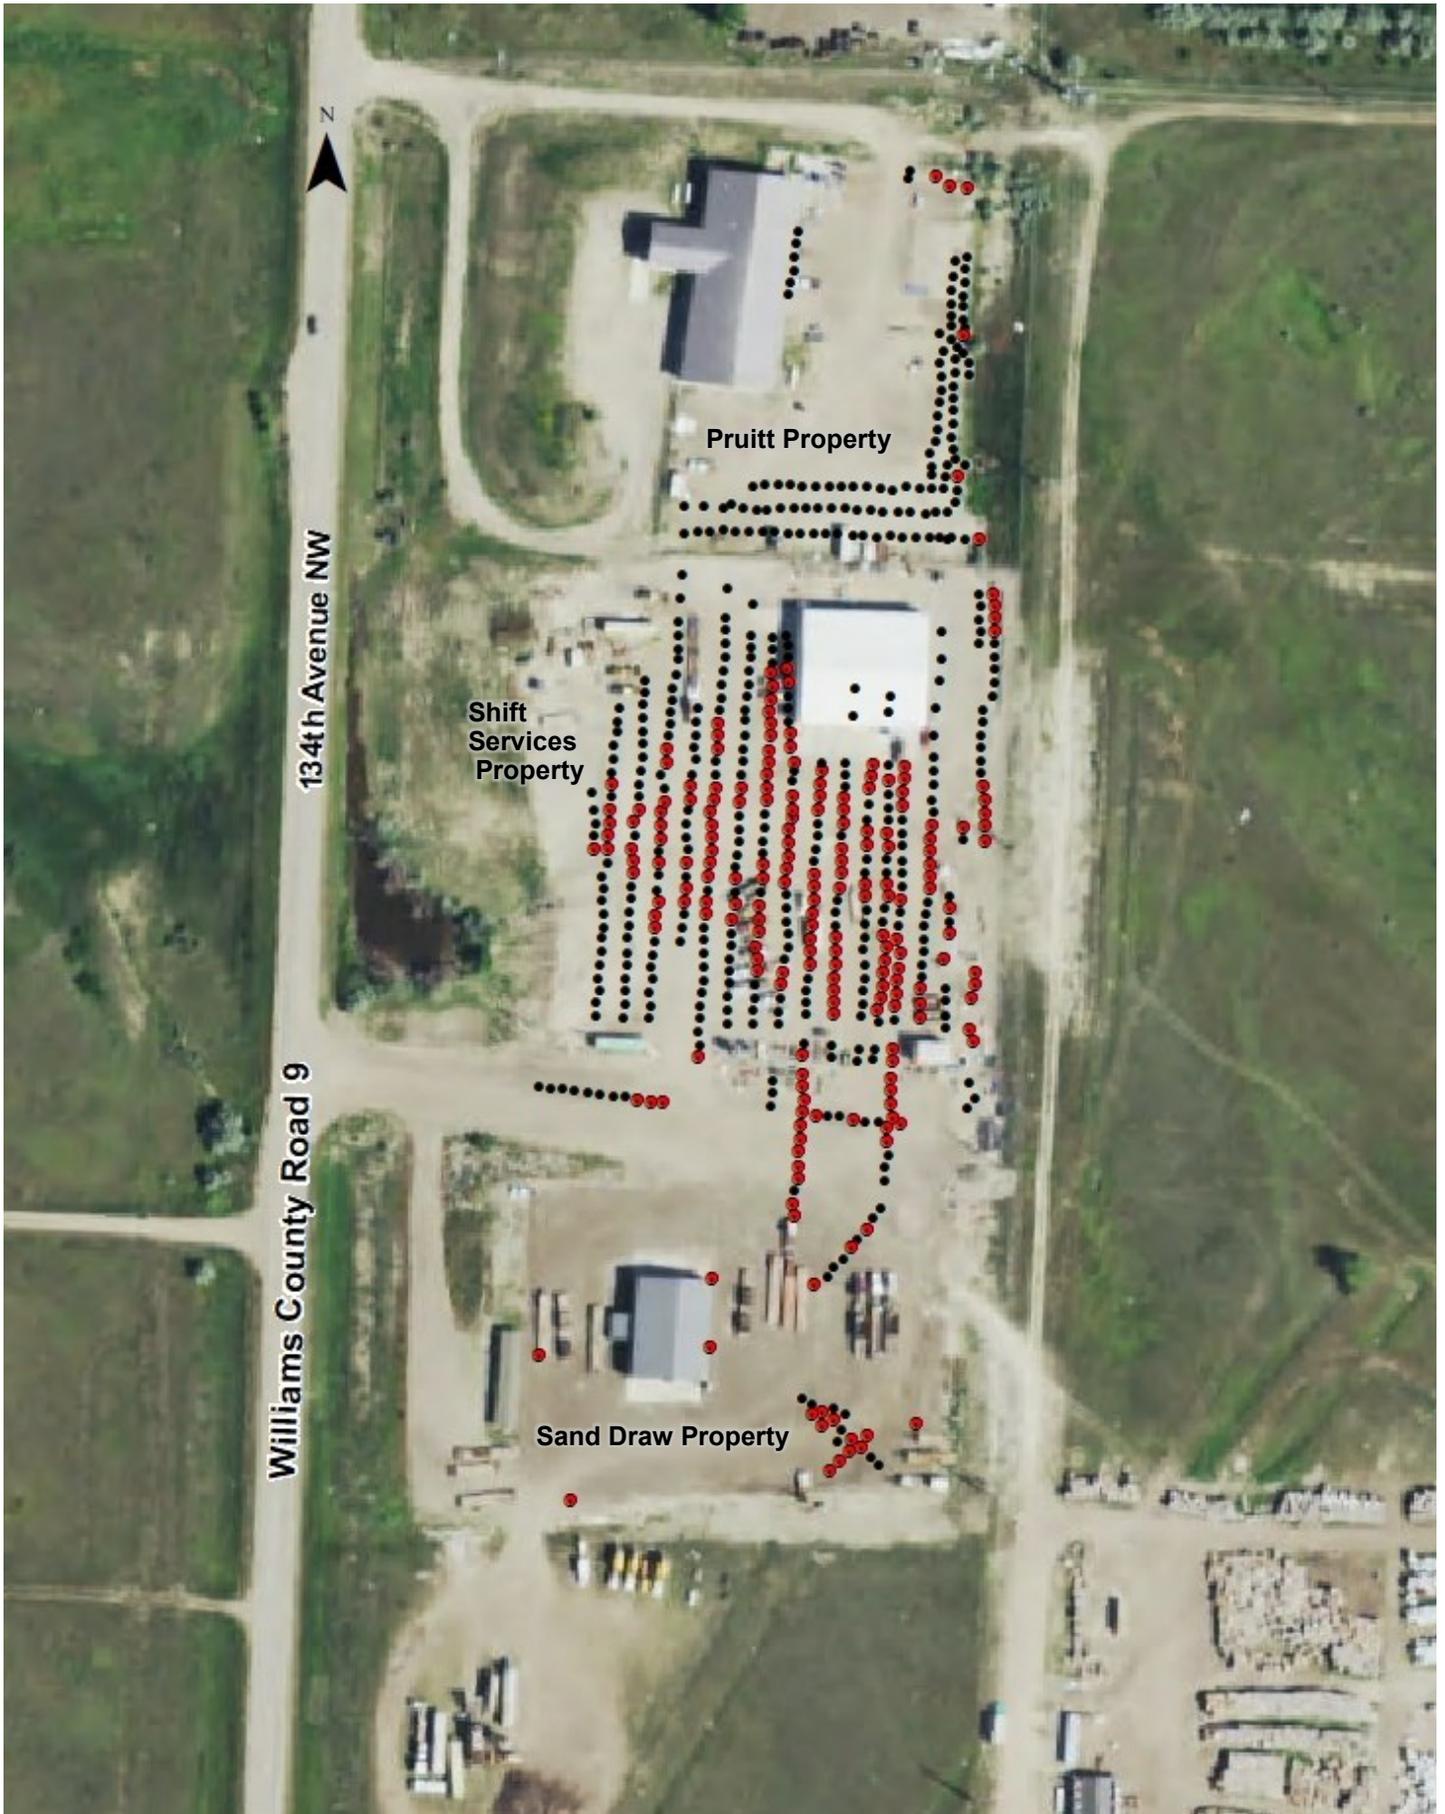
Williams County Road 9, also called 134<sup>th</sup> Avenue NW, runs north and south. Drilling encountered solid coal at **black** dots. **Red dots** are void holes that need grout.

To get a better idea of the condition of the mine, a 2019 Exploratory Drilling Project was conducted at the Shift Services, Pruitt Properties and near the Drivelines Property (1314 28th Avenue E) prior to the 2019 drilling and grouting project. Drilling at the Shift Services and Pruitt Properties is shown on the map on page 5. Drilling was done in a grid pattern. Rows are 20 feet apart and holes within a row are 10 feet apart. At each red dot drilling encountered the mine workings. These holes were cased with PVC pipe to be used for pumping grout into the mine. Confirmation drilling done at the Sand Draw Property revealed additional grout is

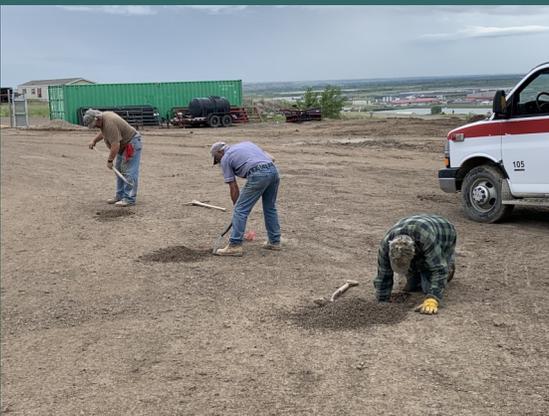
Left: Contracting crew locating cased holes for pumping grout in Williston.

Right: Drilling rig set up in front of the Shift Services Building in Williston.

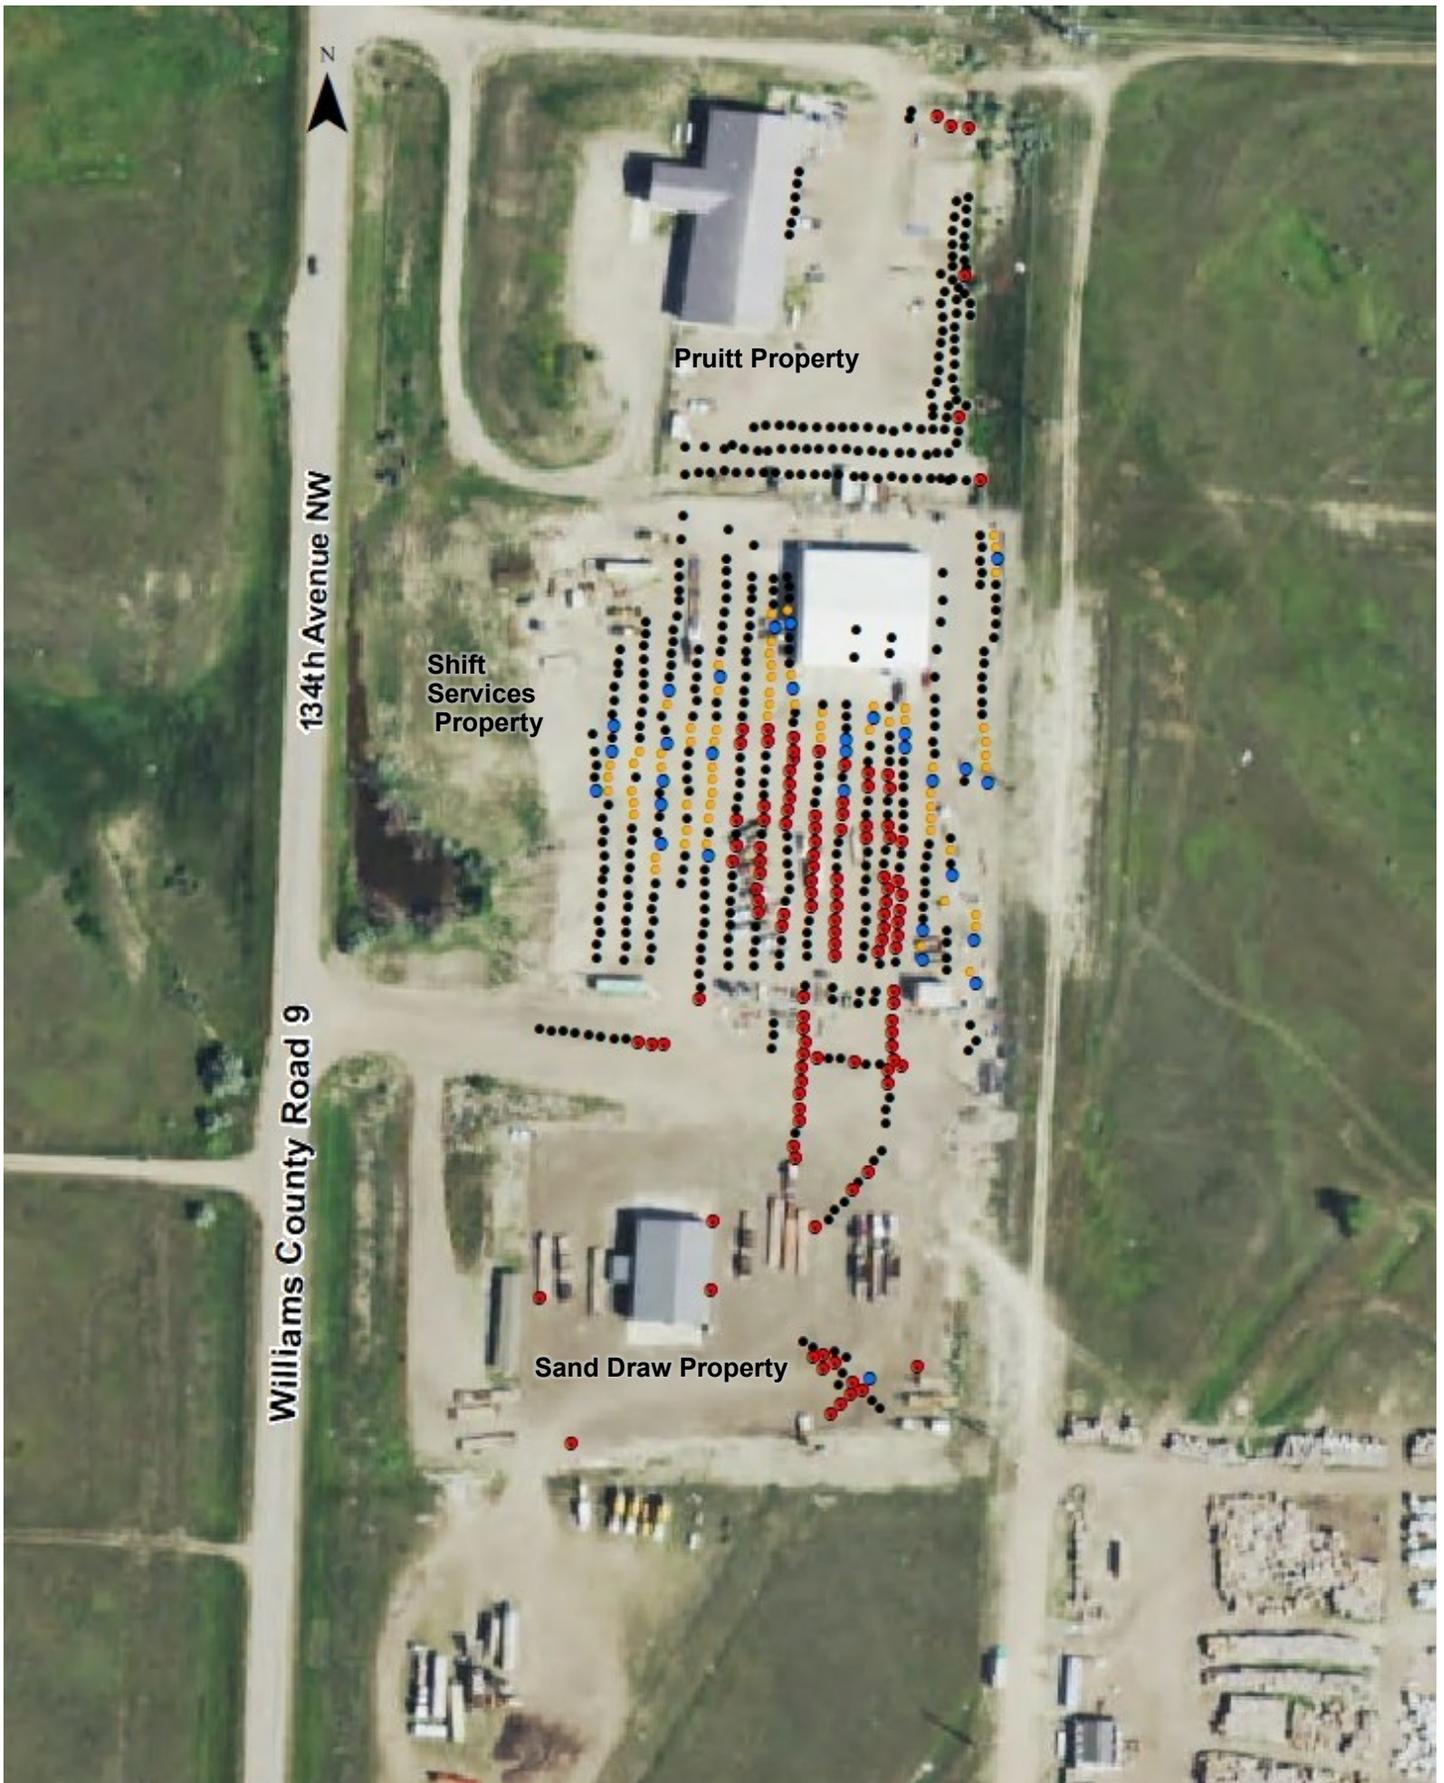
Williams County Road 9, also called 134<sup>th</sup> Avenue NW, runs north and south. Drilling encountered solid coal at **black dots**. Grout was pumped into holes at **Blue dots**. The **orange dots** are holes filled by pumping grout into a different hole. **Red dots** are void holes that still need grout.

The 2019 drilling and grouting project immediately followed the 2019 Exploratory Drilling Project at the Williston site. The map on page 7 shows all of the holes drilled in the Exploratory Drilling Project like the map on page 5. The difference is the map on page 7 shows holes that were pumped and filled with grout. The blue dots are holes where grout was pumped. The orange holes are holes that were filled with grout while pumping on a nearby hole.

Pumping on 29 holes filled an additional 65 holes and took 2,945 cubic yards of grout. The exploratory drilling and grouting work took coordination with Shift Services who had to move their equipment to allow space for drilling rigs and grout pumping equipment. Exploratory drilling began in the southeast corner of the Shift Services property and continued north and west. Since the Shift Services lot was empty on the western edge at the end of the drilling, grouting started on that side of the property and worked north and east. We tried to limit the amount of moving that Shift Services had to do.

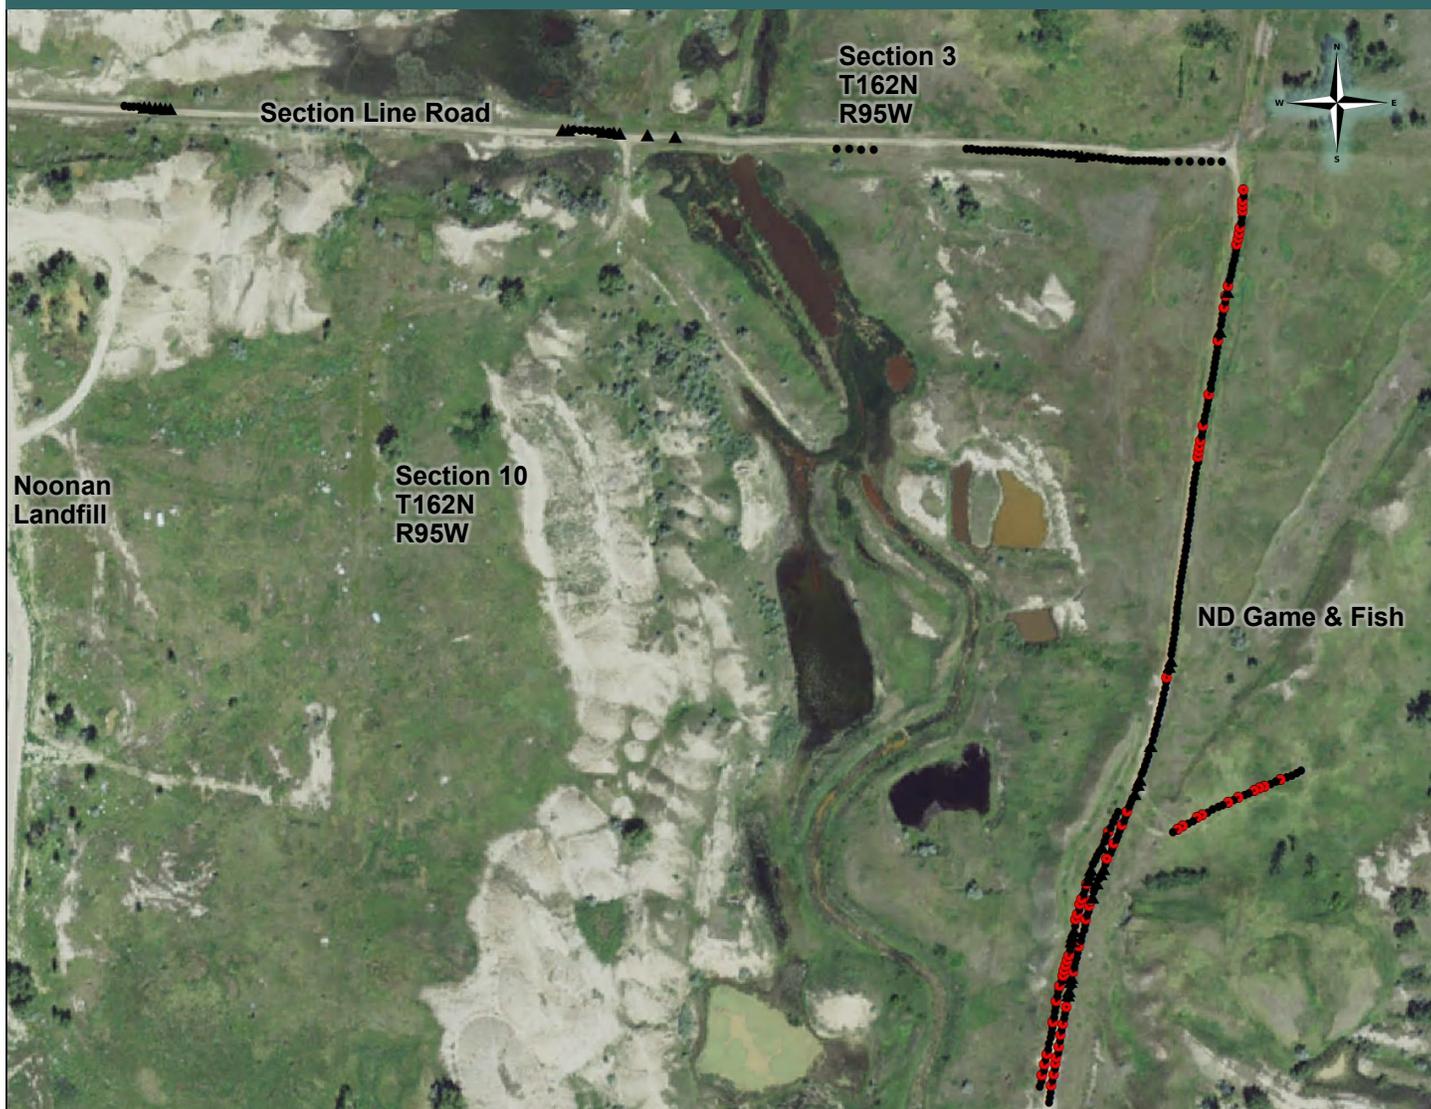
**Noonan Drilling:** Drilling encountered solid coal at **black dots** and no coal at **black triangles** . **Red dots** show holes where foamed sand will be pumped in 2020.

(black triangles) by surface mining and replaced with spoil material to create the section line road.

The drilling portion of the project started on the east-west section line road on July 3, 2019 (shown on the map below). Drilling in this area revealed that the coal had been removed

underground coal mine workings are on the Harris M. Baukol WMA. These holes were cased and are shown as red dots on the map on page 8. Drilling confirmed that the mine is collapsed and dry.

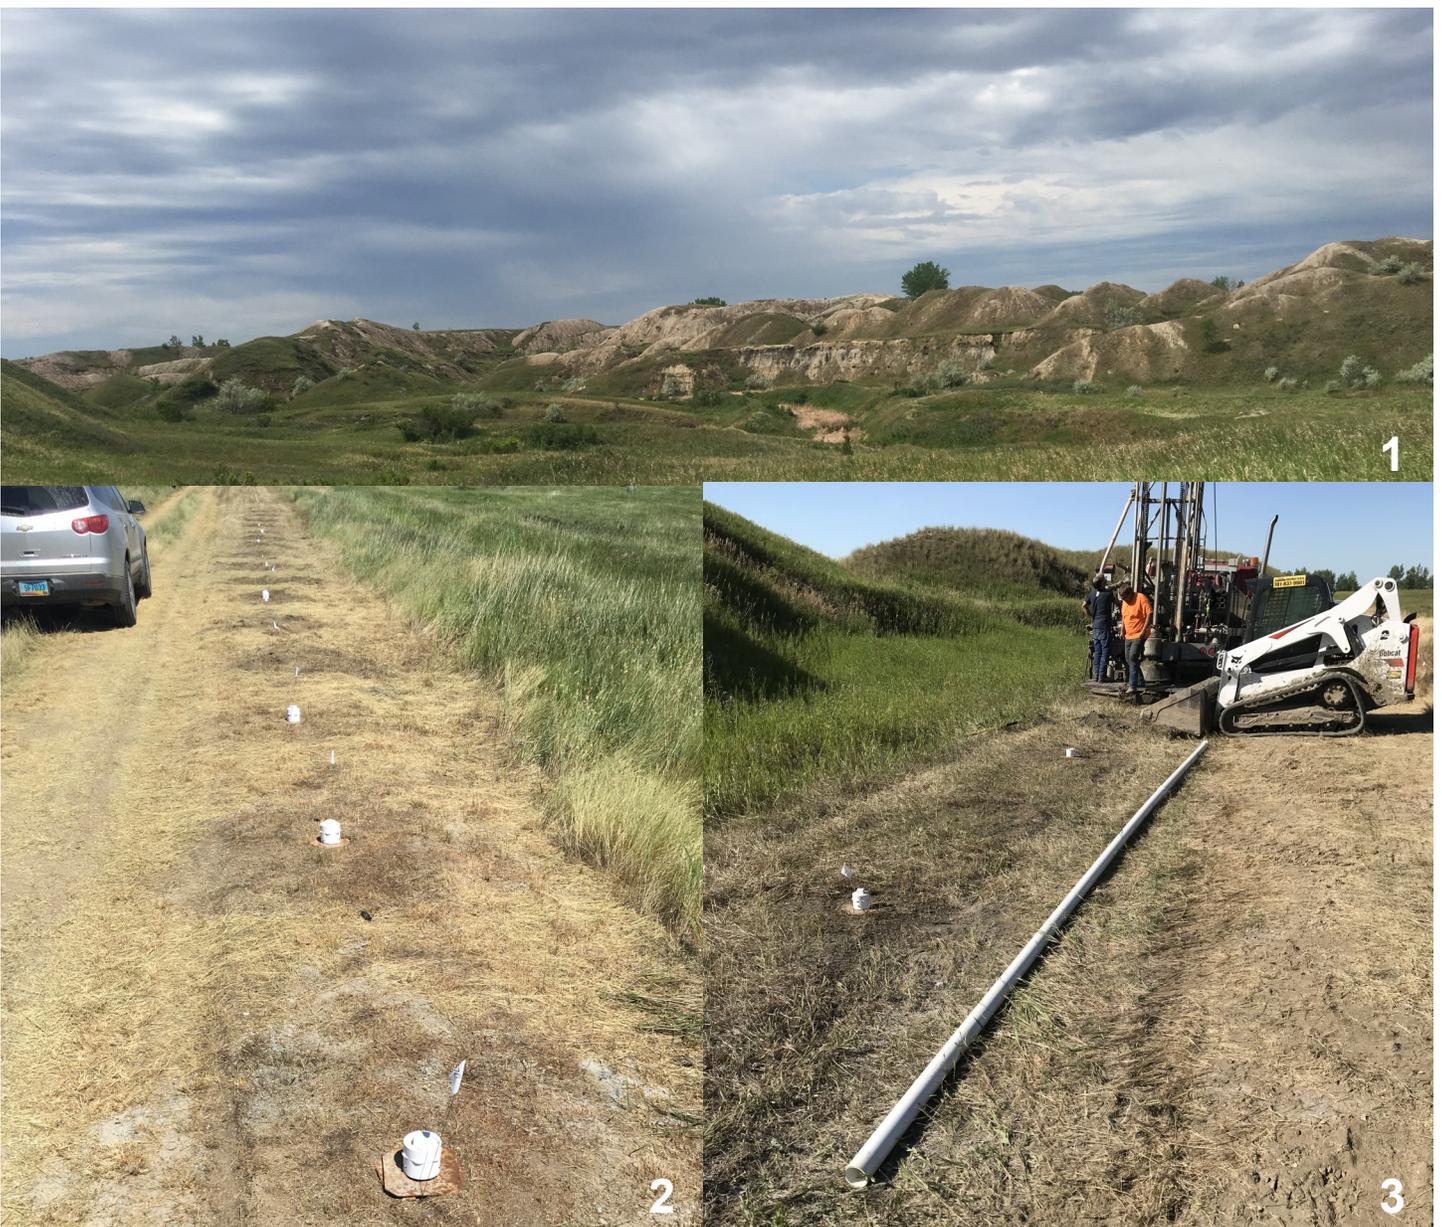
1. Baukol-Noonan Mine spoil piles as seen from the drilling site.
2. A line of cased holes on the Harris M. Baukol WMA near Noonan.
3. Casing to be installed at Noonan.

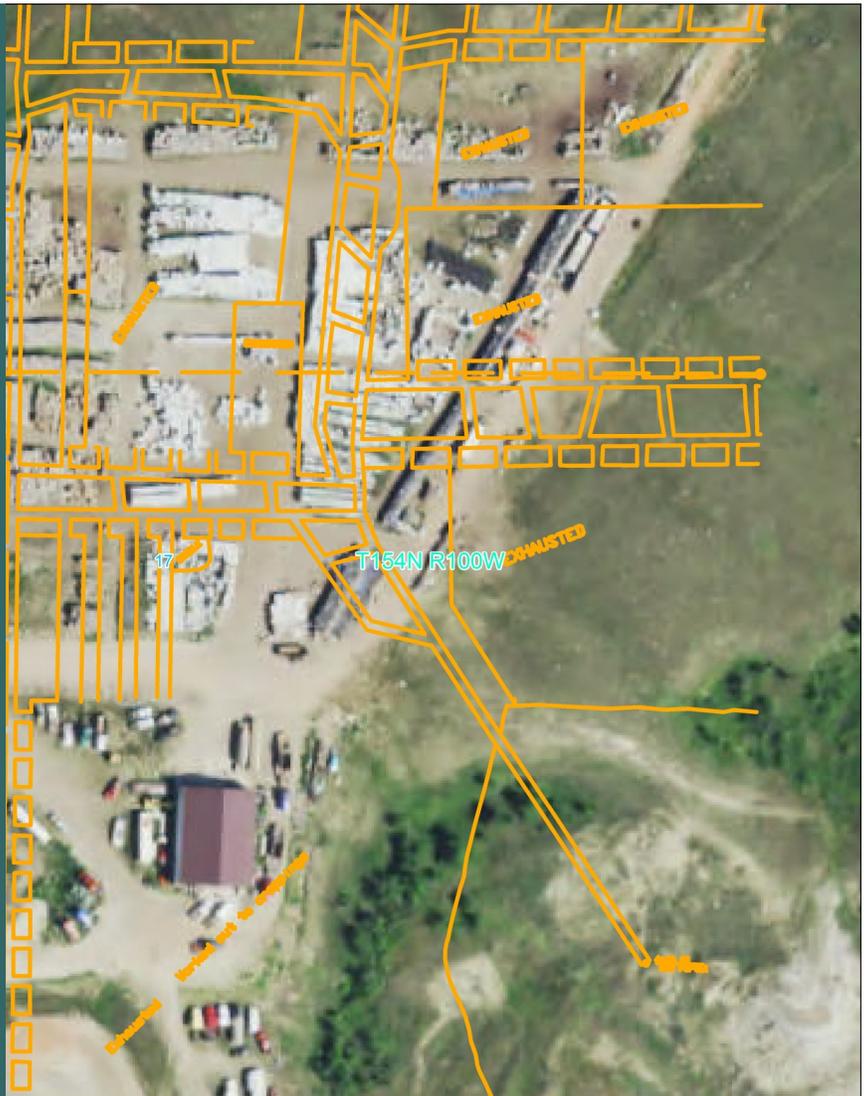
Shown on the right is a portion of the Williston Coal and Ice Company mine map over an aerial image of the ground surface. Around 1919, the State of North Dakota began collecting information from coal companies of the underground mines, including mine maps.

While the ND PSC has mine maps for many of the mines in our inventory, the maps only provide a snap shot of the mine itself. Often mining continued for years after the last mine map was produced. Sometimes the surveyors mapped the tunnels, but not the rooms. Portions of a mine may have collapsed during mining. Some maps were drawn without being surveyed. Other errors can be introduced when the maps are projected onto imagery.

Even with these limitations, the mine maps can be a very useful tool in understanding the extent and conditions of the mines. Maps give us a good idea of where to start drilling. It also serves as an initial guide for estimating how much grout will be needed.

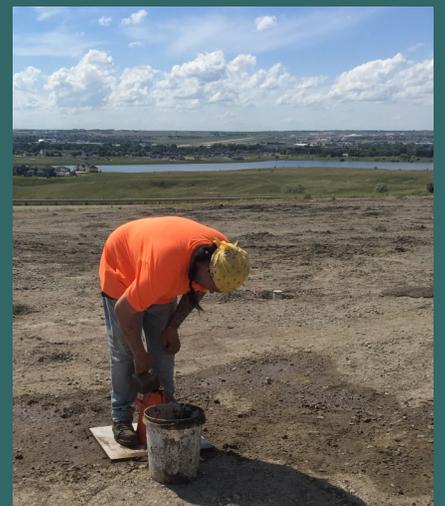
The material tester is doing a slump test on grout at Williston.

For our grout projects, flowability is measured with a slump test. The higher the slump the more flowable the mixture. When we want the grout to flow a long distance or into the rubble of a collapsed portion of the mine, we use a grout with slump between 10 - 11 inches.

If we have an open void or don't want the grout to travel as far, we use a lower slump grout between 6 and 8 inches. Just for comparison, most poured concrete has a 1-3 inch slump-very stiff.

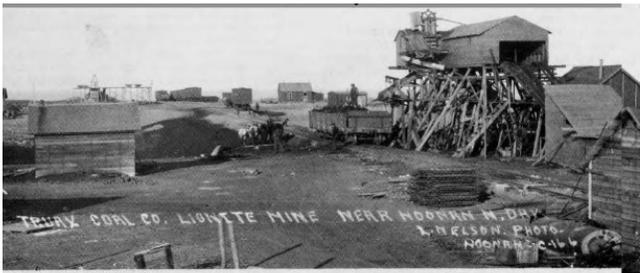
1. A composite photo of the Truax Tipple (Top) and the underground Mine (Bottom) at Noonan in the early 1900s. Images are from the ND State Historical Society.

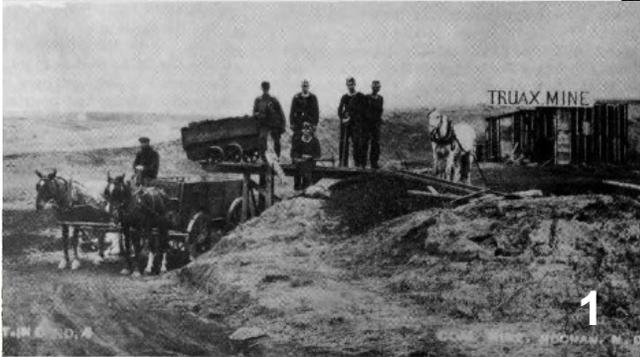
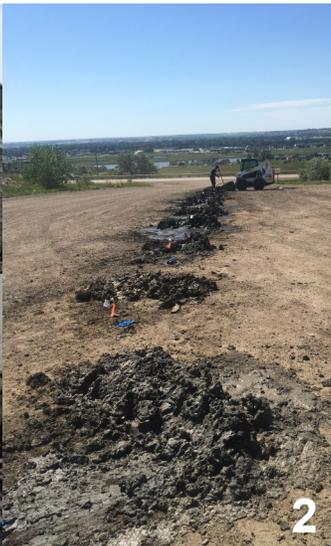
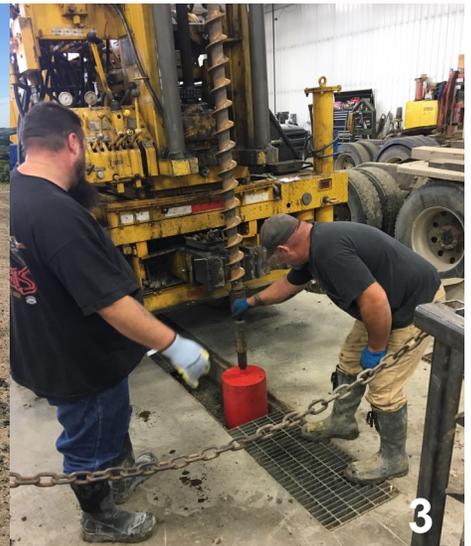
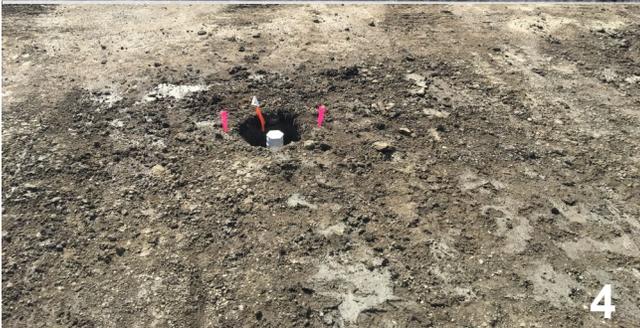
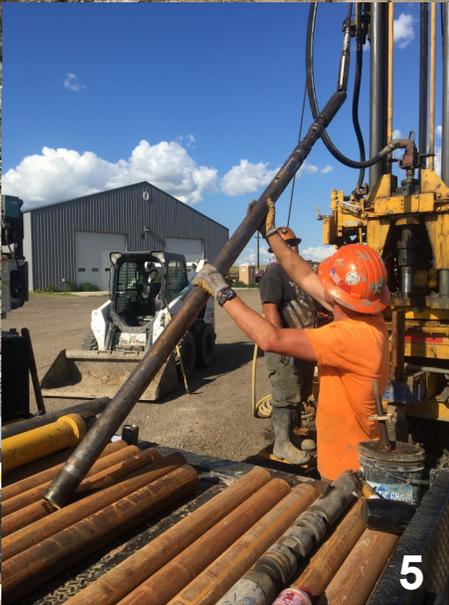
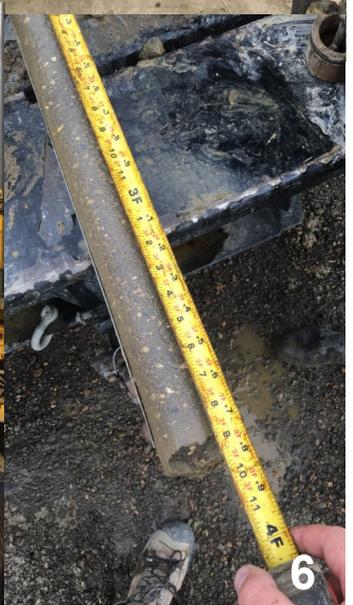
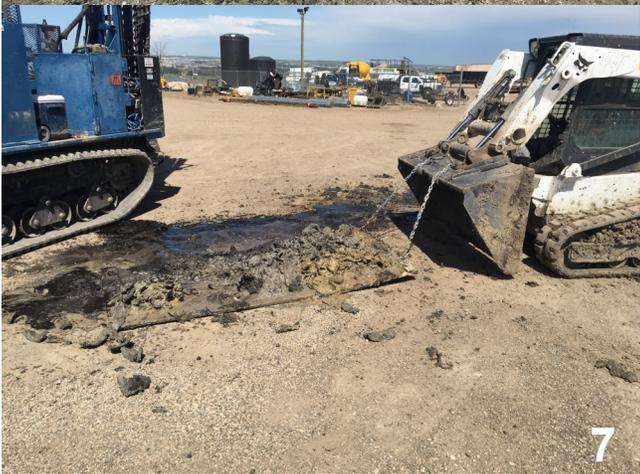
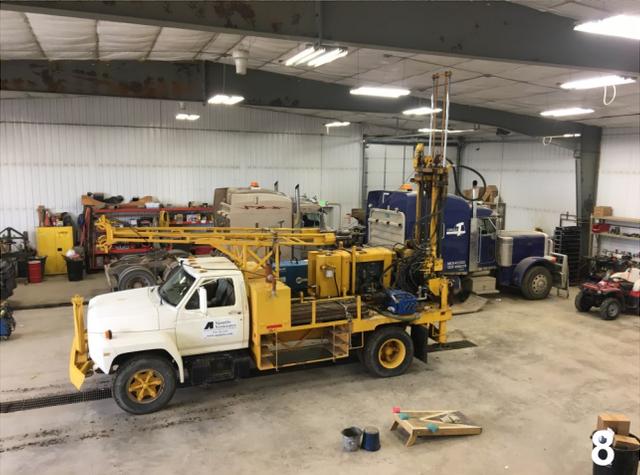
2. A line of drilled holes at Shift Services near Williston.
3. Drillers are carefully drilling through the concrete floor inside the Shift Services building in Williston. Four holes were drilled inside the building. The good news-each hole hit solid coal.

4. A drill hole that has been cased. The cased holes are counter sunk and marked with pink top stake chasers until it is time to pump grout into them.
5. The drilling contractor, Agapito, removing a core barrel from the drill hole. We do confirmation drilling and coring to see where the grout flowed.

6. A 3.75 foot core of grout. The grout in this core was pumped in 2018.
7. The drillers used a piece of plywood to catch drill cuttings. This helps keep the drilling area clean.

8. Agapito's drill rig set up inside the Shift Services building.

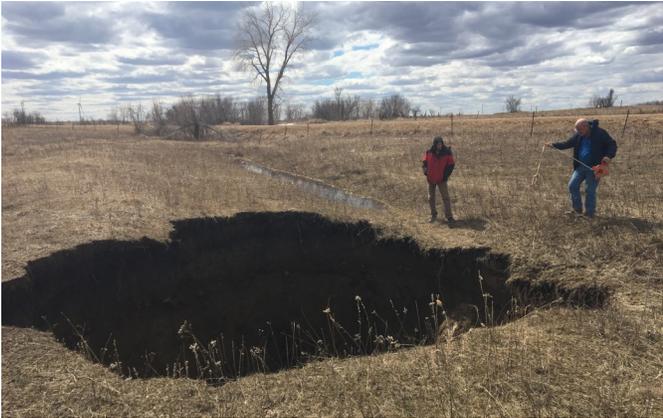
If you live or work near an abandoned underground coal mine, please use caution. The ground can give way without warning. In this photo, the sinkhole is 25 feet in diameter and over 20 feet deep. It was also close to a country road. According to the rancher, one day it was a depression filled with water. The next day the water was gone and a very large hole was left.
