## 2024 Sinkhole Filling and Maintenance AML Project Summary

**Contractor Name:** Young Gun Construction, LLC

**Contract Number:** AM-901-24

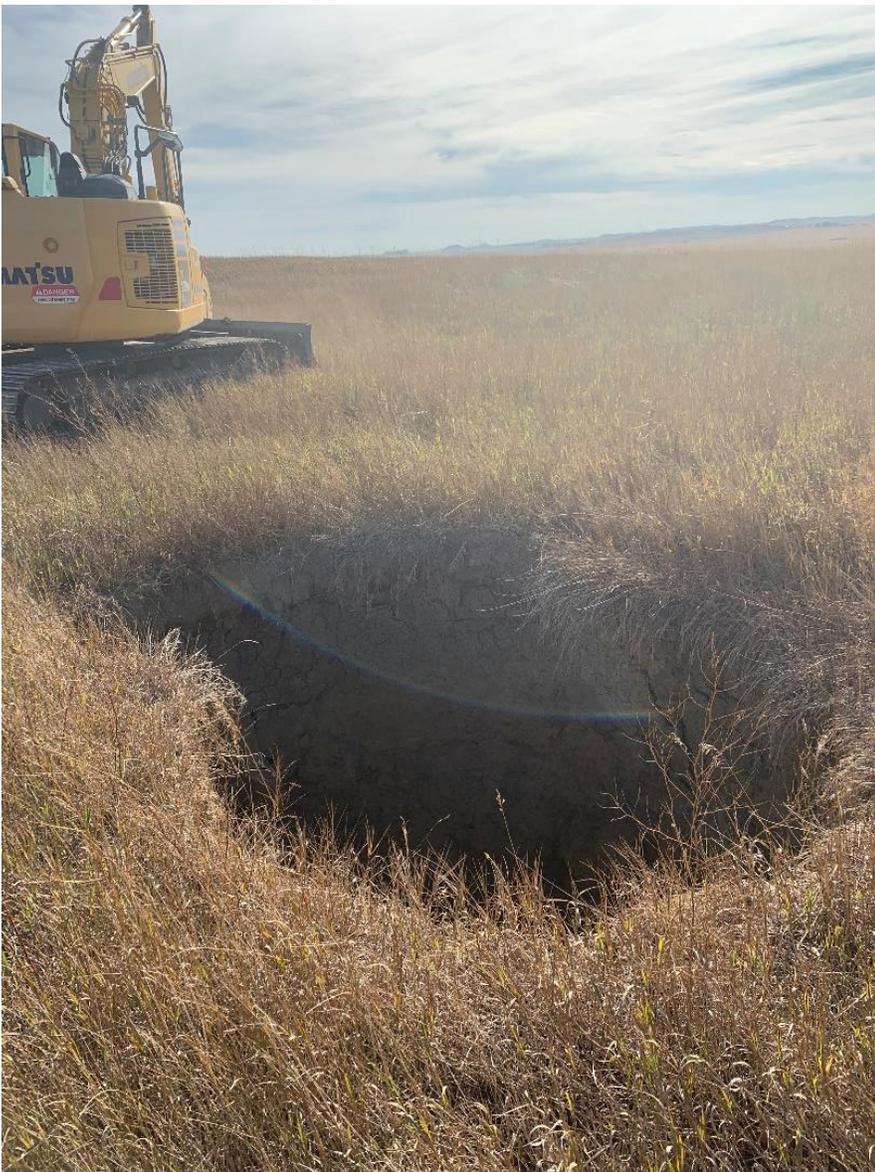
Four large sinkholes were filled between September 30 and October 1, 2024. The sinkholes were in hayland that had not been grazed or hayed. This made the sinkholes very dangerous as they were difficult to see (**Figure 1**). One sinkhole was over 20 feet deep. Once all the sinkholes were filled, topsoil was respread, and the areas were seeded with a native pasture seed mixture.

**Figure 1:** Tall, thick grass made this sinkhole very difficult to see.

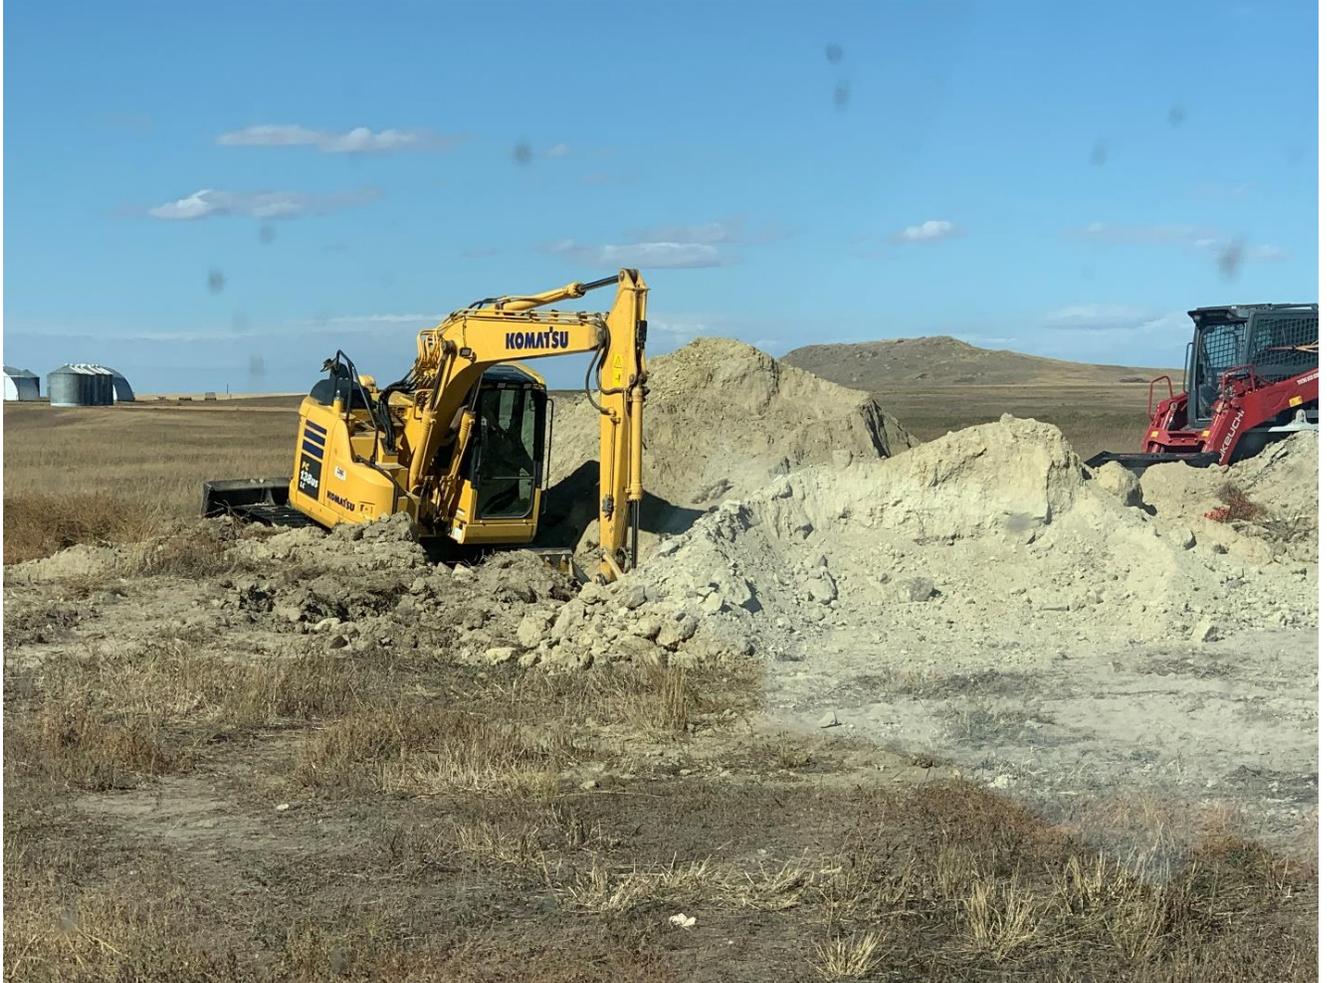
Twelve sinkholes were filled on two AML sites near Scranton between October 2-3, 2024. A few of the sinkholes were much larger than anticipated. Underground mine tunnels often collapse in a diagonal direction that cannot be seen until the excavation begins (**Figure 2**). Once all the sinkholes were filled, topsoil was respread, and the areas were seeded with a native pasture seed mixture.

**Figure 2:** When the excavator opened up this sinkhole, the mine void was more than twice as large as expected.

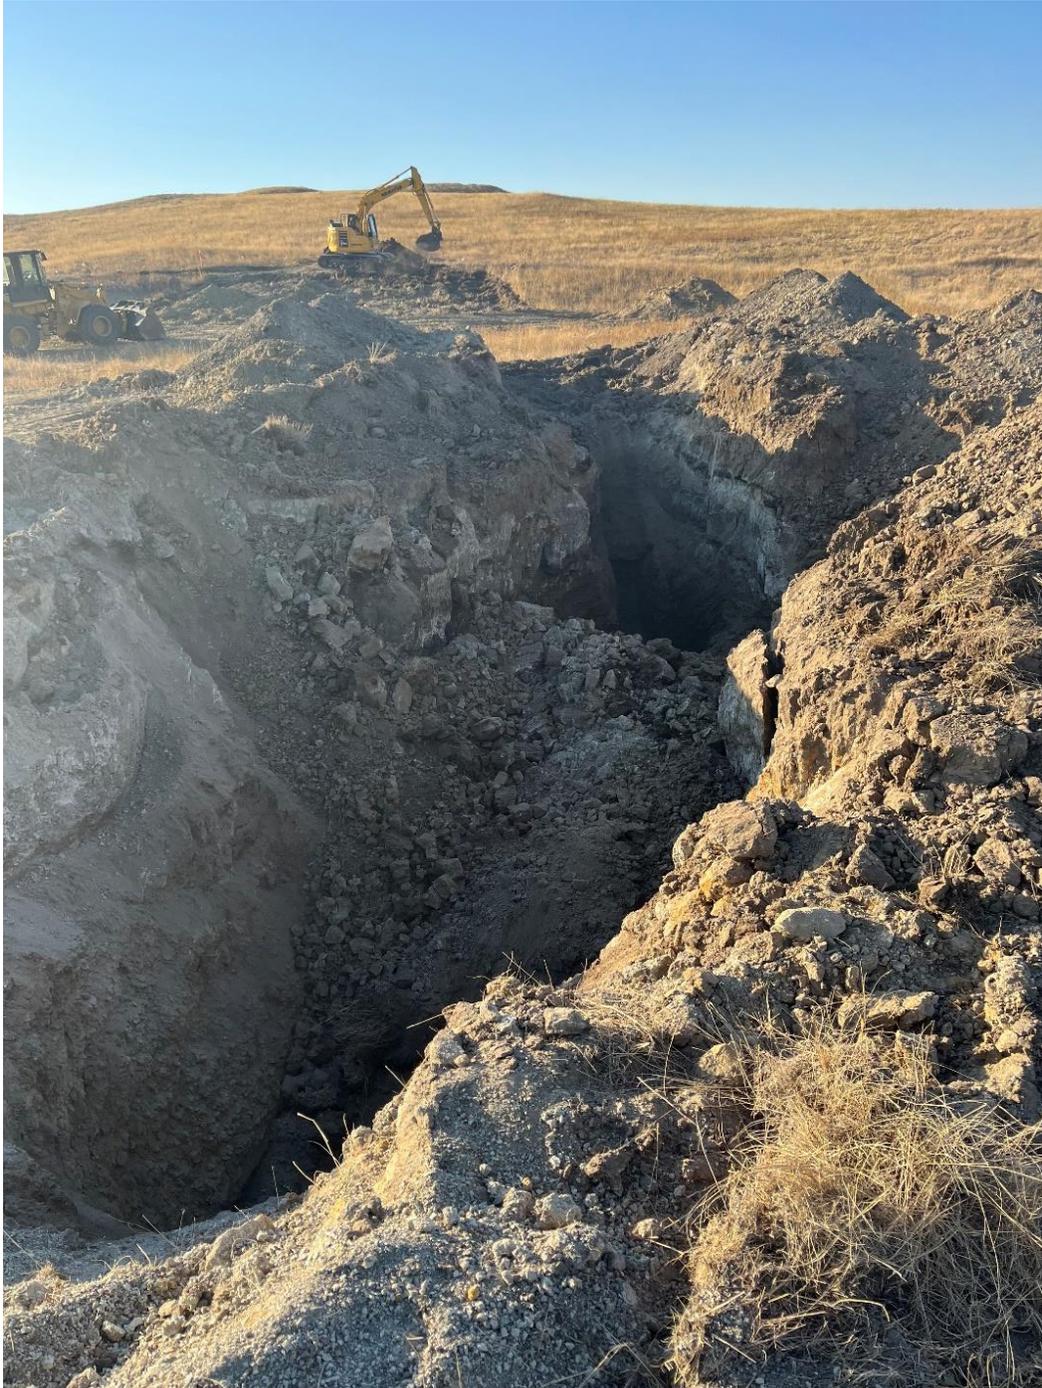
This AML site is located on state school land managed by the Department of Trust Lands. Nine large sinkholes were filled between October 3-4, 2024. Four sinkholes were over 10 feet deep, and a few tunneled extensively underneath the ground's surface (**Figure 3**). Once all the sinkholes were filled, topsoil was respread, and the areas were seeded with a native pasture seed mixture (**Figure 4**).

**Figure 3:** This mine void tunneled extensively underneath the ground's surface.

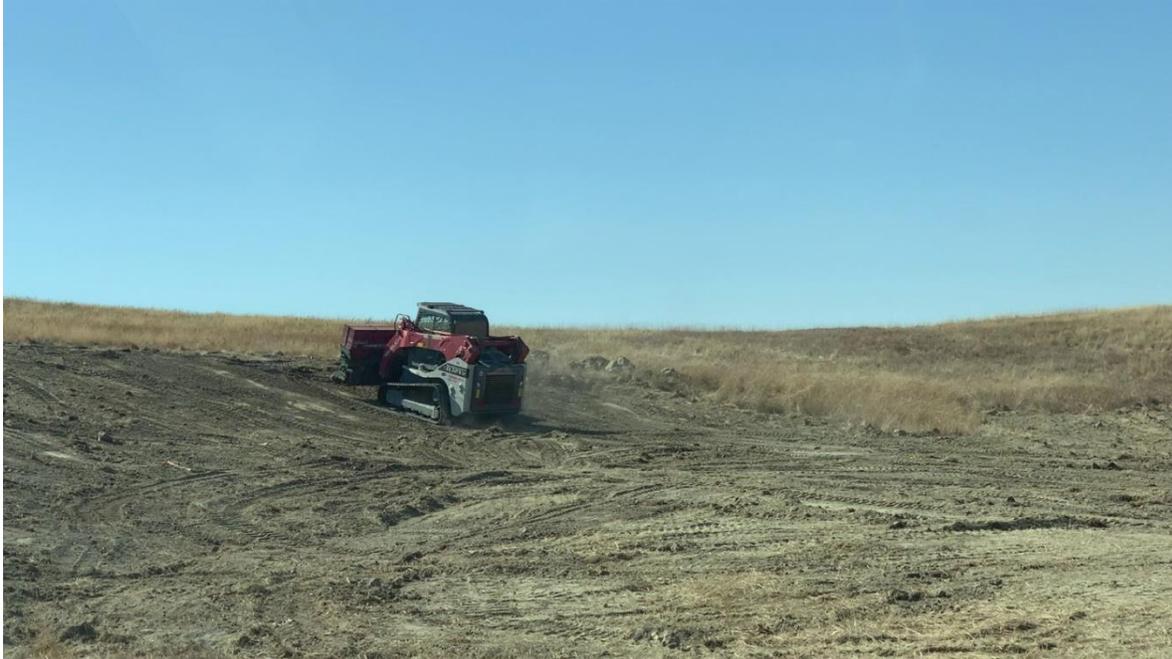
**Figure 4:** A skid steer with a till attachment was used to till the reclaimed sinkhole areas.

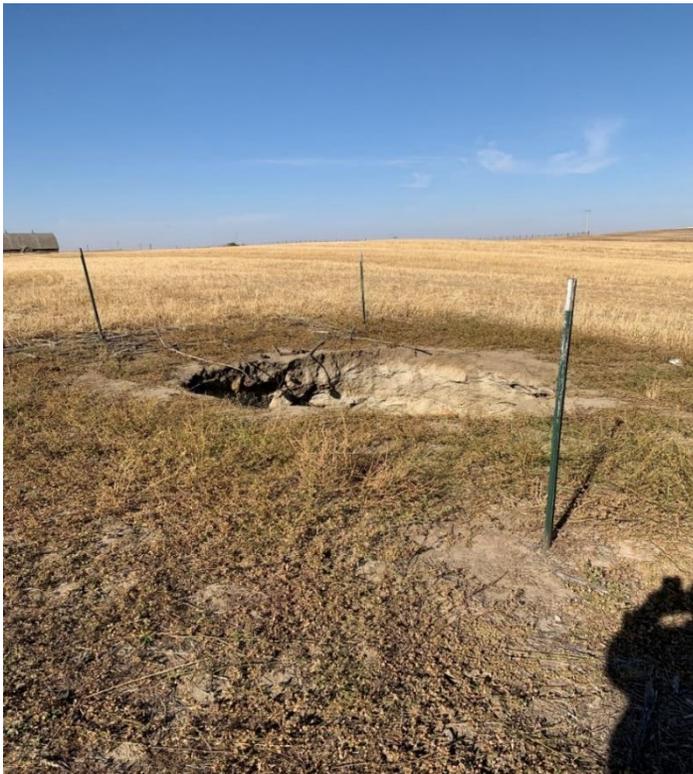
One large sinkhole was filled on this site between October 14-16, 2024. The sinkhole was over 15 feet deep and on the border of cropland (**Figure 5**). All landowners provide us with on-site soil, also called borrow areas, so we can cost-effectively fill sinkholes (**Figure 6**). Once this sinkhole was filled, topsoil was respread and the borrow area was seeded with winter wheat seed provided by the landowner.

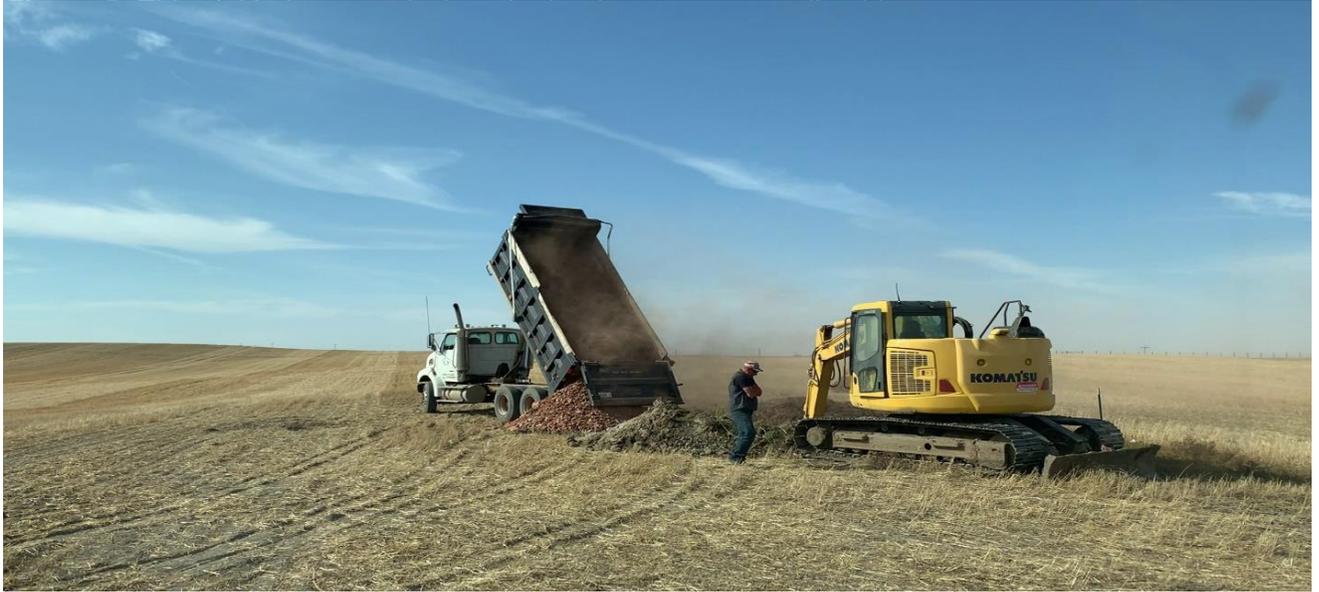
**Figure 6:** This sinkhole is being filled with scoria and soil from a nearby borrow location provided by the landowner.

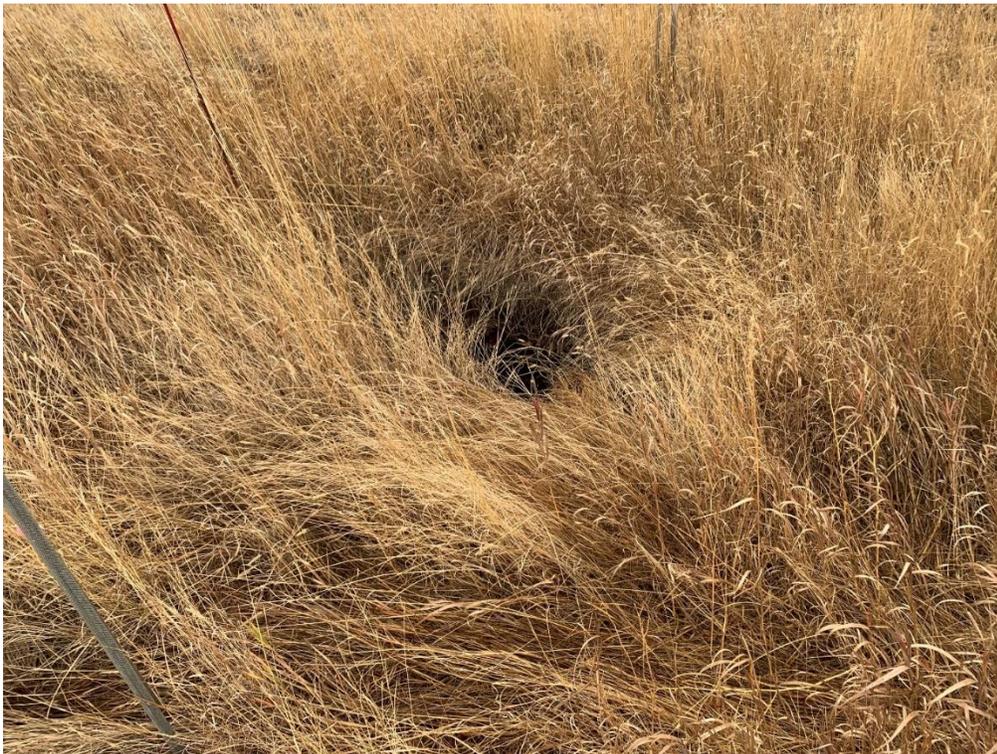
Twenty-five sinkholes were filled on three separate AML sites between October 16-24, 2024. Numerous sinkholes were over 10 feet deep, and many had small surface openings which made them difficult to see (**Figures 7 and 8**). Once all the sinkholes were filled, topsoil was respread, and the areas were seeded with a native pasture seed mixture.

**Figure 7:** Some sinkholes are very hard to see, making them extremely dangerous. A child or pet could have easily fallen into this hole.

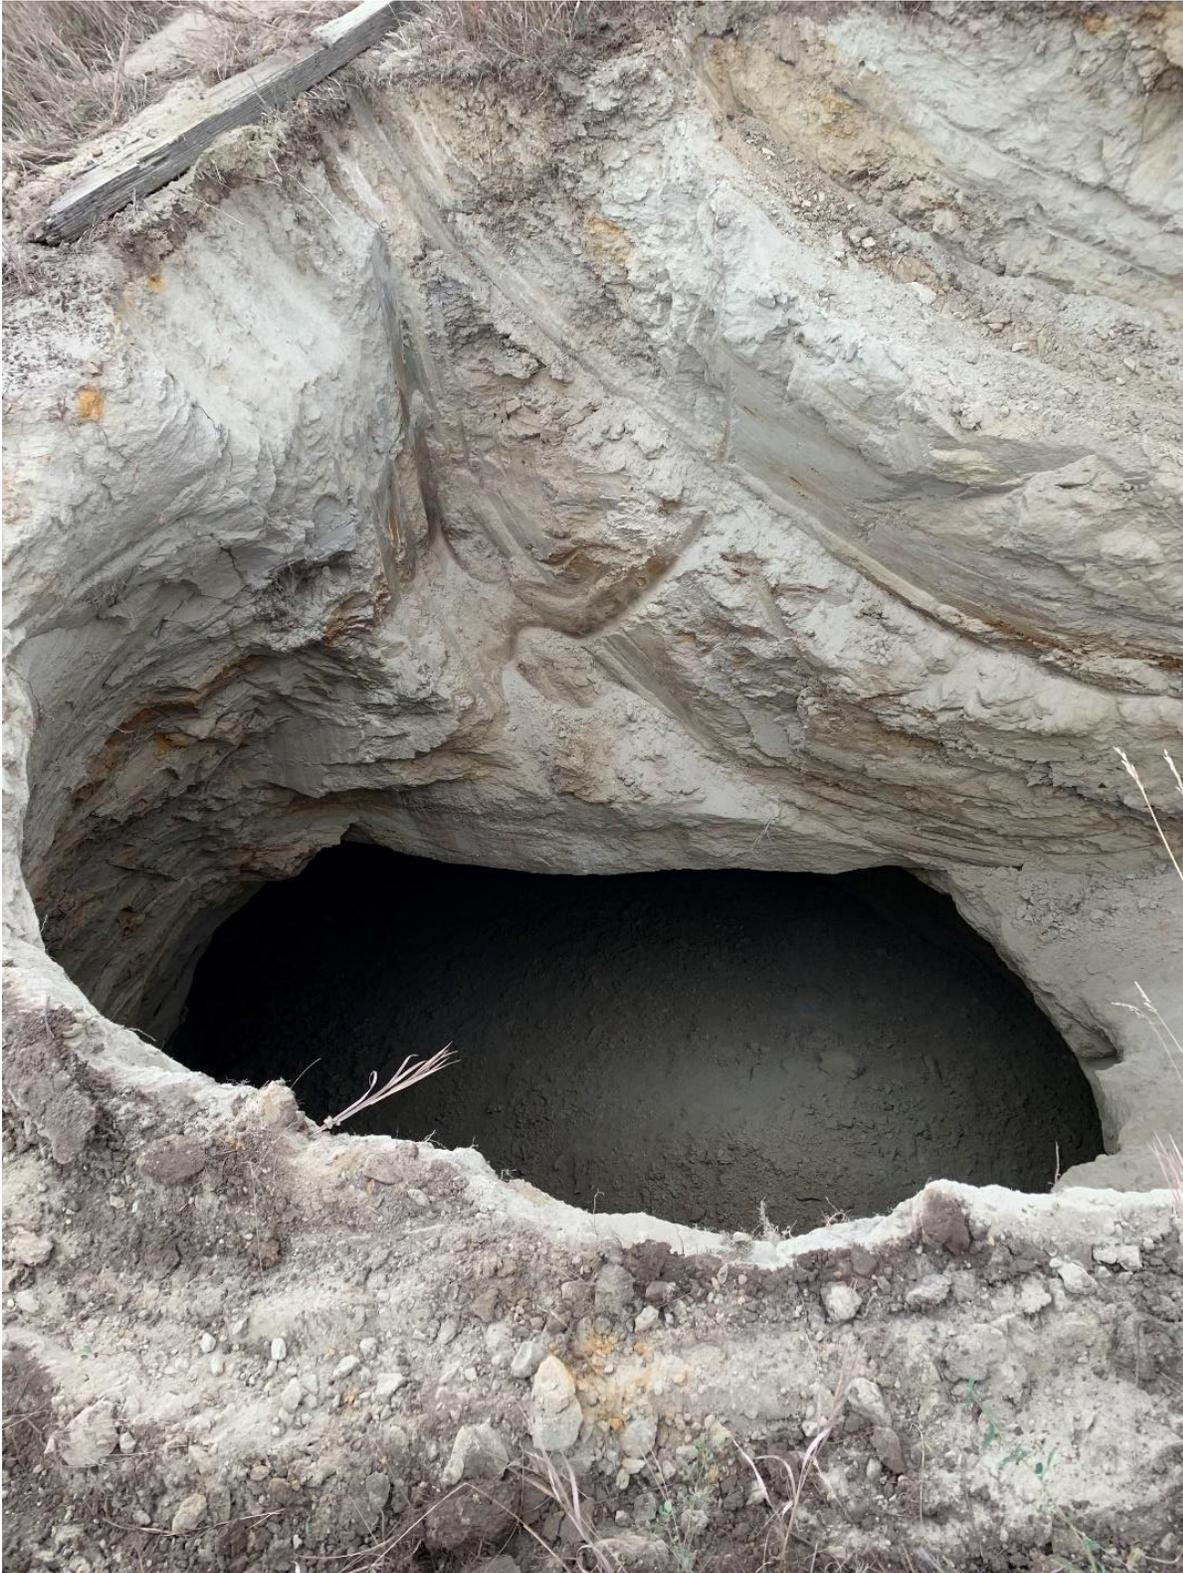
**Figure 8:** The same sinkhole was approximately 10 feet wide and measured 27 feet deep after the contractor removed the topsoil and subsoil.

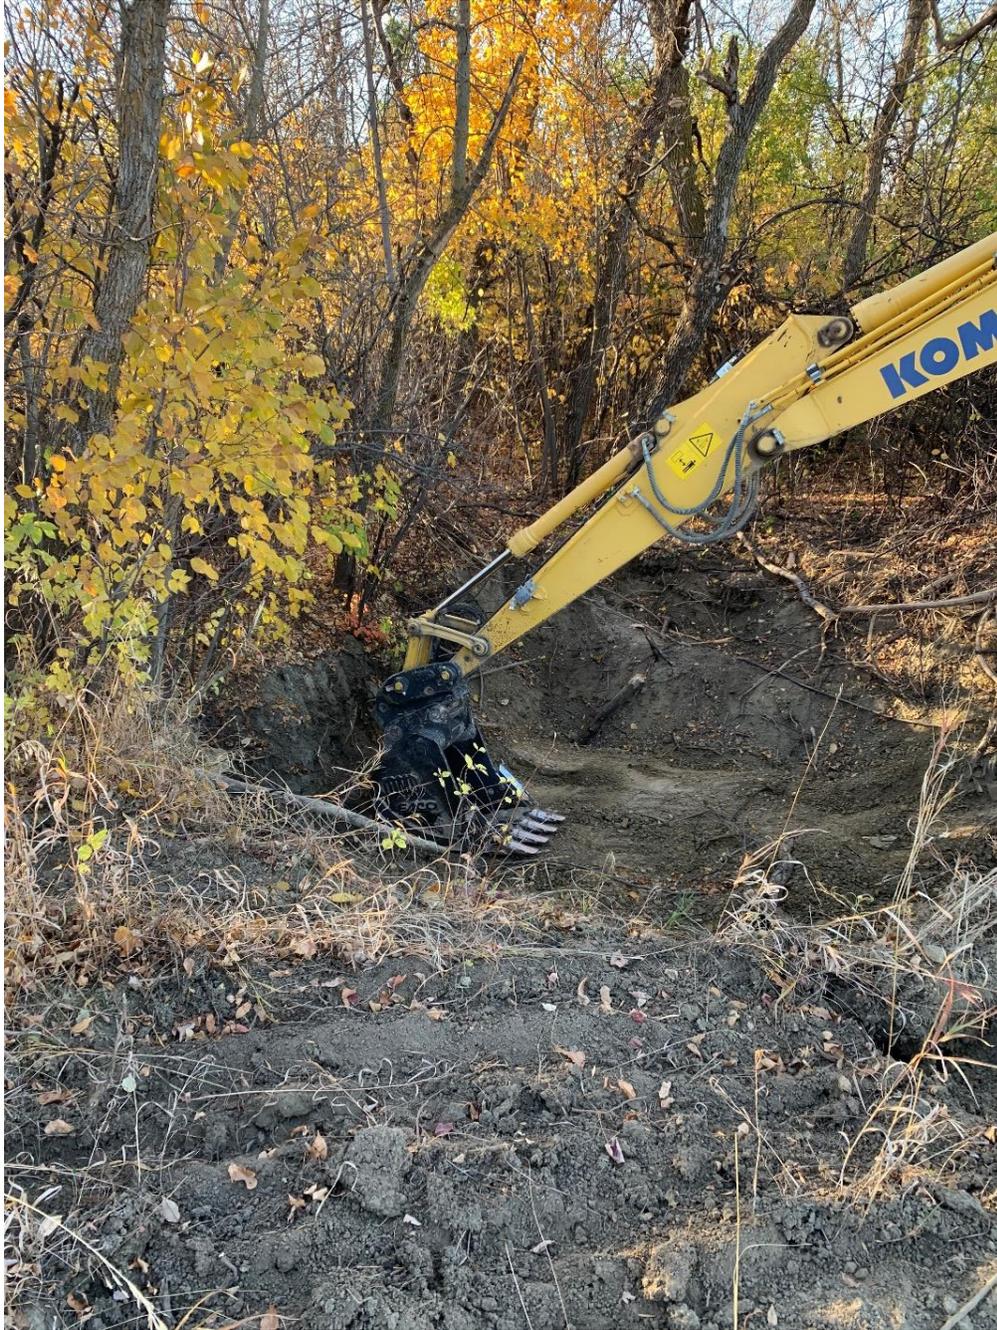
Five sinkholes were filled near Richardton between October 23-25, 2024. One of the sinkholes was over 10 feet deep. Contractors are required to compact sinkholes between truck loads (**Figure 9**). Once all the sinkholes were filled, topsoil was respread, and the areas were seeded with a native pasture seed mix.

**Figure 9:** This sinkhole is being compacted and graded with an excavator.

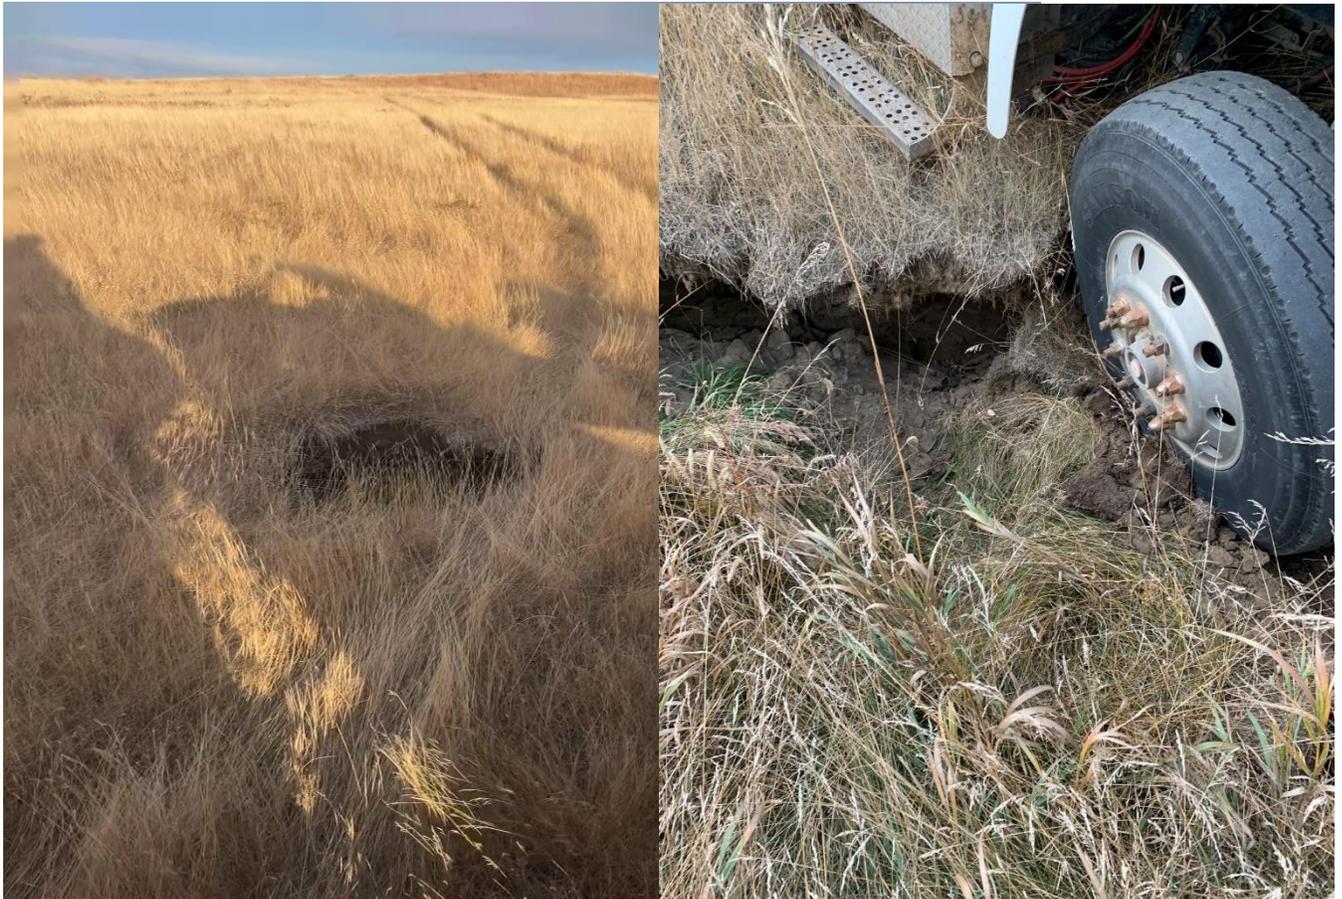
Forty-six large sinkholes were filled on three AML sites between October 25 and November 8, 2024. The thickest mined coal seam in the Beulah area ranges between 15-24 feet. This has resulted in some of the deepest sinkholes documented in North Dakota. Several of the sinkholes filled were over 15 feet deep. New sinkholes generally appear after heavy precipitation events or spring snow melts. However, heavy equipment can also cause mine voids to migrate to the surface (**Figures 10 and 11**). Once all the sinkholes were filled, topsoil was respread, and the areas were seeded with a native pasture seed mixture.

**Figures 10 and 11:** Heavy equipment caused two mine voids to migrate to the surface in the form of sinkholes.

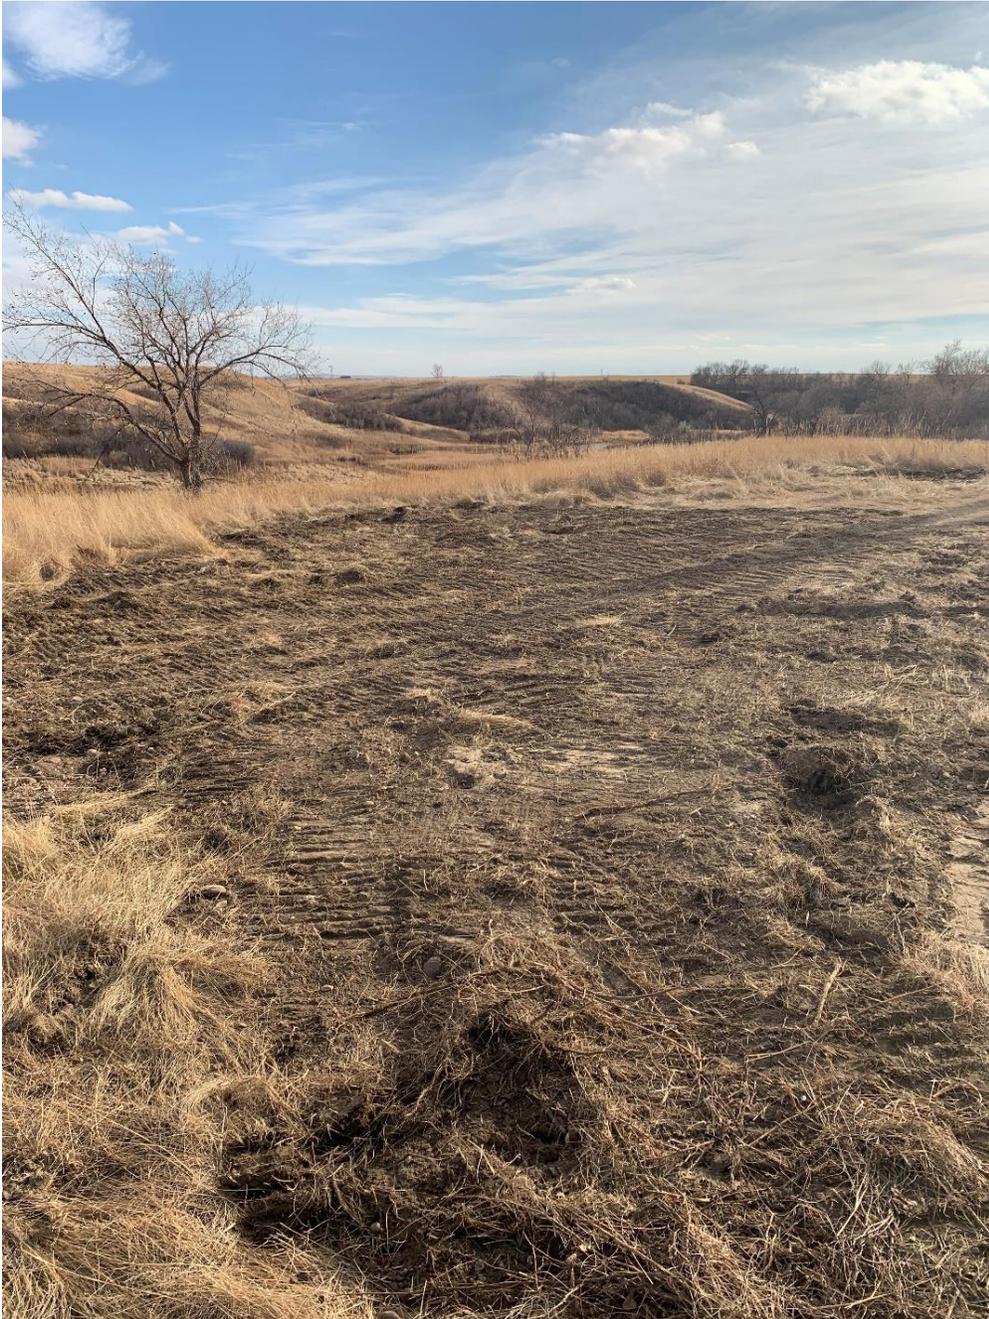
Thirty large sinkholes were filled on two AML sites between November 8<sup>th</sup> and November 13<sup>th</sup>, 2024. Several of the sinkholes were over 10 feet deep. Once all the sinkholes were filled, topsoil was respread (**Figure 12**), and the area was seeded with a native pasture seed mixture.

**Figure 12:** Reclaimed sinkhole before tilling and seeding.

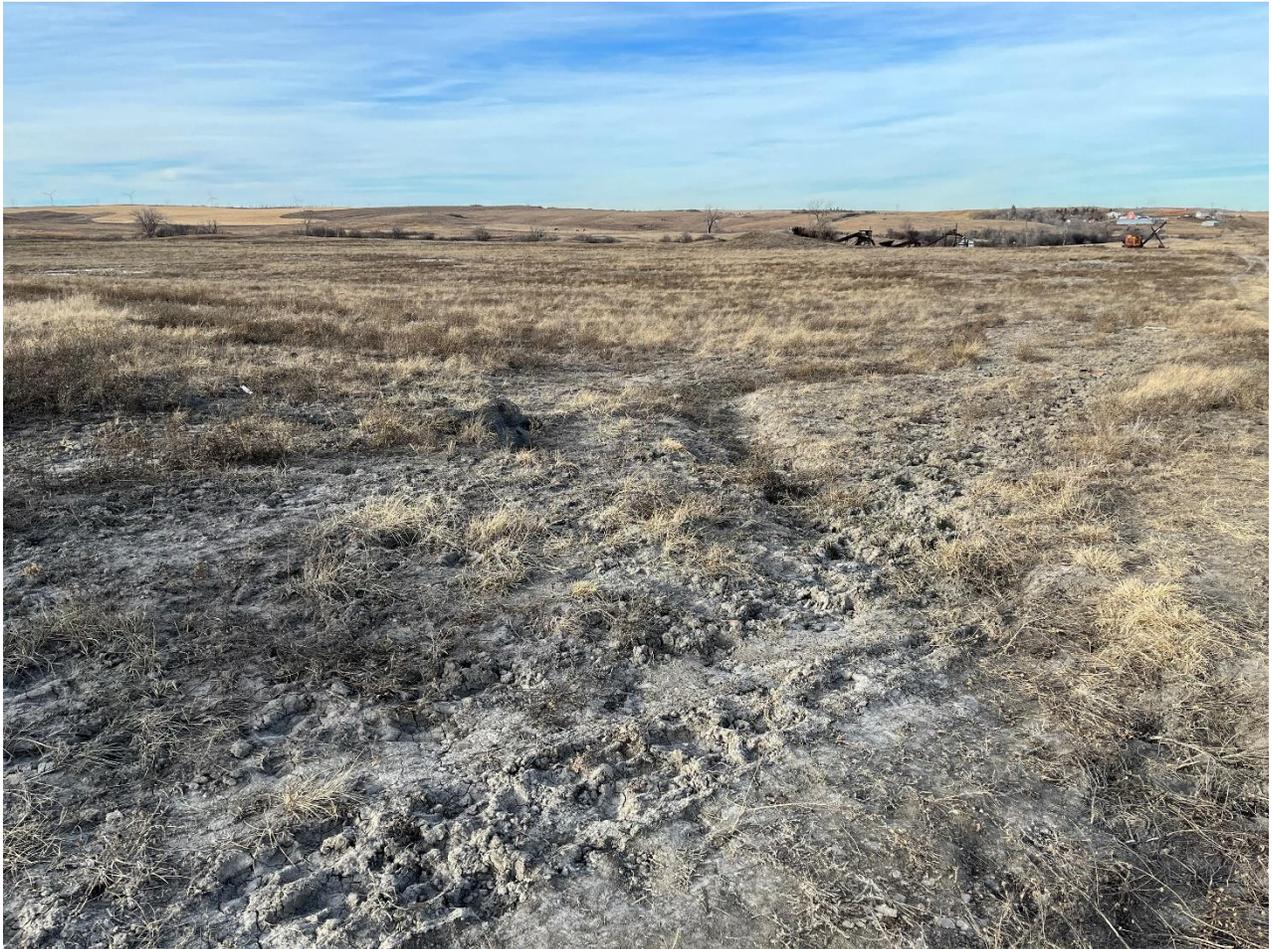
This 16.5-acre surface mine site was reclaimed in 2018 under the Morton County Phase 2 Project. Limited on-site topsoil and low precipitation resulted in sparse vegetation (**Figure 13**). Eventually, some erosional rills formed. Construction began with the grading of several erosion features on September 16. Soil amendments consisting of leonardite, gypsum, a soil microbial product, and fertilizer were spread across the site and mixed into the existing topsoil with a heavy harrow. The site was then re-seeded with a native pasture seed mix and mulched (**Figure 14**). Construction was completed on September 20, 2024.

**Figure 13:** *This area had sparse vegetation and an erosion rill before construction.*

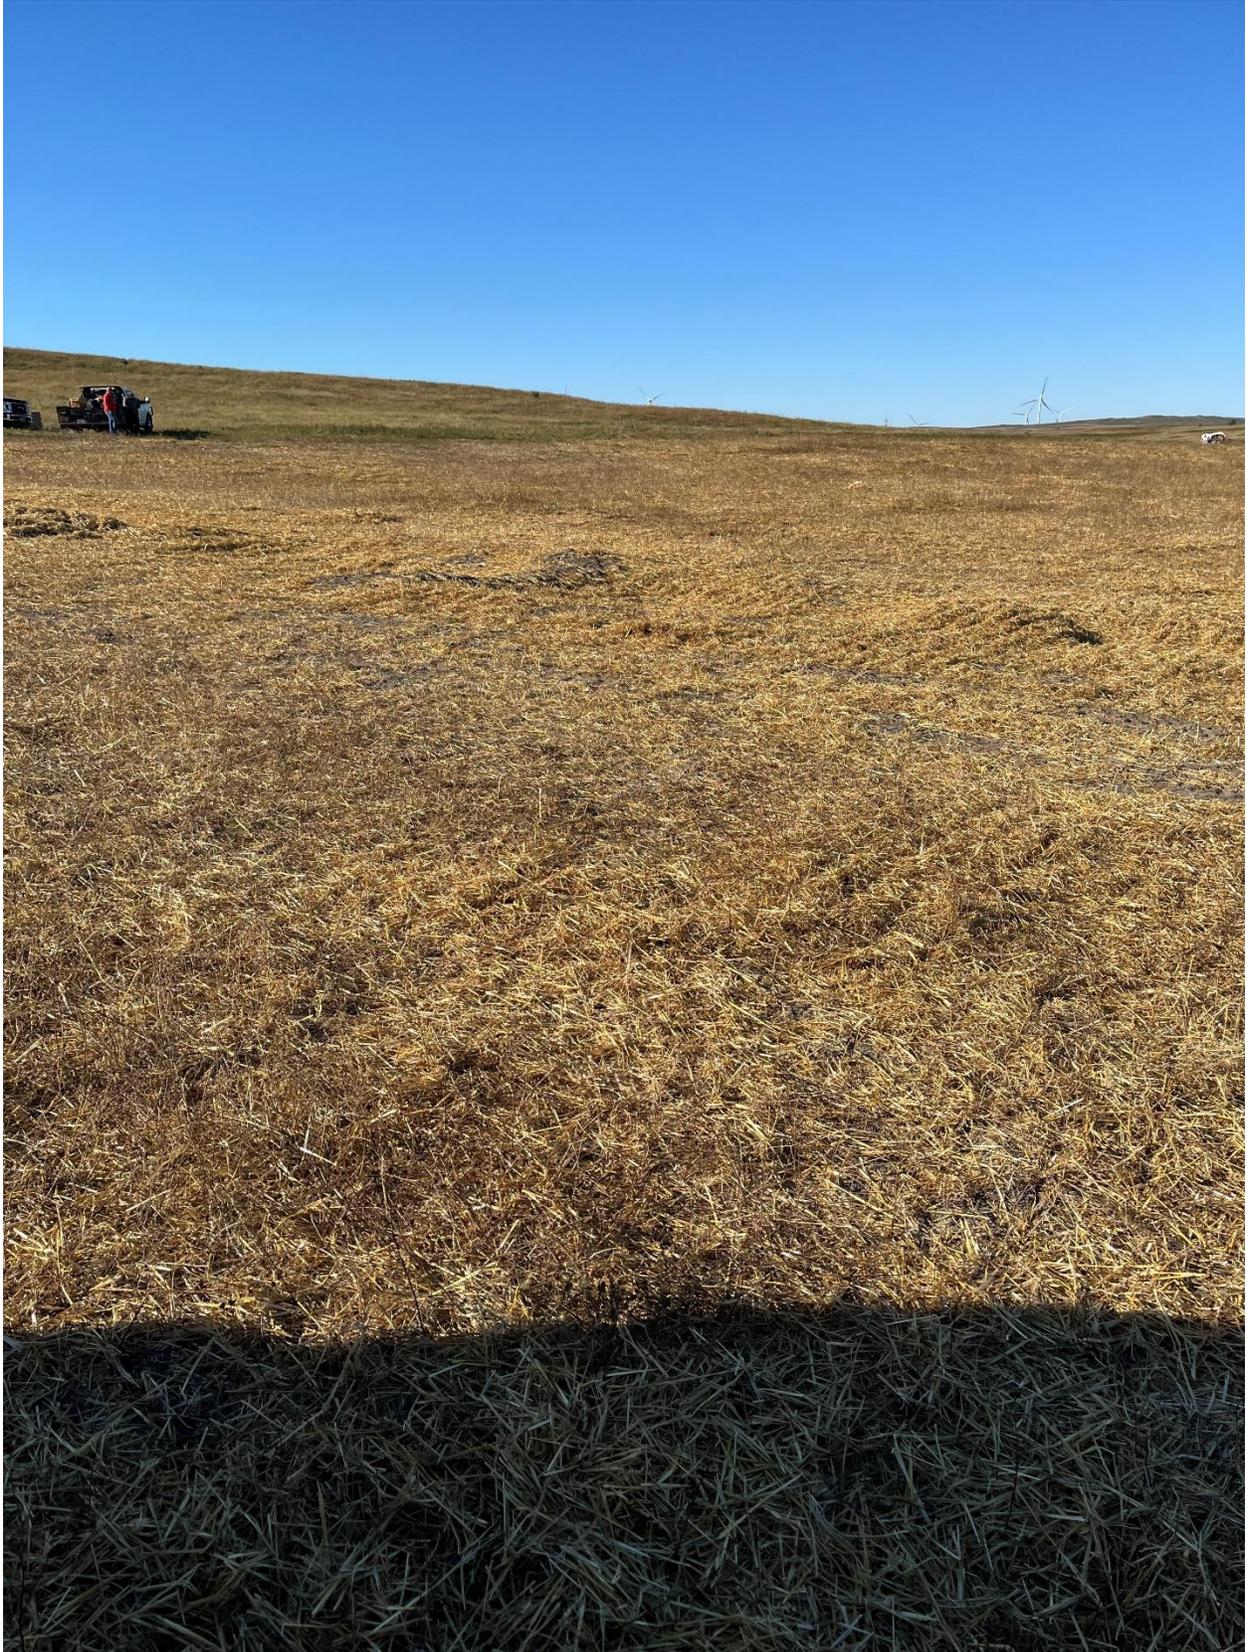
**Figure 14:** Erosion features were graded, and straw mulch was crimped to prevent further erosion.
