673 PU-06-421 Filed: 8/1/2009 Pages: 6
Keystone Independent North Spread Report for July 28, 2009

DAILY REPORT

Job Site: North Spread.

Date: 7.28.2009

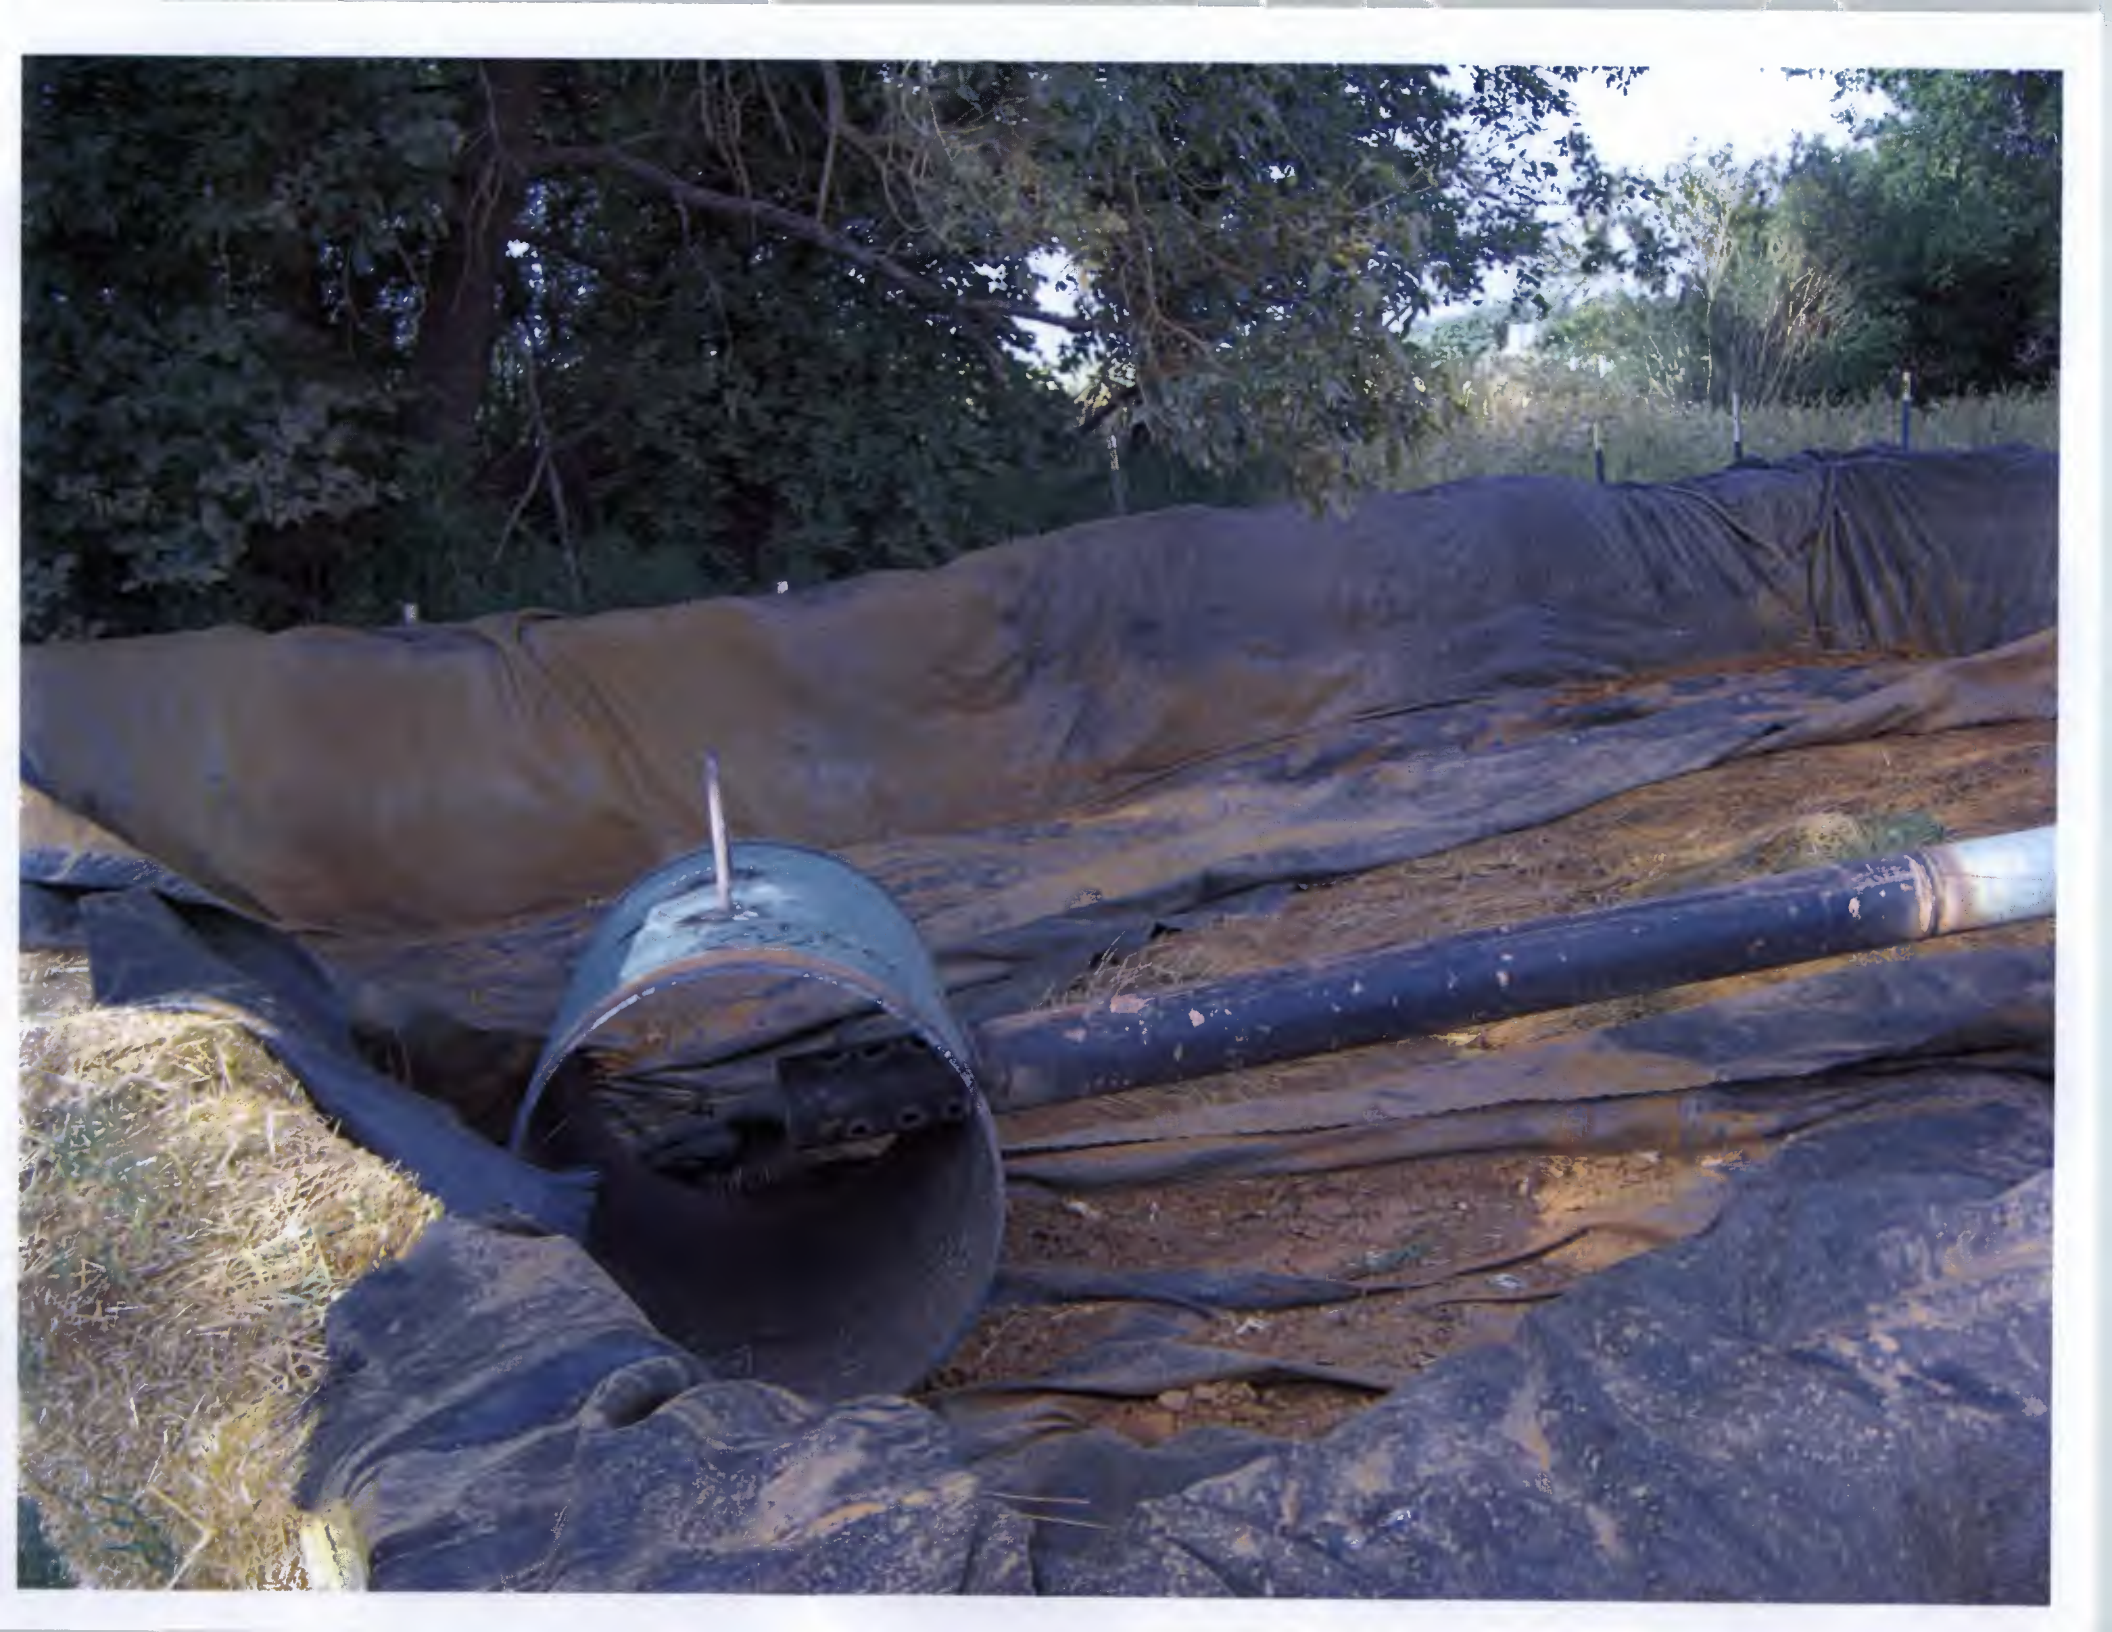
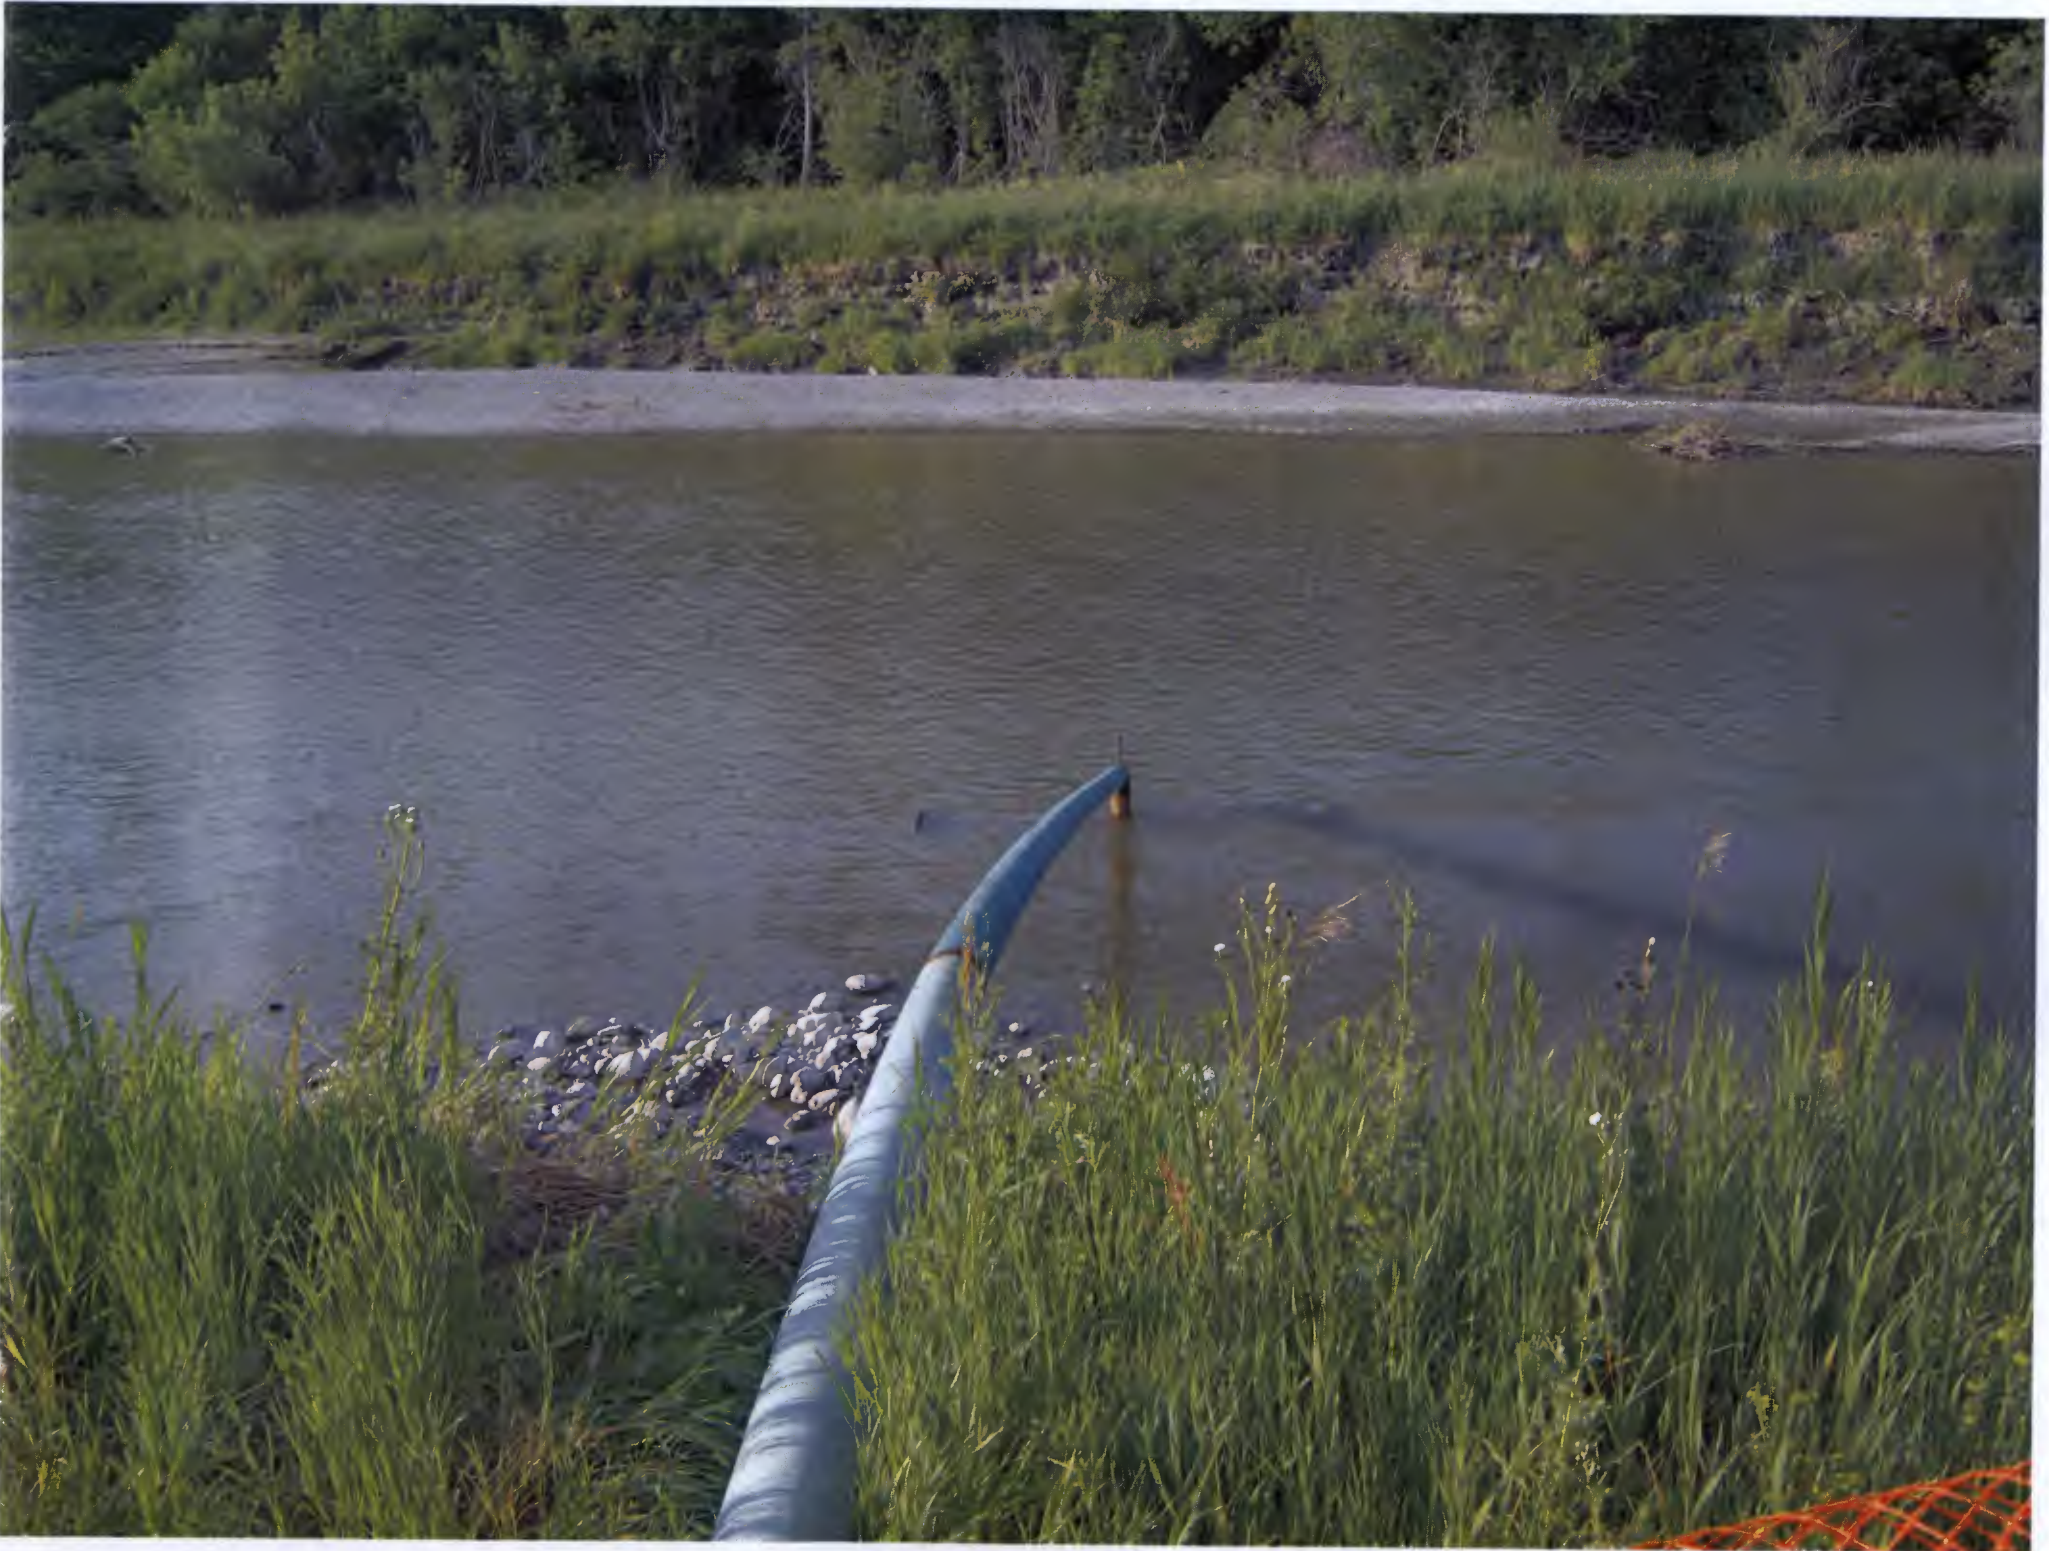
Attached please find our report for the North Spread on 7-28-09. Also attached are two photos of the dissipaters that are being used on the outlet end of the contractors pumping activities.

MP 1 - Contractor was pressure testing and cleaning
scale from the pipeline from the Canadian border,
south to Mi. 7 on south side of Pembina River.
Contractor has installed & used energy dissipation devices

and sediment barriers as illustrated on Detail 6 of the Keystone Pipeline Construction mitigation & reclamation plan. I asked the contractor (Ensco constr manager Bill Laffoon) if permits & testing were in-place & being done as outlined in Section 8.0 of the construction & mitigation manual. He told me all monitoring & testing was being followed as set forth by the NDPS & Bill stated the actual samples were being sent to ND State lab for water quality testing. Mi. 2 activities I observed involved a large tractor w/ cultivator working the right-of-way area where ready in mile 2. Wooden matting remains to be picked up & hauled off-site. Some topsoiling remains to be done. Mi. 3-4 activity free. Land is well vegetated or is being farmed. A spot check of this area looks good at this point. Mile 6 I observed some topsoiling remains to be done.
