PSC CASE NUMBER: PU-06-421

DAILY REPORT

Job Site: North SPREAD

Date: Aug 6, 2009

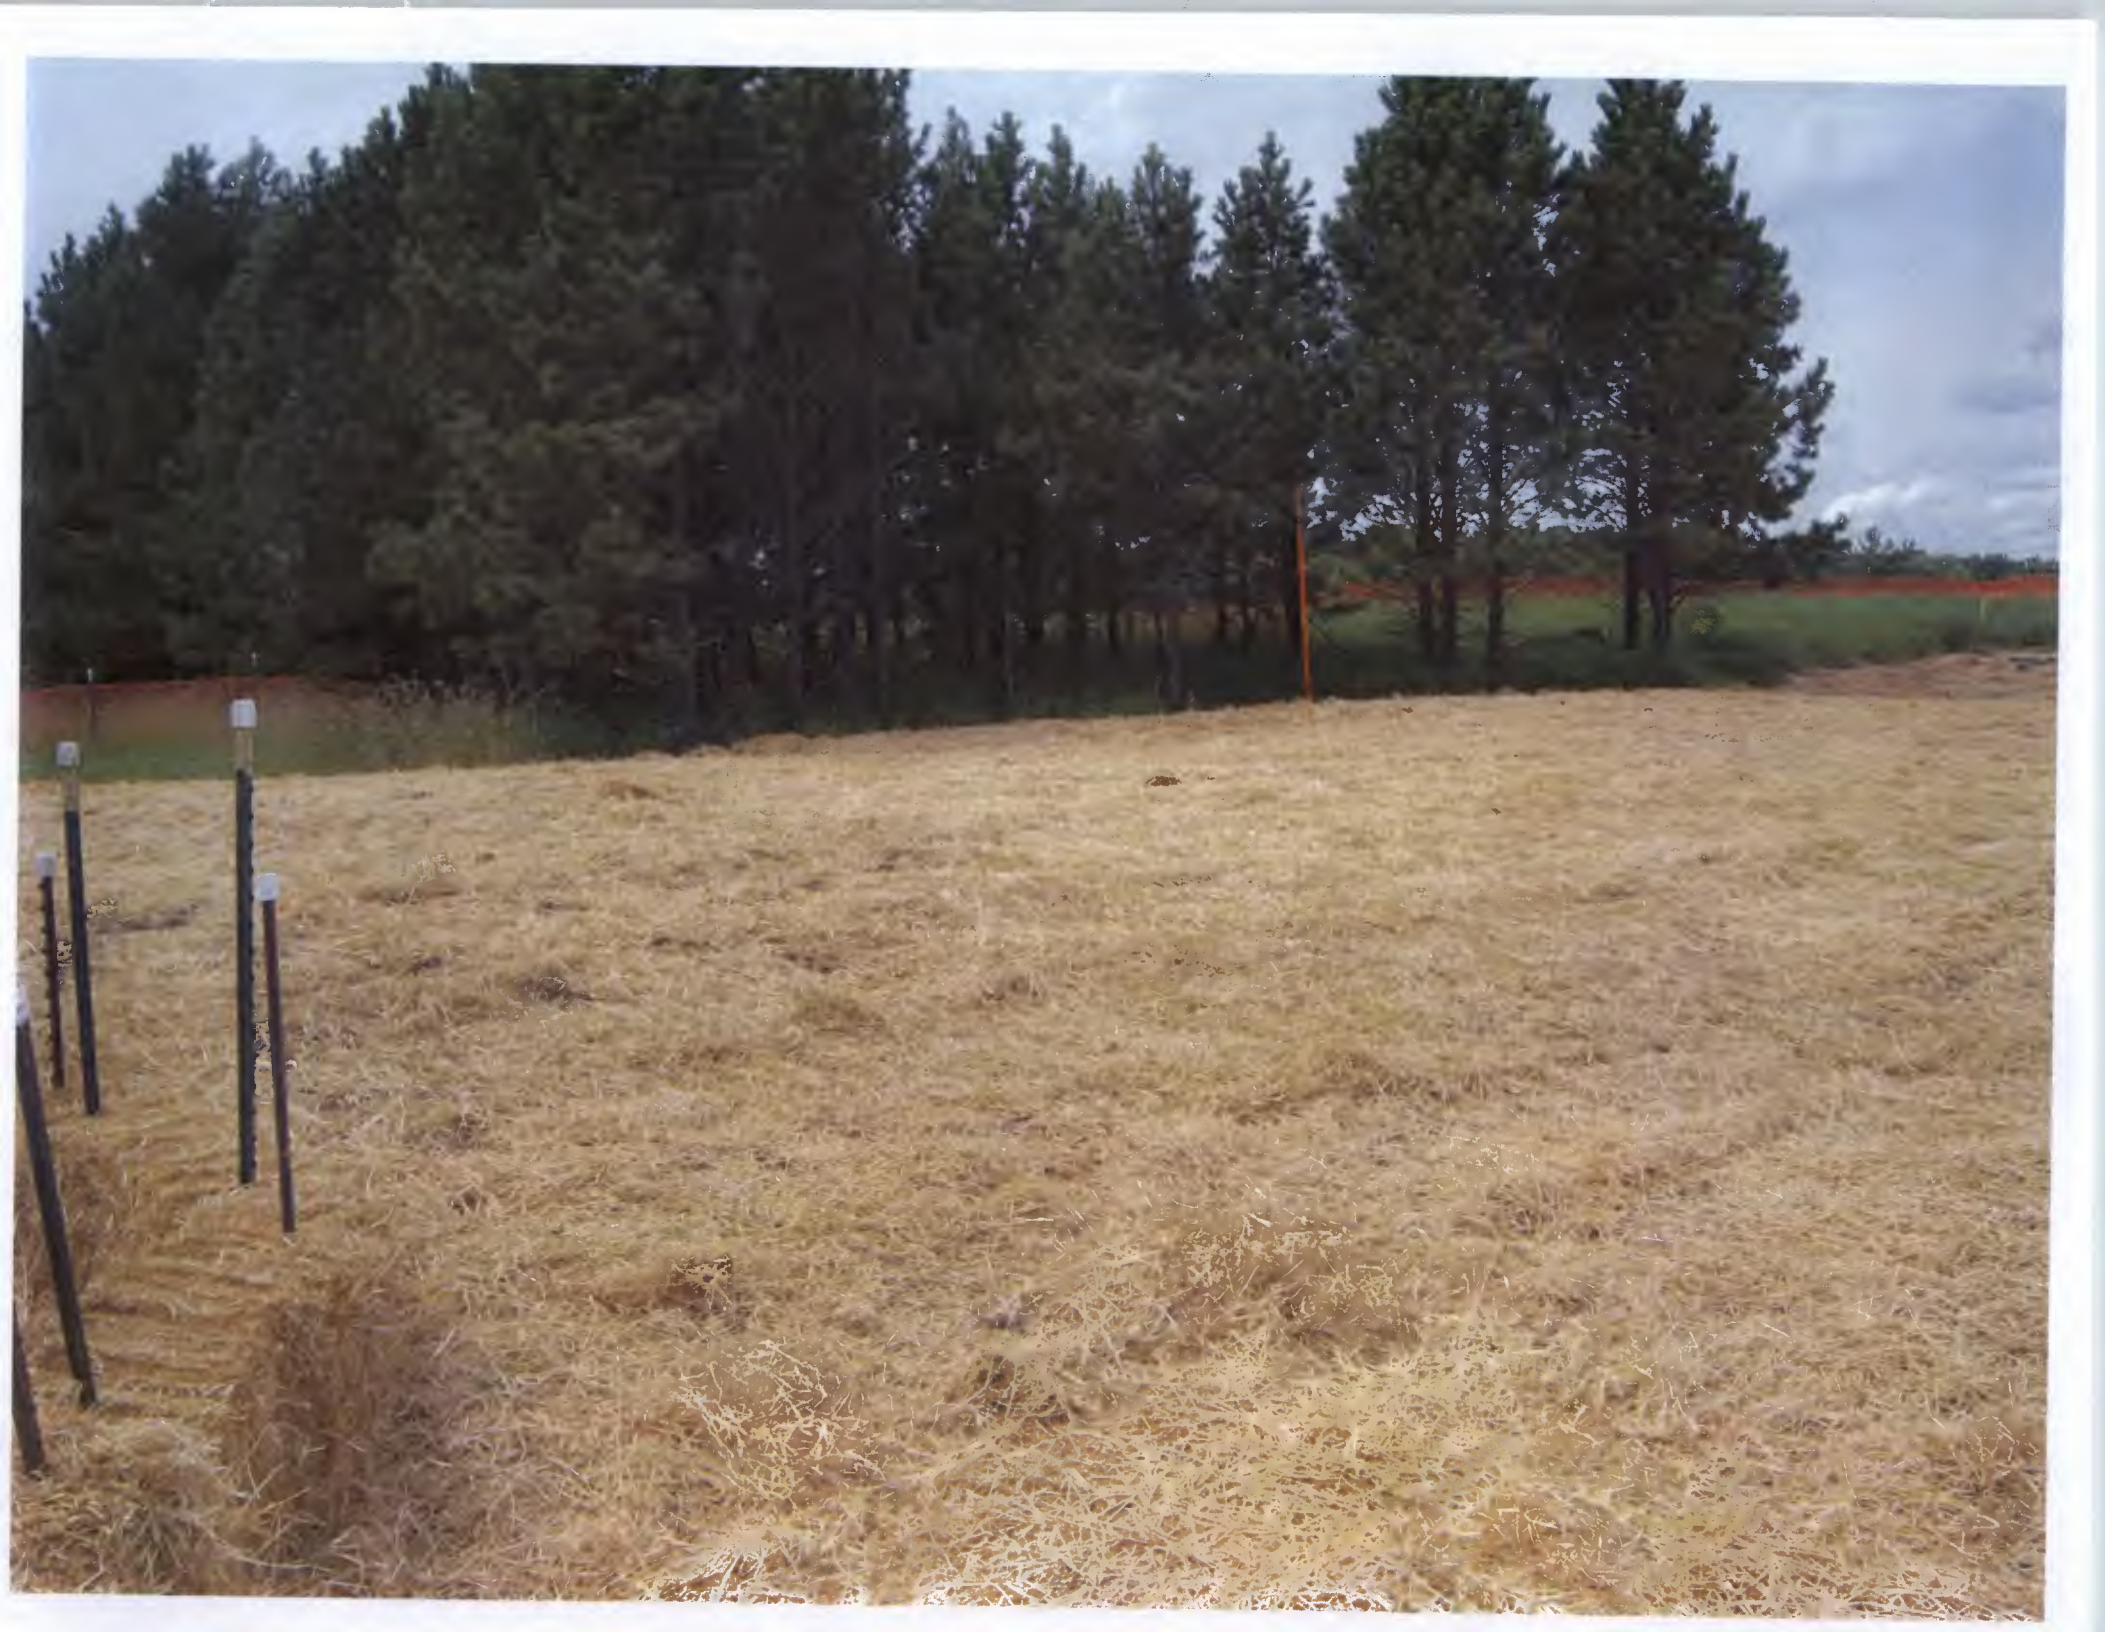
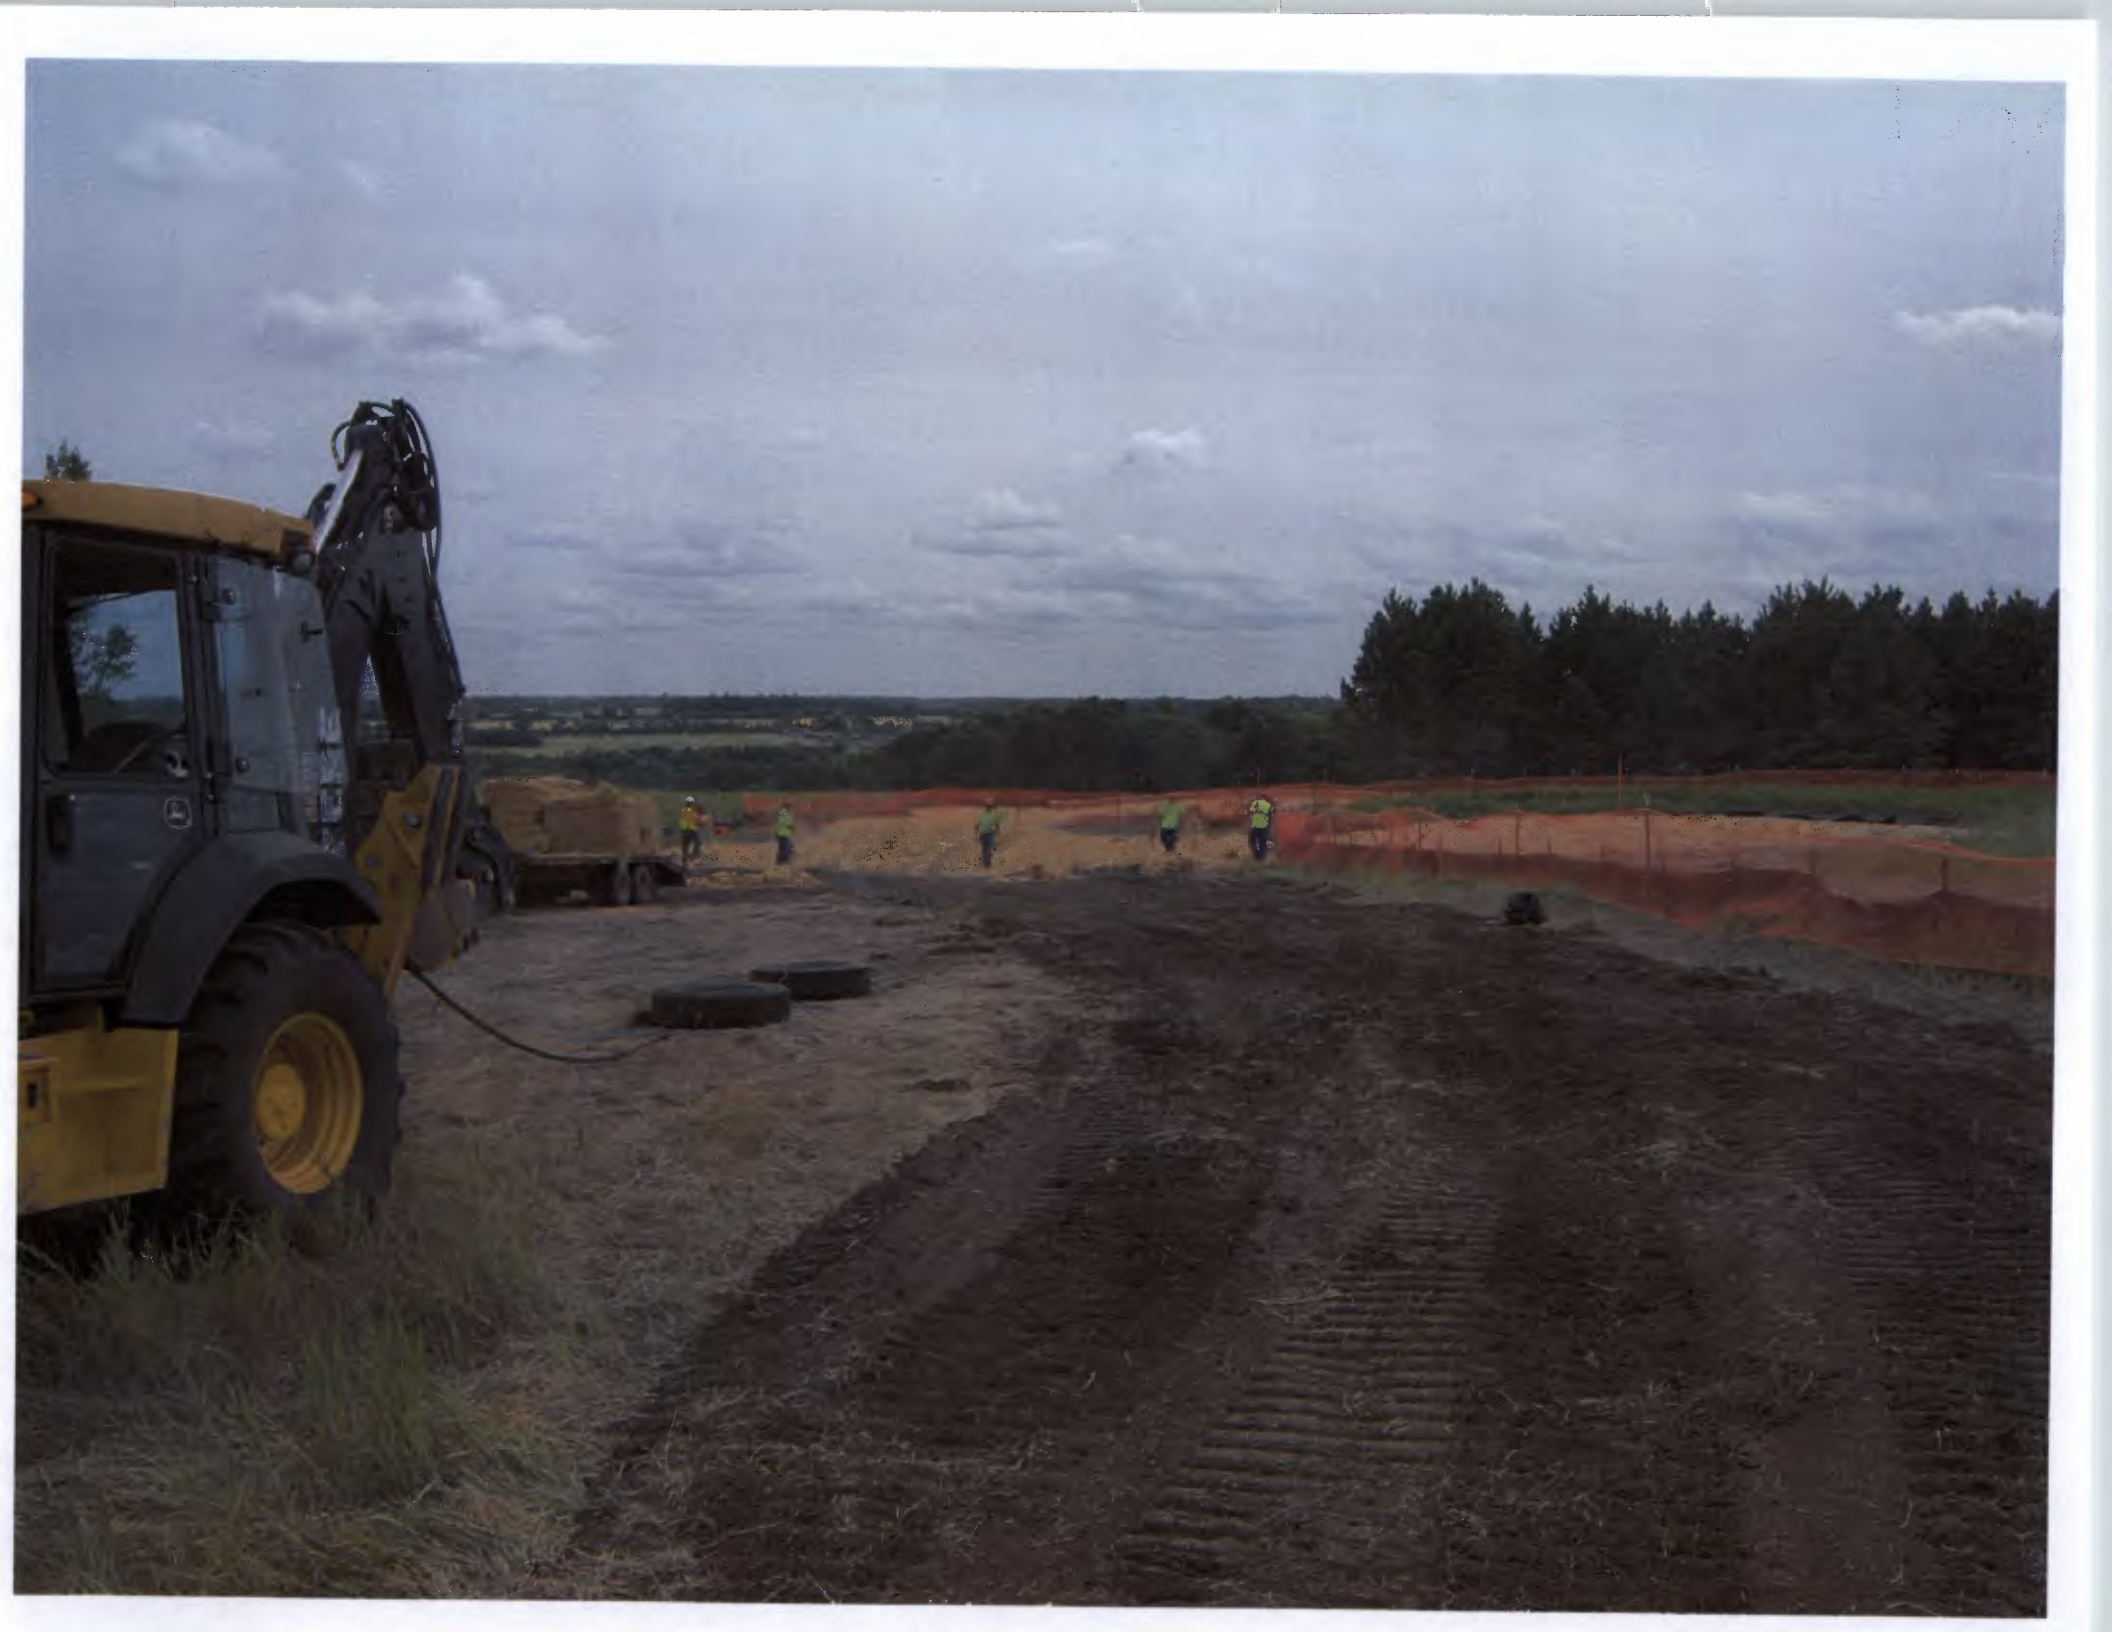
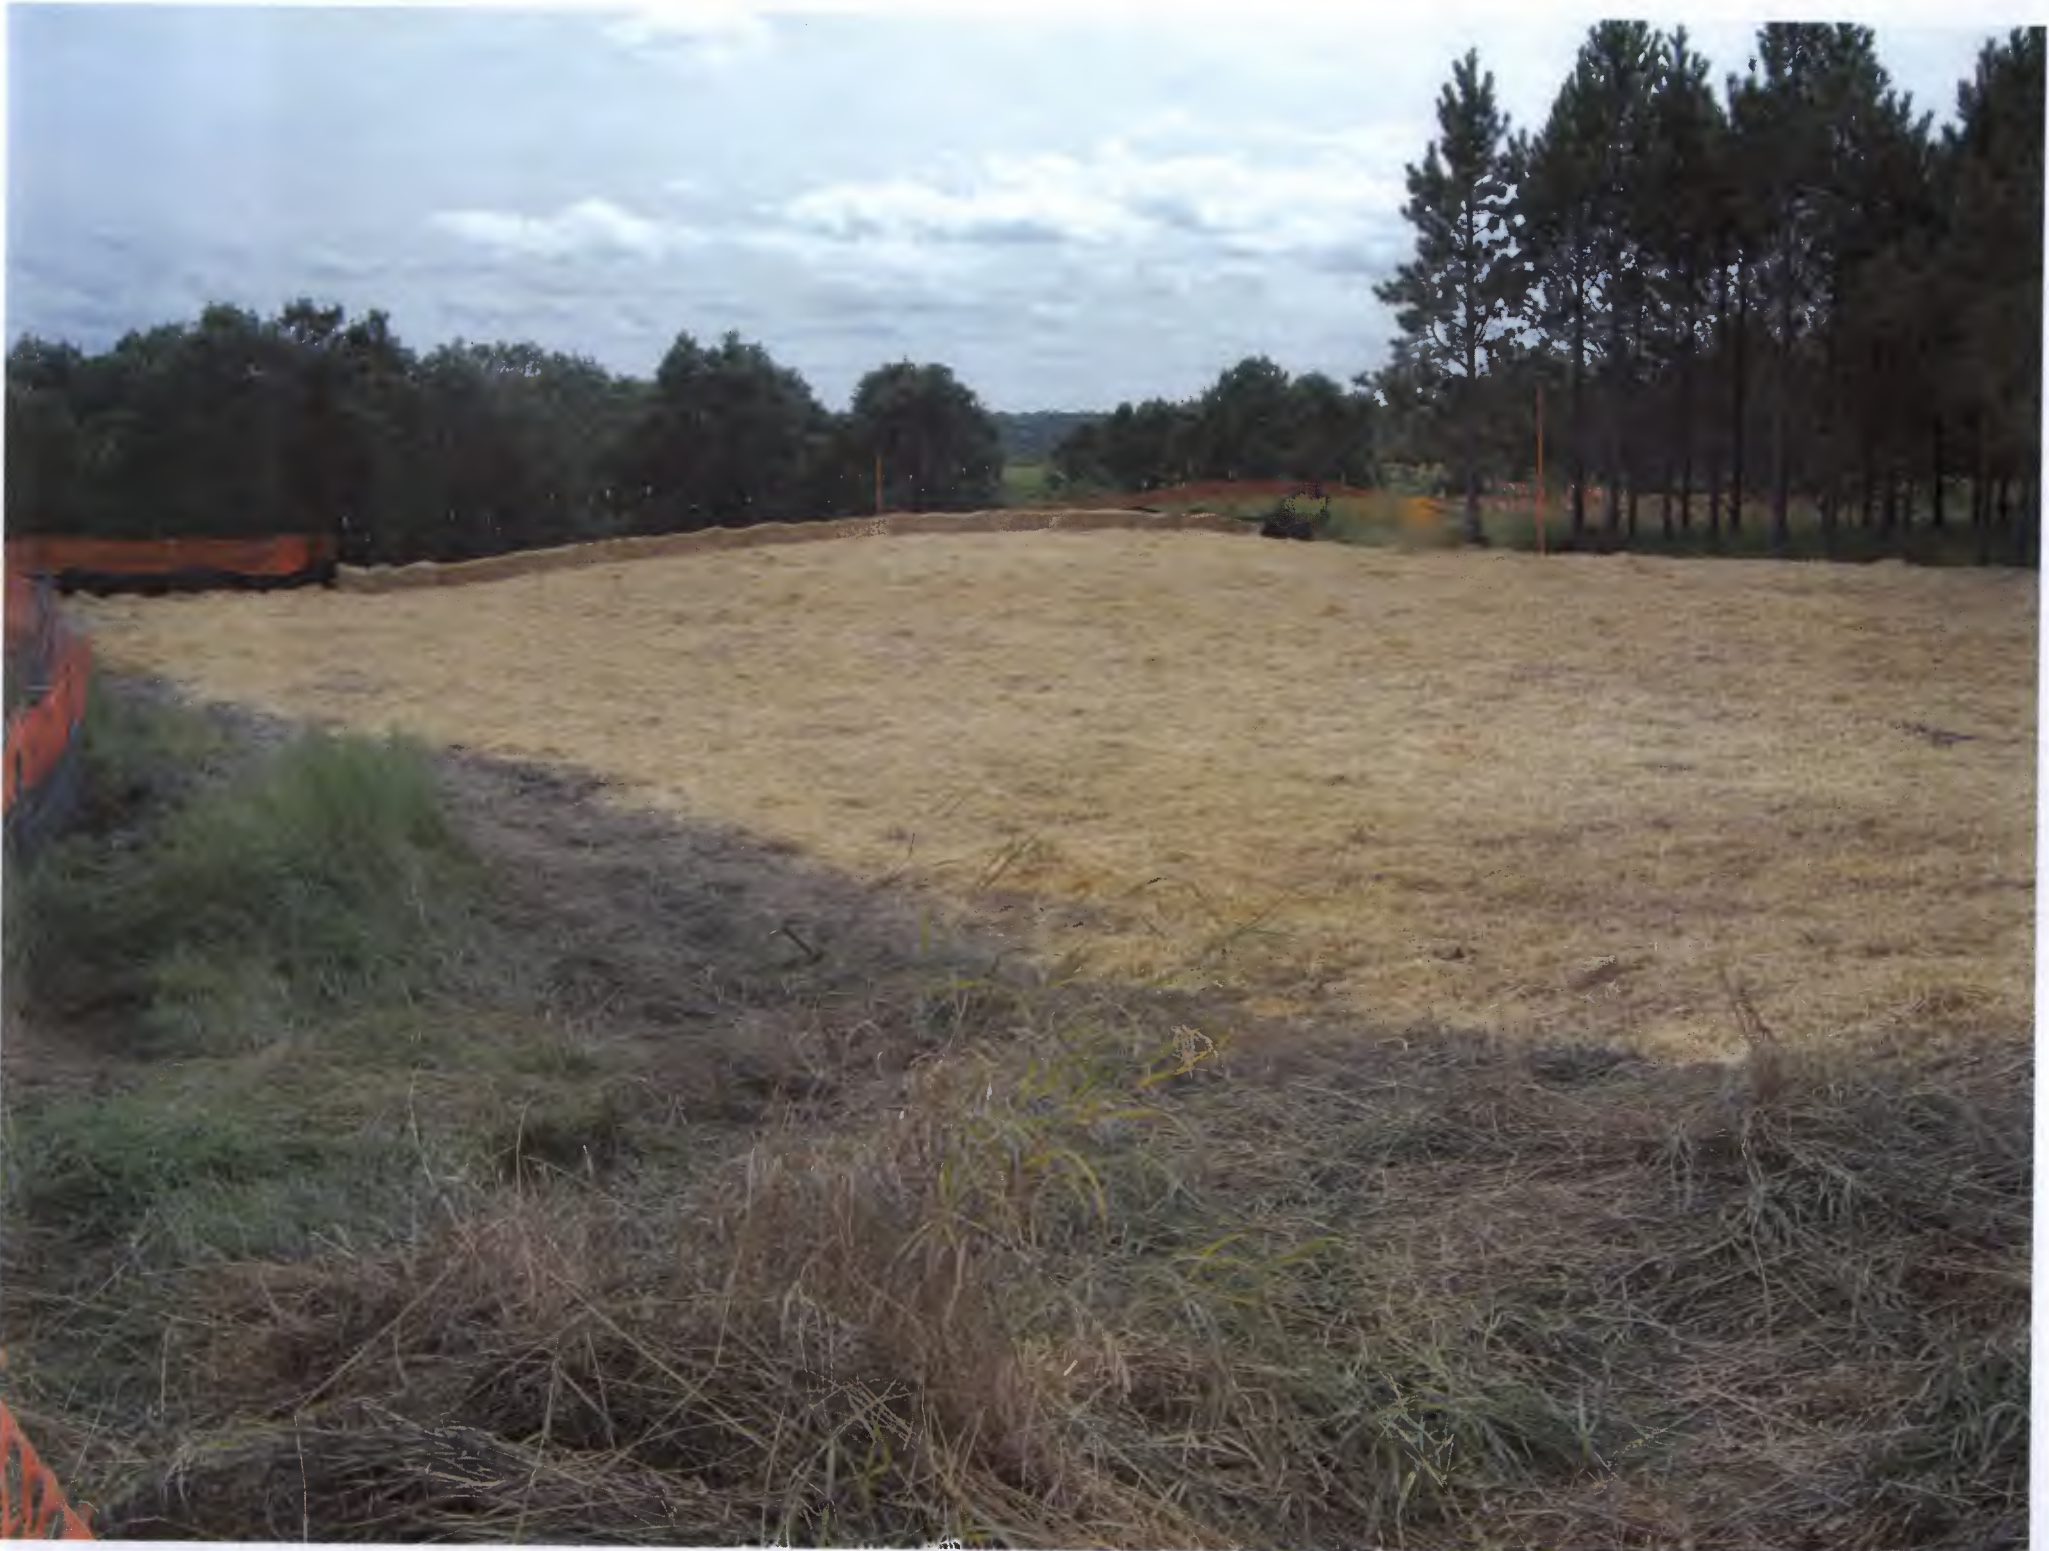
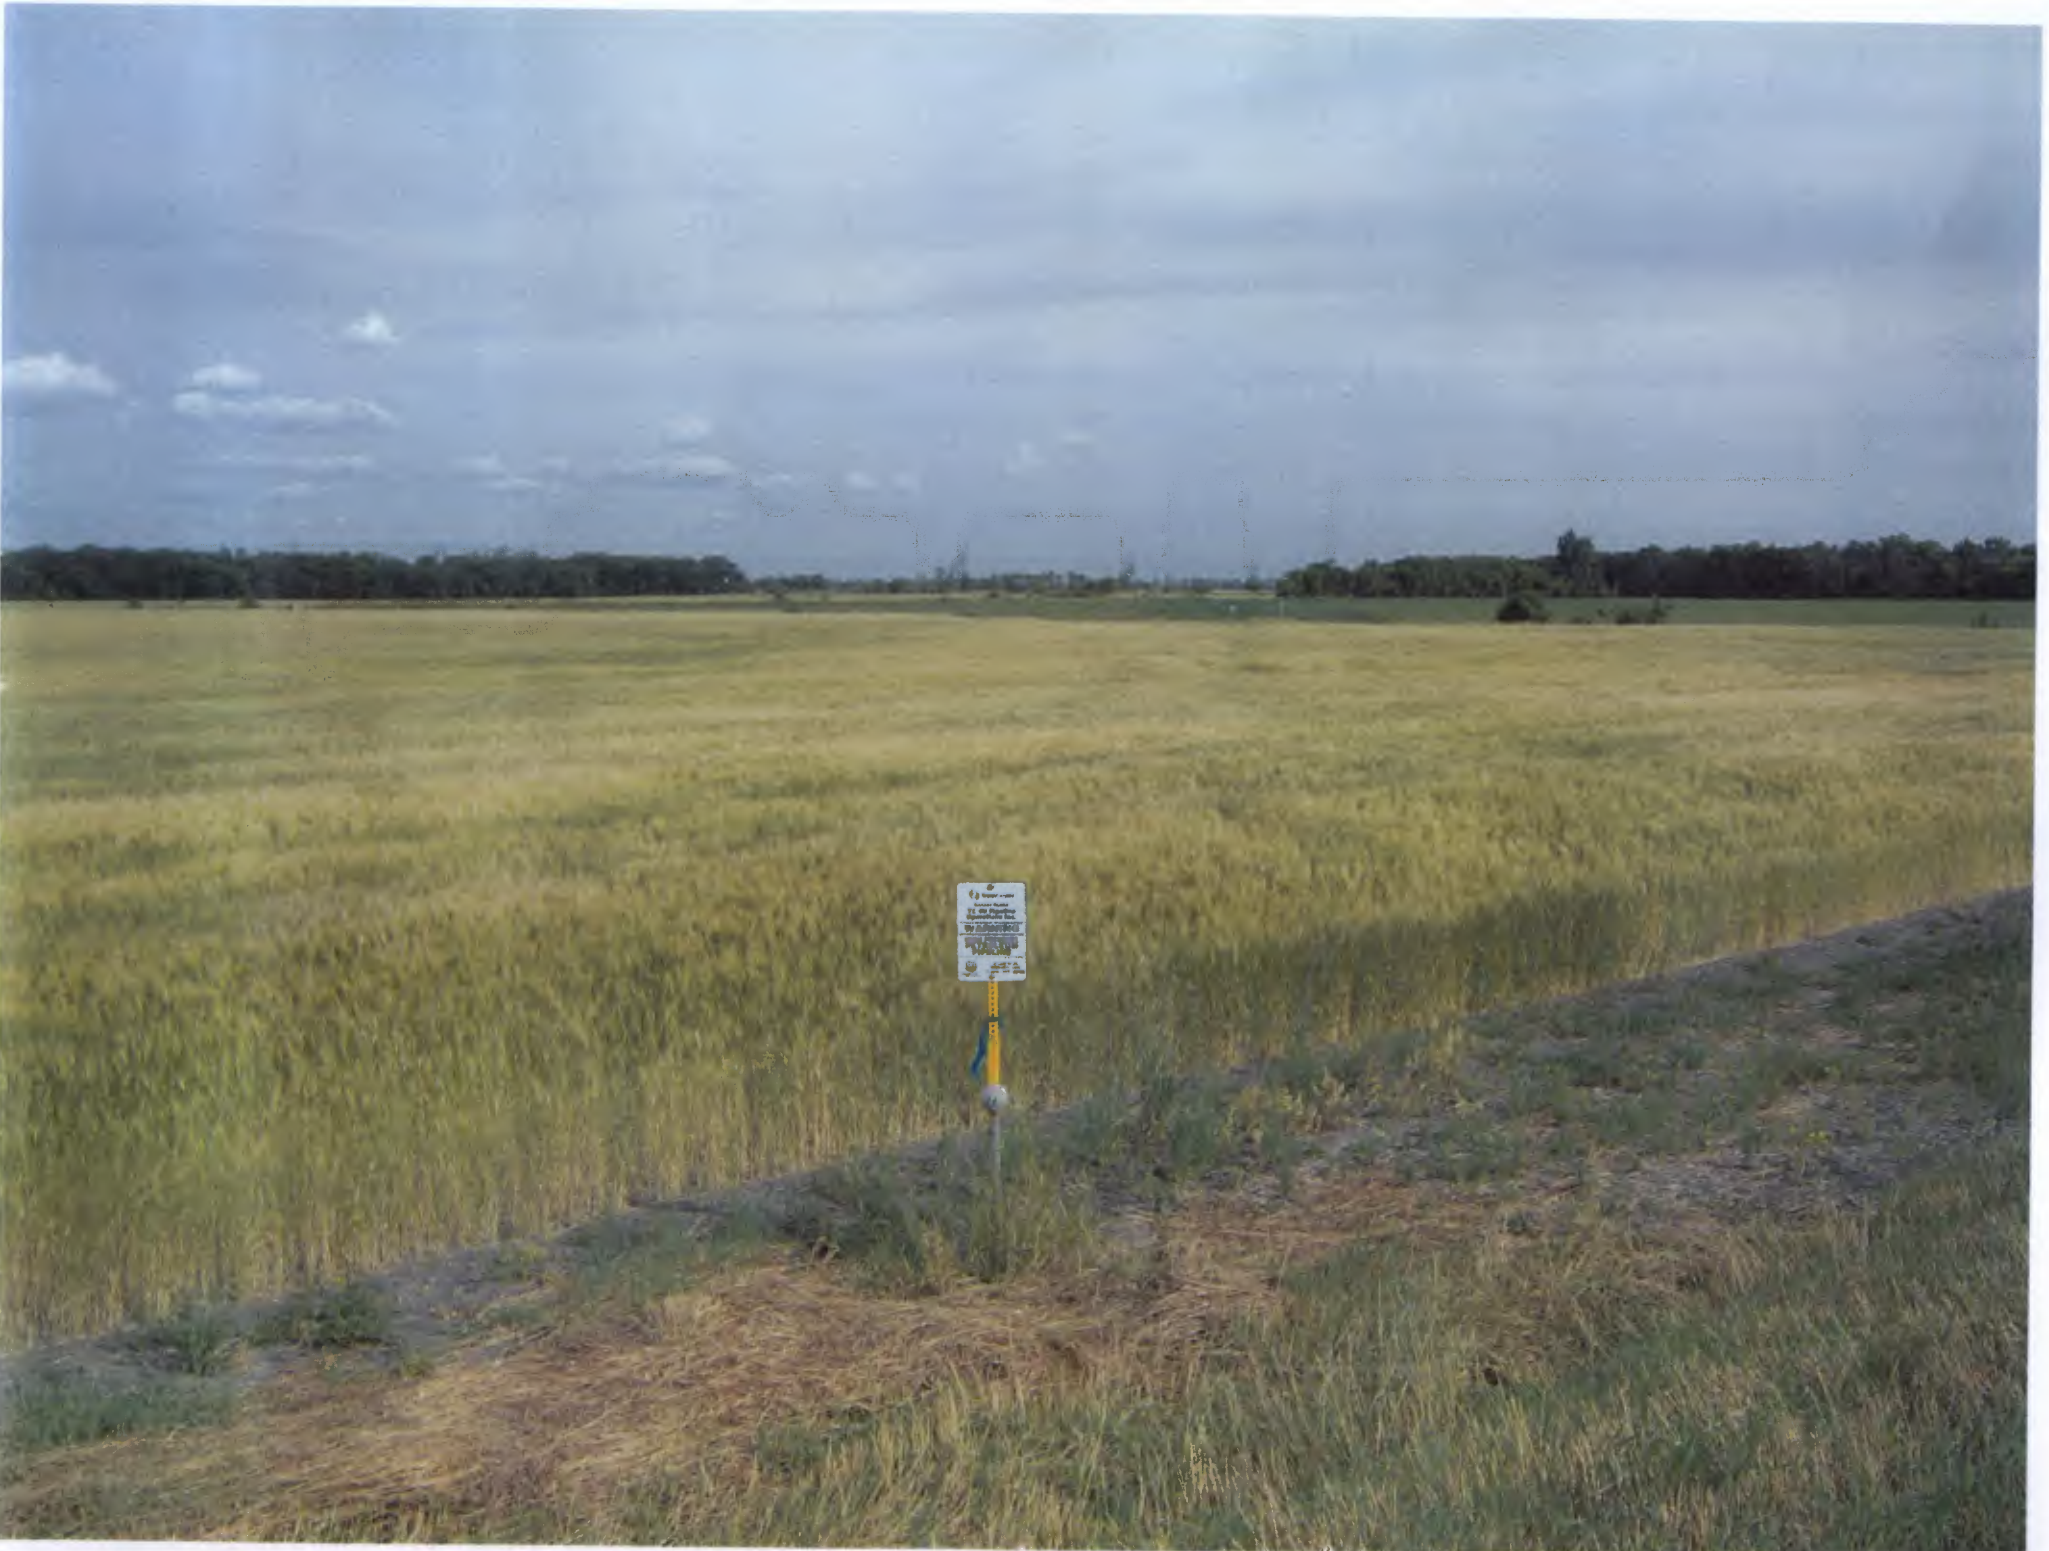
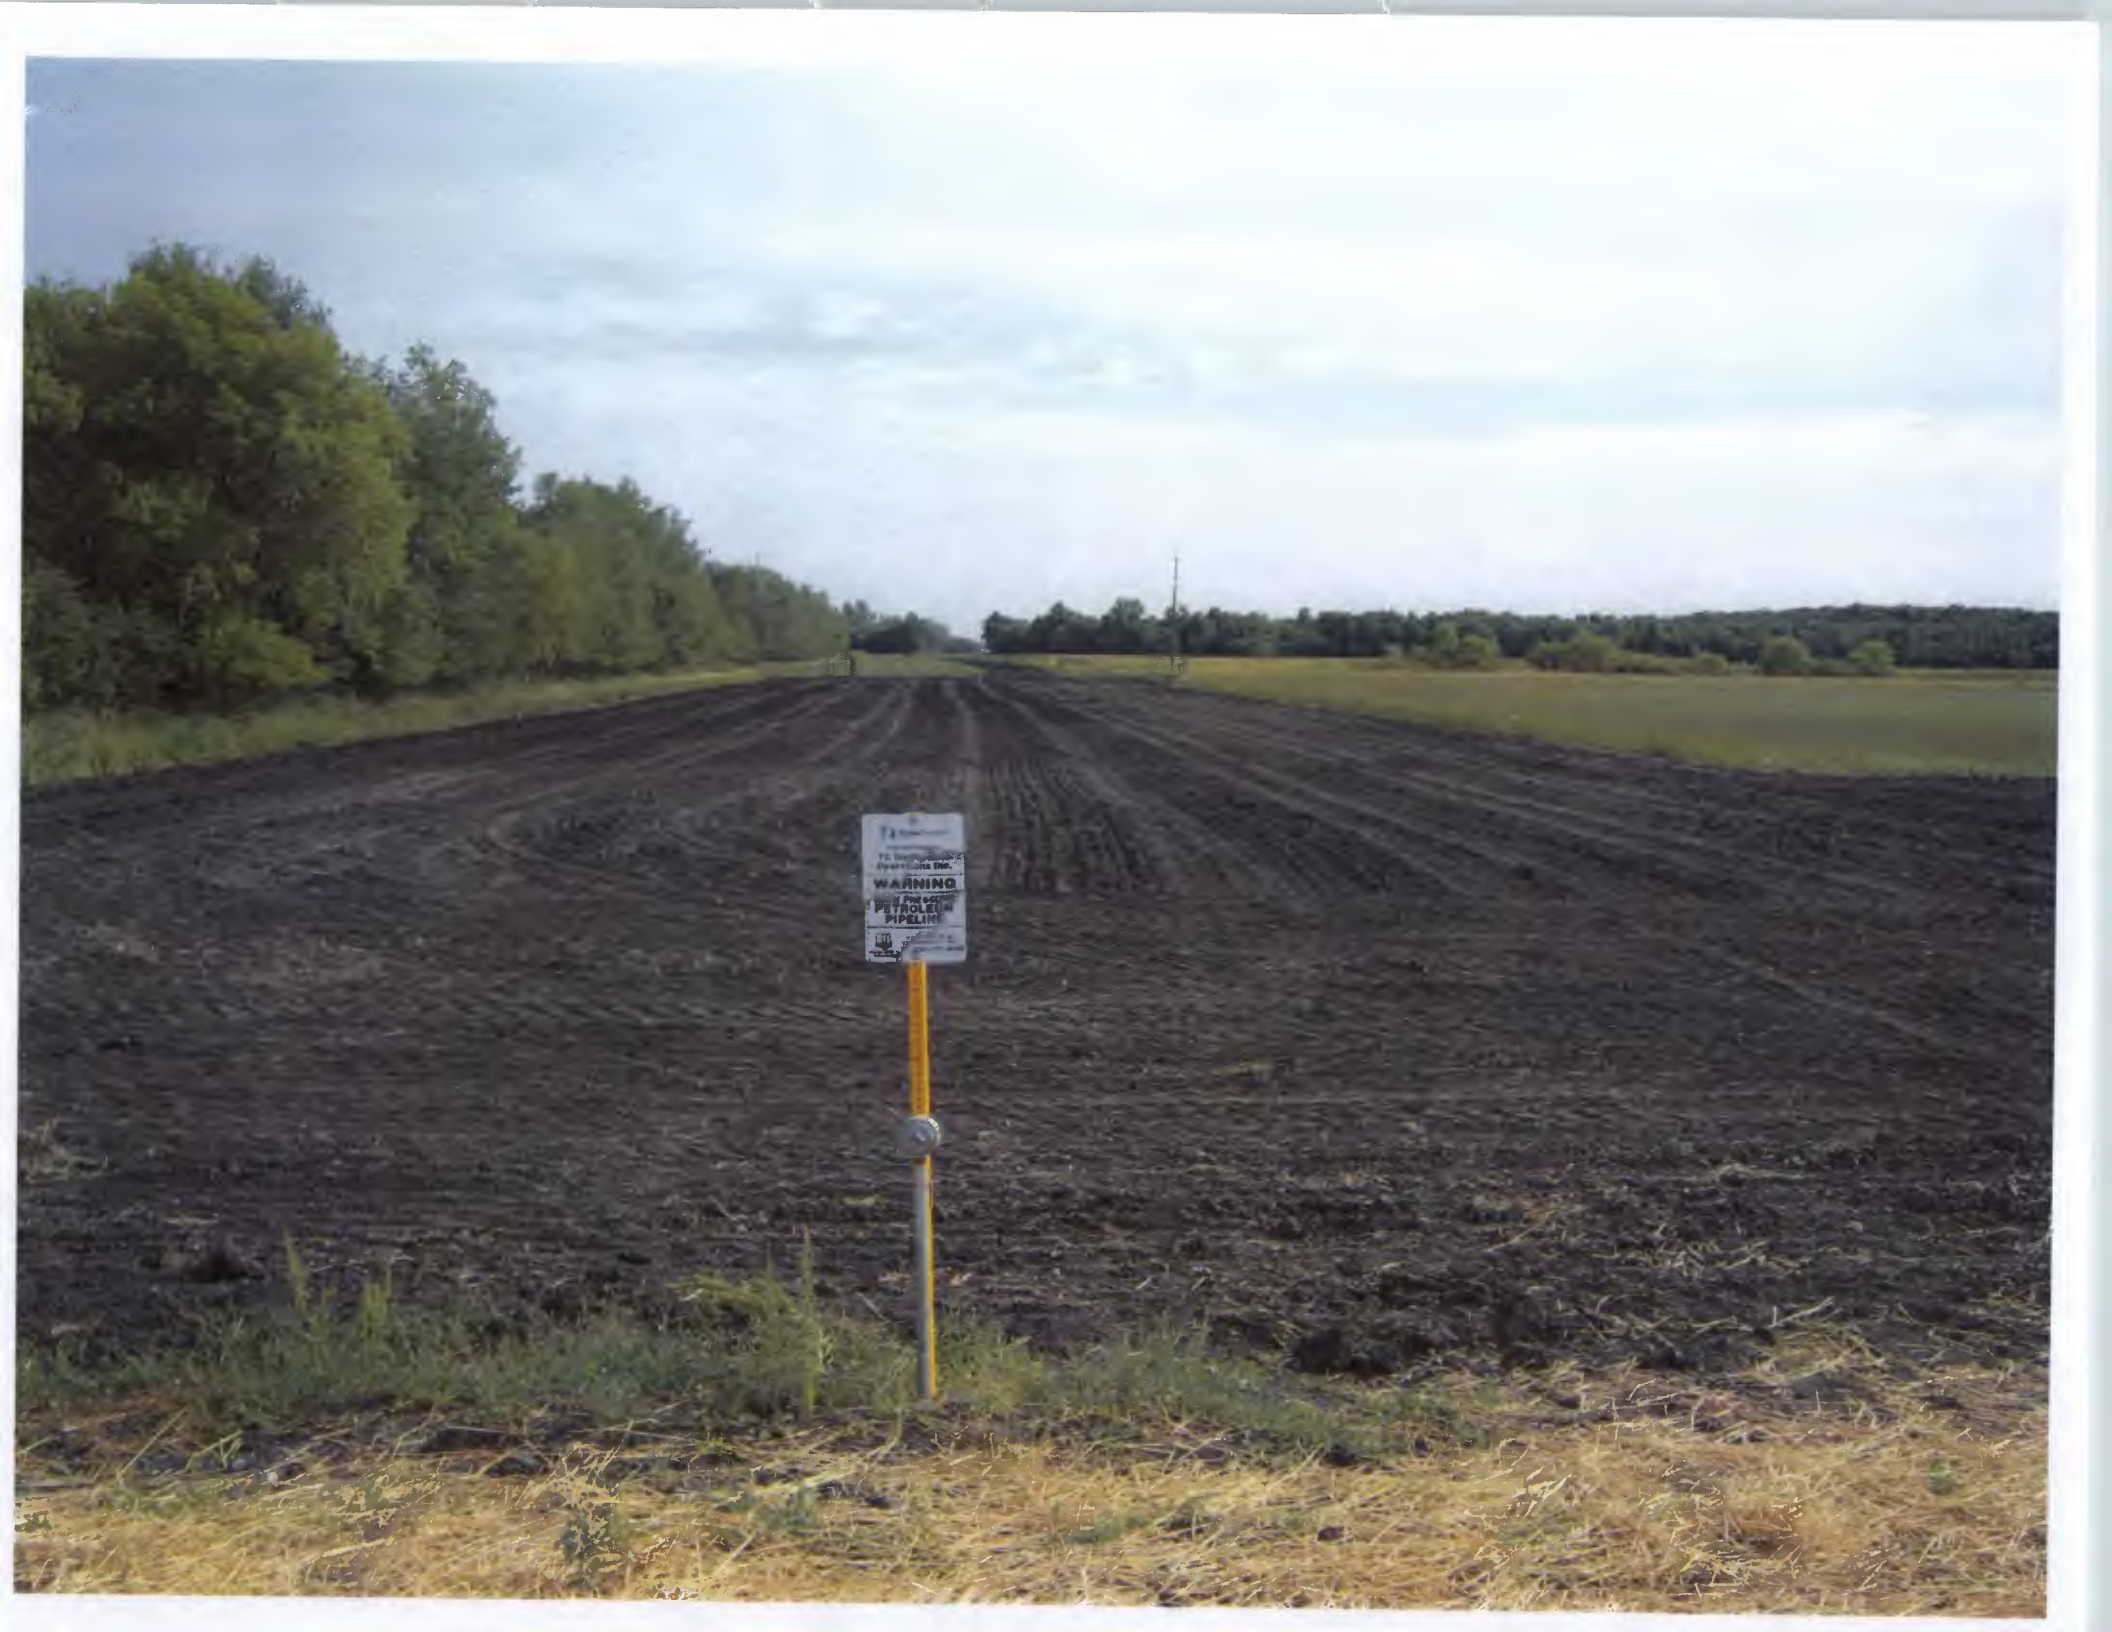
Attached is Dennis' report for the week of August 3, 2009. Also attached are several pictures from his site visit showing the remediation work on the sink hole areas and also a picture of the restoration work on the Belanus property. Please let me know if you have any comments or questions. Thank you.

Today I spent a majority of my time on Mi. 6 & 7. Although there is ample evidence of restoration elsewhere, the majority of workers have converged on Mi. 6 & 7 and are working to complete activities over the sinkholes that developed during last years boring activity. I spoke at length with Mike Waldenburg, Foreman for Michels Pipeline Construction concerning their involvement of the Sinkhole Remediation effort at Pembina Gorge. Michels began their work Aug 3, 2009. Removed trees from sinkholes. Suitable material meeting soil type (SP-SM) specifications (page 2 of TransCanada Draft report) was hauled from adjacent farmland North west of the site. Mr. Waldenburg said

The material was placed with a 65' boom excavator. Quantity placed .... approx 9250 cu. yds according to Mike Waldenburg. A layer of geo grid was placed near the top of the leveling layer. Topsoil was then placed on top of that material & was mounded approximately 2 feet higher than adjacent ground to allow for settlement & subsidence. The area was then seeded & mulched with silt fence being placed around the outer perimeter of the work area to control any potential soil erosion. A monument was installed near the center of each mounded sinkhole to assist inspectors in monitoring the settlement of material over these areas. The perimeter is also enclosed with orange security fence & warning signs to alert the public to the potential hazard within bounded area.
